**COMMITTEE FOR THE RE-INVESTIGATION
OF THE SMOLENSK AIR CRASH**

TECHNICAL REPORT

**Facts regarding the crash of the TU-154M No. 101,
(Fight PLF101), that took place in Smolensk, Russia on the 10th of April 2010**

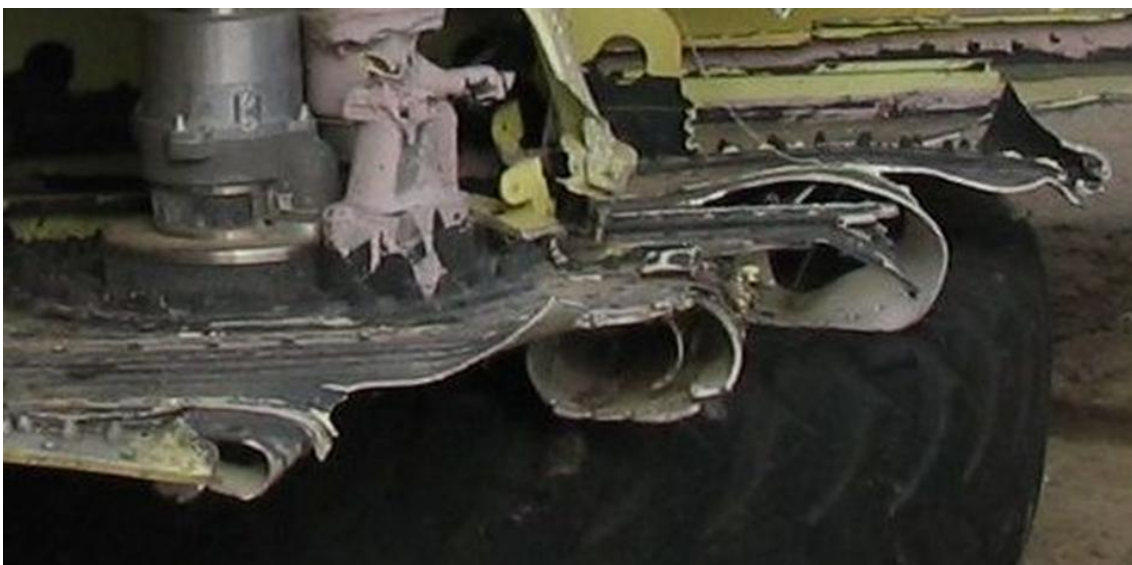
The wing tip shows a number of curls up to 450° seen as significant signs of explosion. In addition a long number of characteristic signs of explosion can be seen (Fig.2).

Fig. 2. Side view of the broken section of the left wing tip of TU-154M no.101 showing significant explosive signatures (curled edges of up to 450°).

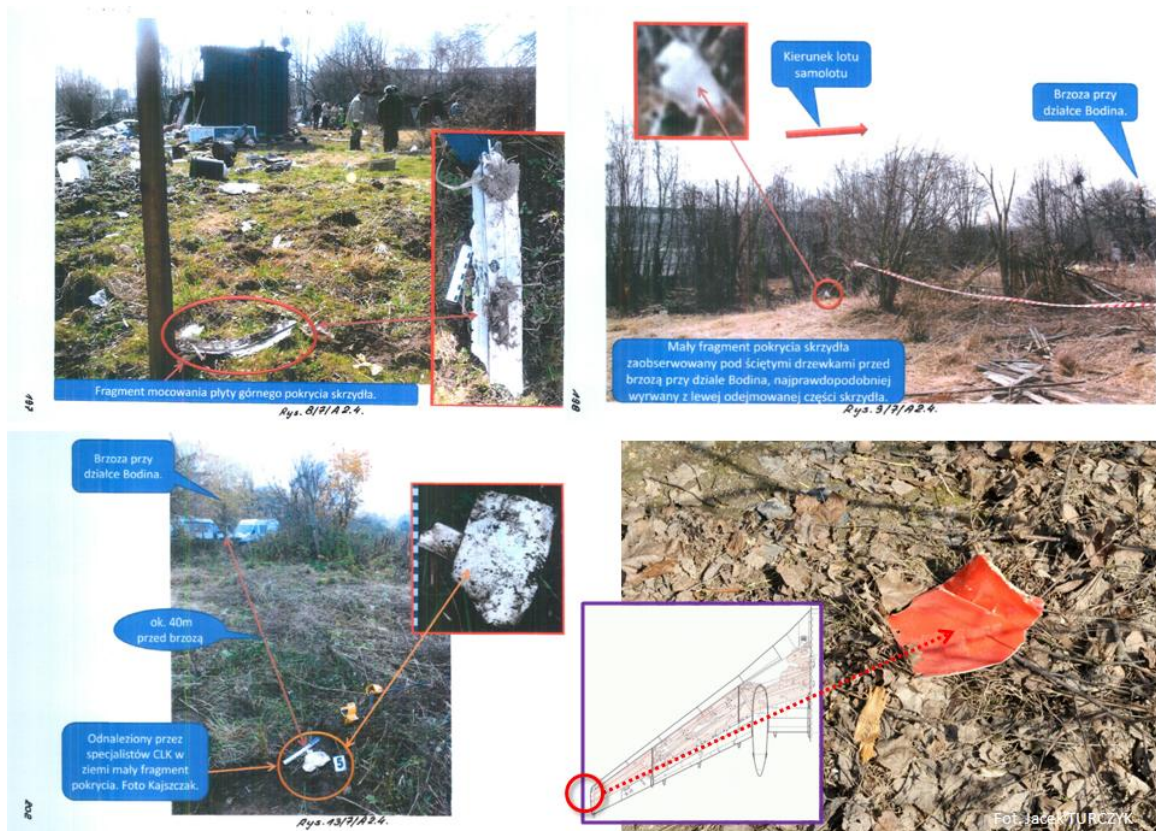
Many pieces of the left wing, in the vicinity of the Bodin birch (bb), were found in front of the tree in an area of 41 meters north and 17 meters south in the direction perpendicular to the flight direction, and 43 meters to the east of the tree (Fig. nr.3)

Fig. 3. Debris of the detachable part of the left wing identified by the Committee and experts of the Prosecutor's Office of the Republic of Poland.

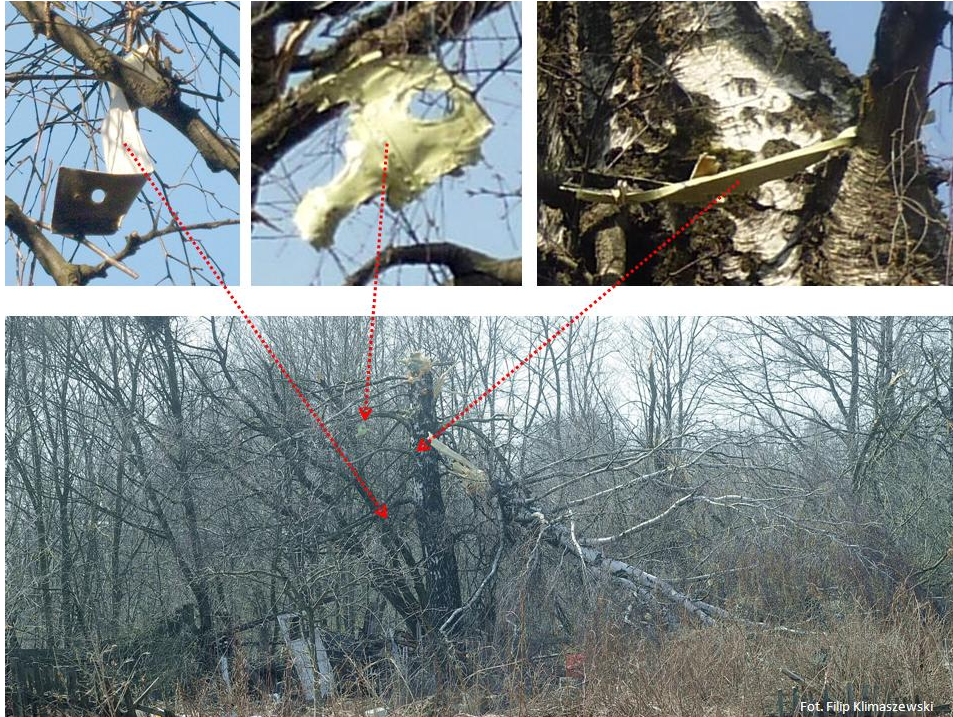
Three pieces of the detachable part of the left wing were hanging on the branches of the so called Bodin birch (Fig.4).

Fig. 4. Identified pieces of the detachable left wing part hanging on April 10, 2010 on the branches of (Bodin) birch tree claimed to have cut the wing (noted "bb").

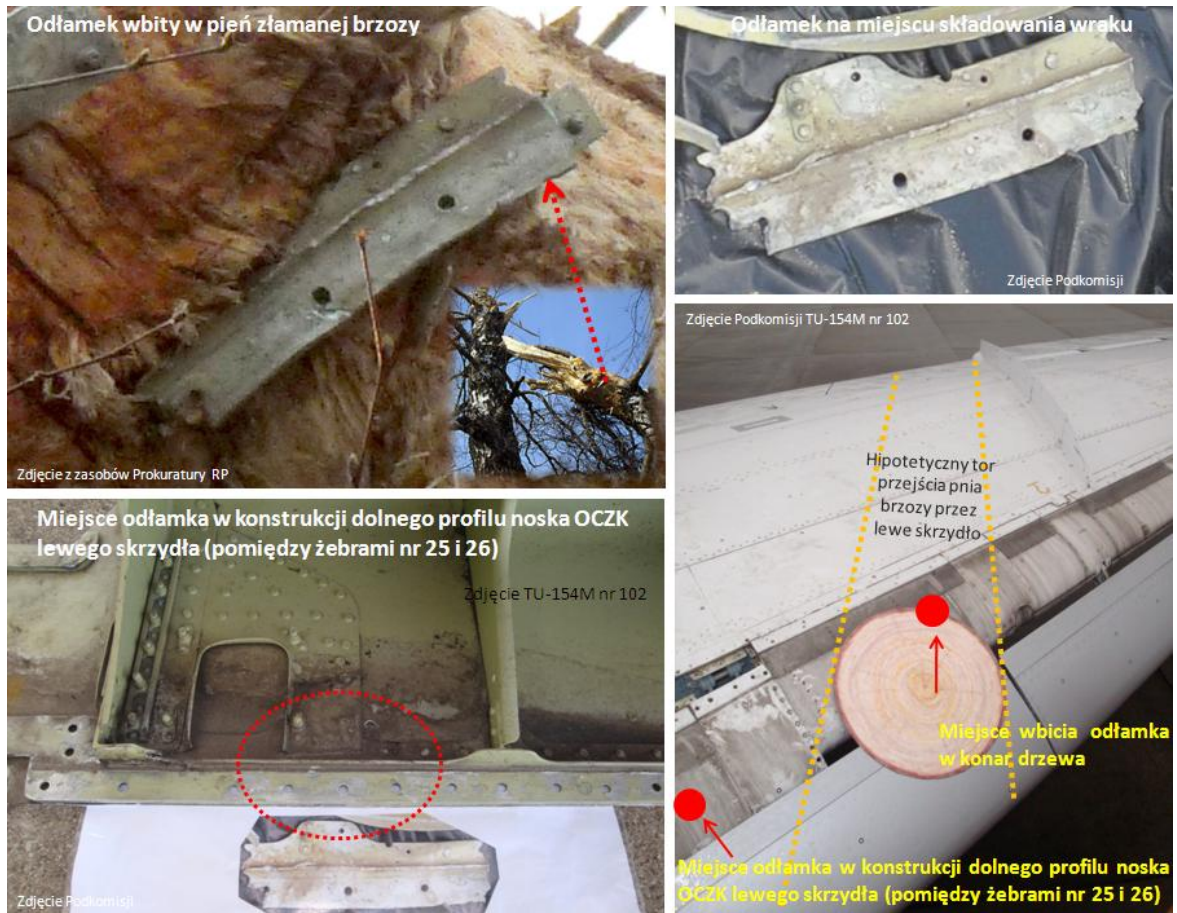
Fig. 5. The place in the wing construction of the piece rammed into the so called Bodin birch tree.

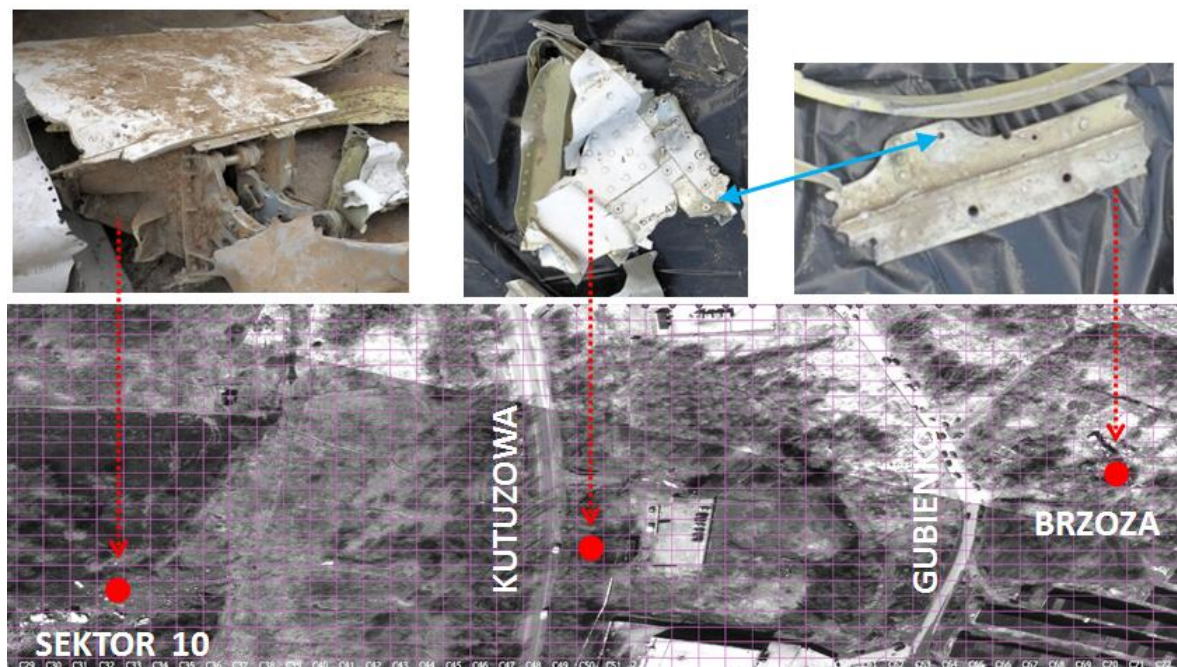
A piece of the skin of the nose, to which the piece rammed into the birch tree trunk was attached, was identified over 200m further in the direction of flight-next to the Kutuzov street. A fragment of the spar, to which this piece was attached, was identified 400m further in the direction of flight in sector 10. (Fig. 6).

Fig. 6. Position on the ground of neighboring elements in the wing construction to the debris rammed into the trunk (bb).

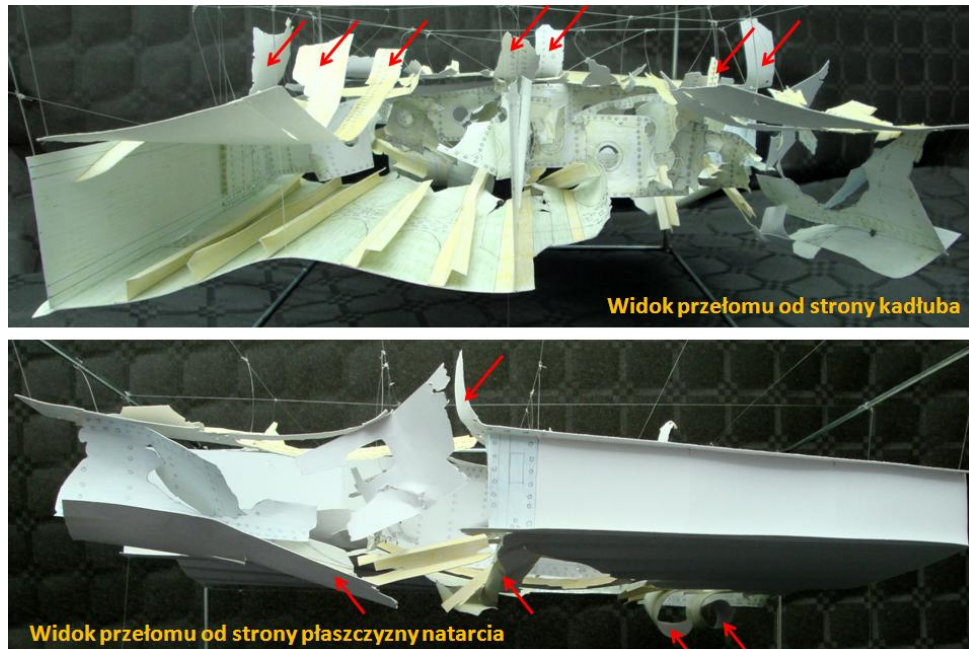
In the area of damaged pieces bent in the opposite direction to the flight direction the presence of buckling and bandings due to an impact against the terrain obstacle was stated. Elements of the skin of the left wing, which according to the MAK and Miller reports were supposed to have contact with the bb tree were torn off and bent outwards; upper side bent upwards, bottom side bent downwards. (Fig. 7).

Fig. 7. Place of separation of the left wing tip. Places in the outer and bottom skin have been marked with red arrows, which have been bent outwards.

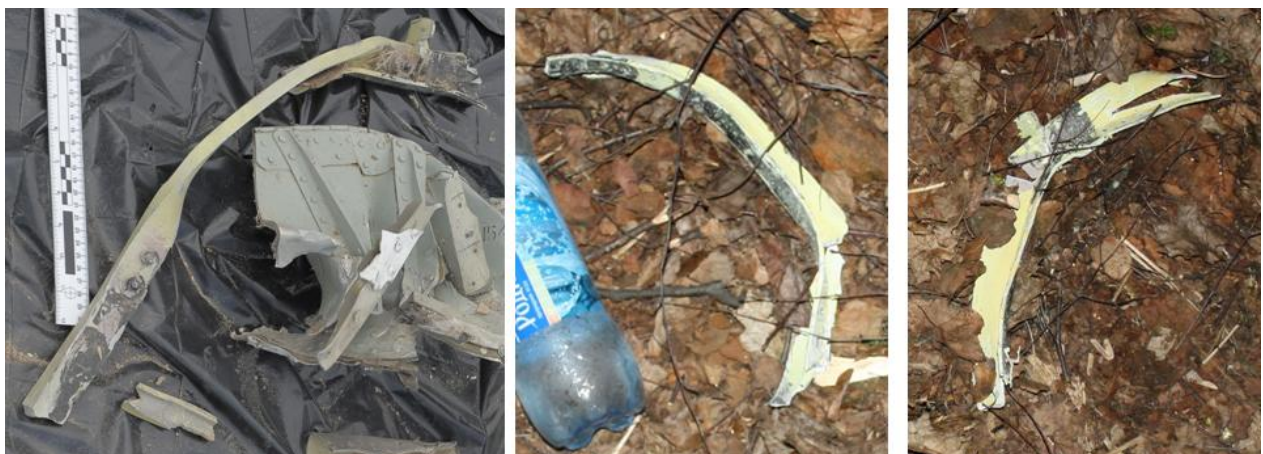
Fig.8. Pieces of stringers of the left wing curled outwards

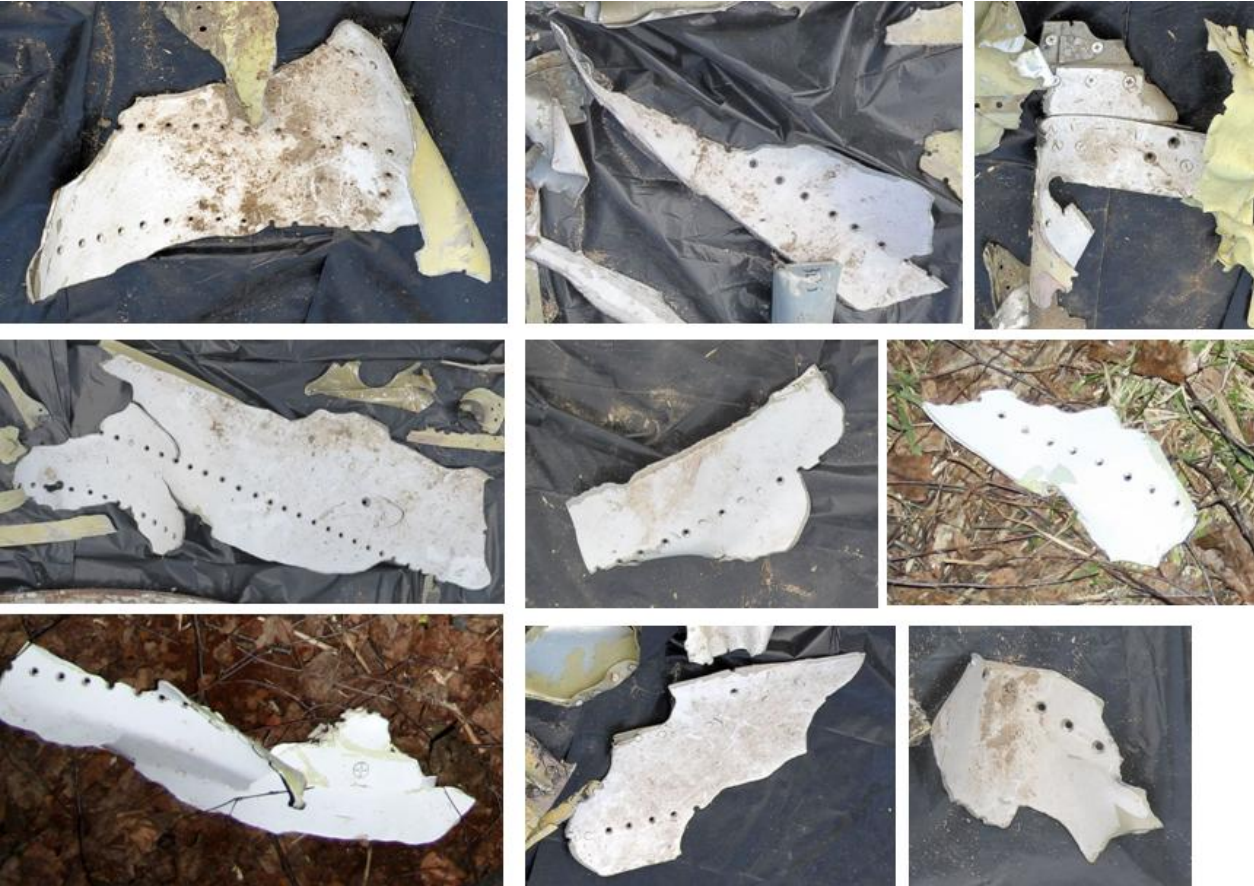
Elements of the plating of the removable part of the left wing, which according to MAK and Miller reports were supposed to have contact with (bb), were ripped out and bent outside the structure; on the surface upwards (Fig. 9), on the bottom surface downwards (Fig. 10).

Fig. 9. Pieces from the top skin curled outwards.

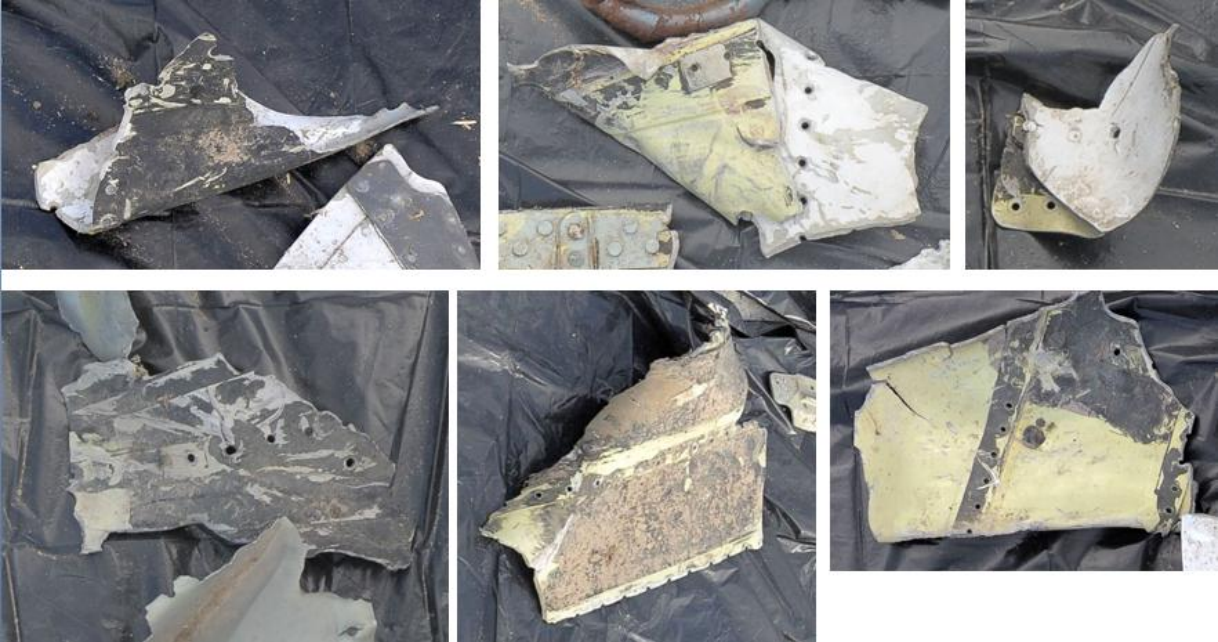
Fig. 10. Fragments of the bottom skin curled outside the structure.

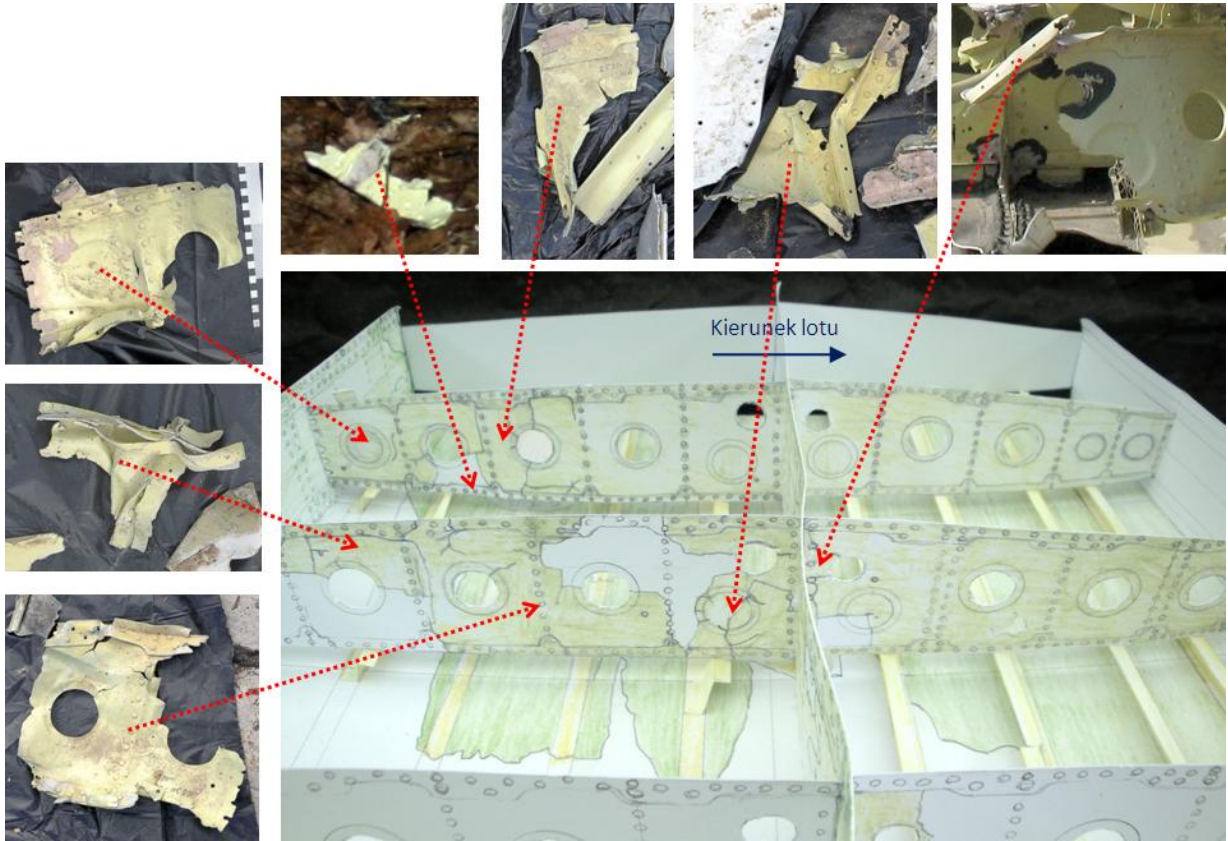
Some pieces of the left wing rib, which according to the MAK and Miller reports were supposed to have had contact with the bb tree, were torn off the construction (Fig. 11)

Fig. 11. Condition of the ribs of the left wing according to the reconstruction made by the Committee.

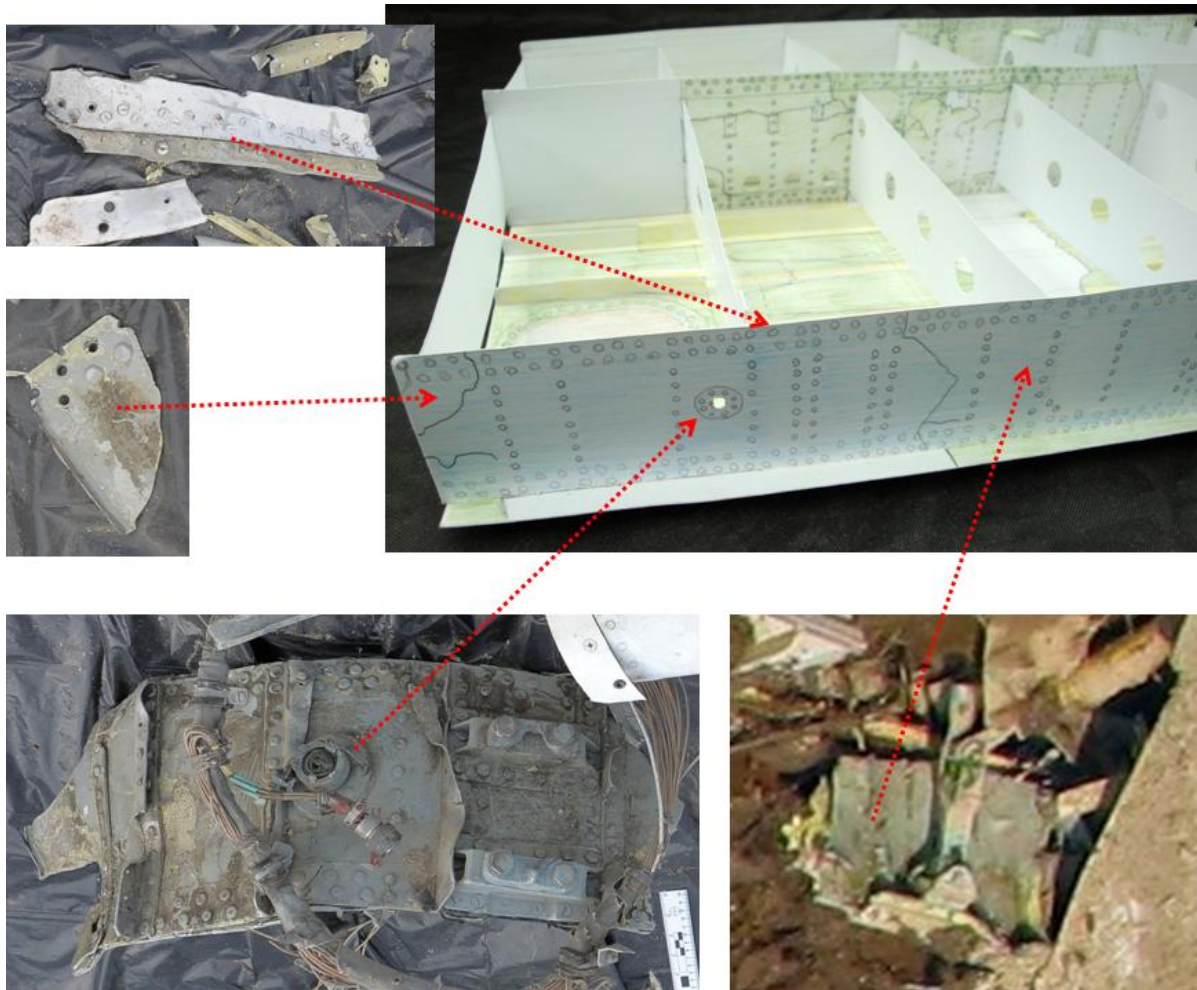
Fig. 14. Condition of the third spar of the left wing according to the model reconstruction made by the Committee.

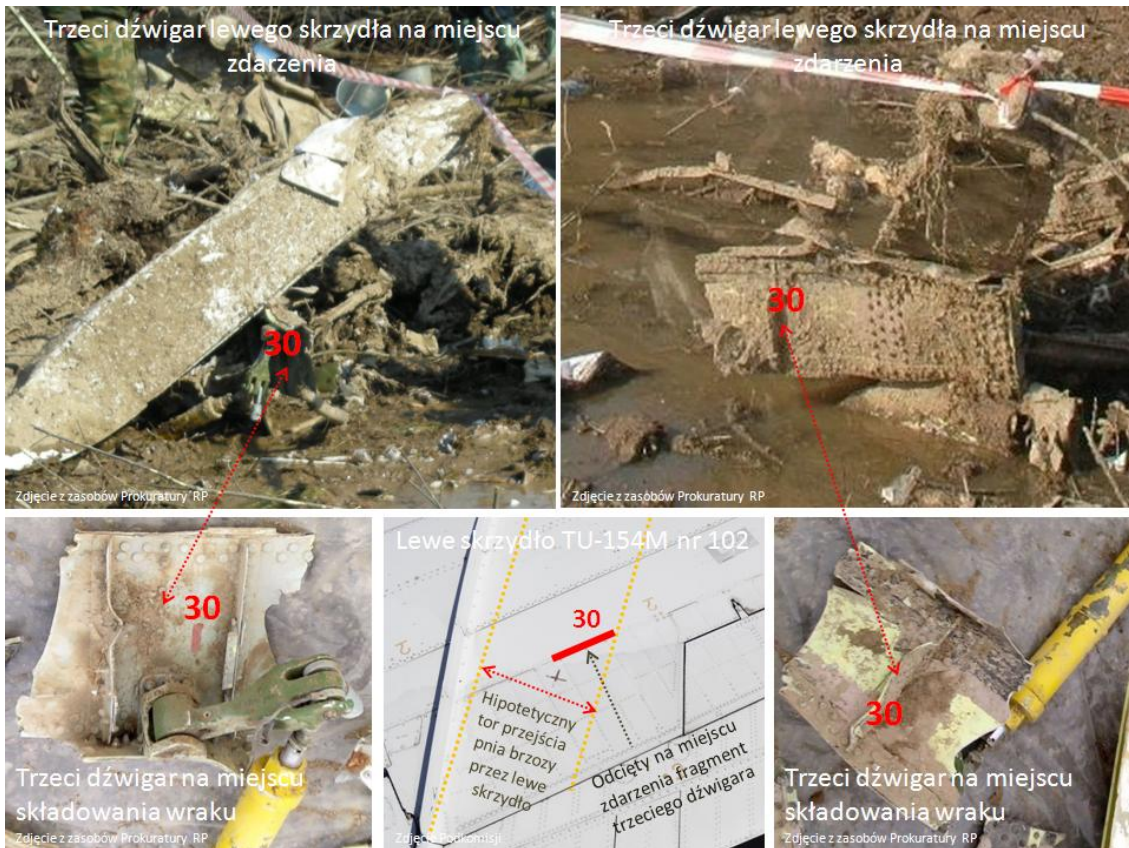
A fragment of spar no.3 of the left wing, which according to the MAK and Miller reports was supposed to be cut by the so called bb tree, was found on the main crash site 450m behind the birch tree and then cut. Its separated pieces were found in various places of the debris storage place (Fig. 15)

Fig. 15. View of the same part of spar no.3 from the detachable part of the left wing on the main crash site and place of storage of the debris.

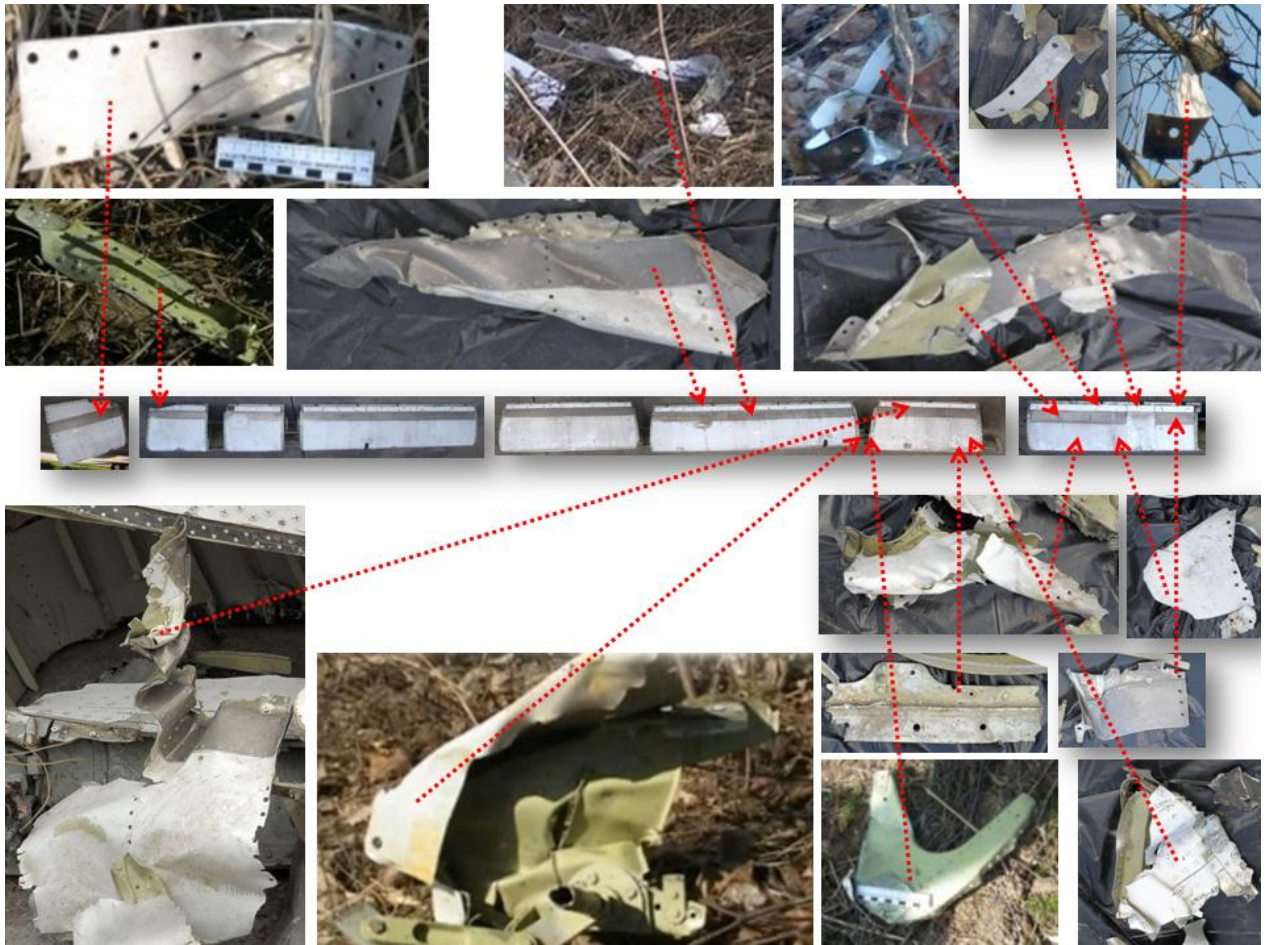
Some elements of the nose of the left wing, which according to the MAK and Miller reports were supposed to have had contact with the so called bb tree, were torn off or bent outwards (Fig. 16)

Fig. 16. Condition of the nose of the left wing according to the model reconstruction made by the Committee

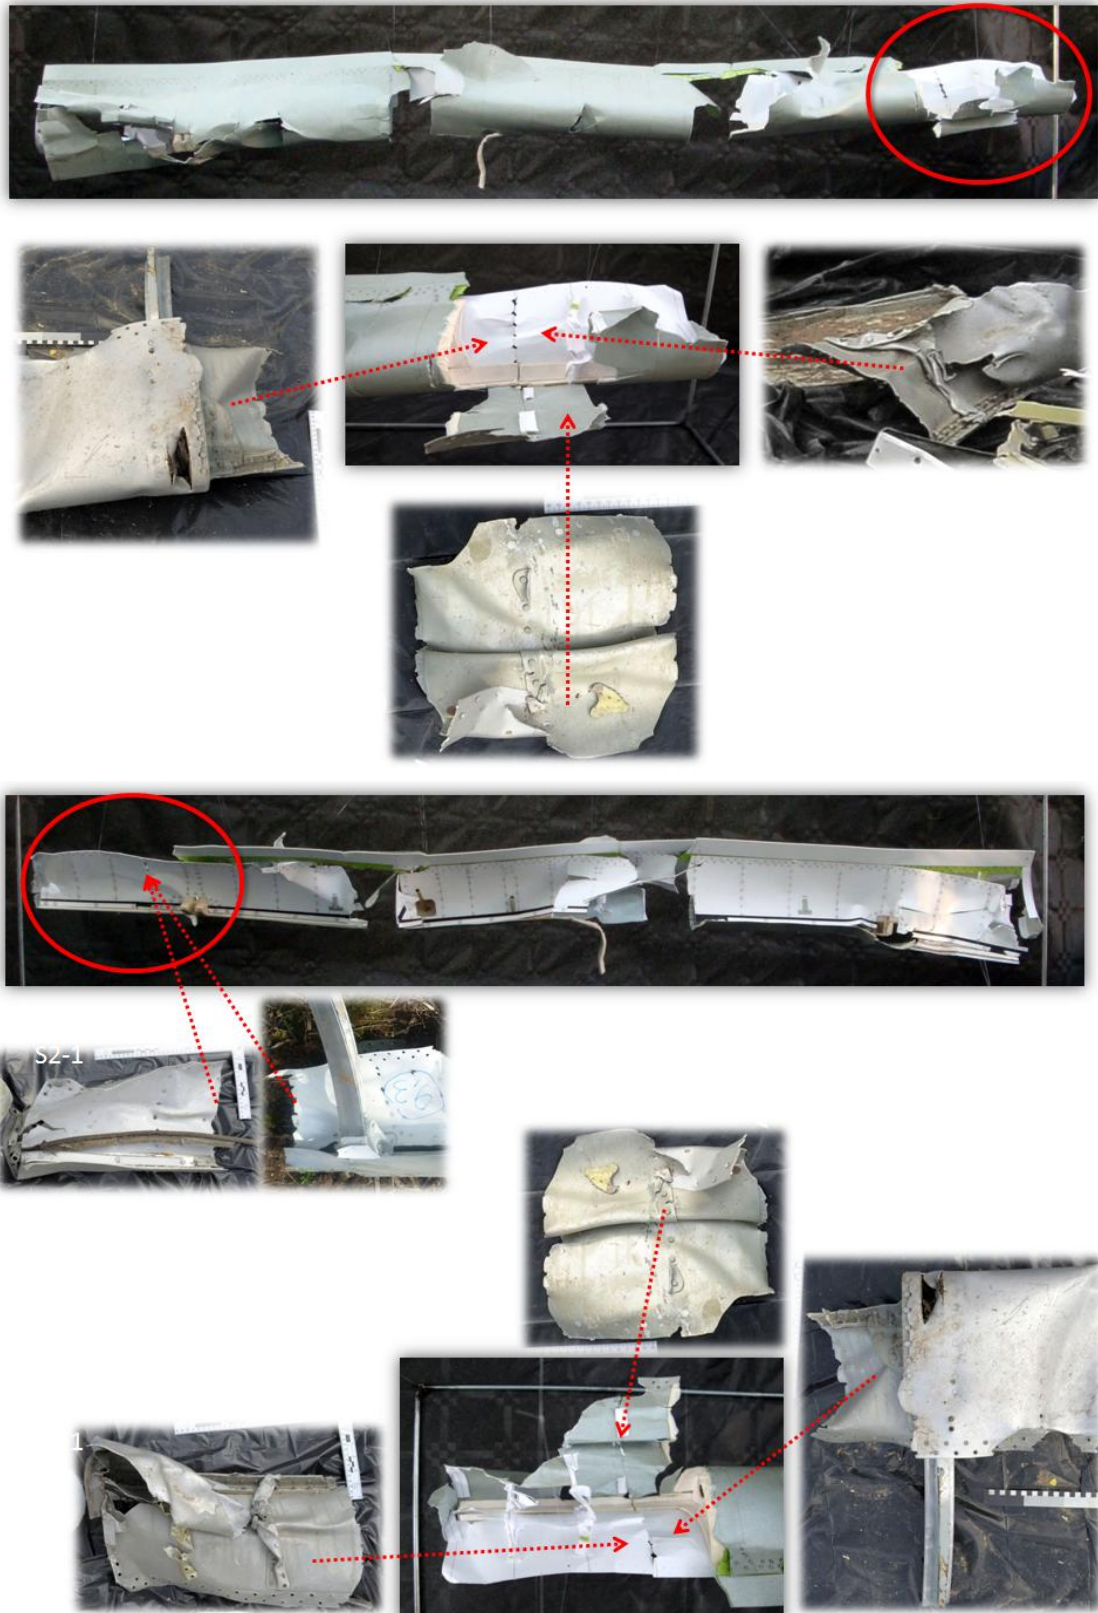
Some pieces of the second section of the left wing slats, which according to the MAK and Miller reports were supposed to have had contact with the so called bb tree, were torn off or bent outwards; upper side upwards and bottom side downwards, and from the side of the angle of attack to the front (Fig. 17).

Fig. 17. Condition of the second section of the left wing slat according to the model reconstruction made by the Committee

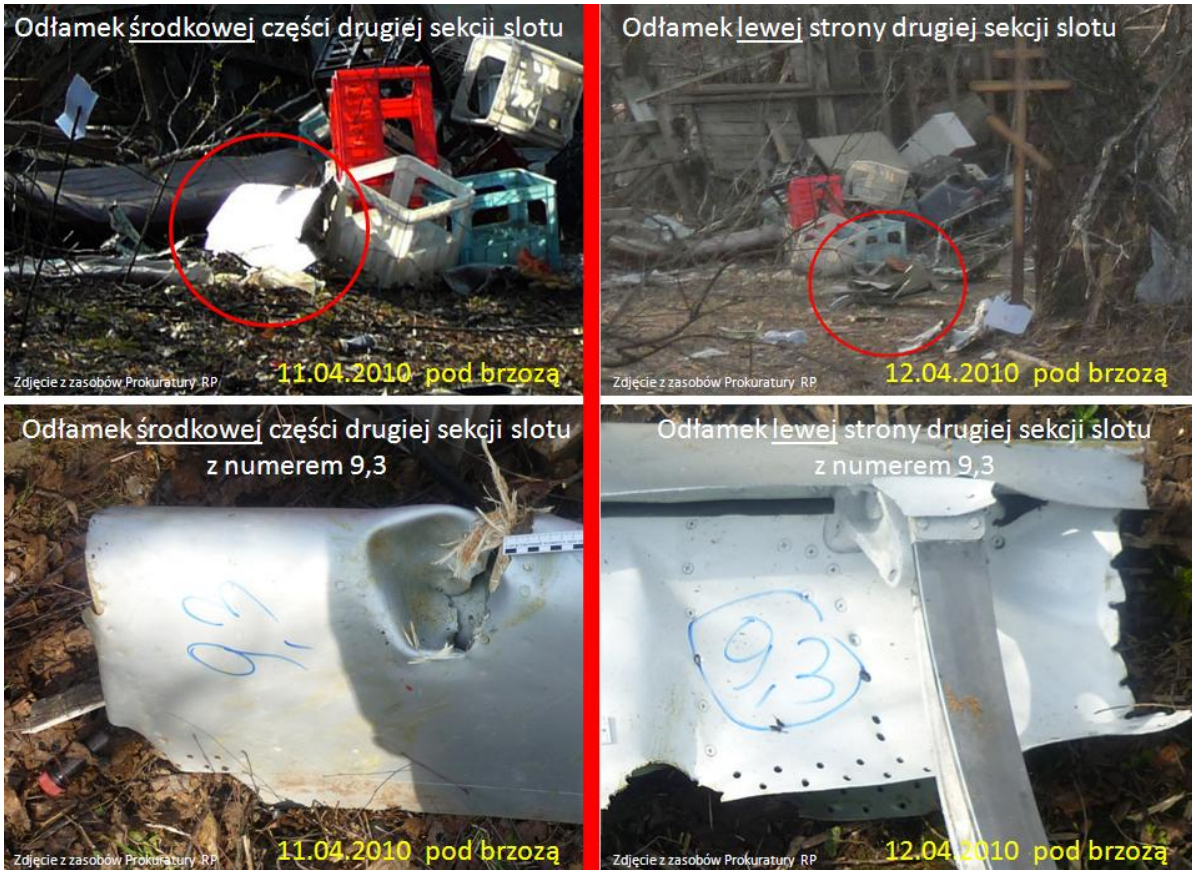
Fig. 19. Fragments of 2 sections of the slot moved from the original location on the ground under the tree claimed to have made contact with the wing.

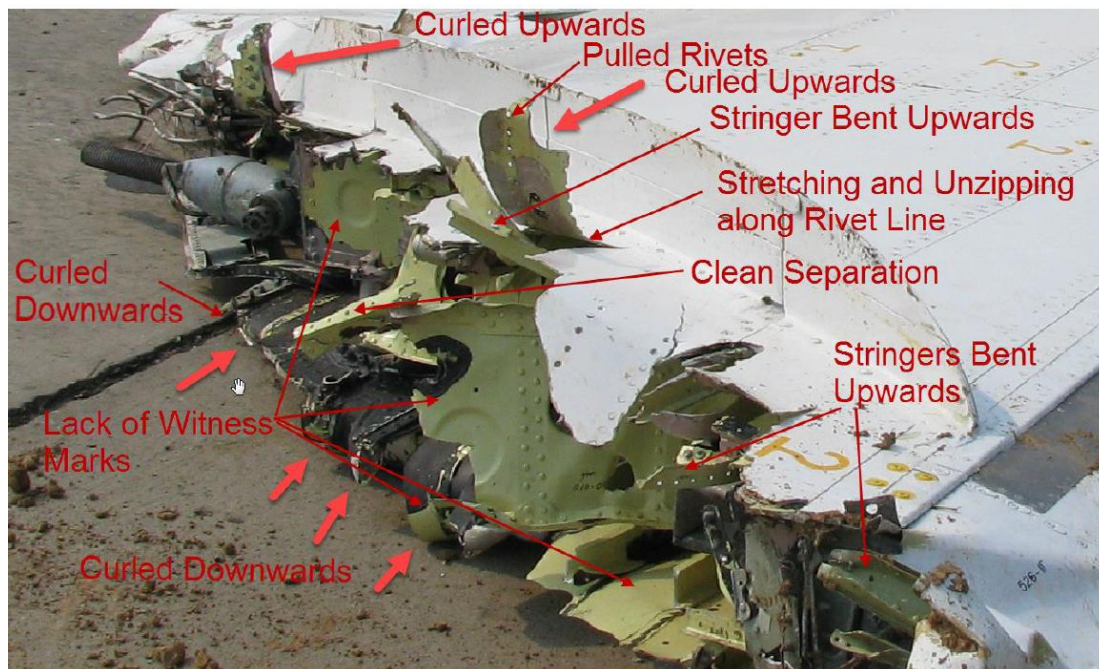
The separation place of the left wing tip shows classical post-explosive signatures typical for the use of explosive materials, like irregularly curled edges with more than one turn. The broken area of the left wing tip shows a large number of the characteristic signs compatible with high internal pressure such as zipping of rivet lines, pulling of rivets and clean separation of skin from the remaining parts. (Fig. 21 and Fig.22).

Fig. 21. The area of separation of the left wingtip of TU-154M, PLF101 showing the classic and significant signs of explosion and an additional number of characteristic signs of an explosion.

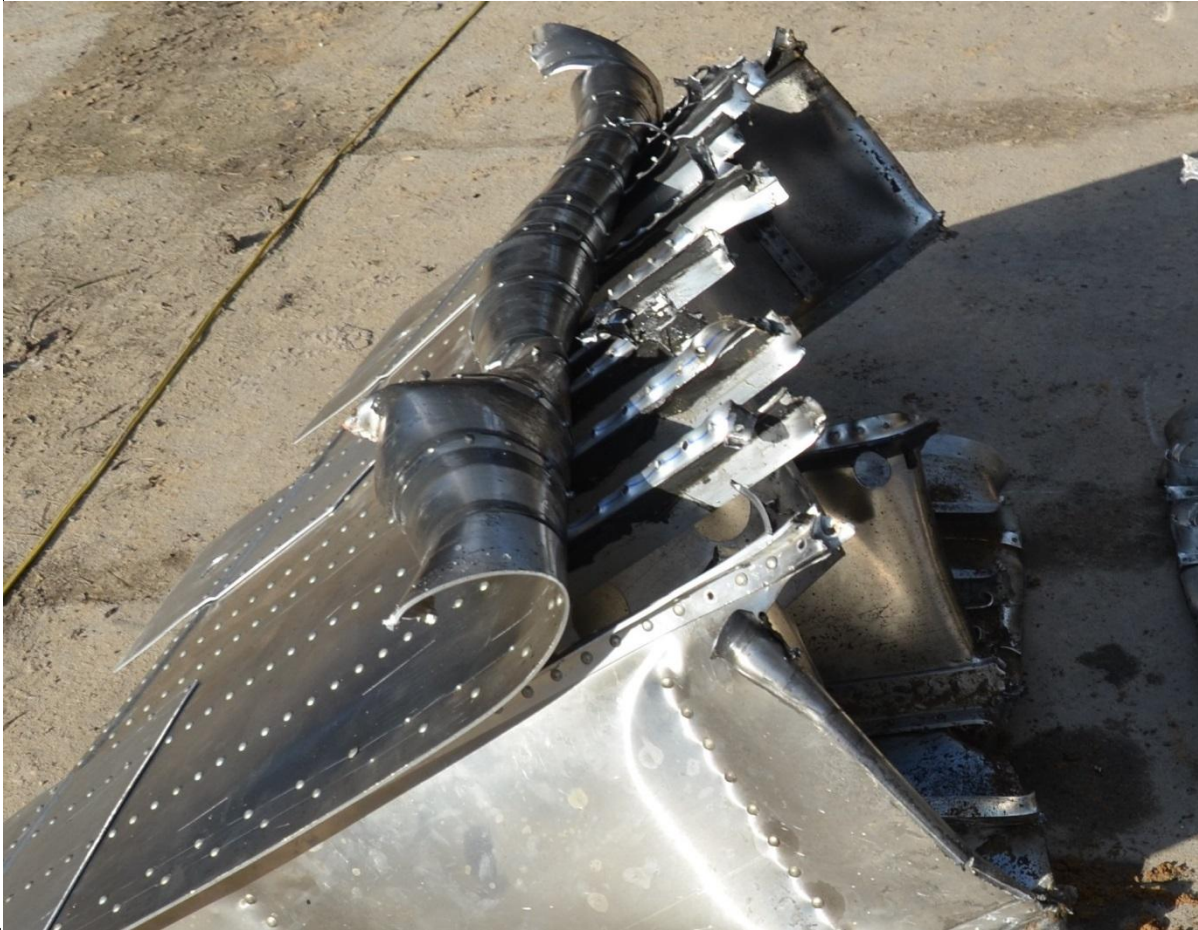
The experiments carried out by the KBWLLP Committee in March 2018 on the wing fragment model in the scale 1: 4 and 1: 1 show that the wing with fuel and fuel vapors can be destroyed by explosive charges with similar features of destruction of the structure without a major fuel explosion with many observed features similar to the wing tip in Smolensk. (Fig. 23 and Fig. 24)

Fig. 23. Scale 1:1 Separation by explosive material of the wing box containing fuel. The experiment demonstrated the wing could be cut without a secondary major fuel explosion.

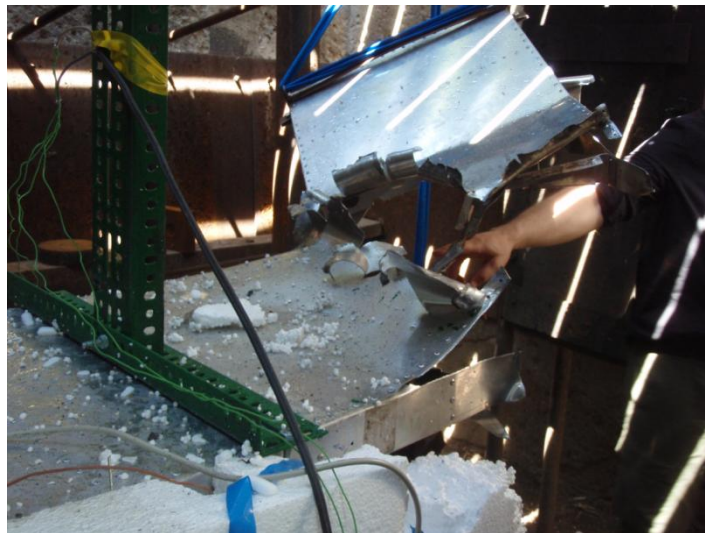
Fig.24. Experiment of cutting the wing model on a 1:4 scale with fuel, with the use of 6g/m PETN Cord Note the direction of curls away from the area of high internal pressure. The experiment demonstrated the wing could be cut without a secondary major fuel explosion.

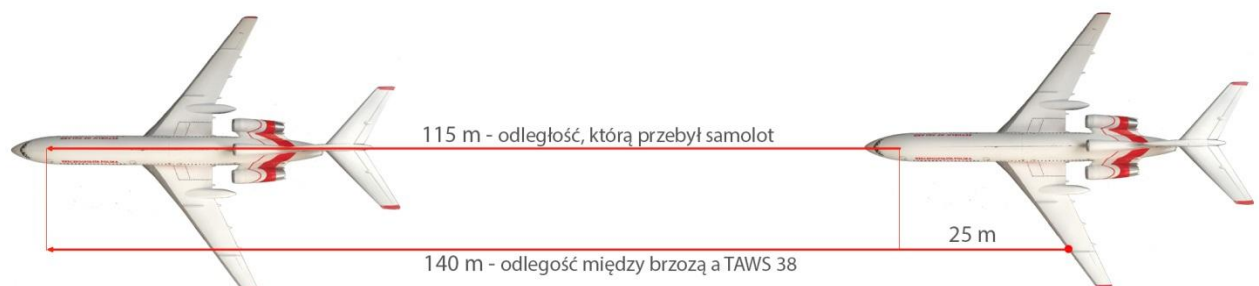
The distance between the so called bb tree and TAWS38 is approx. 140m. The distance that the plane traveled between the places of supposed contact of the wing with the bb tree, as assumed in the Miller and MAK reports, and TAWS 38 was 115m.

Fig. 26. The difference in distance from the tree, that is claimed to have made wing contact with TAWS38 (140m) and the distance that the plane travelled (115m). The distances are different as the GPS antennas are located 25m in front of the hypothetical zone of contact.

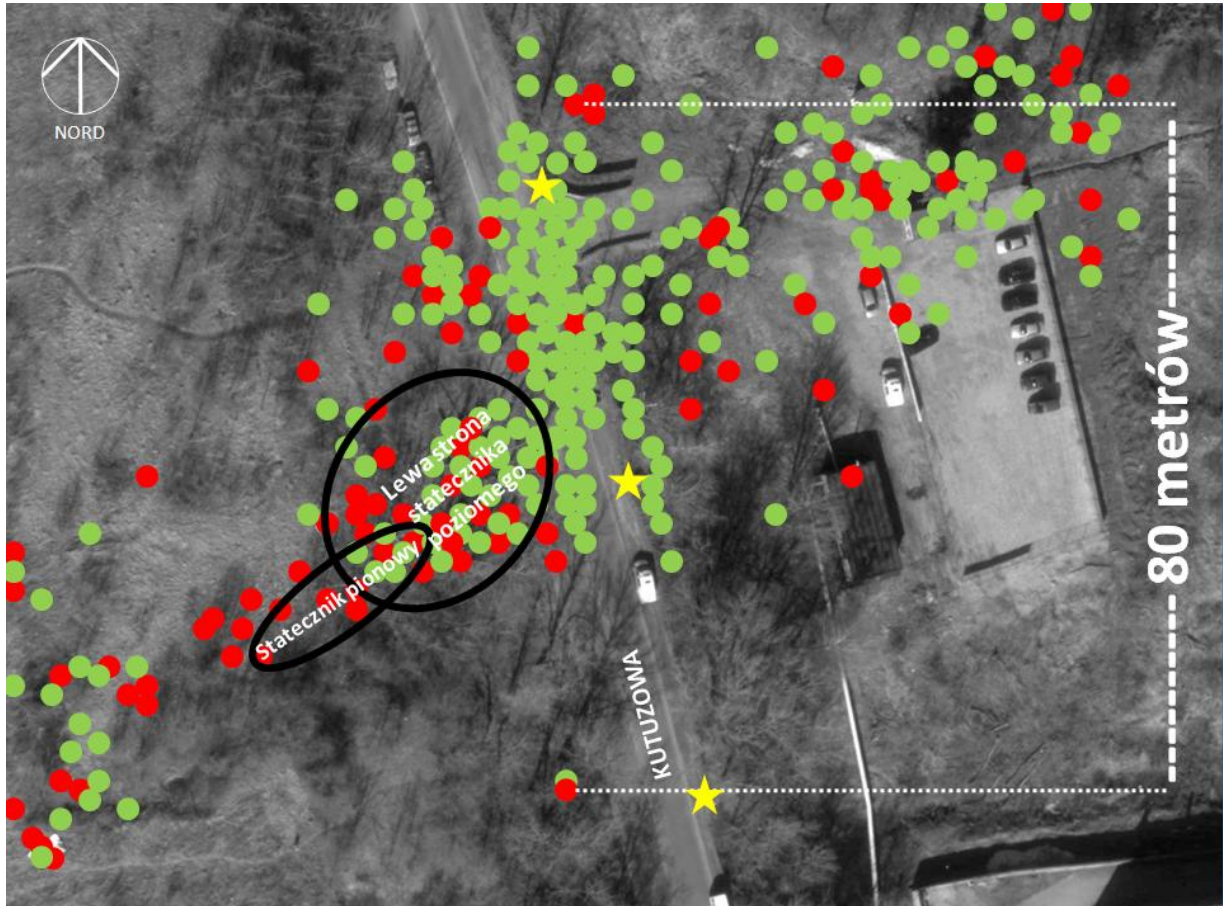
One line of elements from the left horizontal and vertical stabilizer (stemming from the area, where it was connected to the horizontal stabilizer) behind the Kutuzov street shows that the roll of the plane was large and the dispersion of parts falling off the plane and destroyed branches points to a sudden destruction of the plane in the air (Fig. 27).

Fig. 27. Placing the left side of the horizontal stabilizer and the vertical stabilizer behind Kutuzov highway. Flight direction is from right to left. Red dots show debris from the Tu-154M and green dots show debris from the associated tree damage.

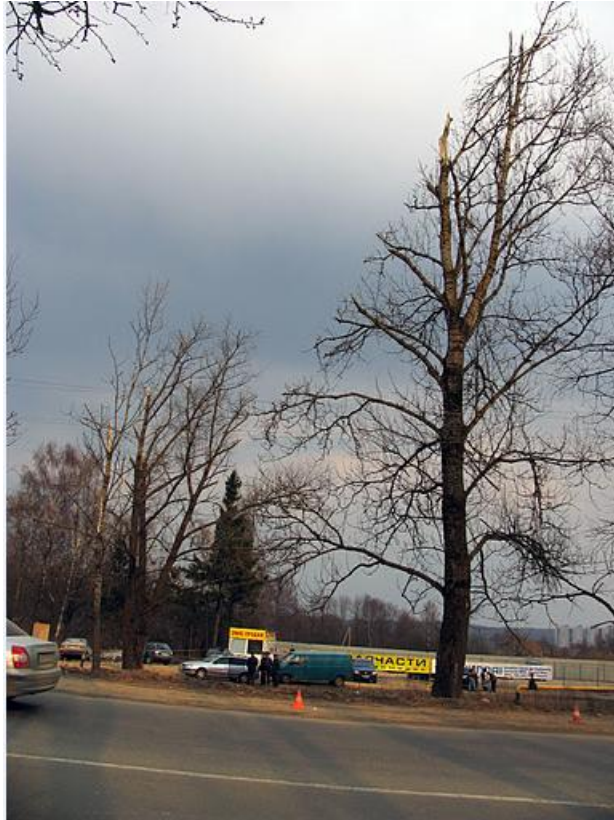
The treetop of one of the trees on the eastern side of the Kutuzov street, on the flight path of the TU-154M, was cut with a straight line with an angle of cut 120degrees from the line of horizon. (Fig. 28).

Fig. 28. A damaged tree on the East side of Kutuzov Street.

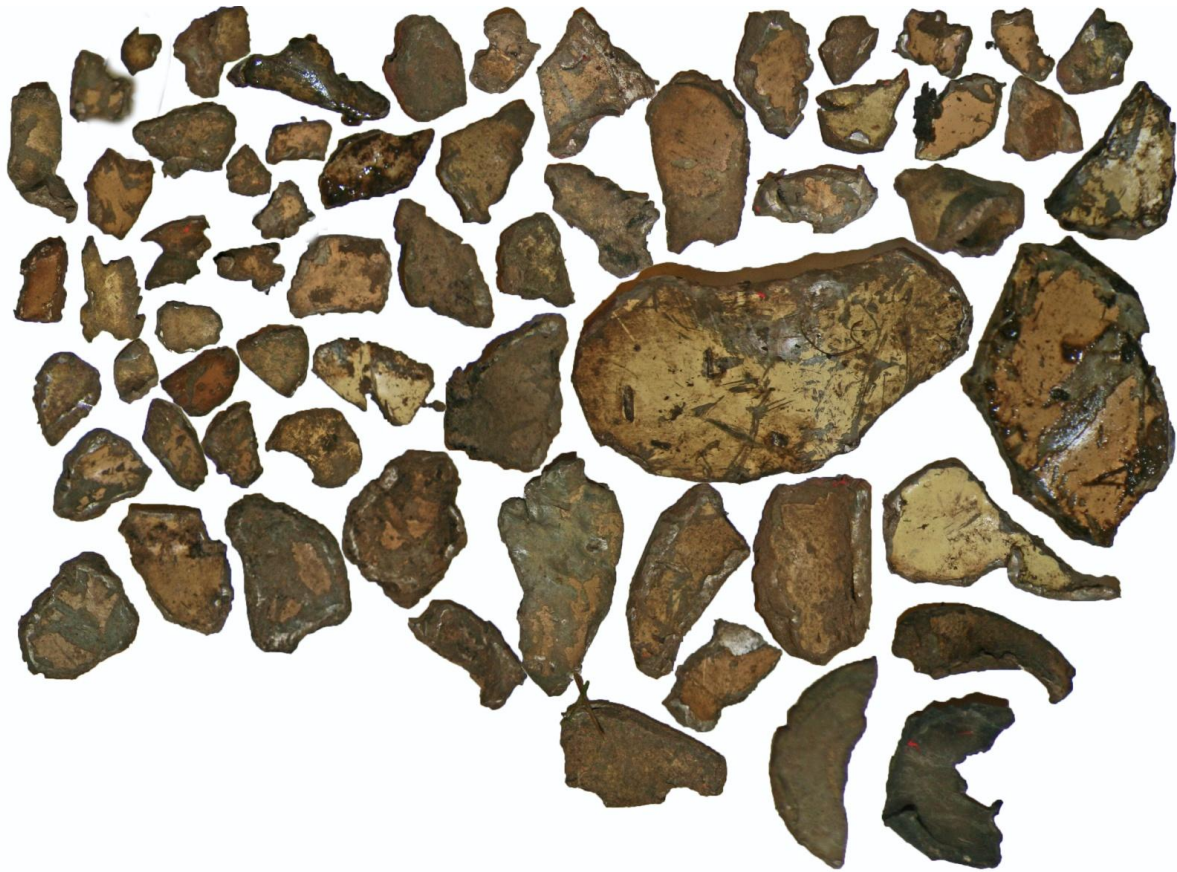
During a terrain analysis, done by Polish archeologists in Smolensk in October 2010 in sector 13 behind Kutuzov Street and before the main crash site, numerous pieces of the plane were found (fig 32). Those pieces, varying in size, from a couple to tens of square centimeters, had traces of thermal and mechanical effects (fig 33).

Fig. 33. Pieces collected of the Tu-154M, taken from the ground 100m before the main crash site showing thermal traces.

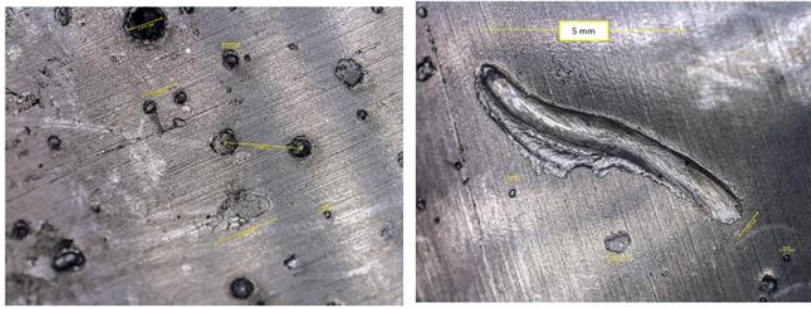
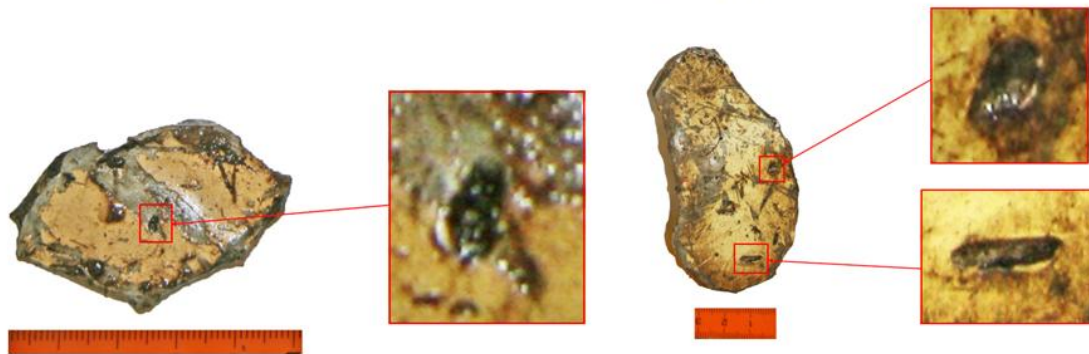
This feature is characteristic for an explosive destruction.

Fig. 34. Comparison of micro craters on the surface of the pieces found by archeologists and pieces created after pyrotechnical experiments.

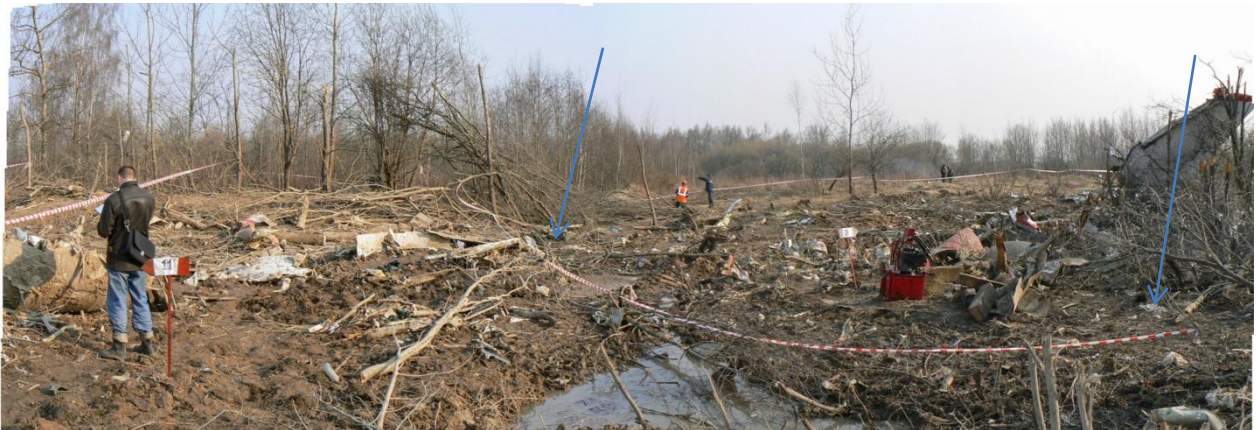
Fig. 36. A picture of the main crash site.

An explosion in the left part of the center wing caused the destruction of the majority of the outer skin, ribs and spar no.1 of the fuel box no.4. Those elements of the plane on the main crash site (Fig. 36) have clear shear marks and visible effects of the blast wave being the result of an explosion. The pictures below reconstruct the mechanism and scale of destruction of the left center wing.
