**COMMITTEE FOR THE RE-INVESTIGATION
OF THE SMOLENSK AIR CRASH**

TECHNICAL REPORT

**Facts regarding the crash of the TU-154M No. 101,
(Fight PLF101), that took place in Smolensk, Russia on the 10th of April 2010**

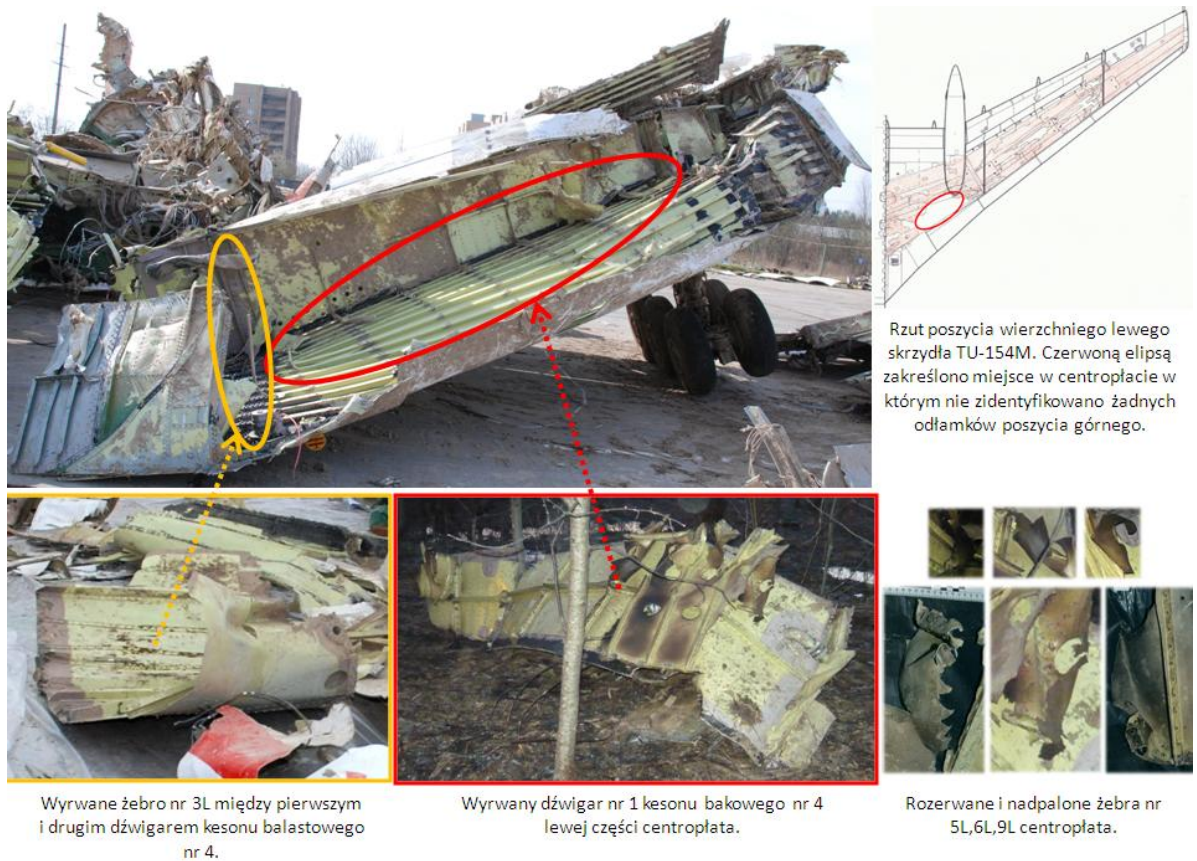
Fig. 37. Note the ripped spar no.1 of the fuel box no.4 of the left part of the center wing with clear signs of high temperature and destruction of burned ribs visible on the right side of the picture. Other parts from this area found outside the fire zones were also found with similar signs.

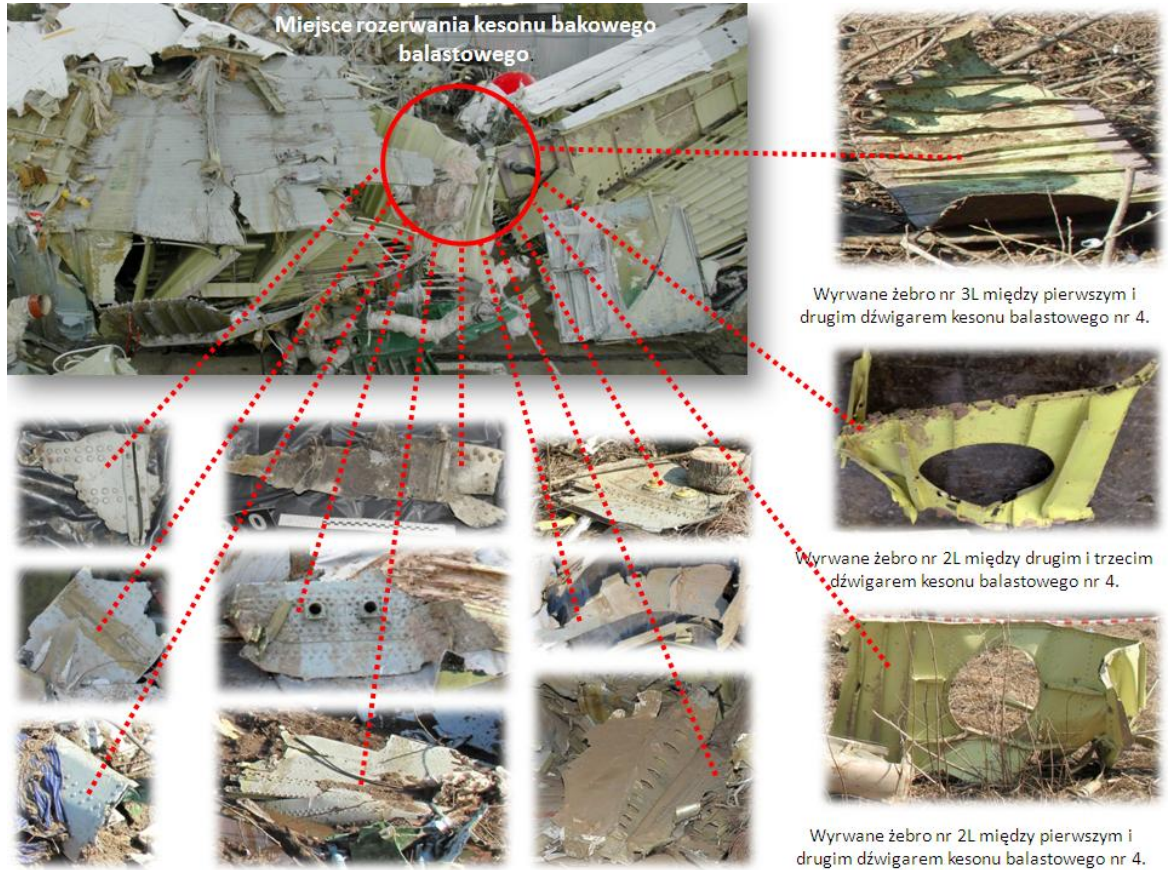
The tearing and the destruction of the fuel box could not have been a result of a hydraulic impact, caused by the impact with the ground, especially looking at the small amount of fuel and limited space. One has to consider the elements of the skin, ribs, rear spar, which were torn off, most likely due to high internal pressure. (Fig. 38 and fig. 40).

Fig. 38a. Place of the destruction of the ballast box and the destroyed elements.

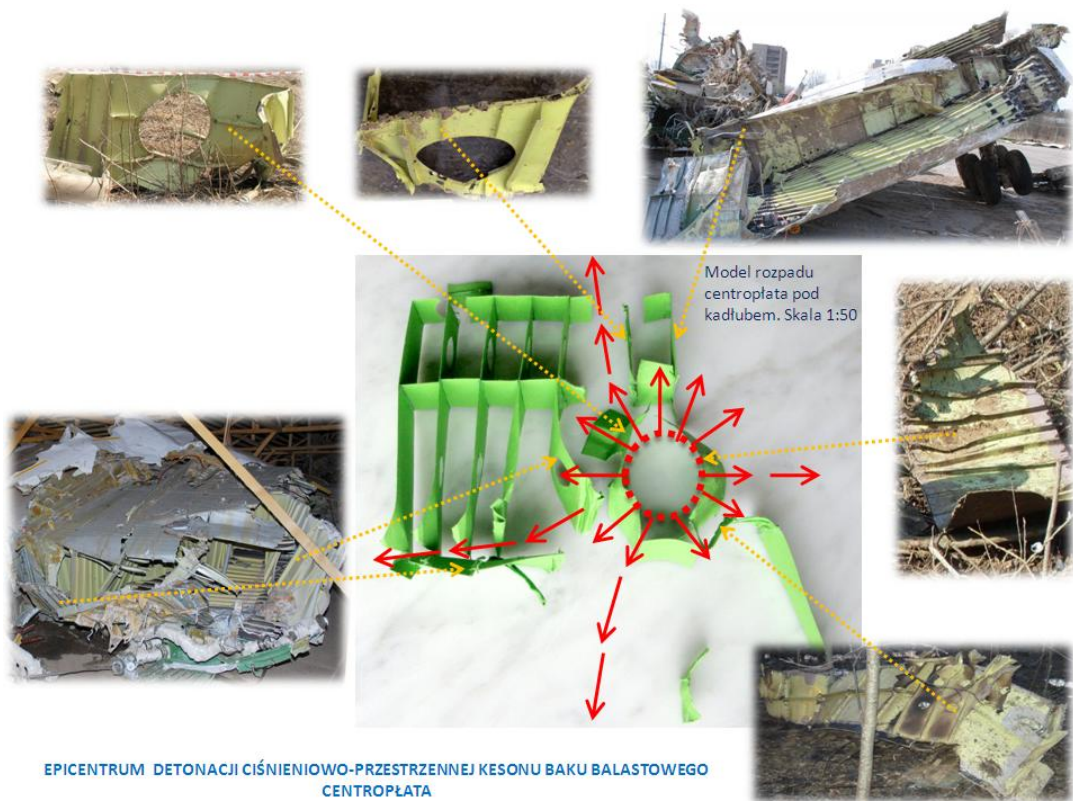
Fig. 38b. Epicenter of the wing box breakage. Study by the Committee.

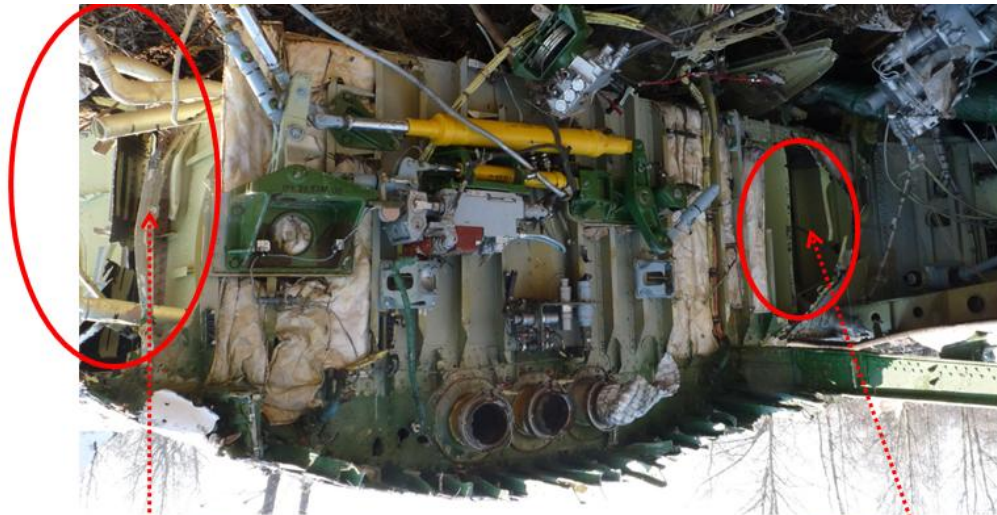
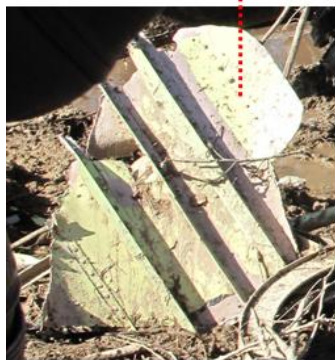
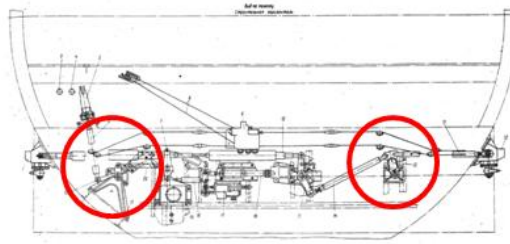
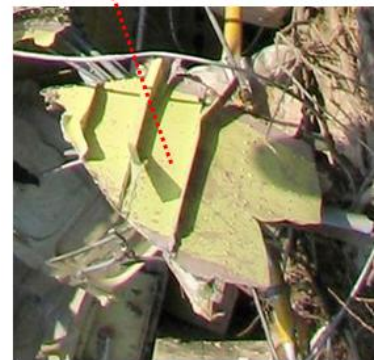
Odłamek lewej strony dźwigara nr 3 kesonu bakowego rozchodowego nr 1.

Odłamek prawej strony dźwigara nr 3 kesonu bakowego rozchodowego nr 1.

Fig. 40 Pieces of the left and right side of spar no.3 of fuel box no.1.

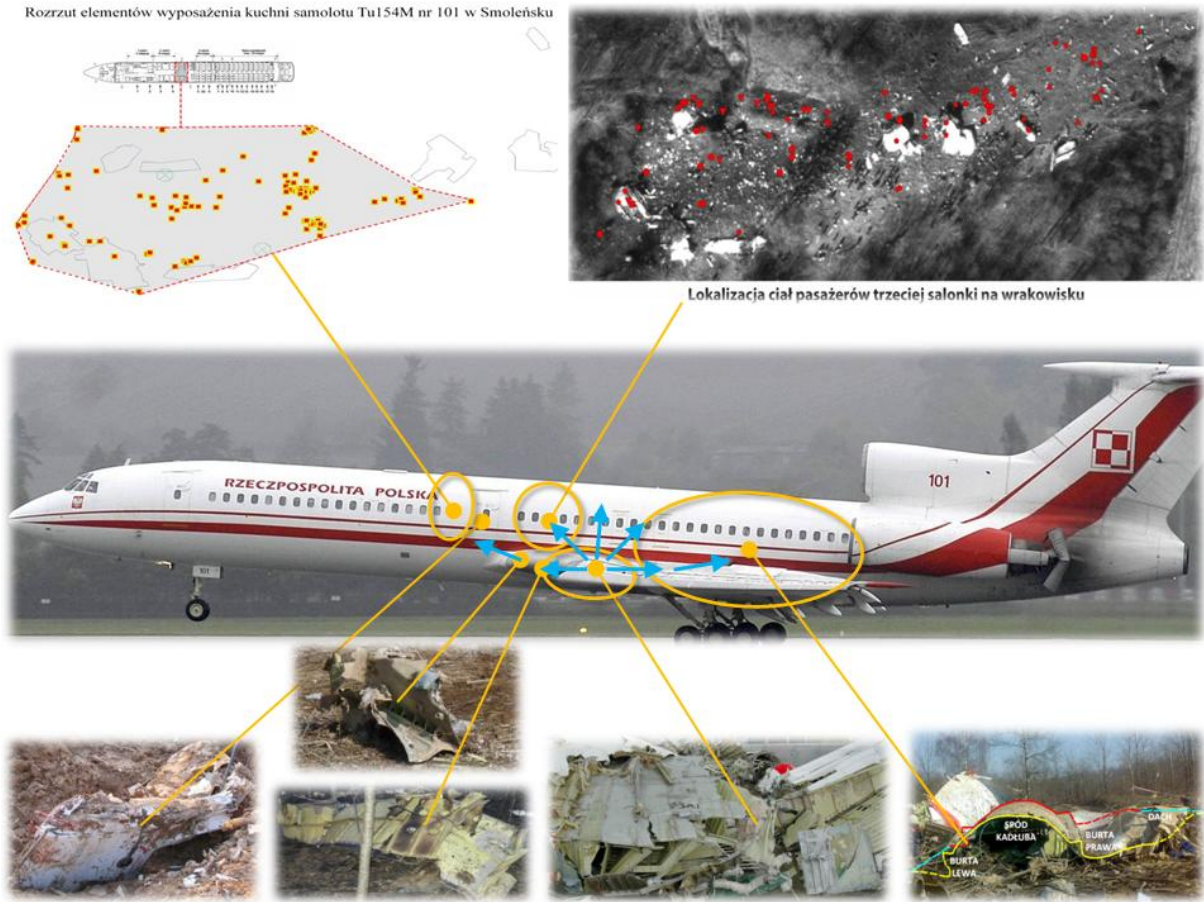
Fig. 42. The effects of the explosion of the ballast tank caisson. From the left of the top picture: galley area, left passenger door no 2. (823), third salon, fragments of the left part of the center wing, passenger compartment. The bottom left picture shows the left door rammed into the ground. The bottom right picture shows the rear fuselage after the crash with both sides opened outwards.

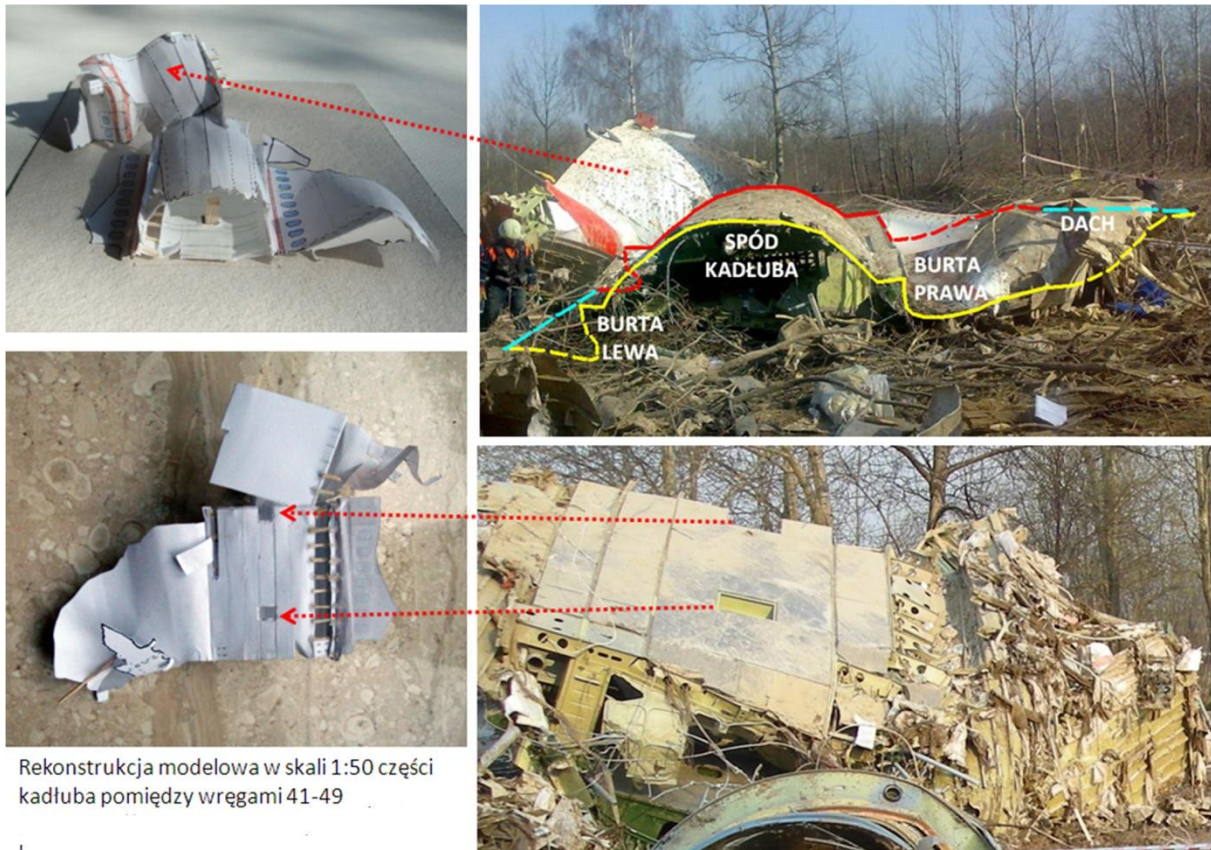
The part of the fuselage between the center wing and the tail was found in an upside down position with both sides of the plane curled outwards. Studies by Sandia laboratories in the US and simulations done at Akron University show that this can happen when the fuselage is exposed to a high internal pressure in mid-air. The side of the plane curled outwards was cut the day after the crash by the Russian services.

Fig. 44. Image of the fuselage destruction with both sides of the fuselage opened and thrown outwards.

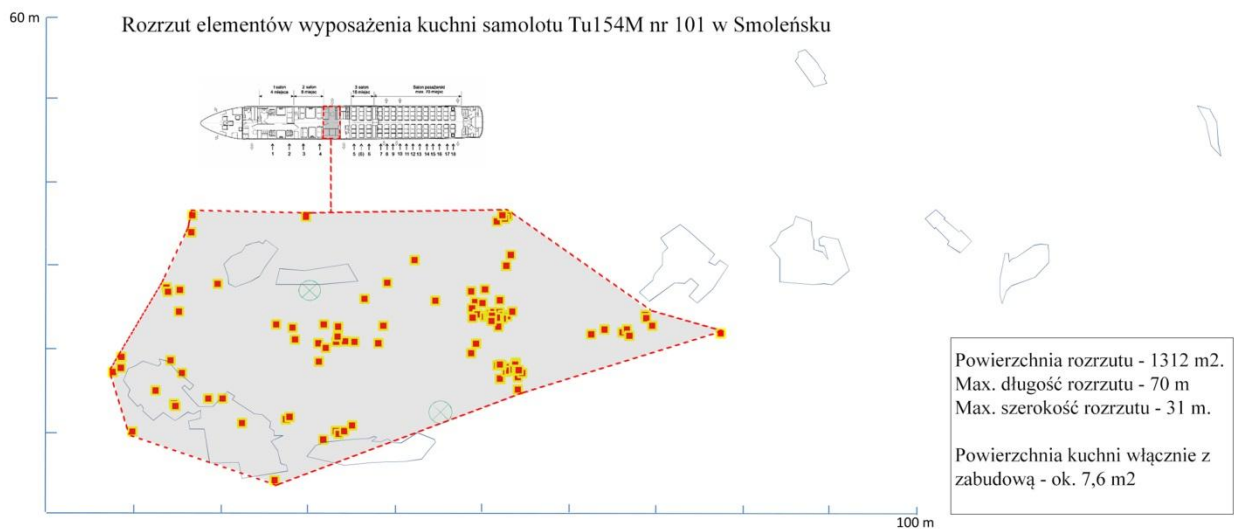
Disintegration of the galley is shown in fig. 45. The smaller than 8m² galley area was found scattered over more than 1300m² in small fragments.

Fig.45. Parts of the galley before the third salon were distributed in the shown region on an area of 1312m².
