## AIRCRAFT ACCIDENT REPORT

ALLEGHENY AIRLINES, INC.

ALLISON PROP JET CONVAIR 440, N5825  
NEAR BRADFORD, PENNSYLVANIA

Report Number: NTSB-AAR-70-10

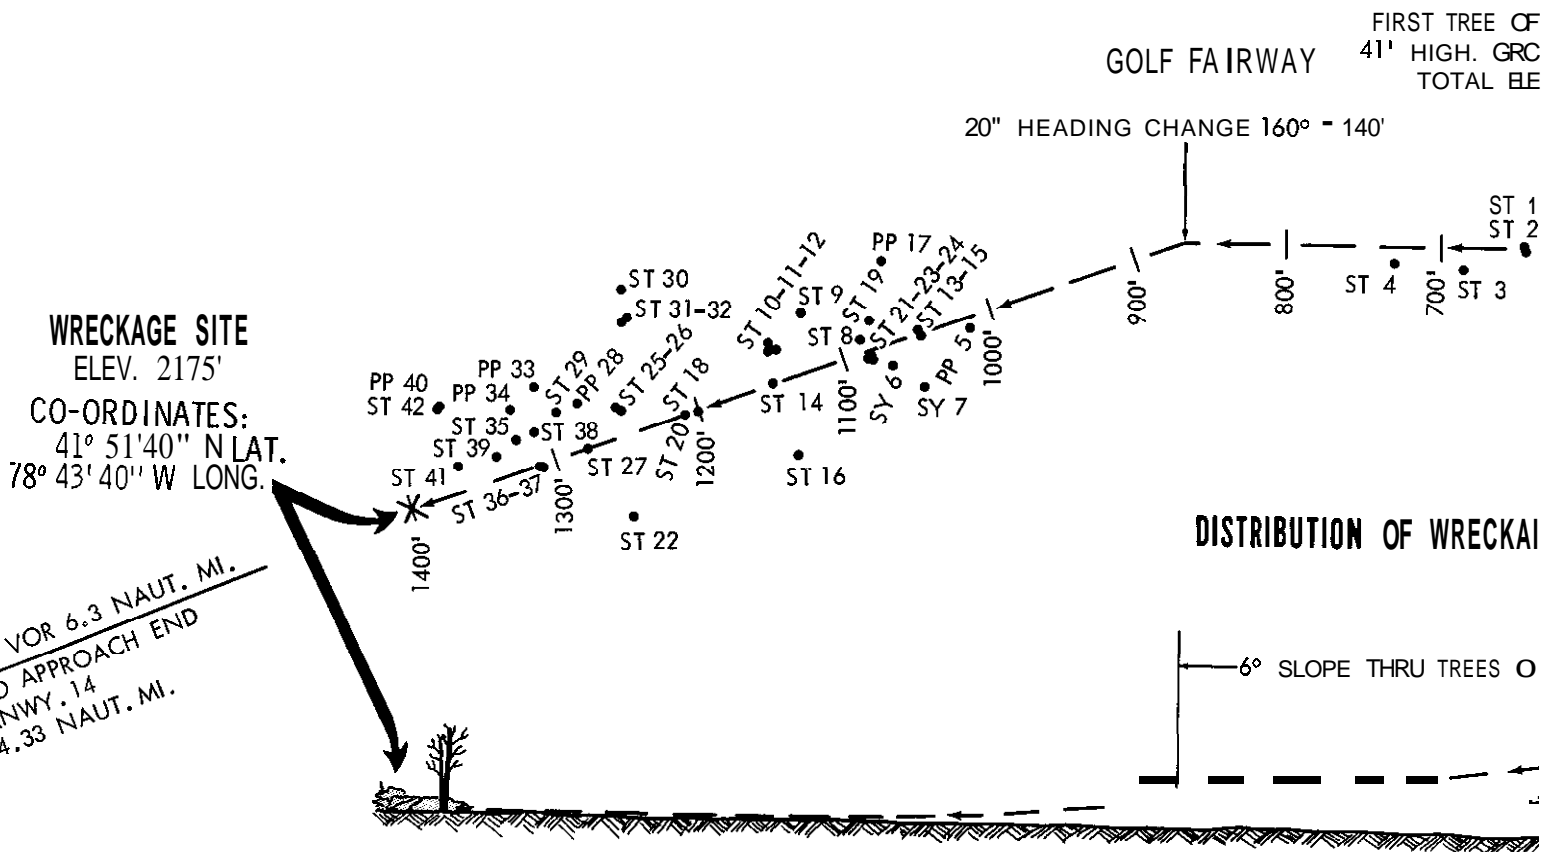
DISTRIBUTION OF WECKAG

- ST-1 Section of Left Aileron and Tab.
- ST-1A Section of Main Gear Door Actuating Rod.
- ST-2 Section of Left Aileron and Tab.
- ST-3 Section of Front Spar and Wing Leading Edge.

- ST-16 Nose Wheel.
- ST-17 Propeller Blade S/N B 9018.
- ST-19 Left Horizontal Stabilizer Including Complete Elevator and Flight
- ST-18 Section of Left Outboard Flap.

- ST-20 Nose Wheel and Axle.
- ST-21 Lower 5' Section of Rudder Including 3' Section of Flight Tab.
