AIRCRAFT ACCIDENT REPORT. AMERICAN
AIRLINES, INCORPORATED MCDONNELL
DOUGLAS DC-10-10, N103AA NEAR WINDSOR,
ONTARIO, CANADA, JUNE 12, 1972

REPORT NUMBER: NTSB-AAR-73-2

SYNOPSIS

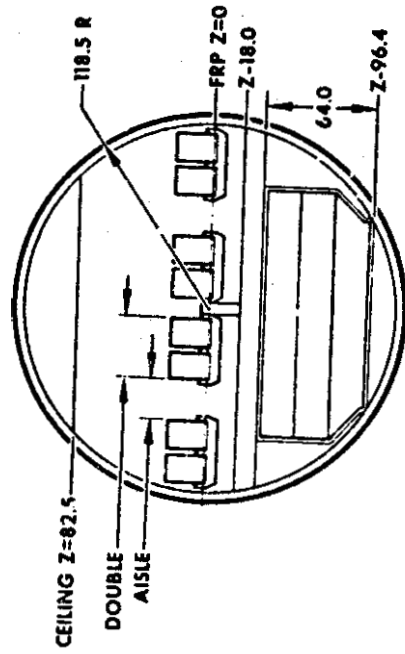
FLOOR PLAN

The cabin floor in the aft lounge area sustained major damage. The first nine transverse floor beams in the lounge area were fractured approximately 6 inches from the vertical struts near the left side of the compartment. These beams also failed in bending near the right side of the airplane, and allowed the floor to settle partially into the cargo compartment. There were no seats attached to this floor section; however, a

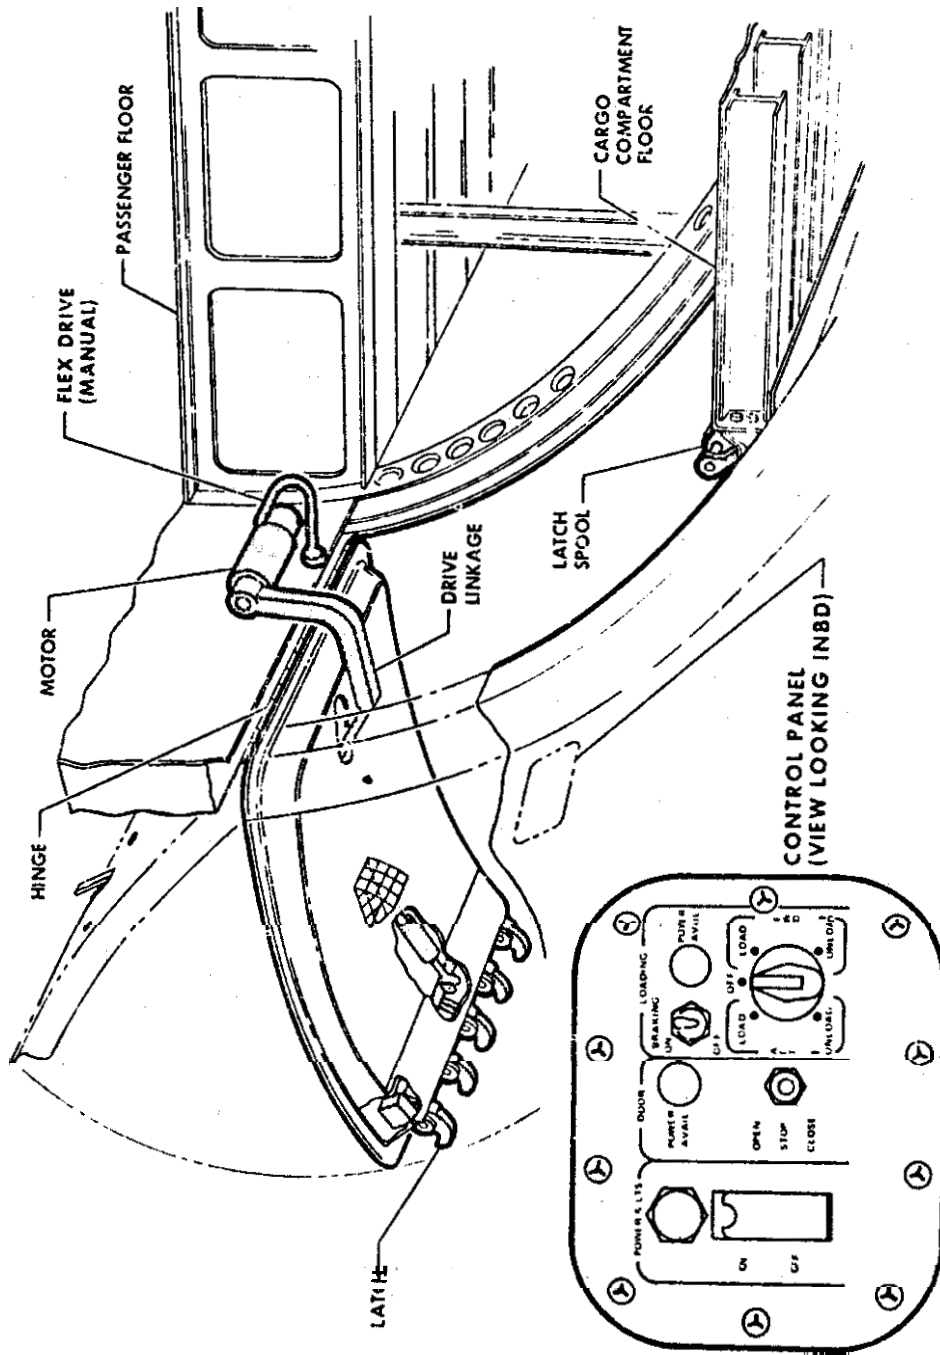
CARGO DOOR

The door was found with the four latches nearly closed, with the lockpins not engaged, with the vent door overtraveled beyond the open position and with the door handle in the stowed position. The latches, which were filled with

Structural damage to the door verified that the latches were not overcenter when the door opened in flight. The two fasteners which attached the door latch actuator to the door had both failed in shear. Part of one of the bolts was found in the piece of door skin which remained on the airplane—an indication that this failure occurred in the air, and not when the main portion of the door impacted the ground.

the latches, which eventually caused failure of the fasteners which secured the actuator support bracket to the door structure. The latches were then sprung open, which permitted the door to blow open. The combination of airloads and impact of the door with the aircraft fuselage caused the door structure to fail, and most of the door separated from the airplane.
