Vladimir Putin's Russian Government Inquiry into the Crash of The Polish Air Force One in Smolensk, Russia, April 10, 2010

**Polish Parliamentary Committee for the investigation of
the Tu-154M crash in Smolensk, Russia on April 10th, 2010
under the chairmanship of Antoni Macierewicz**

Study prepared by Kazimierz Nowaczyk, Ph.D.

European Parliament, Brussels, March 2015

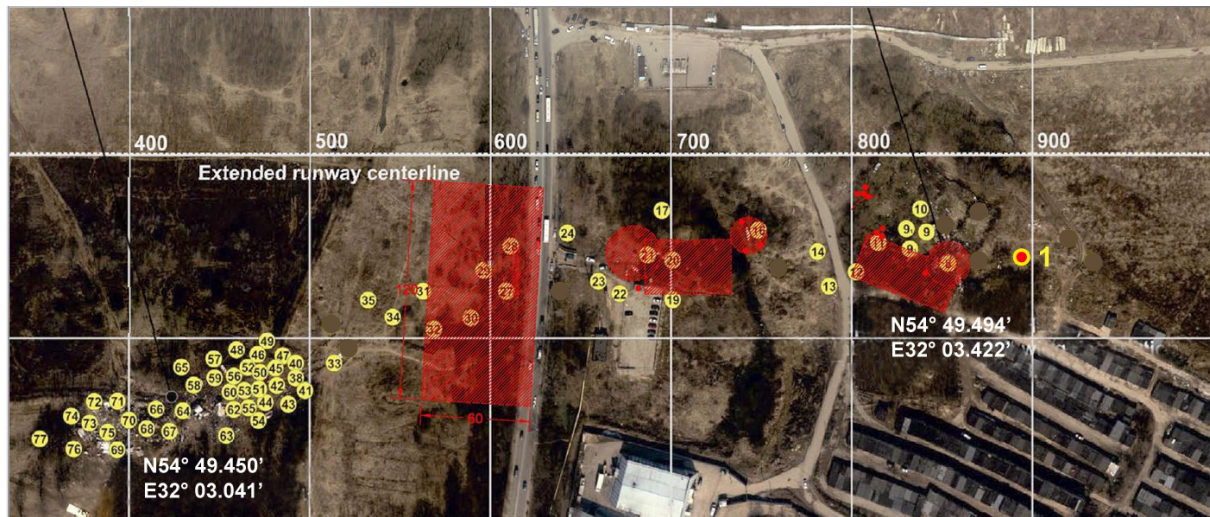
Figure 10. Russian prosecutors' debris localization (red boxes) from 10 and 11 April 2010 over air photo from the IAC report (M. Dabrowski, K. Nowaczyk).

An illustrative example of such a course of the disaster was an aerial view photo of the crash scene taken on 12/04/2010 marking only selected fragments of found pieces of the wreckage debris. Three years after the disaster, journalists published the hidden protocols prosecutors of the Russian Federation dated 10 and 11 April describing the airplane pieces found few hundred meters before main crash scene, where the plane was still in the air. Their quantity and origin not only of the damaged wing (IAC report), but also of the fuselage, deny theses posed in sections 3.1.5 and 3.1.6. Differences between IAC report (yellow dots) and description prosecutors (red boxes) are shown in the Figure 10.

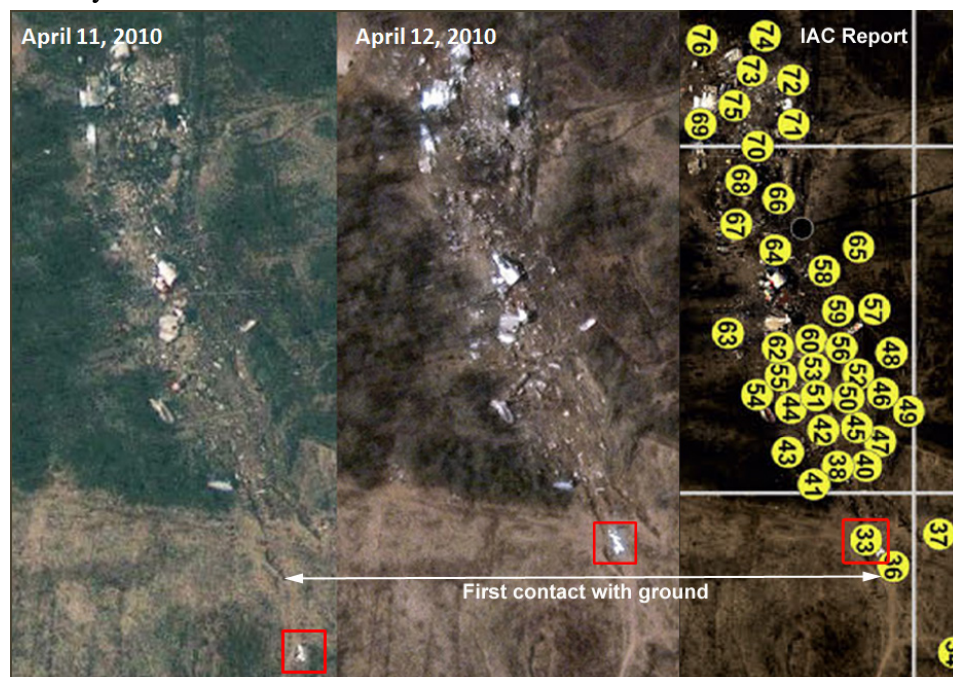
Figure 11. Satellite photos from 11 and 12 April demonstrate left stabilizer position changes (red boxes) and position (33) in ICA final report. (K. Nowaczyk) Appendix VI.

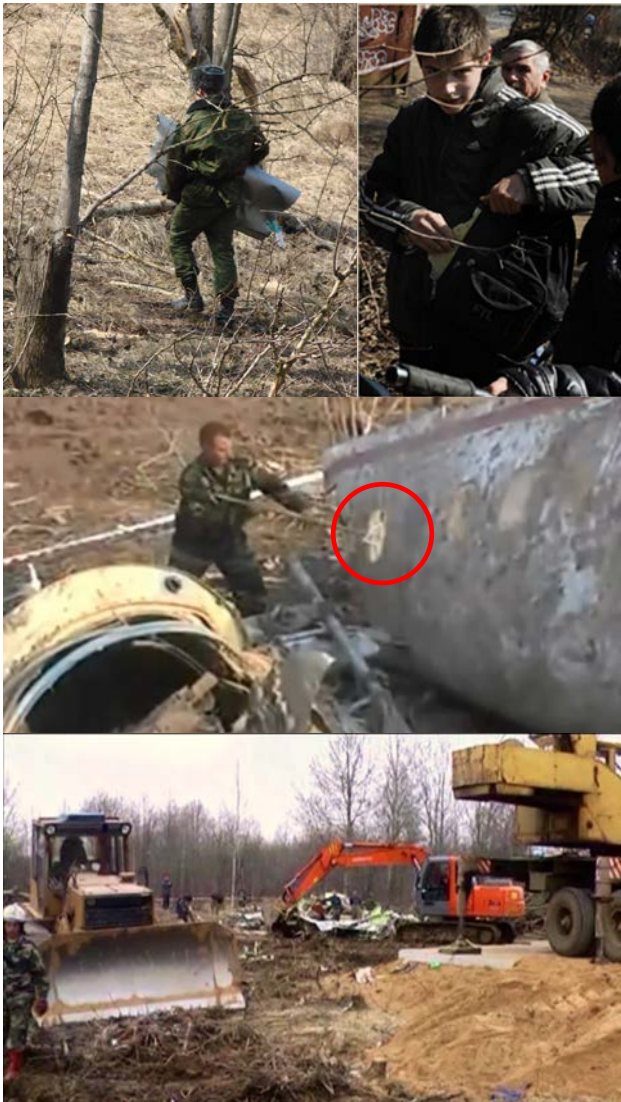
Figure 12. Examples from crash site from first three days, April 10-13. Appendix VI.

windows in the fuselage were broken immediately, large sections of the airplane were cut into smaller parts, cables were cut and pulled out, heavy sections were deformed and damaged further by being dragged by an excavator and other heavy machinery, large areas of the crash site with smaller debris were bulldozed and finally some parts of the crash scene were quickly covered up with fresh soil or concrete. Crash deformation of aircraft tail has been ‘repaired’⁴⁵ even before it was moved to its final storage site. In the end, larger airplane parts were transported to a nearby airport concrete pavement and left for many months without any protection from weather conditions and onlookers (Fig. 13). Several tons of small parts were piled up like trash in a nearby barn, without any order or protection. After many requests from the Polish side, the larger wreckage parts were eventually fenced off and covered by a tarp. Later, a plywood structure was built over the

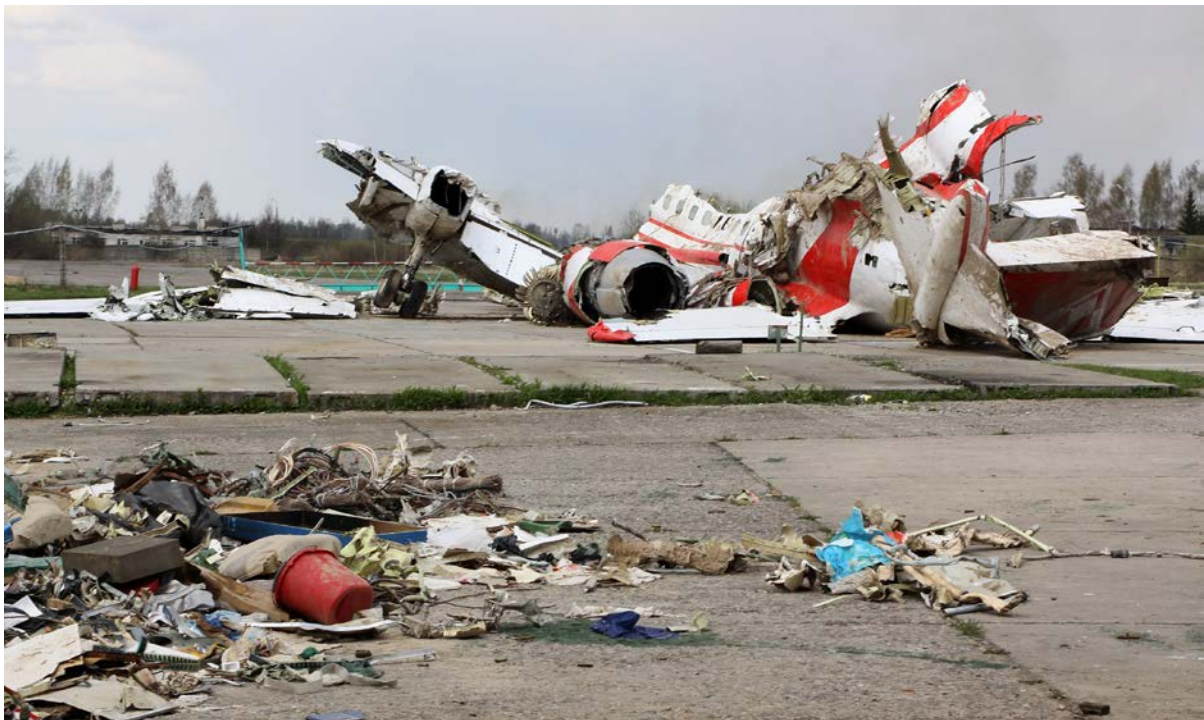
Figure 13. Largest airplane parts on the concrete pavement after transportation from crash site.

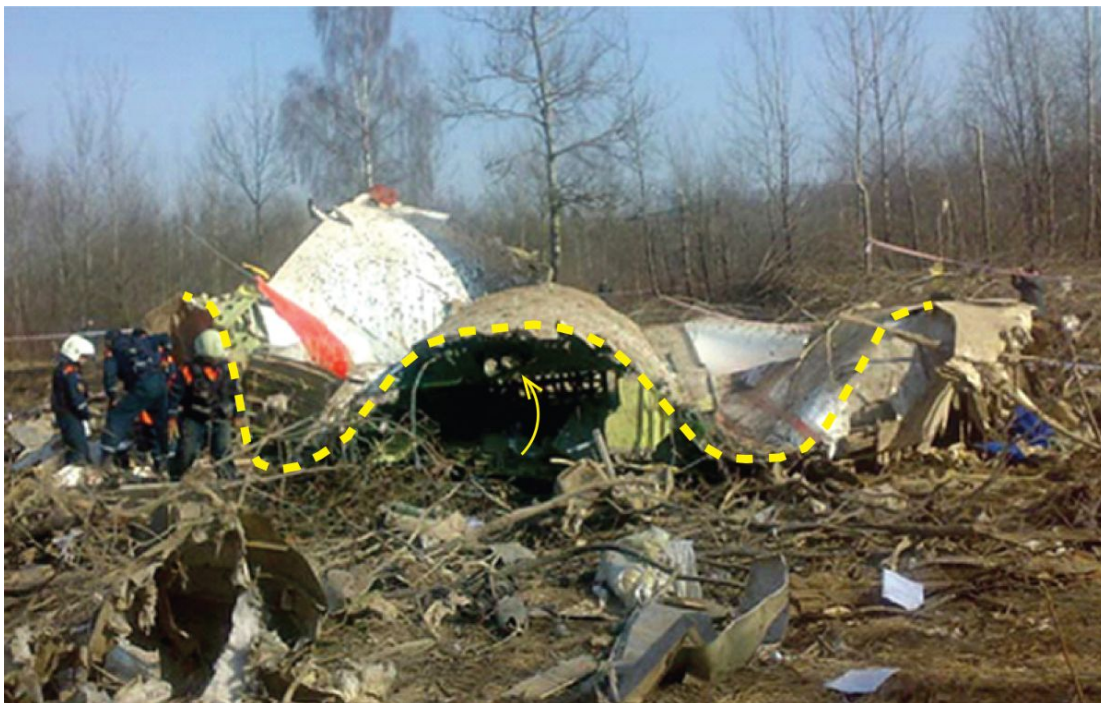
Figure 14. A part of the fuselage inverted and opened up (yellow line and arrow). Appendix VIII.

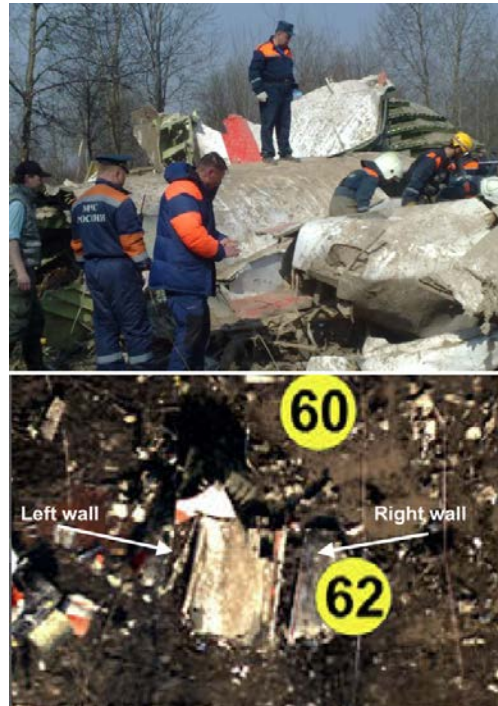
Figure 15. Left and right walls cut off from fuselage on 04.11.2010. Separated walls (white arrows) on air photo in IAC report.

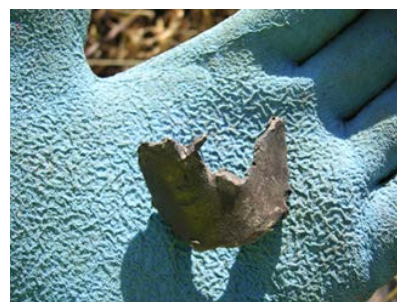
On top of the hidden Russian Federation prosecutors' protocols dated 10 and 11 April described above in part 4.1, six months after the crash a team of Polish archeologists was finally allowed to examine the crash site. The Polish experts found 10,000 small fragments on the surface and identified another 20,000 fragments of metal hidden in the soil up to 20 cm deep using metal detectors operating within the 20cm range. Using several drills, they confirmed that the location of every small metal fragment was accompanied on average by another six non-metal fragments (total estimated number 60,000). Some metal fragments had been exposed to high temperatures (example in Fig. 18).

Figure18. Example of a burned metal piece of debris found in front of main crash site. Appendix XI.

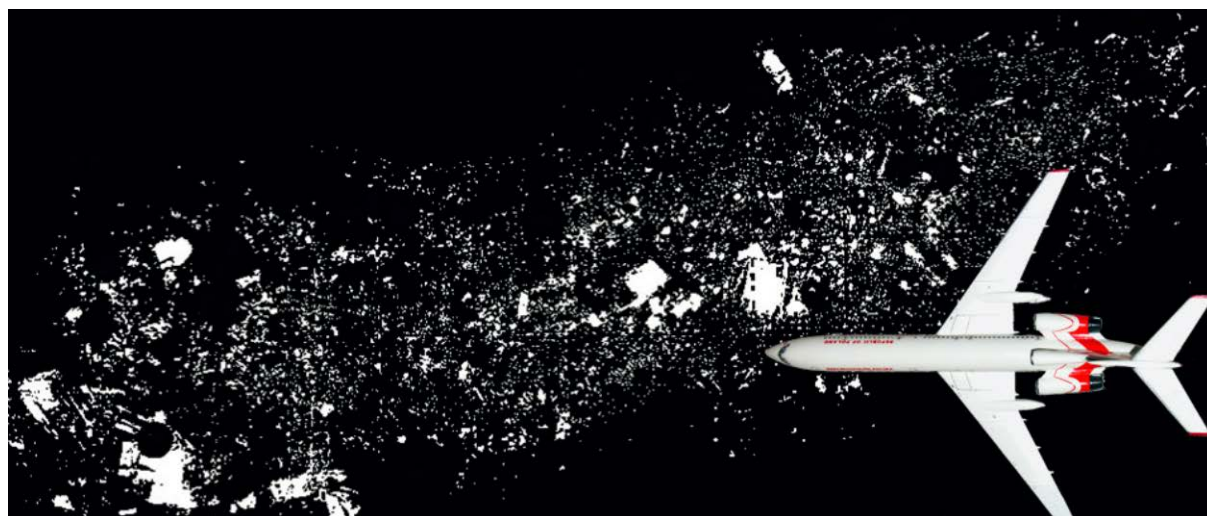
Figure19. Map of debris found at the main crash site, prepared for the Polish Archeologists' Report (Appendix XI). The airplane profile is in scale 1:1 to the ground area. (K. Nowaczyk)

The Polish team was limited in its search only to the area of aircraft contact with the ground, but the number of visible debris on map prepared for the Polish Archeologists' Report (Fig. 19) and listed in Table 2 is incomparable to famous air catastrophes caused by explosions.

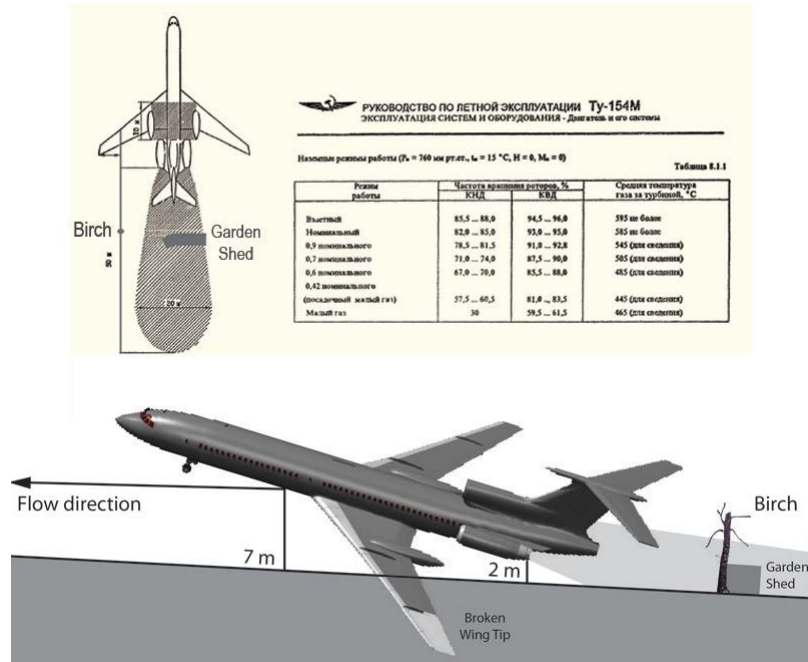
As seen in the figure, the left wing of the aircraft even after having supposedly lost its left tip would have been two meters underground.

Figure 24. Tu-154M position at 6:40:57.375 from ATM QAR digital data (Moscow, June 2011)

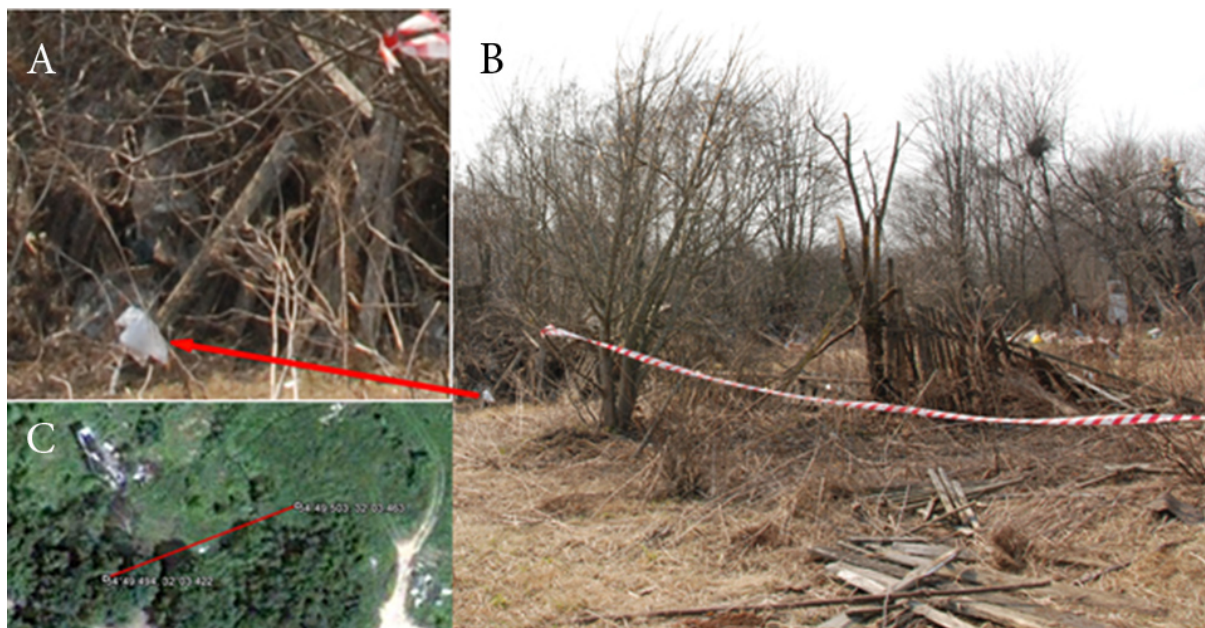
The Independent Investigation found ground evidence of this event. Fig. 26 shows aircraft wing debris found about 25m 'up range', or before, the birch tree. The Russian Report had claimed the birch tree to be the point the aircraft first sustained impact damage (by hitting the tree). Earlier, the official Polish crash investigation documented other debris a little further away at ground coordinates N54 ° 49.503/E 32.03.463, or about 40 m up range from the birch tree [Polish prosecutors report E-che-90/12]. Still other wing debris, found 'down range' at a distances of between 40-150m from the point of the in-flight explosion, evidenced the subsequent break-up of the wing (see Part C Fig-26).

Figure 26. Aircraft wing debris found before, the birch tree.

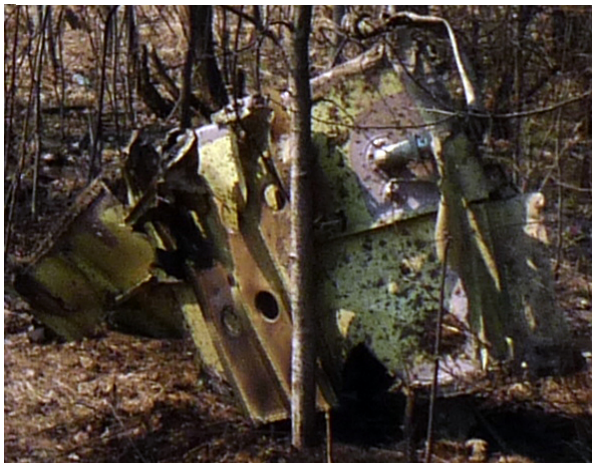
Figure 28. The aircraft's center wing box around 80 m in front of main center wing position on the crash site. On the surface visible signs of the fire.

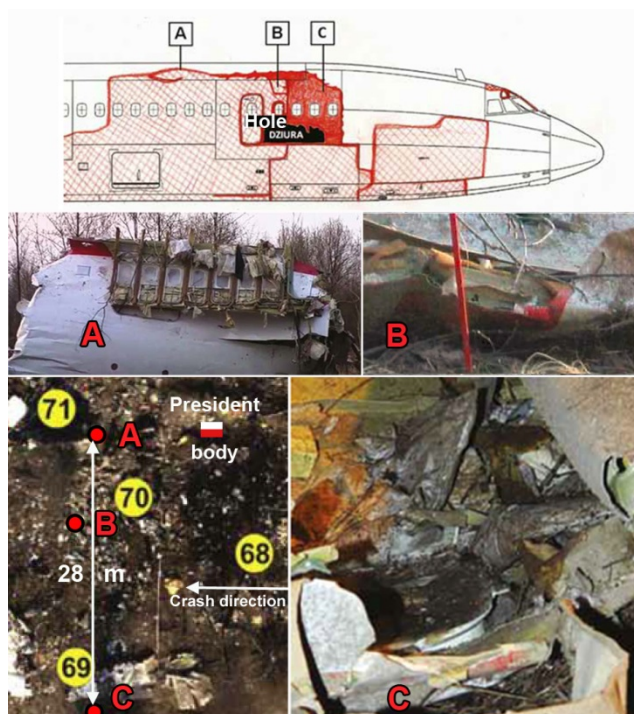
Figure 30. Location of parts from presidential suite at the main crash site, at distance 28 m transverse to the direction of impact (points A and C). Signs of high temperature and high pressure inside the presidential suite (part C).
