Accident Investigation Final Report

All Engines-out Landing Due to Fuel Exhaustion

Air Transat
Airbus A330-243 marks C-GITS
Lajes, Azores, Portugal
24 August 2001

22 / ACCID / GPIAA / 2001

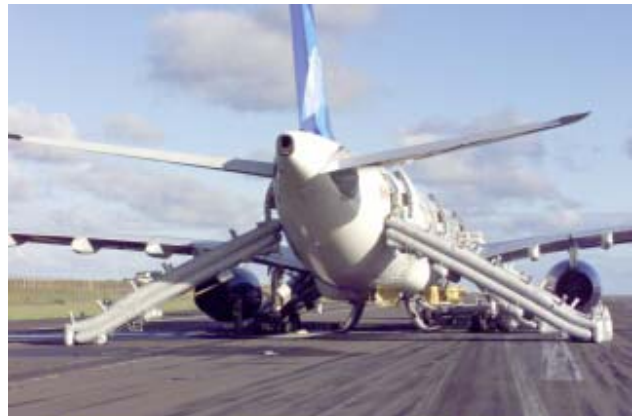
At 06:45, the aircraft crossed the threshold of runway 33 at about 200 knots, touched down hard 1 030 feet down the runway, and bounced back into the air. The second touchdown was at 2 800 feet from the approach end of the runway, and maximum braking was applied. The aircraft came to a stop 7 600 feet from the approach end of the 10 000-foot runway. After the aircraft came to a stop, small fires started in the area of the left main-gear wheels, but these fires were immediately extinguished by the crash rescue response vehicles that were in position for the landing⁶. The Captain ordered an emergency evacuation. Fourteen passengers and two cabin-crew members received minor injuries, and two persons received serious injuries during the emergency evacuation. The aircraft suffered structural damage to the fuselage and to the main landing gear.

Figure 1 - Aircraft After Landing

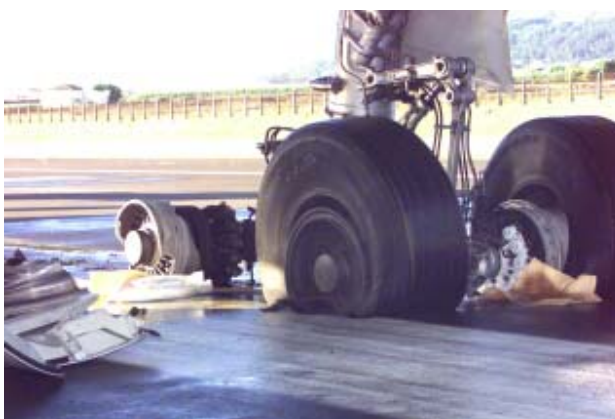
Due to the engines-out condition, the landing was conducted without the brake anti-skid and normal braking systems. Because the emergency brake accumulator only provides for a limited amount of brake applications, full braking was applied and retained at the second touch down, resulting in the main wheels locking up. The tires quickly abraded and deflated at a point between about 300 and 450 feet beyond the second and final touch down. The segments of the main wheels contacting the pavement were worn down to the bearing journals, the left, rear, inboard wheel detached from the axle. Both left and right brake anti-torque links attachment horns on the bottom segments of the main oleos also contacted the pavement; the horns were abraded to the point that some of the links separated from the oleo resulting in the rotation of at least one brake carrier.

Figure 2 - Left-main Boogie

Shedding of brake and wheel components during the landing run also resulted in a combination of punctures and impact damage to the airframe and left engine nacelle.

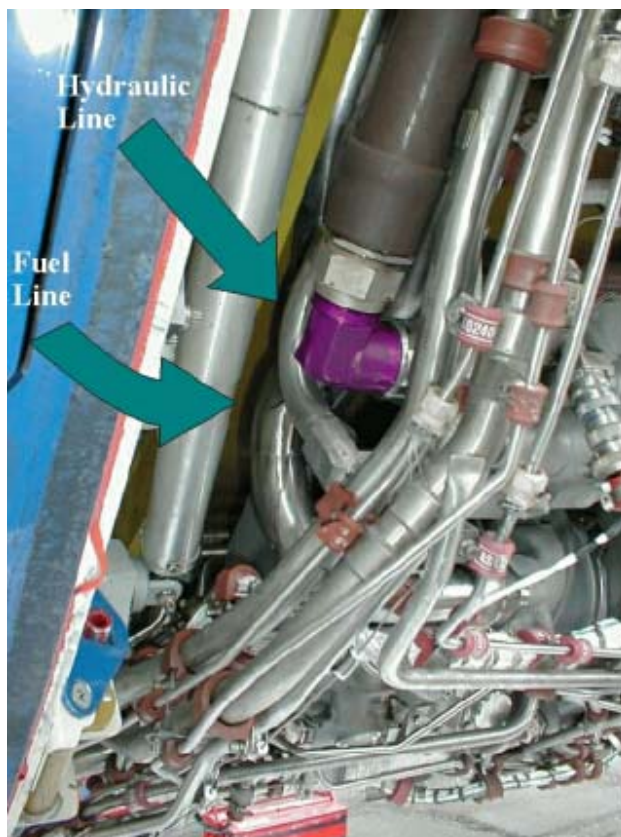
Both reports concluded that the fuel and hydraulic tubes fully matched the drawing characteristics for material, form and shape. The fuel tube wall section was measured and showed that the wear had reduced the wall thickness by 0.005 inches, and that the hard contact had resulted in a dent measuring 0.044 inches deep. The examination concluded that the fuel tube fractured in high cycle fatigue at multiple initiation sites in the bore and the outside diameter, due to a combination of vibratory stresses being superimposed on the tube deformation. Also noted were some scratches and deep scores around the chafed location on both tubes. Report MFR 41281 stated that these marks are believed to have been made at the time of installation of the engine because this was the only time the post-SB fuel line and pre-SB hydraulic lines were mounted adjacent to one another. The report con-

Figure 3 - Right Engine Pipe Contact

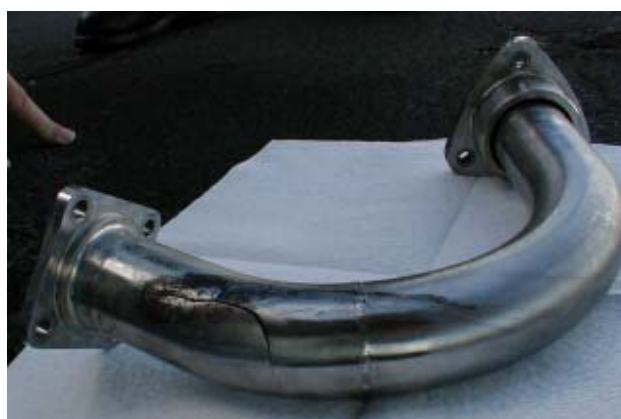
The initial inspection of the right engine following the occurrence uncovered the presence of an L-shaped crack on the inlet fuel tube wall (Part No FK30383). The crack was approximately 3.0 inches (80mm) long, and was spread to a width of about 1/8 inches (2.5mm). In addition, the hydraulic outlet tube (pressure) for the rear hydraulic pump was found to be in hard contact with the fuel tube. The cracking on the fuel tube extended to both sides of a mechanically worn (chafed) area where the tubes came into contact. It was evident that the interference and chafing occurred due to the mismatched installation of the post-mod fuel tube (P/N: FK30383) and pre-mod hydraulic tube (P/N: LJ51006). Based on the DFDR data, it was determined that the fuel leak rate through this cracked reached a maximum of about 13.0 metric tons per hour.

Figure 4 Fuel Pipe Crack & Scratches

cluded that the scratches and scores were directionally aligned and that they could have been caused from repeated contact from a blunt instrument, such as a screwdriver being inserted between the tubes in order to force a clearance between them. There were no cracks initiated from the score or scratch marks.
