Explosion and Fire of Hydroxylamine

【June 10th, 2000 Ojima Town, Gunma, Japan】

Hiroshi Koseki. (National Research Institute of Fire and Disaster)

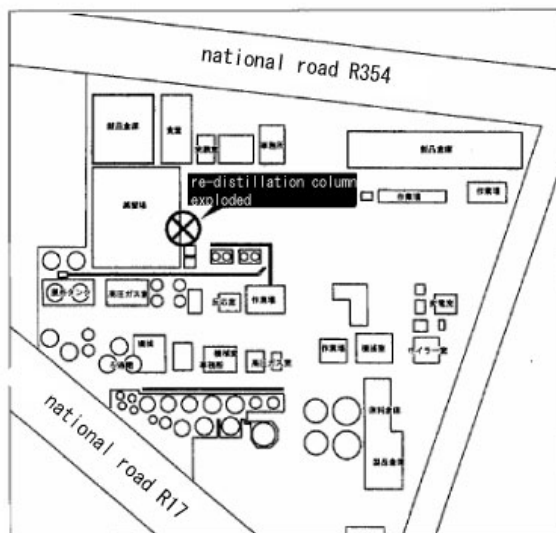
Fig.1 Overview of the factory

After 18:00 on Saturday June 10th, 2000, the explosion occurred suddenly at the re-distillation column resulting in a fire. A pillar of flames like a flash spouted out from the factory at the moment of the explosion. The damage involved the housing area that adjoined the factory. Four persons were killed and 58 persons were injured in the accident. 54 persons of injured persons were residents living near the factory. The re-distillation column disintegrated without leaving any trace, and the factory was severely damaged. Damage outside of the factory included the complete collapse of two buildings, severe damage to five buildings and partially damage to 285 buildings.

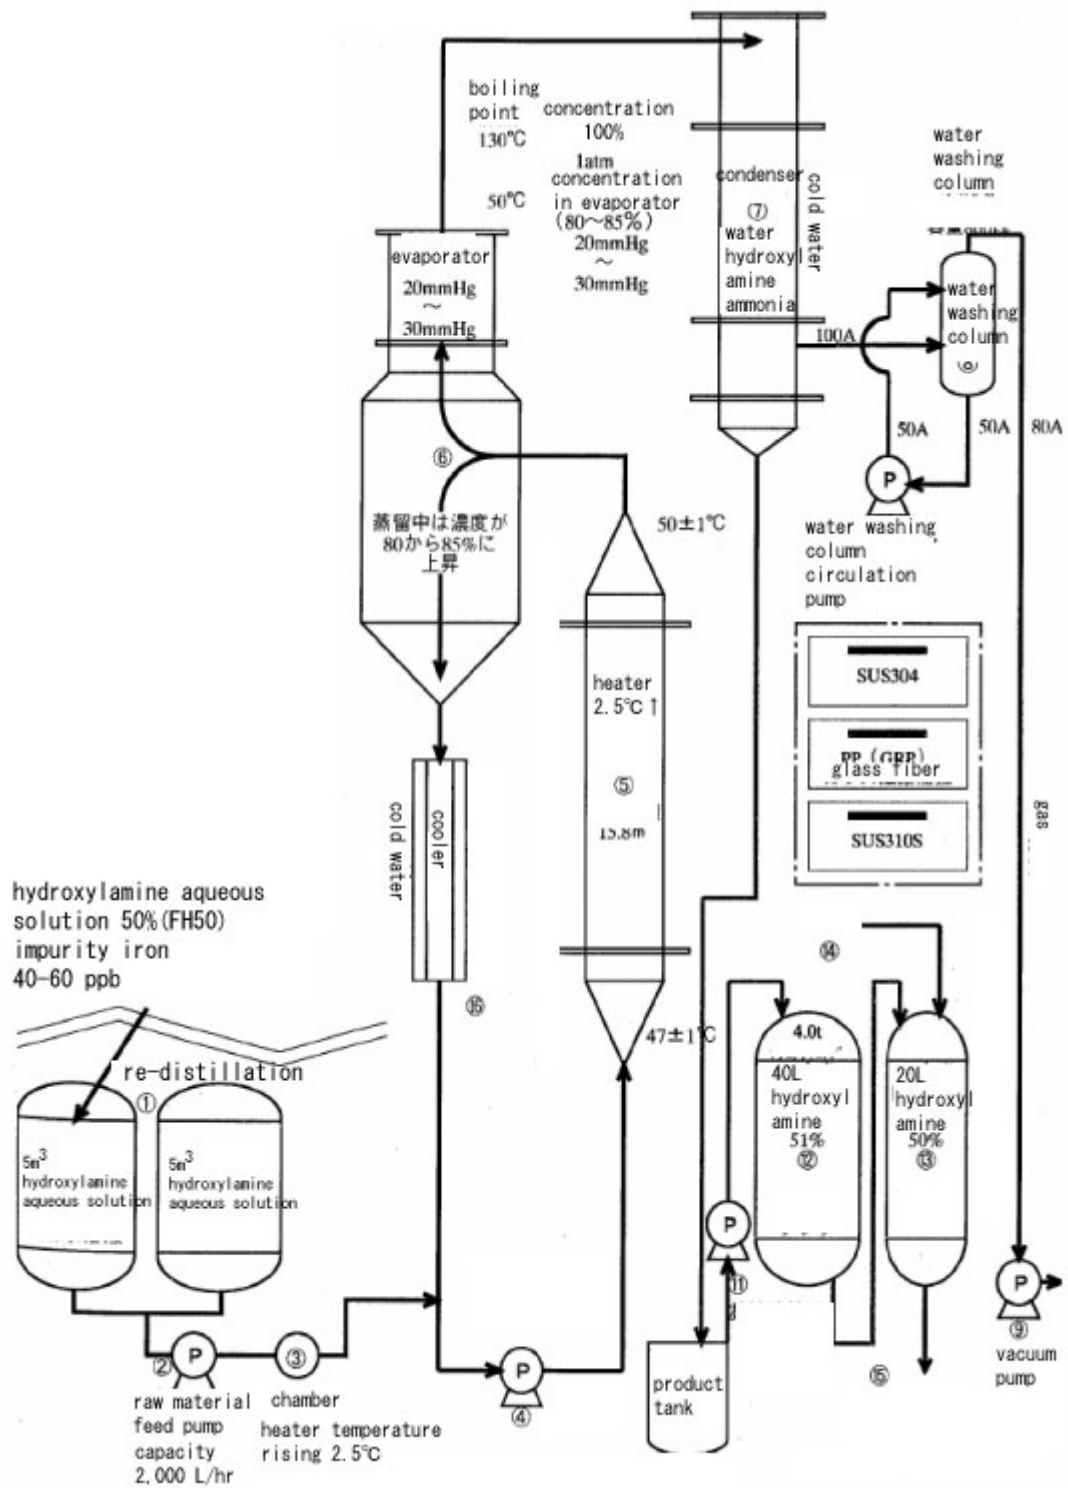
Fig.2 Flow sheet around the re-distillation column

The method of re-distillation was as follows. A large amount of 80-85% hydroxylamine aqueous solution was circulated at the bottom of the column. A feedstock 50% hydroxylamine was fed to the circulating liquid, and the whole circulating liquid was heated and partially evaporated, and then charged to the column. The column was operated at a vacuum of 20 to 30torr, and the temperature was controlled so that the vapor concentration should be the same with the 50% feedstock. As the vapor pressure of a ferrous ion is almost zero, ferrous ions remained at the bottoms without being entrained, and were accumulated in the bottom circulation. The vapor at the top of the column was totally condensed, and after adjusting concentration, it was shipped as "Free hydroxylamine". The flow of the Re-distillation column is shown in Fig. 2.

A part of the bottom circulation was continuously drawn off so that the ferrous ion concentration would not exceed the danger threshold. About 4% of the feedstock was drawn off in order to keep the concentration at 3ppm or less. An emergency line branched from the bottom circulation line for emergency evacuation of the circulating liquid at the column bottom into the underground vessel for cooling and diluting, when a temperature rise was detected. There was about 70 to 80 mm of a dead-end piping between the stop valve and the branch point. The valve had never been opened after the initial start-up.

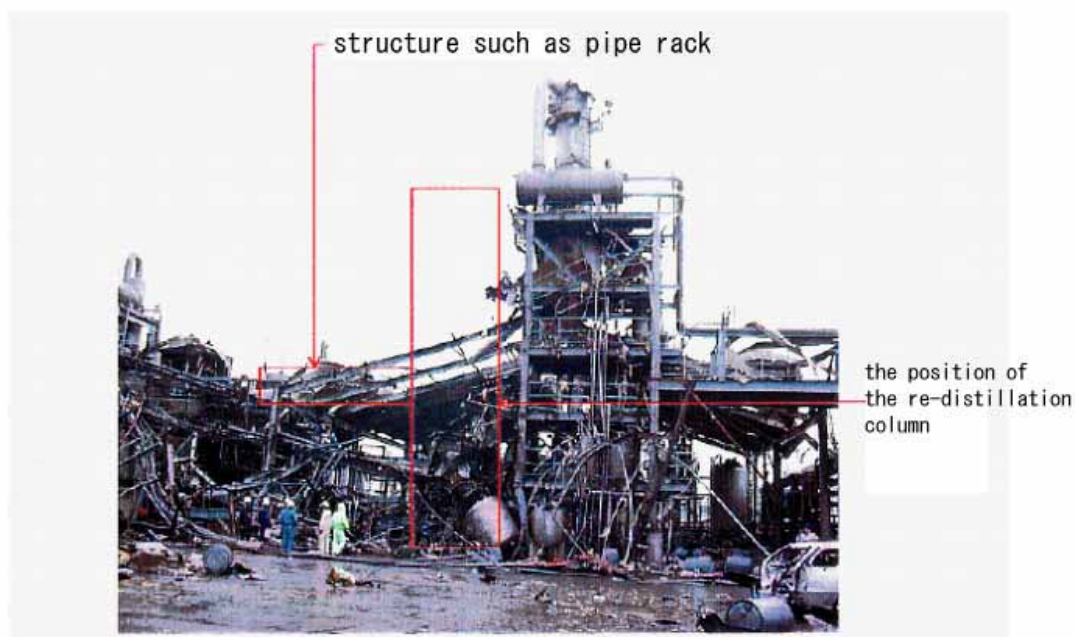
Fig. 3 Photo of the re-distillation column after the accident

All four operators died, and the operation record was destroyed. Furthermore, the re-distillation column was also completely disintegrated, and so investigation into the causes of the accident was very difficult. The cause was estimated from status investigations, interviews of the related parties, characteristics of hydroxylamine, and so on. Though the cause could not be made perfectly clear, it was estimated to be as follows.

The material that exploded was 80 to 85% hydroxylamine at the bottom of the column and in the bottom circulation line, which was estimated from the fact that the detonation position was in the column, that the explosion had occurred at the circulation line or near the heater, and that the only flammable material that existed in the column was the 80-85% aqueous solution. It was confirmed that the detonation of 80 to 85% hydroxylamine aqueous solution was possible from experiments on the explosive properties and calculations.

As for the physical damage, the column where the explosion occurred was completely disintegrated and many buildings in the factory site were damaged. Outside of the factory, two buildings were completely destroyed, five buildings were half destroyed and 285 buildings were damaged partially, and 47 cars were damaged.

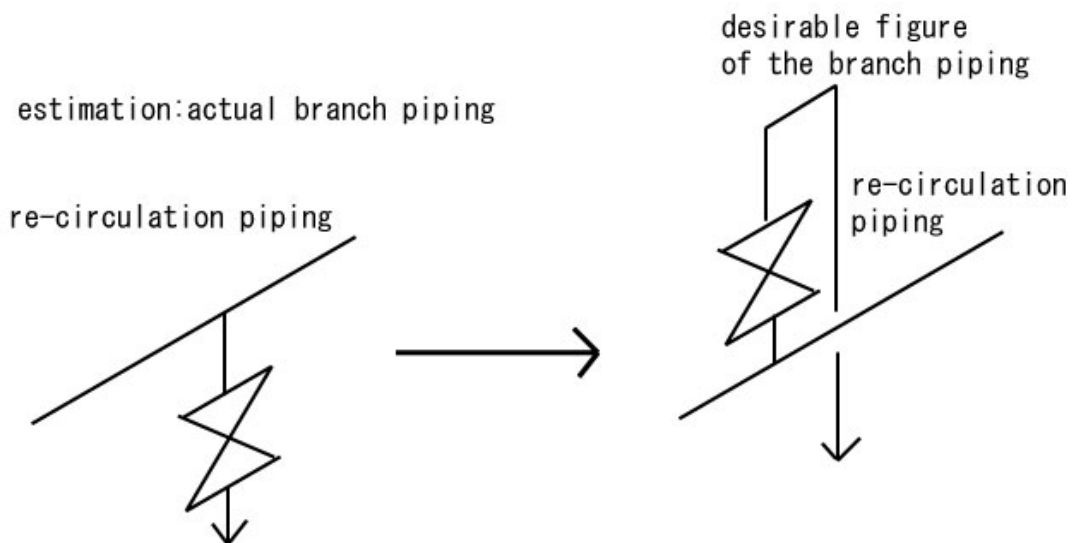
Fig.4 about the branch piping

As for the cause of the accident, following three possibilities were considered: 1) a rise in the ferrous ion concentration, 2) a rise in the temperature of the aqueous solution, and 3) a rise in the aqueous solution concentration. As a result, it was shown that the cause was the "partially rise in the concentration of a ferrous ion that had accumulated in the dead-end piping in the emergency piping".

destroyed severely. A rise in the concentration of the circulation liquid was also rejected, because 1) the area of severe destruction was limited to the lower part, and, 2) the temperature at which decomposition starts is about 130 °C, is not lowered, even if the concentration rises, and the outlet temperature of the evaporator was only about 50 °C. Therefore, only a rise in the ferrous ion concentration remained. The possibility of an insufficient quantity of chelate of the inhibitor was also rejected because the sample taken on the previous day was normal and the feedstock of the day of the accident was from the same lot as that of the previous day. There is no possibility that ferrous ions could have been supplied by rapid dissolution, because stainless steel was used as the material of the column and piping. So by the process of elimination, the cause was estimated to be an increase in the ferrous ion concentration at the downward dead-end piping located in the emergency line which had been accumulated over the long-term operation.

There seems no domestic manufacturer anymore, since it is too dangerous at present. As shown in the "Cause" section, the only one possibility, which remained as the cause of the explosion, is the emergency blowdown piping. If the cause is correct, the piping, which was mounted for preparation for very rare troubles, was the cause. It is very unfortunate. Although it has not been specified in the reports, probably the piping branched off from the lower part of the main piping. If the piping had branched off from the upper part, the remained possibility might be also rejected. There are some accidents that are caused by a mistake in the direction of the branch piping. Careful attention and adequate consideration are necessary even in the design of simple piping.
