SCIENCE OF TSUNAMI HAZARDS

FIELD SURVEY REPORT OF TSUNAMI EFFECTS CAUSED BY THE AUGUST 2012 OFFSHORE EL SALVADOR EARTHQUAKE

Francisco Gavidia-Medina*

MARN – Ministerio de Medio Ambiente y Recursos Naturales, El Salvador

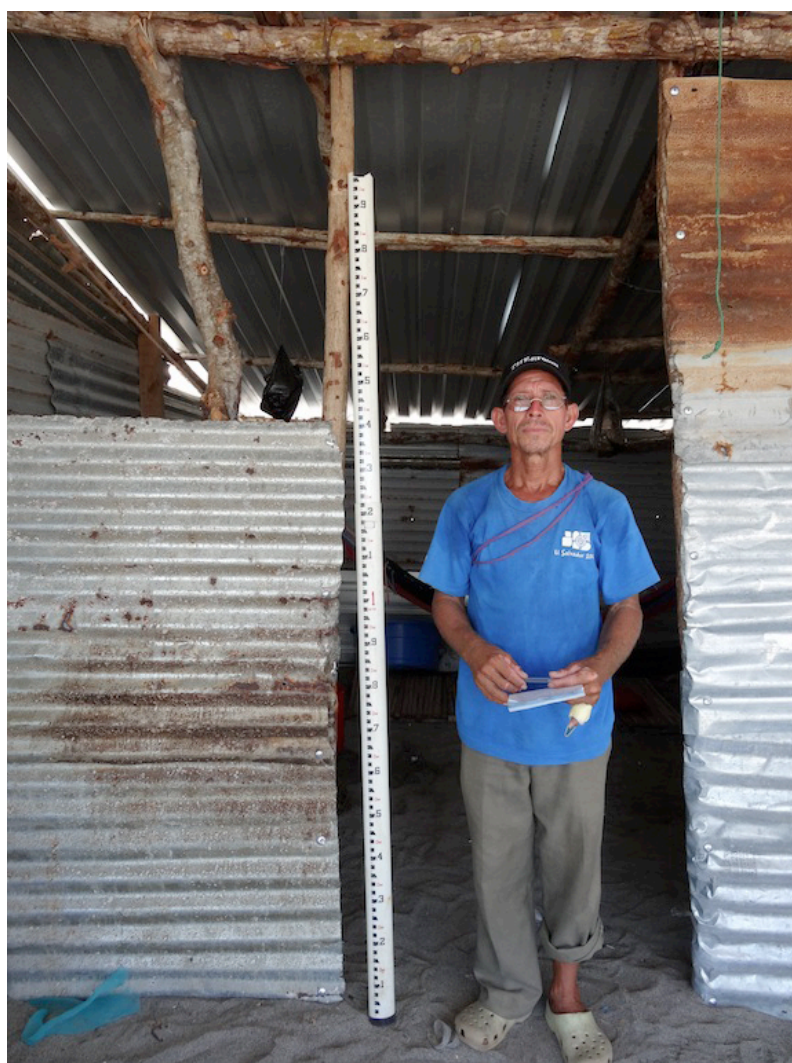
During the tsunami, the walls of the ramada were torn off of the posts that are deeply embedded in the sand. The posts themselves were not pulled out of the ground, but some were leaned over by the force of the water. By the time of the survey the ramada had been repaired and had new walls and roof.

A worker at the hatchery, Jose Barrera-Garcia, was in the ramada as the tsunami struck and came out when he heard people crying out. He was dragged some 90 m by the wave from the ramada to a tree, where he was suspended in tree branch. The height of the branch was measured at ~2.1 m above ground. Mr. Barrera-Garcia reported that he saw three waves, however we suspect there is some confusion in differentiating between wind and tsunamis waves. Mr. Barrera-Garcia said it took 20 minutes for water to recede and fully drain. He said flow depth reached just beneath the roof of the ramada as indicated in Figure 3.5. At maximum inundation extent observed (340 m) by Mr. Garcia, he said less than 1 m water depth.

Figure 3.5 Jose Barrera-Garcia at the newly rebuilt ramada. Mr. Barrera-Garcia was swept away by the tsunami and suffered minor injuries. The tsunami flow depth at this location was reported by Mr. Barrera-Garcia to be over 2 m.

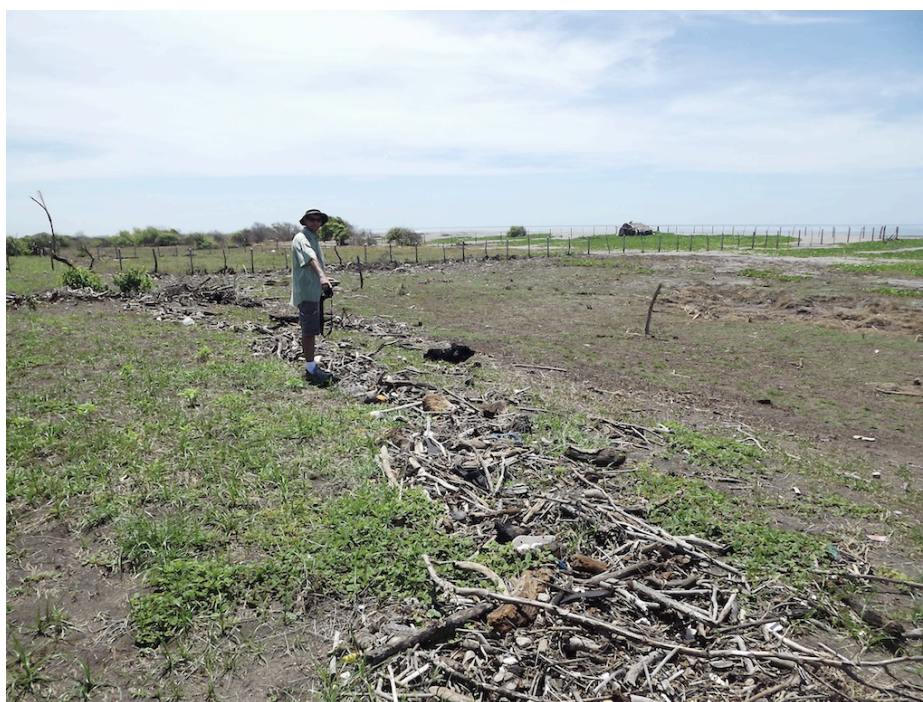
Driving eastward towards Ceiba Doblada, the team stopped at several sites where there was clear evidence of tsunami inundation. There were no residents or locals in the area available for interviews. At these sites the teams measured run-up and inundation and documented the evidence of the tsunami (Figure 3.26 through Figure 3.28).

Figure 3.26 Tsunami debris line.

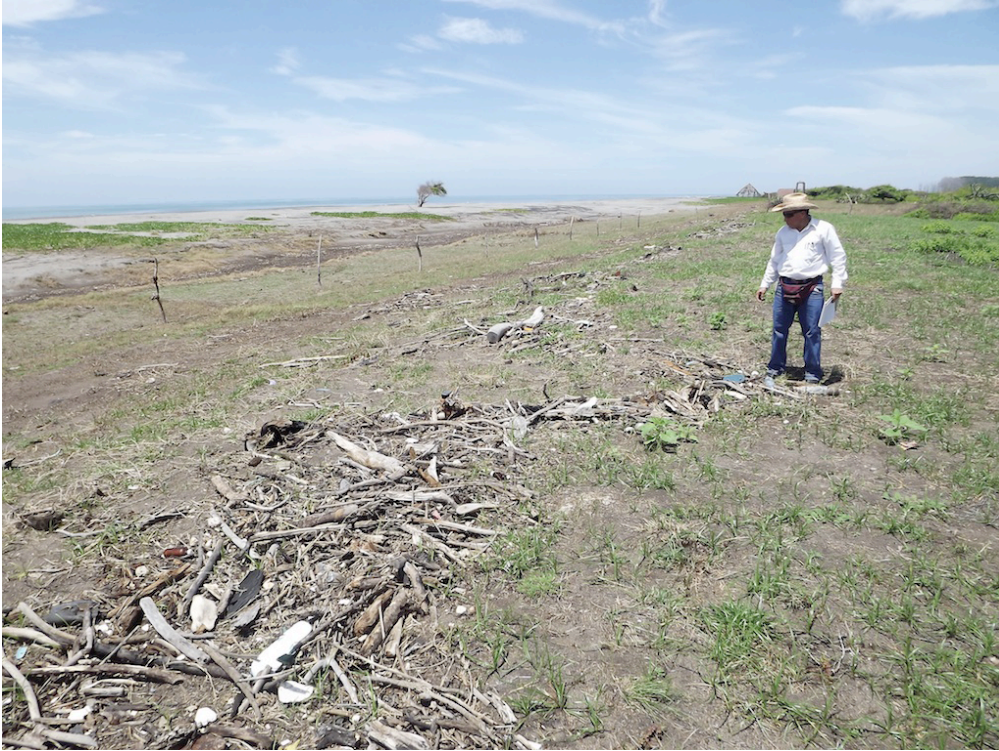
Figure 3.27 Tsunami debris line.

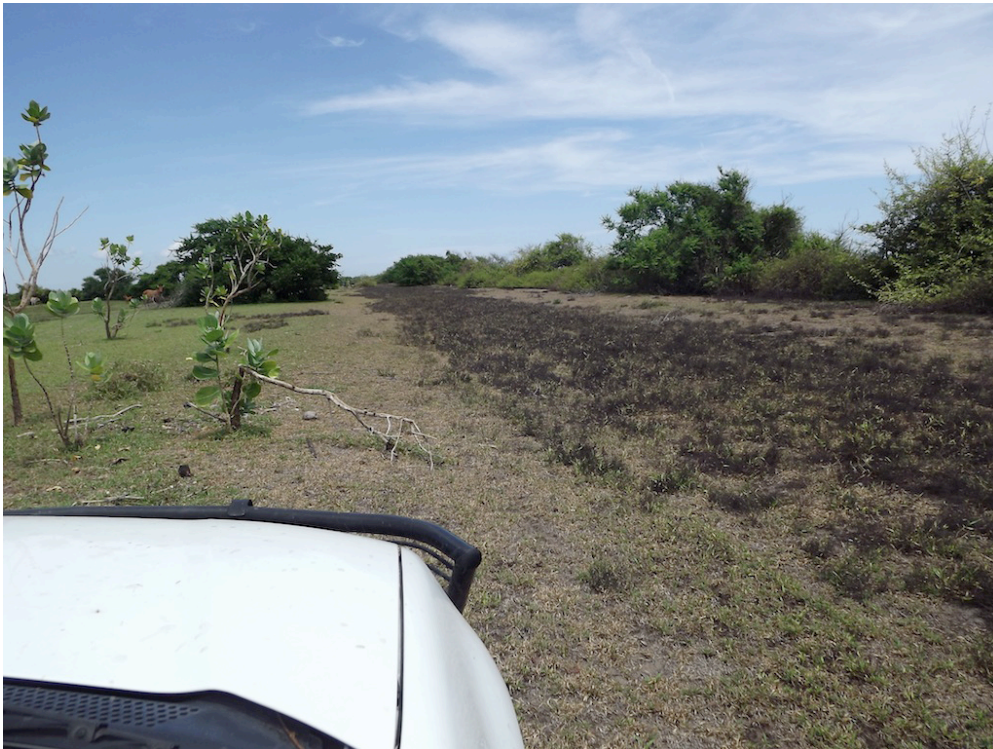
Figure 3.28 Dead vegetation from salt water intrusion.

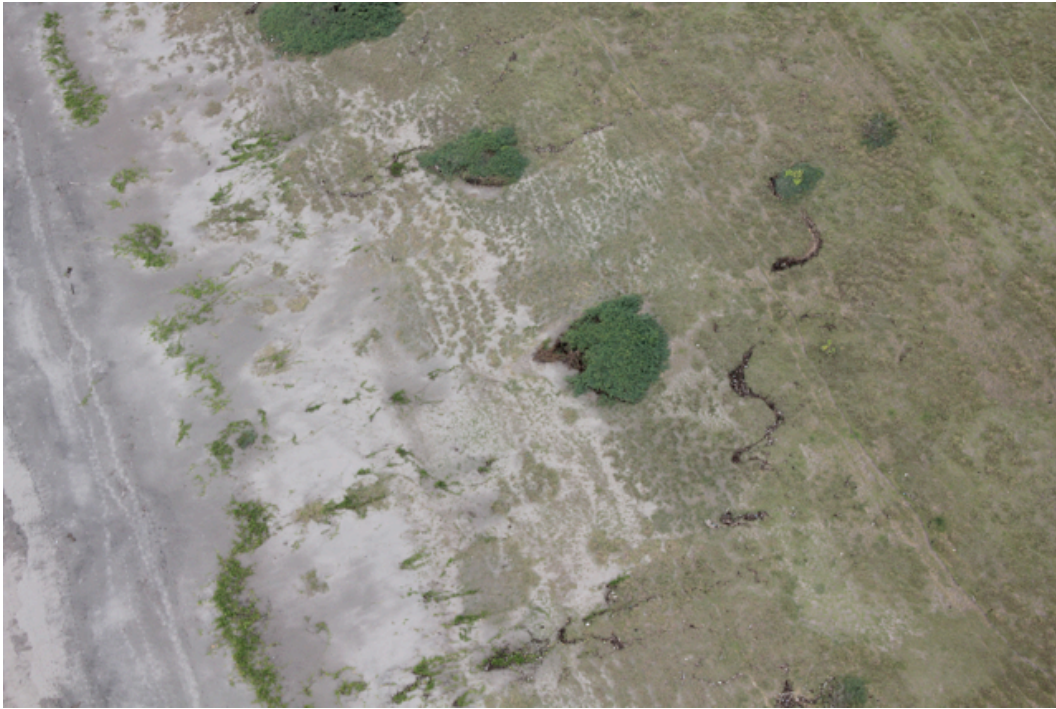
Figure 3.29 Aerial view of a tsunami debris line.

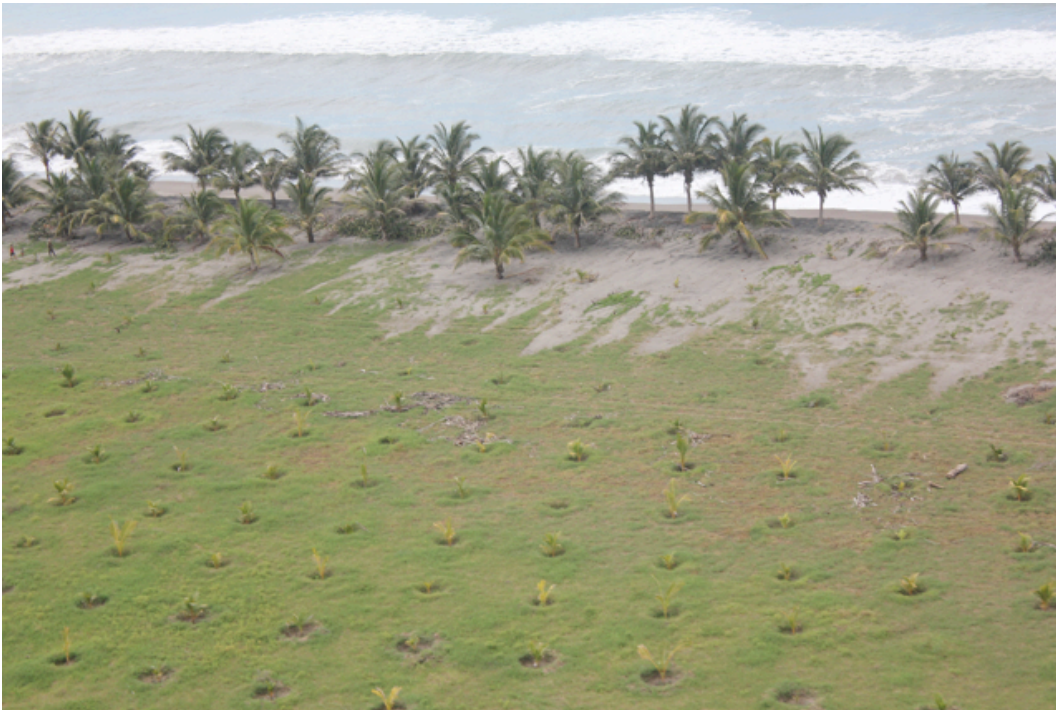
Figure 3.30 Aerial view of sand deposits from tsunami overwash.
