FRACTOGRAPHIC ANALYSIS OF OPTICAL FIBERS

J.J. Mecholsky, S.W. Freiman and S.M. Morey
Naval Research Laboratory
Washington, D.C. 20375

November 1977

Interim Technical Report 1

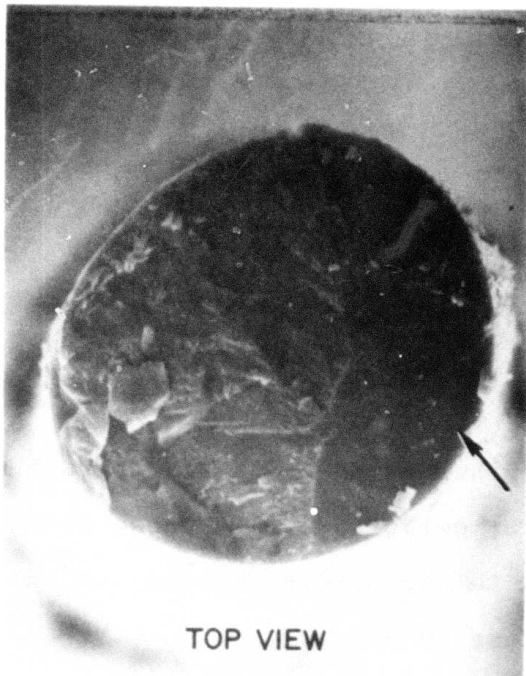
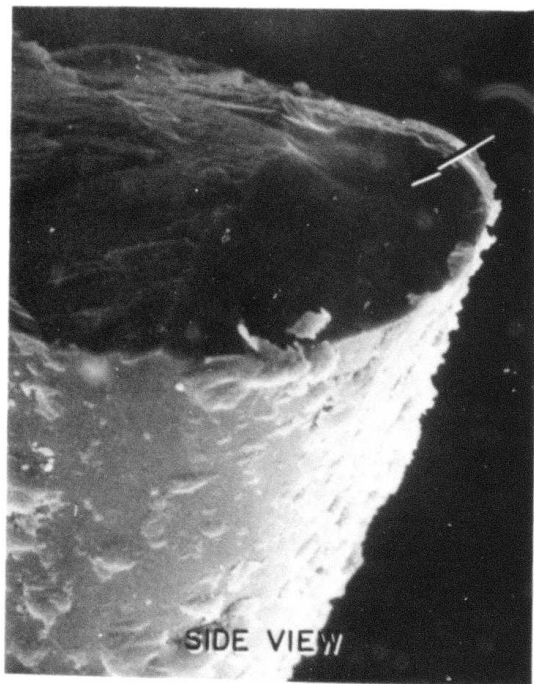
Observation of fracture surfaces on brittle materials and in particular on fibers can be misleading unless one can determine that the origin is real and is primary, that is, the main cause of failure. For example, if one observes the top view in Fig. 2 it could be concluded erroneously that a relatively large somewhat irregular mirror exists surrounding the origin. However, if care is taken to get another angle of observation (side view) one sees that in reality a chip out of the fracture surface is being observed. A true fracture mirror in most cases would not deviate from the total plane of fracture as much as indicated in the figure.

Fig. 2. SEM fractograph of a Hughes fiber (770209- H-SS-3) after removal of metal coating. Top view shows appearances of irregular "fracture mirror" around "origin" (arrow). Side view shows this to be really a chip that is missing from the surface (arrow) giving the false appearance of a fracture mirror. From the fracture markings beyond this lost area, one can conclude that a surface defect initiated the fracture. (The silica fiber is nominally 120 μm in dia.).

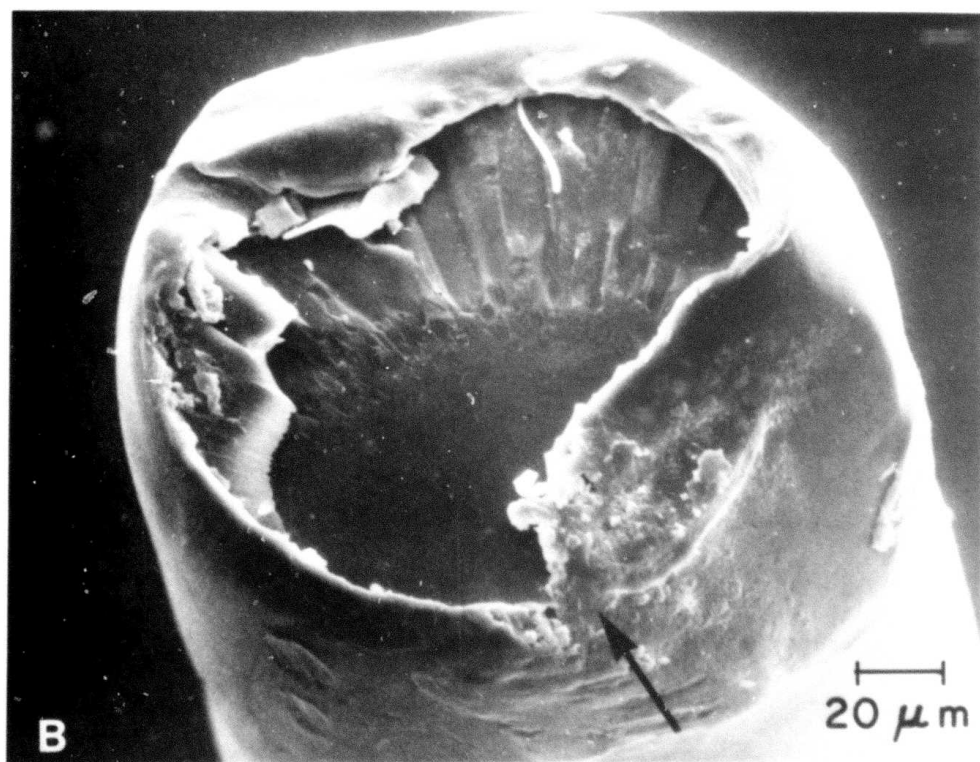
Fig. 3. Matching halves of a SEM fractograph of Hughes fibers
(A-770725-37b; B-770725-37a). These show that fracture features
"point" back to the origin (arrows) at the surface even though
the exact cause is unknown.

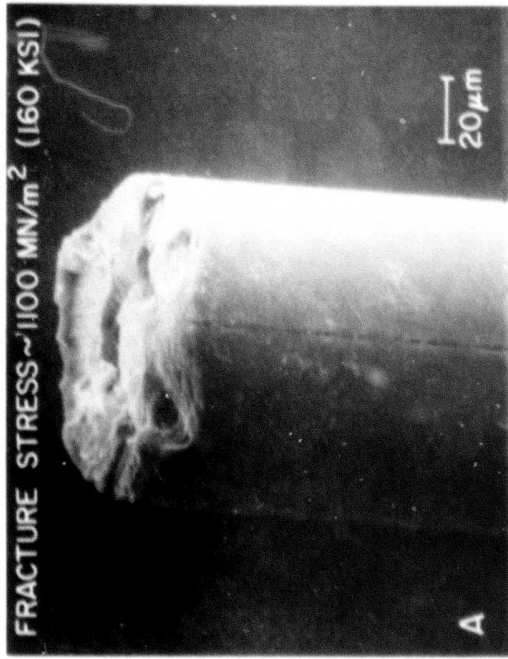
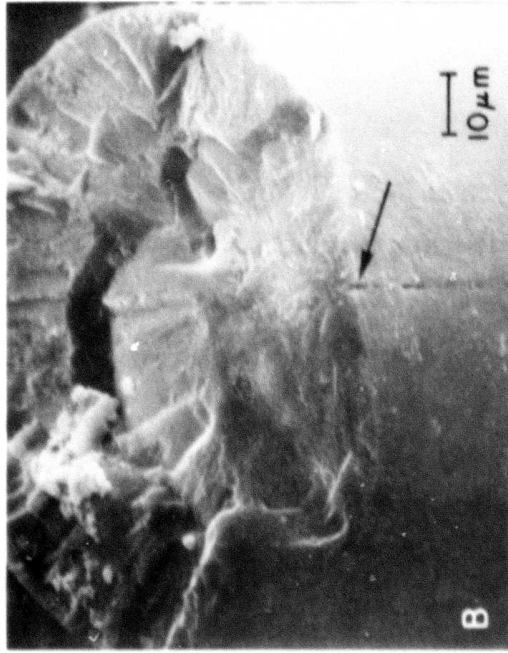
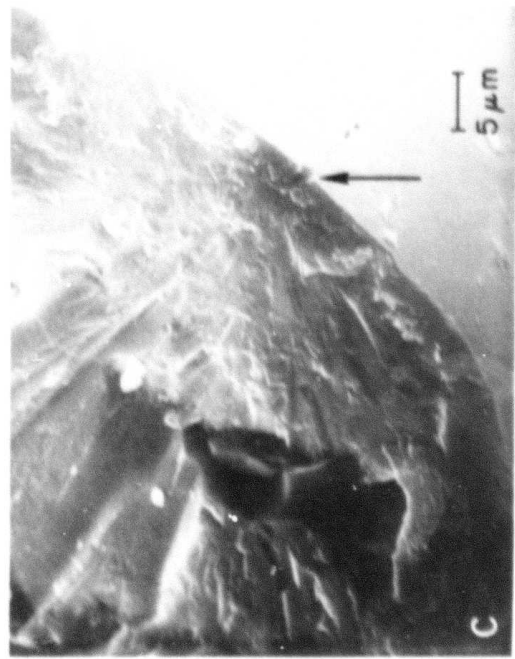
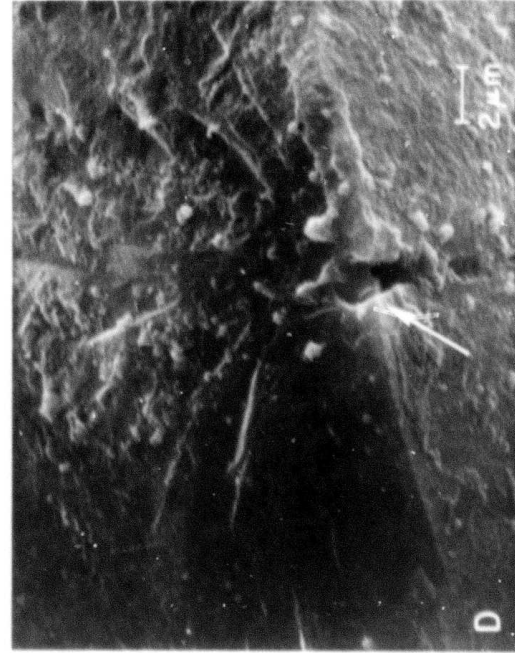
origins observed to date on Hughes fibers were from surface defects. These include a surface crack(Fig. 4) and a bubble which originated in the preform(Fig. 5). In the latter, the bubbles along the surface indicate that a large bubble in the preform was drawn out during fiber pulling. Even with the large defect (38 μm half-width) it's spherical shape resulted in approximately 160,000 psi(from mirror measurements) breaking stress in reasonable agreement with the approximately 200,000 psi measured during the test. Other origins were not found, but the fracture markings leading back to the surface on a few others could readily be observed as in Fig. 3. In fact, the fiber in Fig. 3A was etched in an aqua regia solution to remove the aluminum coating because it obscured the detail of the origin. Even then, the aluminum appeared coherently connected to the glass indicating that an aluminum oxide interface may be present between glass and metal. Delayed failure specimens 1 through 5 in Table I also showed a high degree of corrosion(Figs. 4 & 6), but the corrosion product has not yet been identified. As can be seen in Fig. 6 there are many cracks in the aluminum coating. Many of these cracks look like they follow the grain boundaries in the aluminum. This indicates that they could be occurring during stressing, although it is not clear that corrosion alone would not cause this. Also, it is possible that they are a result of stress corrosion cracking. One way of determining the cause of these cracks is to examine the fiber after coating and during stressing. In addition to the cracks there is evidence of roughly circular pits. One would suspect that the pits would be elongated if they occurred before or during stressing, and more circular or spherical if they occurred after stressing. Thus, one would surmise that these

Fig. 5. SEM fractograph of a Hughes fiber (770209 - H-SS-5) after removal of the metal coating. Source of failure (arrow) is from an elliptical defect, most likely from a bubble in the preform that was drawn out with the fiber.

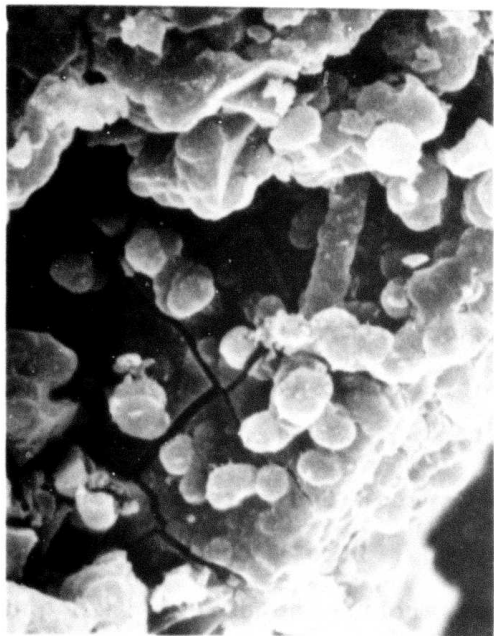
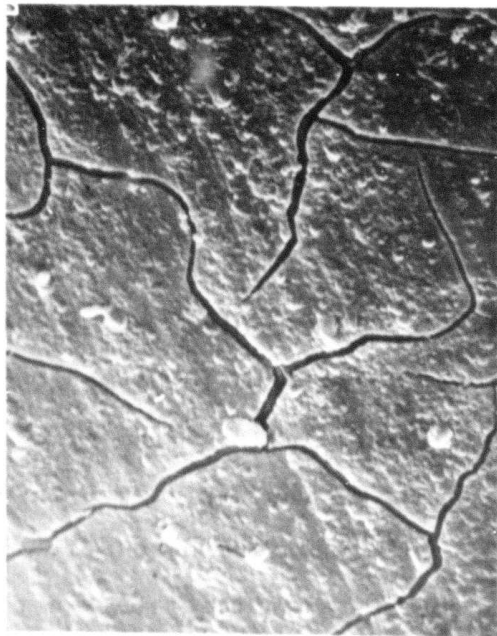
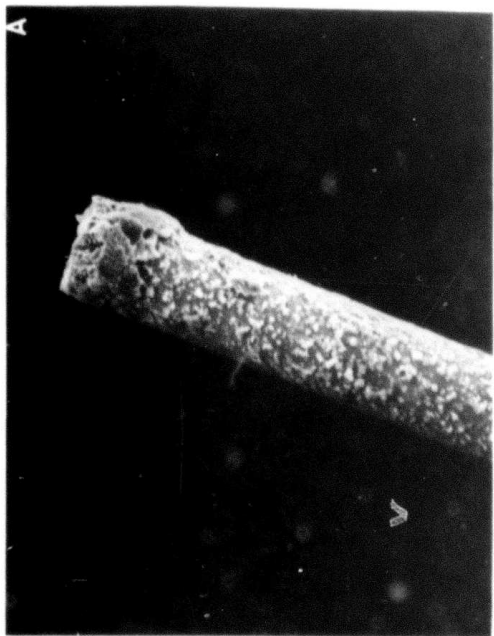
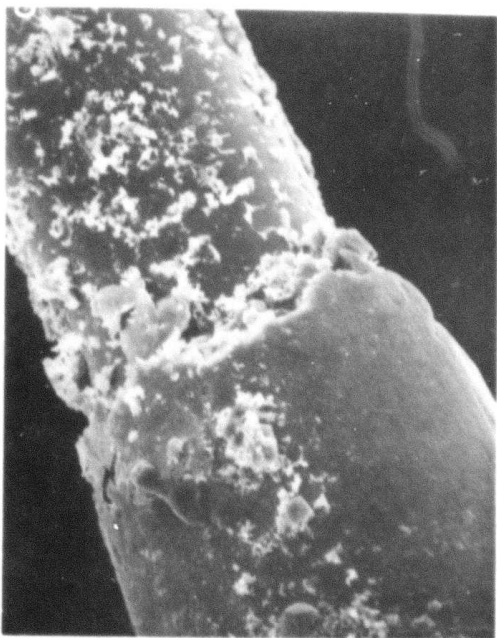
Fig. 6. SEM micrograph of the corroded surface of metal and fiber as a result of failure in salt water. (Hughes fiber 770209-H-SS-1). Notice the cracks in the metal tend to follow grain boundaries (C and D).

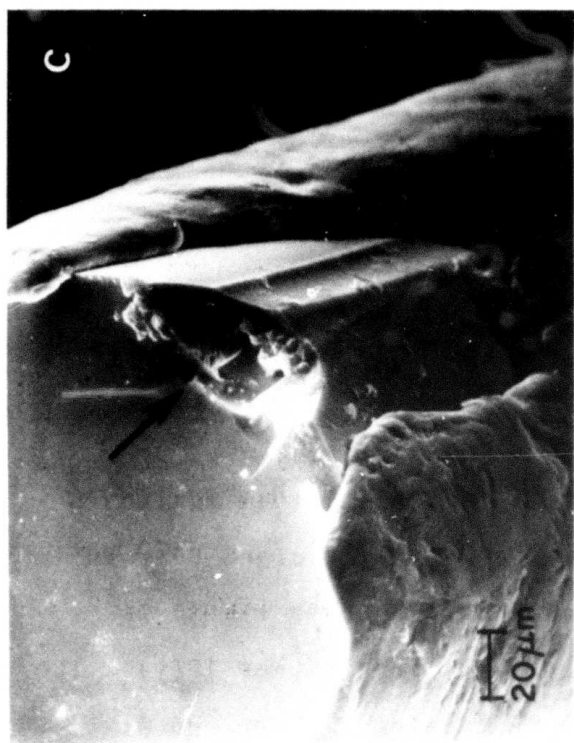
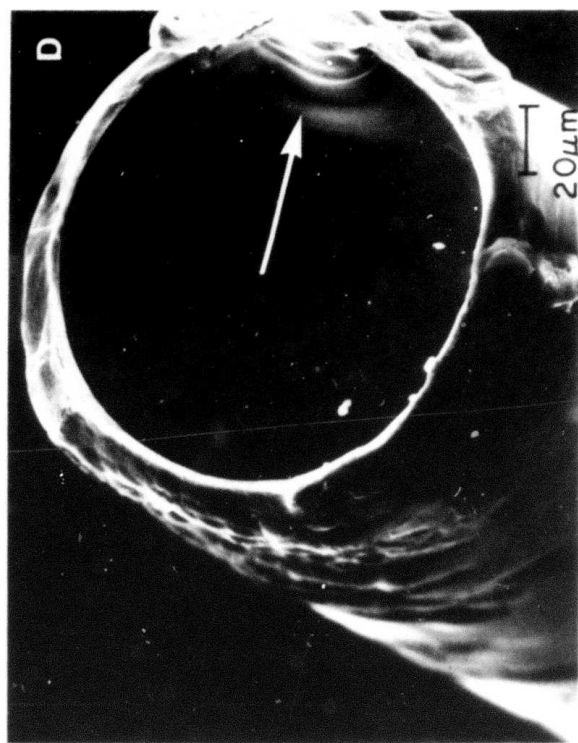
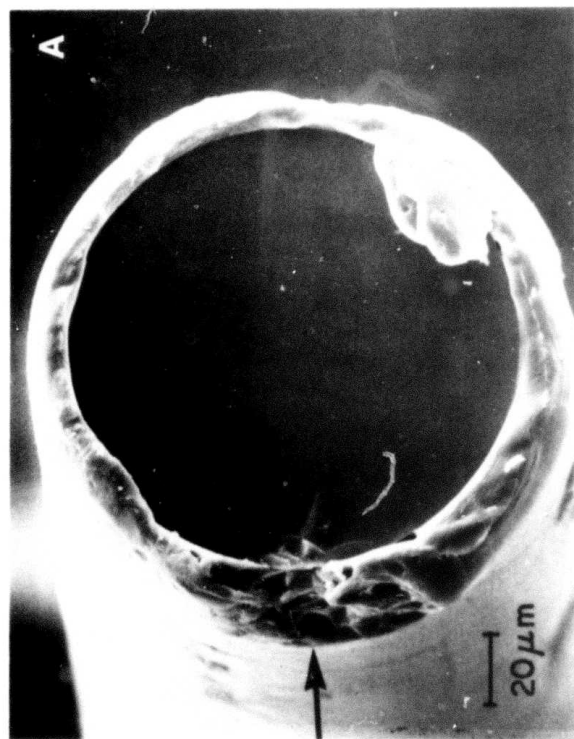
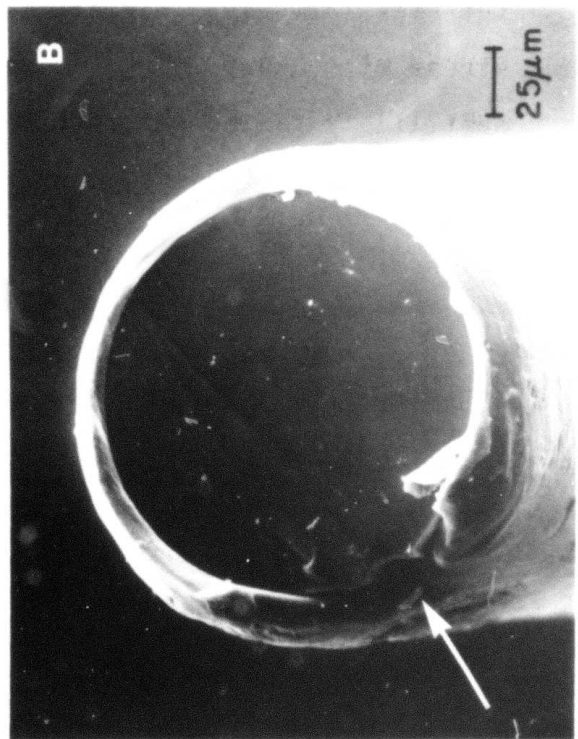
Several low strength fibers were sent from Hughes for identification of fracture origins. Although the analysis is not complete, it is quite evident that a semi-elliptical ridge on the surface of most of the fibers examined is consistently the cause of failure (Fig. 7). Because the ridge along the fiber surface is relatively smooth it would appear that this defect is being caused in the drawing process when the fiber is relatively hot. One would expect a rough gouge if some object were pulled across the surface. Further communication between NRL and Hughes will hopefully trace the exact cause of this defect and thereby eliminate it.

Fig. 7. SEM fractograph of four Hughes fibers failed in proof test at relatively low strengths. Notice that all fibers indicate surface failure from an elliptical cut with ridge. The smoothness of the depression in B and C would indicate this occurred while the fiber was soft. Also, most likely the metal is debonded from the fiber in the area around the defect in B and C. (770725-: A-4a; B-2a; C-1a; D-3)

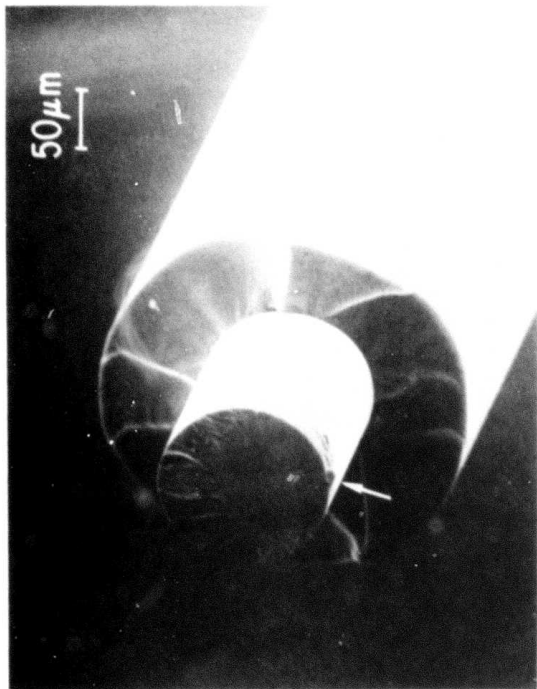
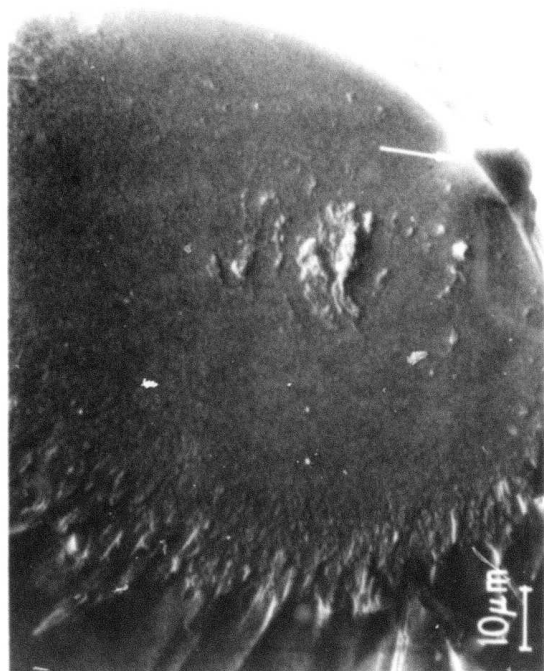
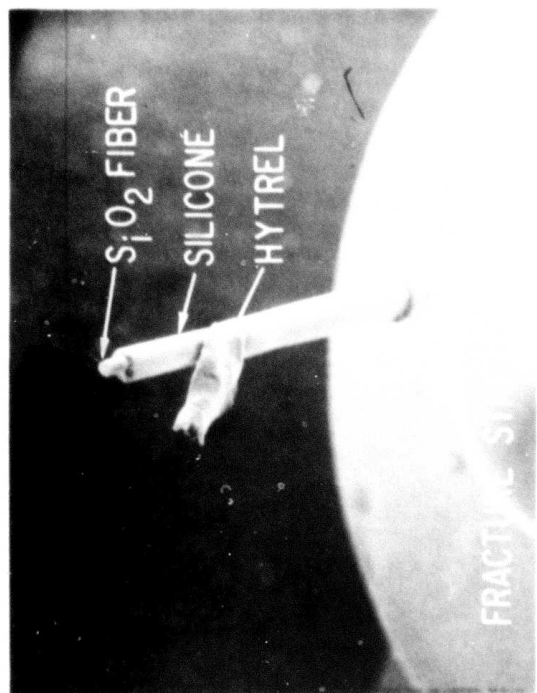
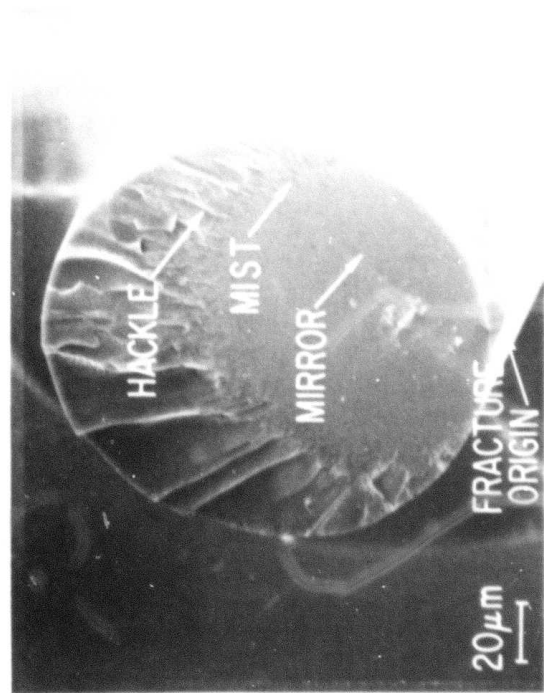
A foreign particle is shown attached to the silica in Figures 8 and 13. The particle was analyzed using an electron microprobe; the results indicated the presence of magnesium and iron as well as silica (Fig. 13). This type of failure can be avoided by filtering (clean room). This "dust" particle which attached to the fiber during drawing caused a small (approximately 1.5 μm) crack, most likely upon cooling, which subsequently lead to failure. The size of this crack (2 μm) is in

Fig. 8. SEM fractograph of an ITT fiber (761221-4) that failed in a proof test (200 ksi). The source of failure (crack between foreign particle and bulk SiO_2 , as shown in lower right) is shown surrounded by the fracture demarcations (lower left). The foreign particle is identified as containing Mg, Fe, and Si (cf Fig. 13). The 'mirror' size measurements indicate a failure stress of $\sim 315 \text{ MN/m}^2$ ($\sim 45 \text{ ksi}$). This means that this fiber most likely failed before the full proof stress was achieved, i.e. around the edge of the drum.

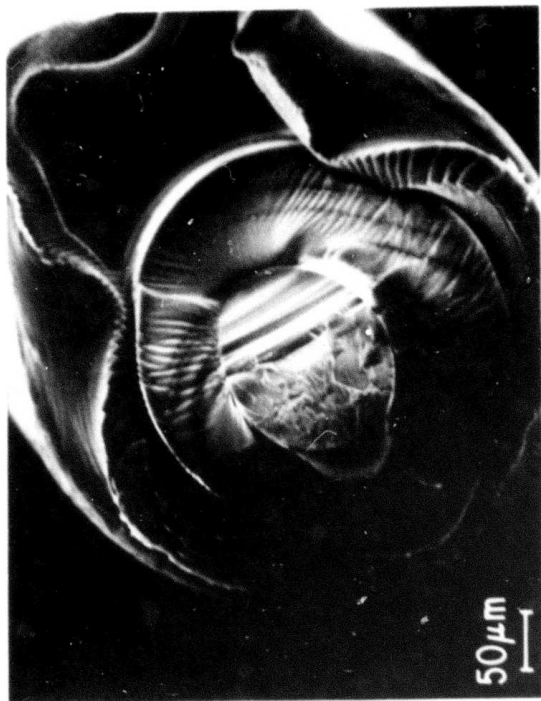
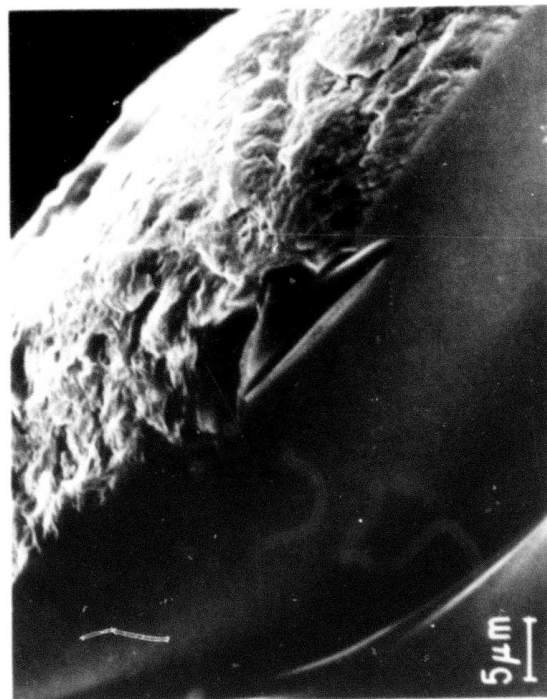
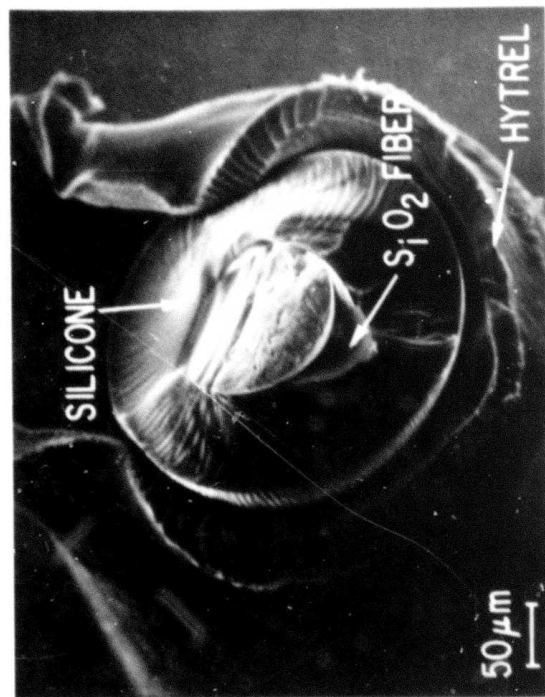
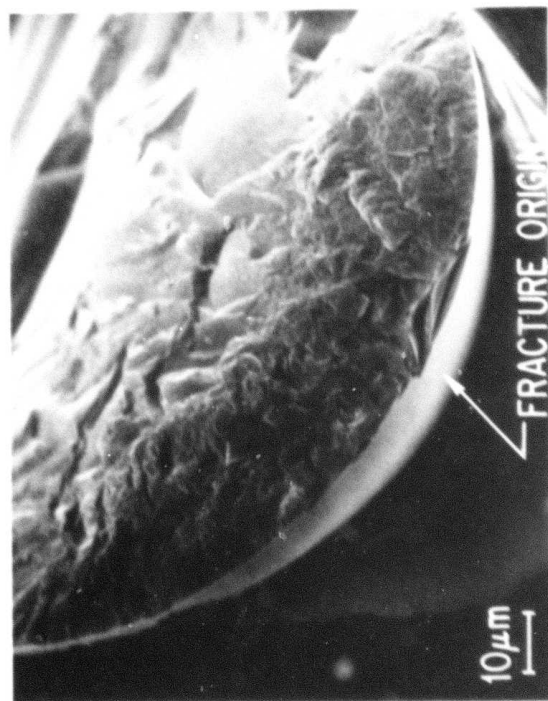
The surface failures were a result of a foreign particle (Fig. 8), five from cracks or mechanically induced chips (e.g. Fig. 9 and 10), and 5 "unidentified" sources of failure (e.g. Figs. 11 and 12). It is suspected that at least four of the last 5 listed are from small crystallite formations, but this has to be determined for certain.

Fig. 10. SEM fractograph of an ITT fiber (761221-5) that failed from a mechanically induced crack. Although the crack is relatively large, it is probably not sharp, and thus, this fiber most likely achieved the 1400 MN/m^2 proof stress.

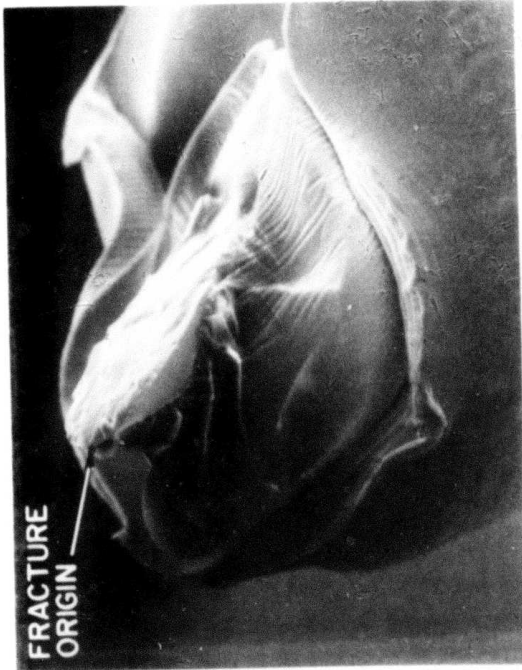
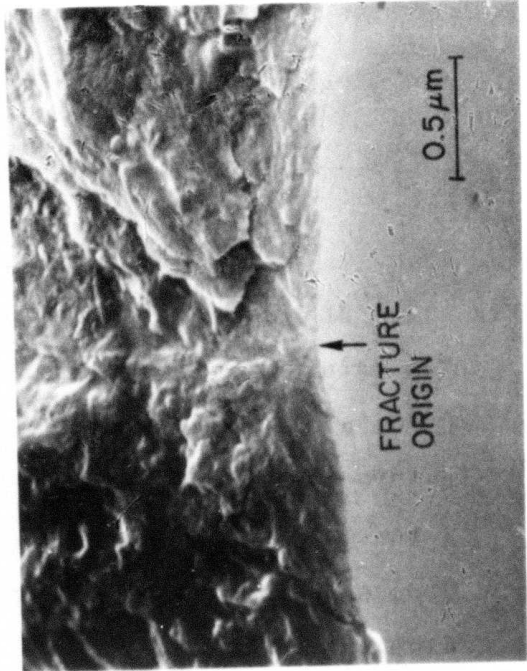
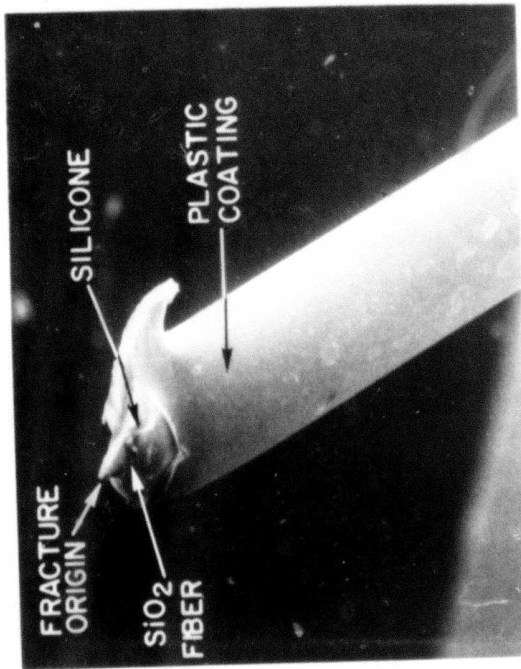
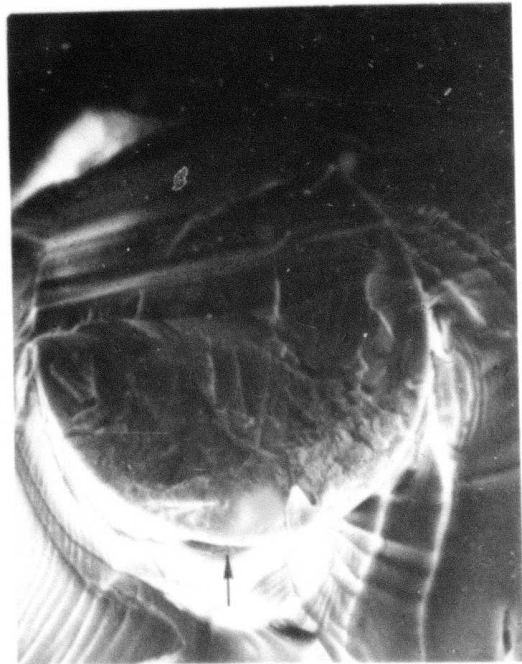
Fig. 11. SEM of an ITT fiber (770209-A) failing from the surface. The nature of the fracture origin and surrounding area (rough surface) indicates a high stress ($> 2100 \text{ MN/m}^2$). The exact source of failure is unknown.

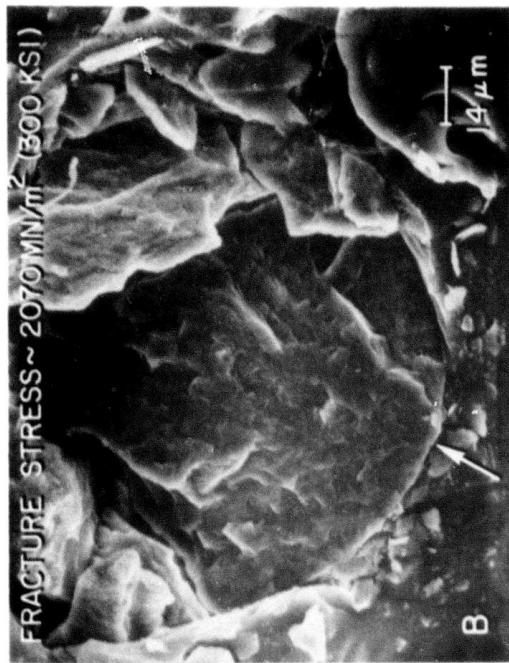
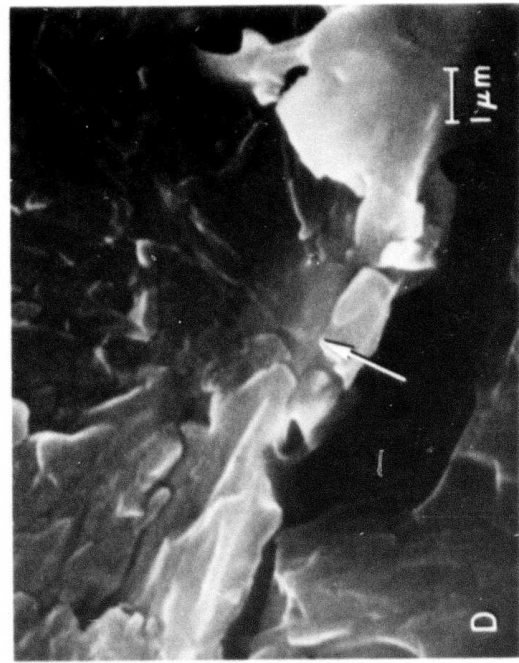
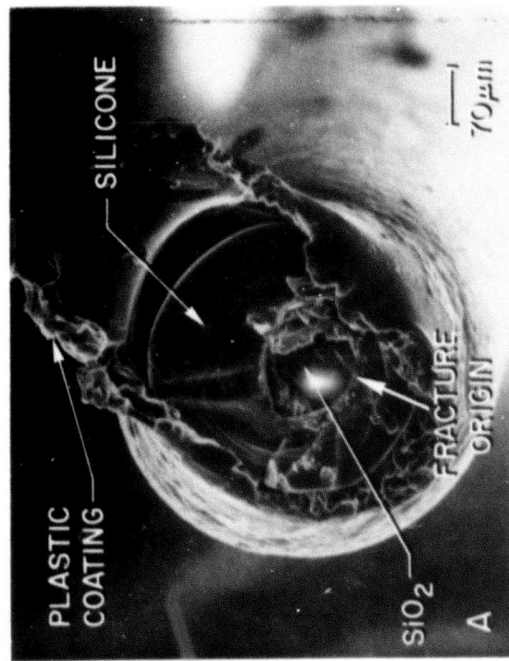
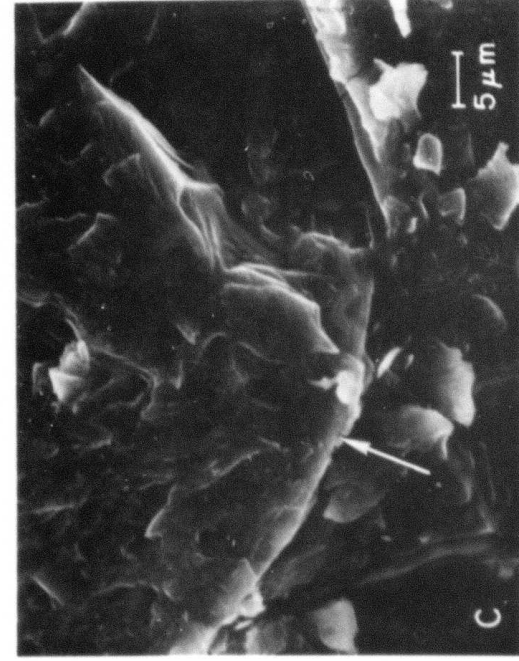
Fig. 12. SEM of an ITT fiber (770209-1) failed from the surface.

The nature of the rough area surrounding the origin (arrow in B, C, and D) indicates a high stress ($\sim 2070 \text{ MN/m}^2$). The exact nature of the fracture origin is unknown, but could be due to a thermal expansion mismatch between two phases (i.e. glassy SiO_2 and crystalline SiO_2 or crystalline metal or crystalline alumina).

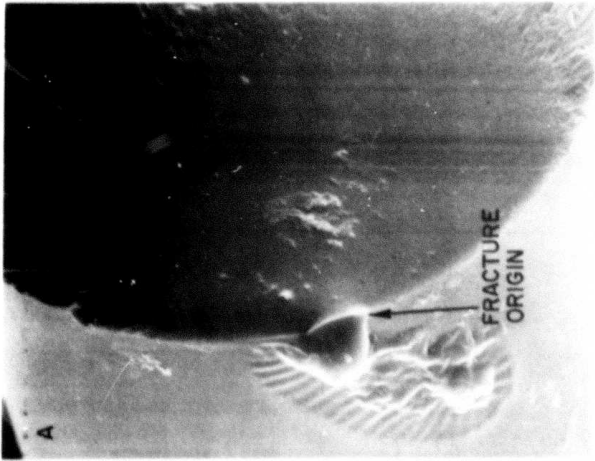
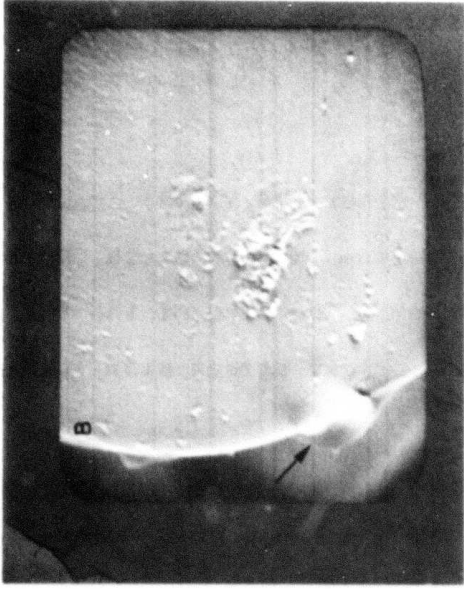
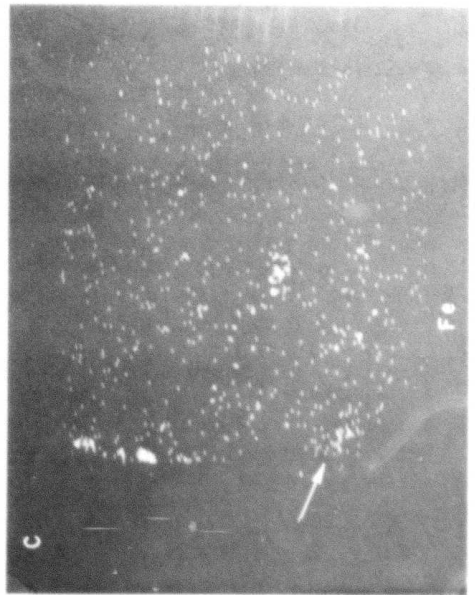
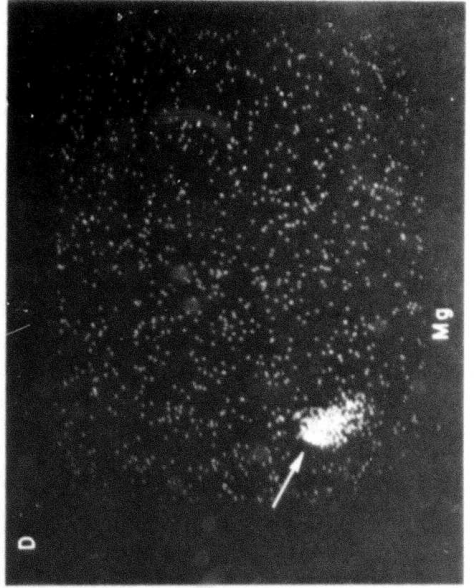
Fig. 13. A) SEM fractograph of Fig. 8 for reference. B) Real image of A as given by microprobe unit. C and D) Microprobe electron images showing relative concentrations of Fe and Mg, respectively. Arrows indicate fracture origin for reference.

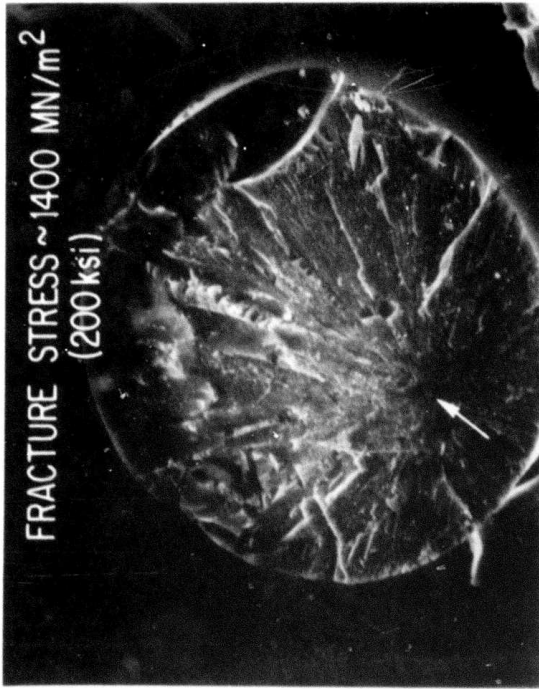
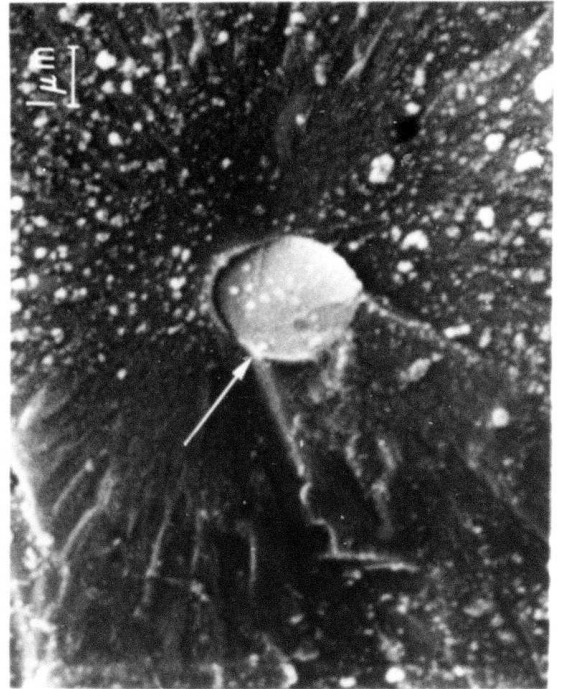
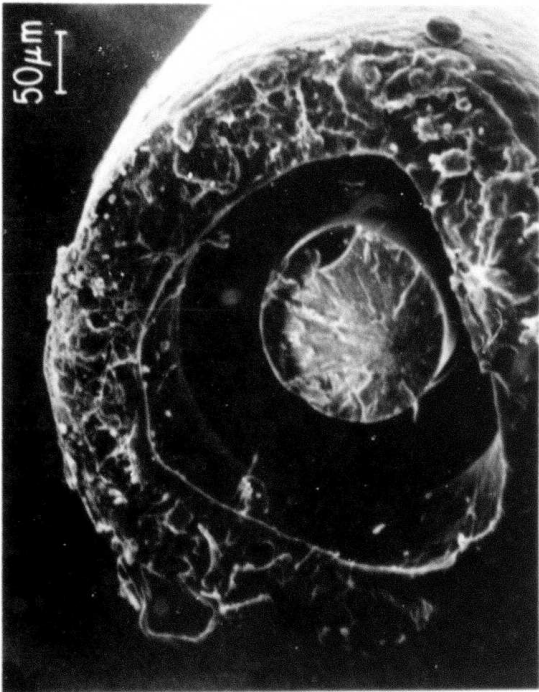
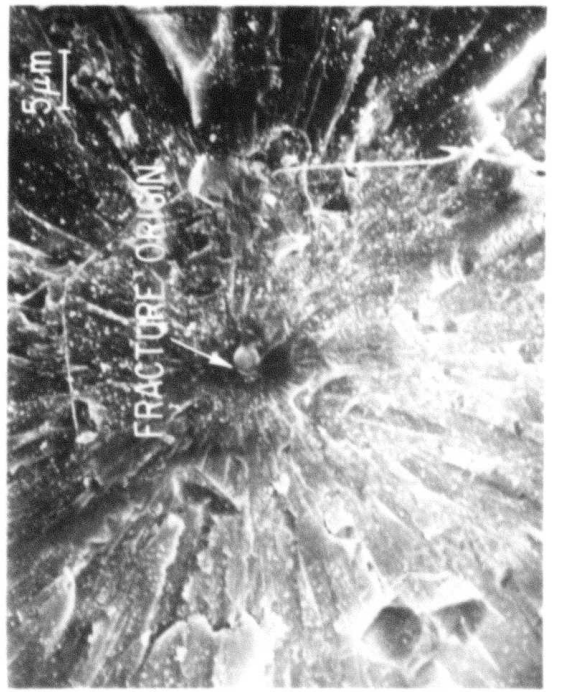
Although most fractures were from surface origins, there are seven cases where internal origins occurred. One internal origin was an inclusion containing rare earth elements (Nb and La) Fig. 14. This failure occurred due to a ($0.2 \mu\text{m}$) crack formed between the inclusion and bulk SiO_2 . Failure from inclusions related to natural forming elements can most likely be eliminated by using synthetic quartz material rather than the natural quartz. This also applies to preform manufacture used in the CVD process. If the outer tube or preform material is natural quartz, then defects such as bubbles and inclusions will be transferred to the final silica fiber. Closer examination is planned to determine the source of these internal failures. Higher magnification is required to determine the source of these failures because the size of the defect, in most cases, is less than $0.2 \mu\text{m}$, and consequently detailed analysis is difficult.

Fig. 14. SEM fractograph of an ITT fiber (761221-2) showing failure from a crack at the interface between a rare earth (Nb and La) inclusion and the bulk SiO_2 fiber. The size of the fracture "mirror" region surrounding the origin agrees with the 1400 MN/m^2 proof stress recorded.

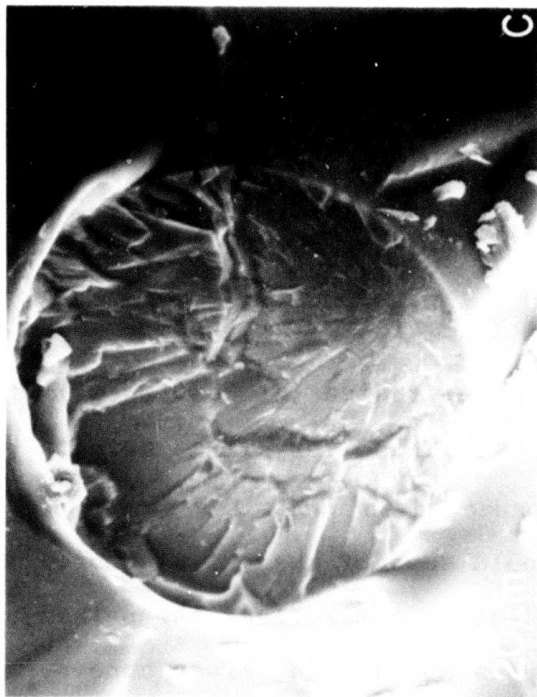
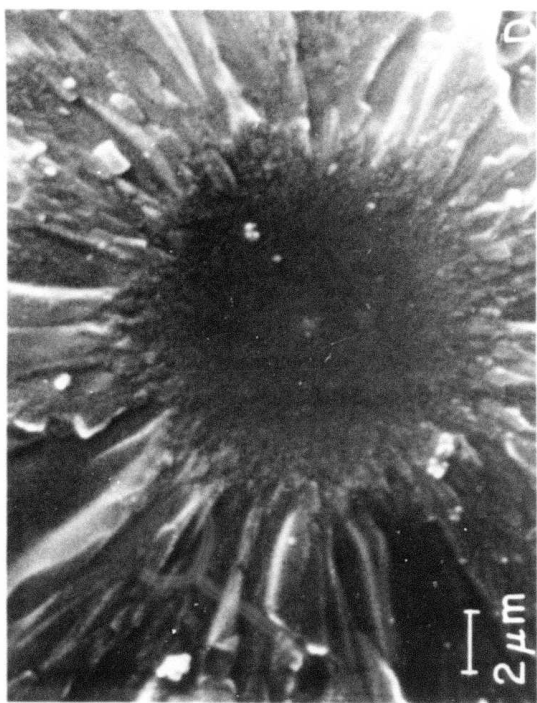
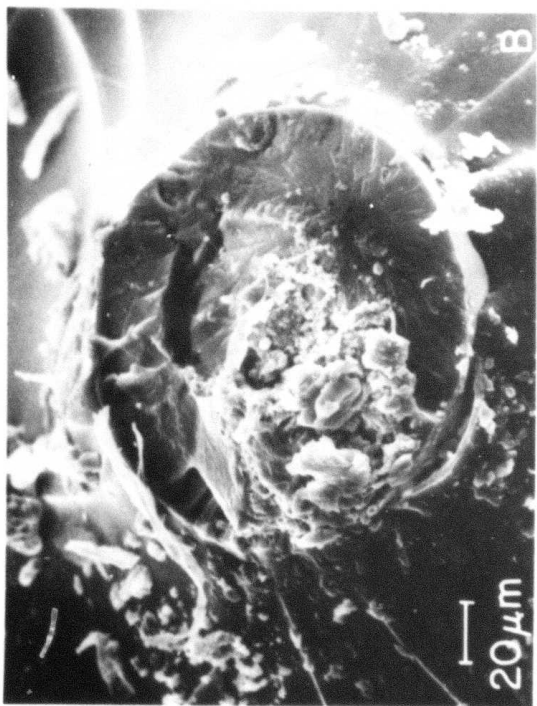
Several fibers were sent that were known to have low strength values. Fracture surface analysis determined that the low strength (approximately 200,000 psi) failures were probably occurring due to a defect that existed in the preform and was drawn out during the pulling of the fiber. This is concluded because there were several internal failures in the same general location in the plane of the fracture (cf Fig. 15a and b).

Fig. 15. SEM fractographs of three ITT fibers failing from internal sources. (A=770708-4; B=770708-3; C and D=770510-9.) The location of the origin in A & B and the other fibers of this set (Table II) indicate that the same type of source is probably causing failure. Although not certain, the white dot evident in D could be a small microcrystallite of silica.

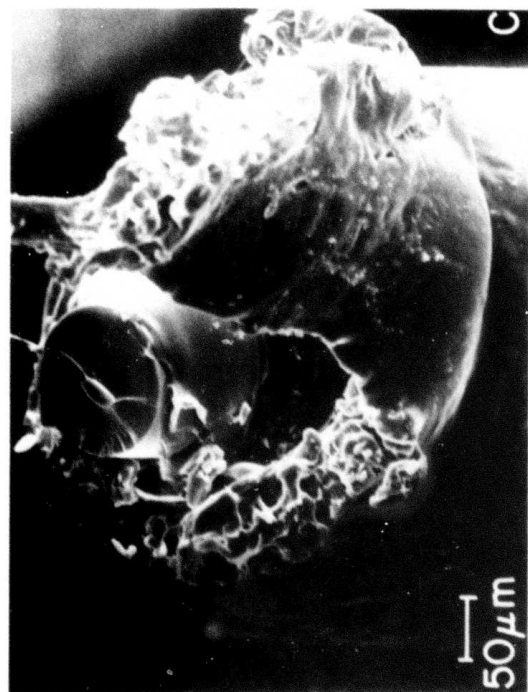
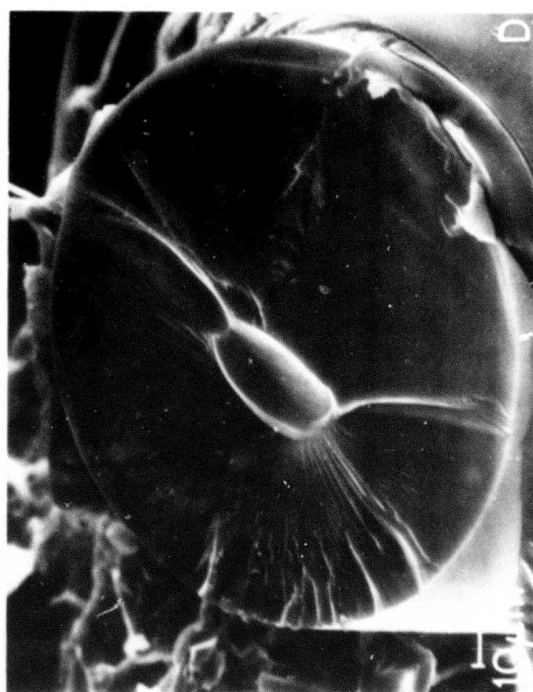
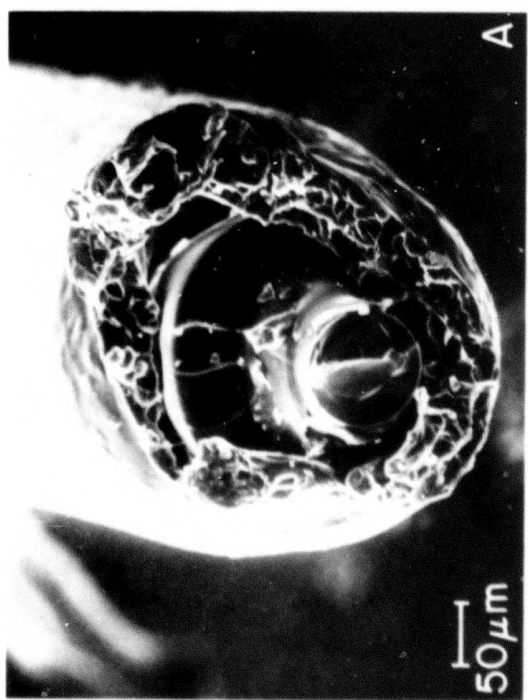
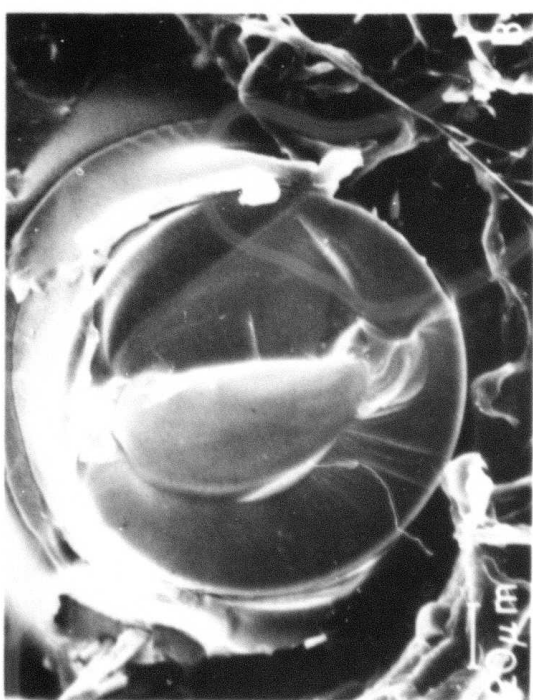
Of all the fibers observed (28 pairs) which were sent from NOSC, only two origins were found. The low yield is due to the fact that these fibers all had a relatively high strength since the pretest proofing at 300 ksi eliminated the weak fibers. These high strengths > 500 ksi mean that fracture origin determination is very difficult, if not impossible. However, two of the three fracture surfaces were similar in appearance (Fig. 15) to each other but not to any other fibers observed, either from ITT or Hughes. The large semi-elliptical sections in the interior of the fibers observed in Fig. 16 should have caused low strength breaks. The reported strength is $\sim 3500 \text{ MN/m}^{3/2}$ ($\sim 500 \text{ ksi}$), indicating that these fractures are probably secondary, rather than primary breaks. However, the question arises of why these large inhomogeneities did not cause failure at lower stresses as the primary break. Perhaps, because these inhomogeneities are SiO_x of a slightly different composition than SiO_2 , they were not high stress concentrators leading to low strength failure. The composition and identity of these anomalies is unknown but further research is being performed.

Fig. 16. SEM fractograph of an ITT fiber tested (at 3500 MN/m^2) at NOSC. A and B - 4-8; C and D- 2-6. These very large defects are unidentified, but would be expected to cause low strength ($< 700 \text{ MN/m}^2$) fractures. One would suspect, then, that these are probably secondary failures and do not reflect the primary break, or that the inhomogeneity is not a high stress concentration.
