National Transportation Safety Board

Safety Recommendation

Date: January 15, 1998

In reply refer to: A-98-1 and -2

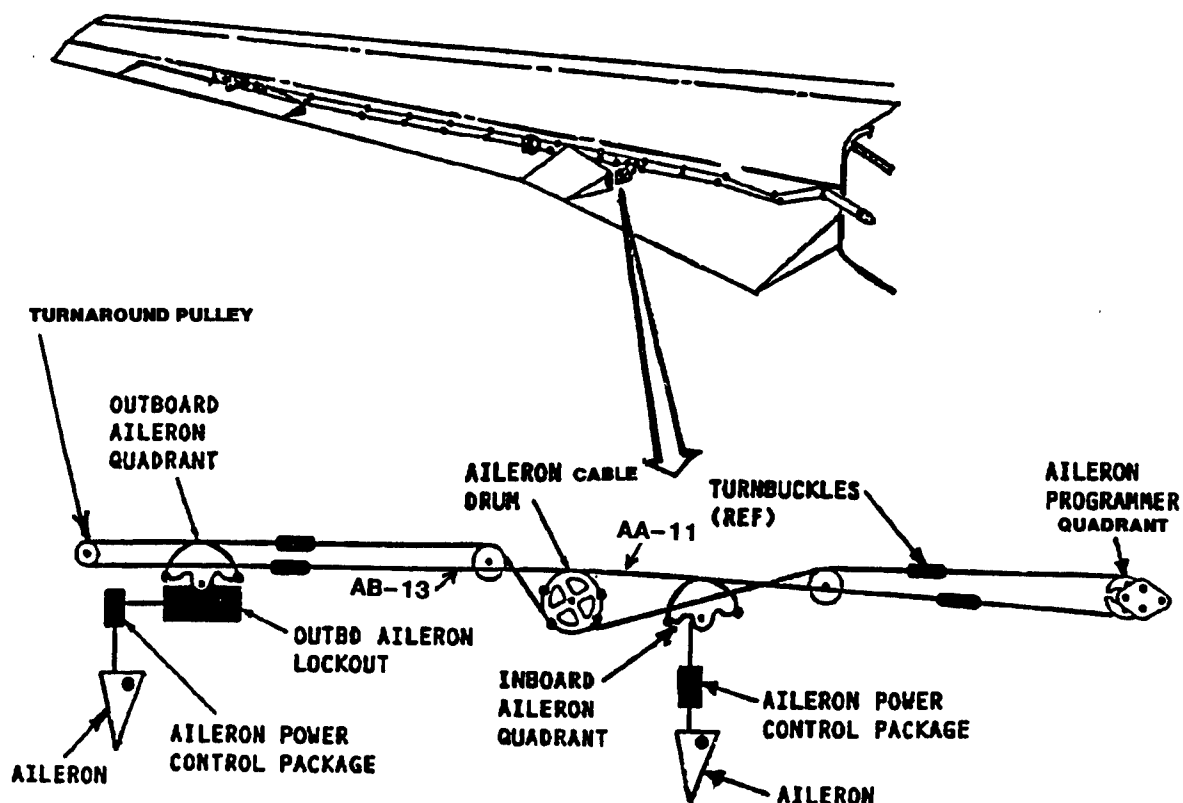
Figure 1. Aileron Wing Control Cable System.

Each wing has two AA and two AB aileron cable assemblies (see Figure 1.), one inboard and one outboard. The inboard AA cable run connects the aileron programmer quadrant to the aileron cable drum, and the inboard AB cable run connects the same quadrant to the inboard aileron PCU quadrant. The outboard AA cable run connects the aileron cable drum to the outboard aileron quadrant, and the outboard AB cable run connects the drum to the same quadrant via a turnaround pulley. The aileron cable drum, which is located at wing station (WS) 776.98, is a four-slotted pulley with a guide pin and is used to provide a complete (closed) cable loop to the inboard aileron even if the outboard segment is lost because of malfunction. The guide pin's purpose is to ensure that all four cables remain in the correct pulley slots at all times.

Further investigation by BASI revealed that the two aileron control cable decals¹ on the aileron cable drum's inboard and outboard mounting brackets at WS767 and WS780 were installed incorrectly. The decal for WS767 was fitted at WS780 and vice versa. BASI also found that a similar 747 aircraft, S/N 23028, production line number 584, had the aileron cable replaced because of excessive wear, and the cable was frayed down to one remaining strand. This aircraft also had the two aileron control cable decals on the aileron cable drum's inboard and outboard mounting brackets at WS767 and WS780 fitted incorrectly and interchanged. Because of the decals' transposition, the Safety Board requested a U.S. operator to randomly inspect its 747 airplane aileron control systems for the aileron cable drum decal identification at WS767 and WS780. An inspection on November 24, 1997, of one 747-251, S/N 21707, production line number 378, revealed similar decal transposition on the right WS767 and WS780.

The BASI investigation concluded that the Brisbane incident was caused by misrouting of cables on the aileron cable drum at WS776.98 and that transposition of the aileron control cable decals on the aileron cable drum at WS767 and WS780 has the potential to cause misalignment of the aileron control cables during installation. The Safety Board is concerned that airplanes with mispositioned aileron cable installation decals may be susceptible to aileron cable failures in flight, which could jeopardize flight safety. The Safety Board believes that the Federal Aviation Administration should issue an airworthiness directive to require operators of 747s, produced before production line number 1130, to conduct a one-time inspection of the aileron control system to ensure correct routing of aileron control cables on the aileron cable drum located at WS776.98 and correct installation of aileron cable decals at WS767 and WS780 at the earliest possible inspection interval.

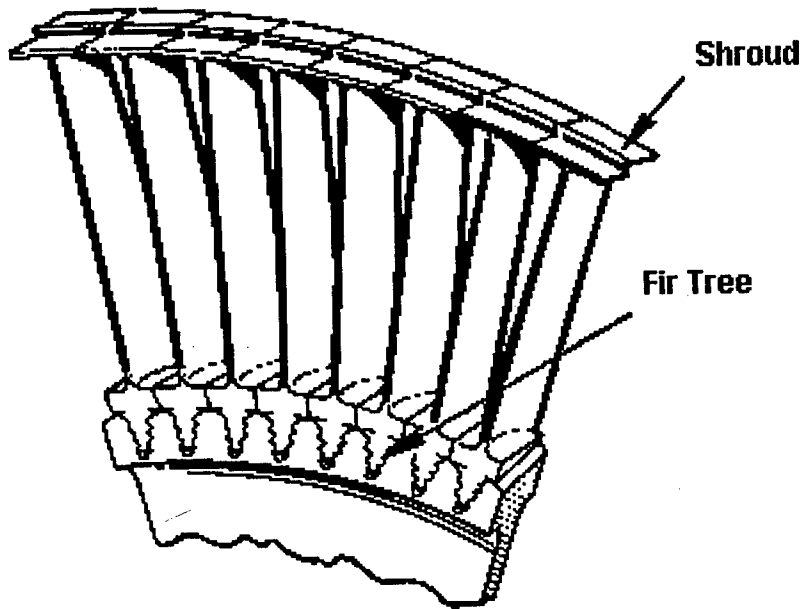
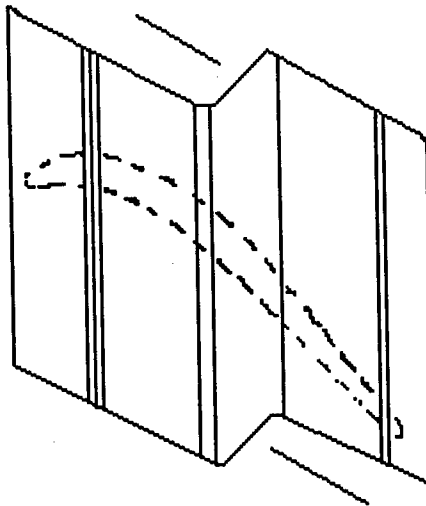
Typical Top View of Blade

origin area. Examination of the 4th stage LPT blade shroud notches³ that were recovered from the exhaust case revealed evidence of extreme notch wear estimated at 0.030 to 0.050 inch in depth.

The JT8D LPT blade design incorporates a blade tip shroud for structural support and vibration dampening. The blade shrouds interlock to provide stiffness so that they function as a single ring to reduce blade flexing caused by thermal, aerodynamic and centrifugal loads. The shroud notches (contact areas) are coated with PWA 694, which is a cobalt alloy that is a hard temperature and wear resistant material, to help reduce wearing. Worn shroud notch surfaces reduce blade damping and drop the blades' resonance frequency into the engine operating range. This increases the vibratory stresses to levels that can initiate fatigue cracking.

According to P&W, the JT8D-200 series engine has experienced 180 3rd and 4th stage LPT blade failures resulting from two different failure modes. The first is excessively worn LPT blade notches that can result in HCF fractures occurring at the root of the 3rd and 4th stage blades. P&W indicated that approximately 95 percent of all 3rd and 4th stage blade failures are the result of

worn shroud notches. The second is a low cycle fatigue (LCF)⁴ crack initiating in the 4th stage blade shroud fillet resulting in a cross-notch failure.

Determine the effectiveness of inspection techniques used to measure the amount of shroud wear on installed 3rd and 4th stage low pressure turbine blades on Pratt & Whitney JT8D-200 series turbofan engines, and mandate inspection techniques determined to be most effective based on an interval derived from failure and operational data. (A-98-8)

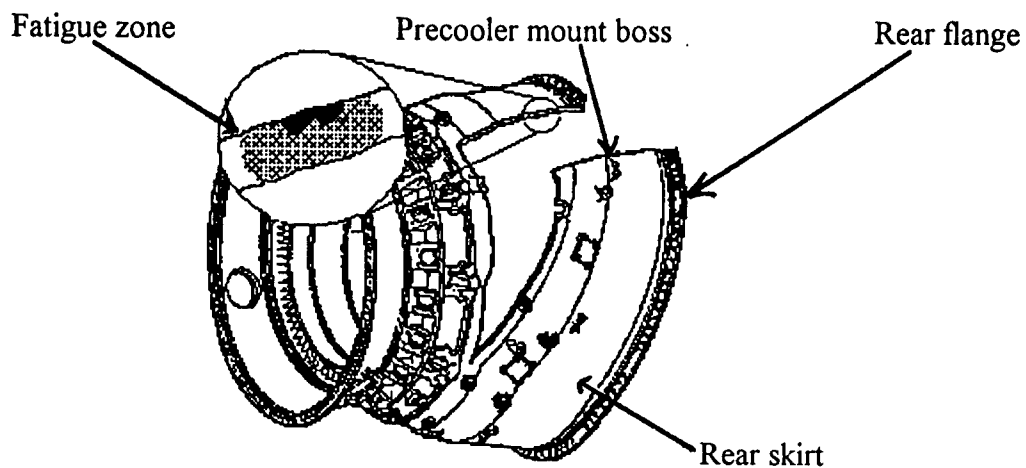
Figure 1: Ruptured diffuser case

A section of the diffuser case rear skirt (see figure 1) was examined at the Safety Board's materials laboratory in Washington, D.C. Examination of the fracture surface, approximately 10 ½ inches from the rear flange, adjacent to the upper precooler mount boss, revealed a 5-inch long discolored high cycle fatigue³ (HCF) zone with about 90,000 striations. The fatigue initiated at a crack that looked like two thumbnail-shaped, gray-colored areas, which were approximately 0.040-inch wide by 0.010-inch deep. High levels of delta phase precipitate⁴ were discovered in the thumbnail-shaped origin areas. Individual 0.0005 to 0.0008-inch deep toolmarks or scratches were found on the outer case wall extending the length of the origin area. Numerous additional toolmarks were found on the exterior surface of the rear skirt. The toolmarks were formed when the exterior surface of the case was machined (blended) during manufacture. The diffuser case had accumulated 9,342 total flight cycles⁵ since new.

A metallurgical analysis of the fracture surface indicated that the thumbnail-shaped cracks had initiated at the base of the toolmarks because of a combination of high residual stresses and low-cycle fatigue⁶ (LCF). The crack then propagated in HCF, as evidenced by the very small striation spacing found in the majority of the 5-inch long fatigue zone, after which the crack progressed to failure in tensile overload.

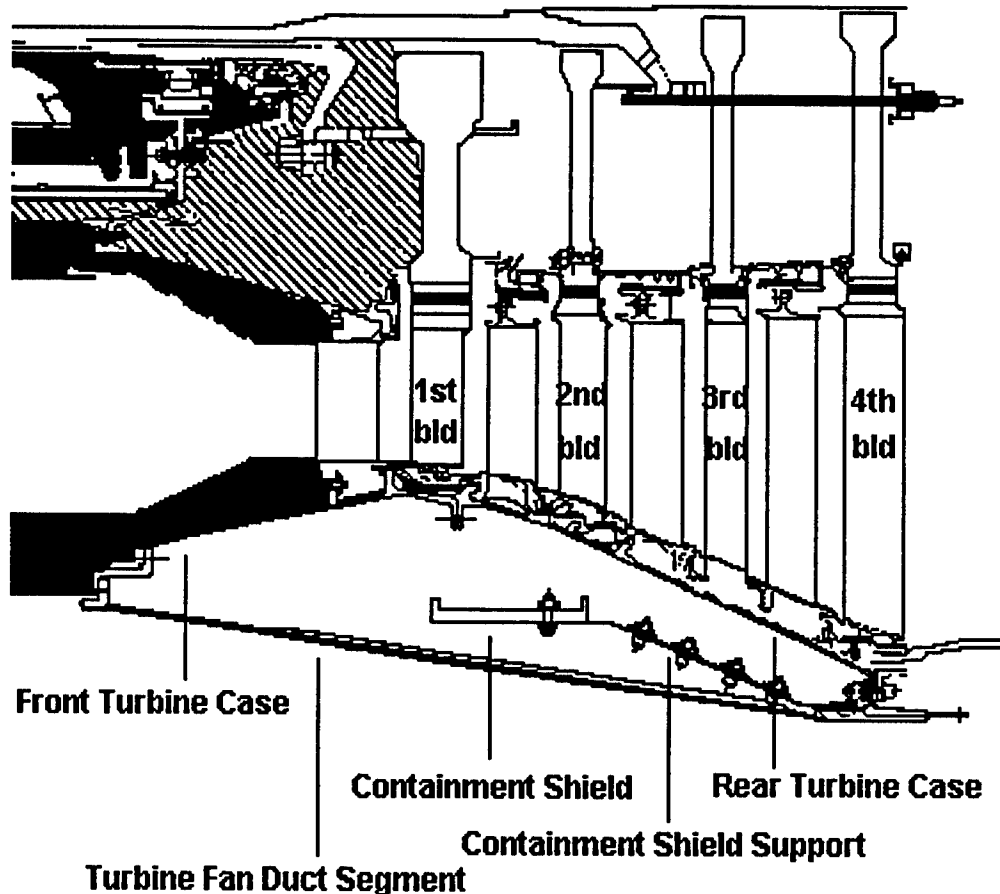
Figure 1 Containment Shield Configuration

applicable to all JT8D-209, -217, -217A, -217C, and -219 turbofan engines. The containment shield is a clam shell design consisting of two half-shields joined by clevis plates and supported by a cantilevered shield support attached to the HPT rear flange. Considerable impact damage (engine debris) was observed on the inner diameter (ID) of the containment shield; however, the shield remained intact. The impact of turbine material on the lower shield shifted it outward and aft from its normal installed position, buckling its support. First-stage turbine blades and 2nd-stage turbine vanes had exited the engine through the openings between the HPT and LPT case flanges and deflected off the containment shield ID while exiting the engine and before striking the airframe.

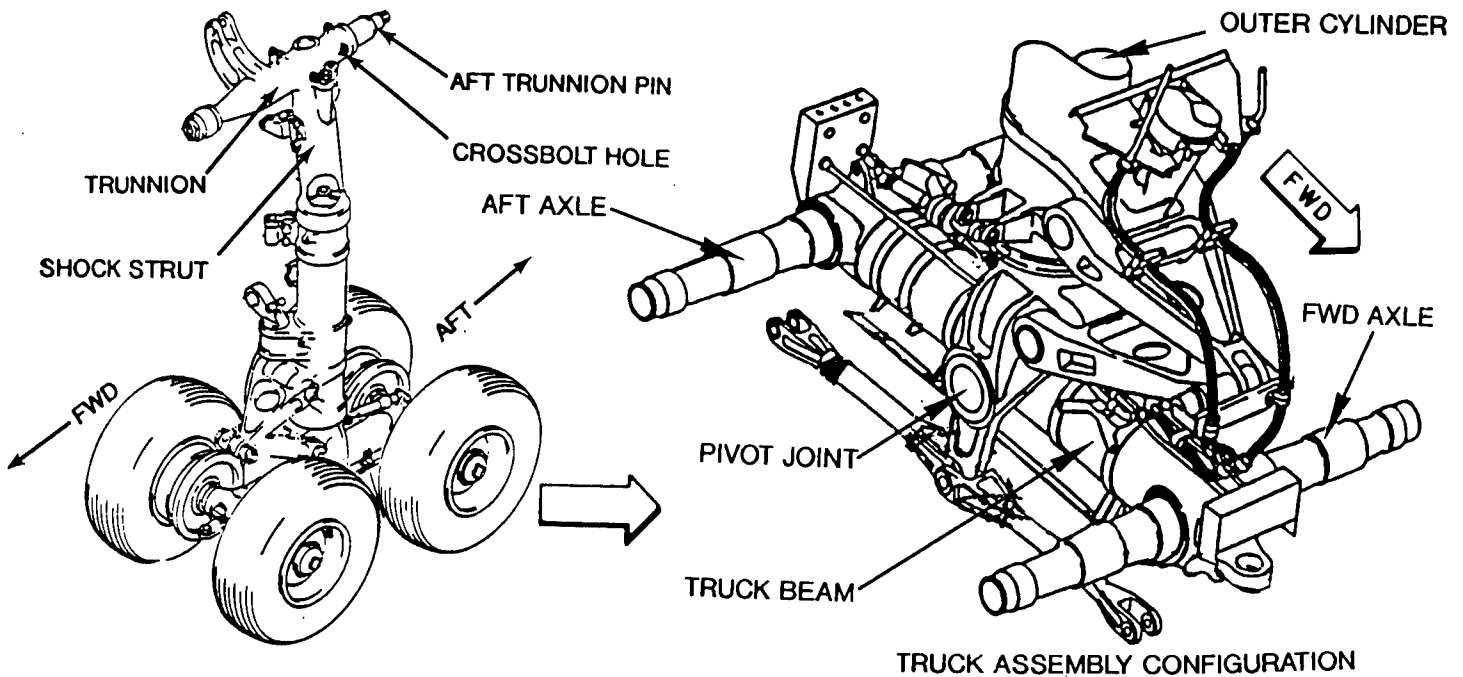
Figure 1. Boeing 757 Main Landing Gear Assembly

The 757 MLG is a conventional, four-wheel, dual-tandem landing gear that has a metering pin orifice shock strut (see figure 1). The gear has four support points: the forward trunnion, the aft trunnion, the drag brace, and the side strut. The shock strut outer cylinder of the MLG assembly transfers operational loads from the truck assembly to the four support points. The assembly consists of a truck beam, axles, wheels and tires, brake rods, and a protective shield. The truck beam is the primary supporting member of the truck assembly. It pivots on the lower end of the shock strut outer cylinder.

The truck beam is a hollow cylinder made from 4340M steel. The inner surface has three primary means of corrosion protection: cadmium-titanium electroplating; Boeing Material Specification BMS10-11 type 1 primer; and MIL-C-11796 Class 1 corrosion-inhibiting compound (CIC), also called Cosmoline. This CIC is applied in a hot liquid form and coats the inner surface of the truck beam with a uniform layer. Any moisture in the truck beam is drained through an opening at the aft end of the cylindrical truck beam section by gravity during truck tilt during takeoff.

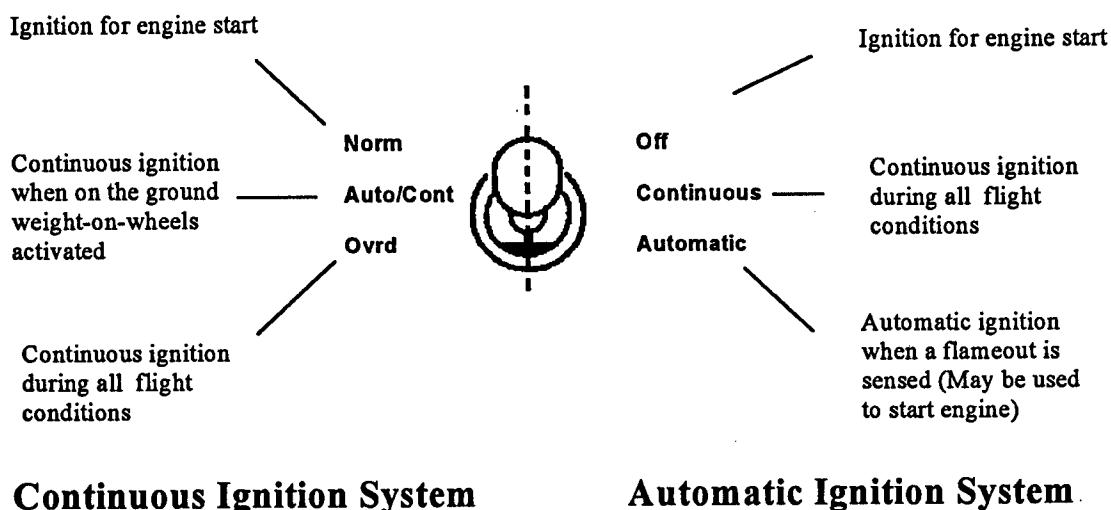
Figure 1. Typical Ignition Switch Position Labeling in TPE331-powered Airplanes

not truly automatic because the pilot must first select an ignition mode using a manually selectable three-position switch. Flameouts can be detected by the decay in certain engine parameters, such as engine revolutions per minute or torque. The automatic ignition system can relight the engine without pilot action or awareness of any engine or airplane performance changes if the ignition mode switch is in the automatic position.

The Fairchild Aircraft ignition system installed in the Bullhead City and Blountville accident airplanes did not incorporate the automatic ignition system but a "continuous" ignition system (see left side of figure 1), which provides continuous ignition in flight when the pilot selects the "override" mode using a similar three-position switch. The Fairchild SA227-AC and SA227-TT airplane AFMs state that in advance of intentionally flying into icing conditions and heavy rain, the pilot should select engine and propeller heat and override ignition. The procedures for inadvertent flight-into-icing conditions state that after discovering ice accumulation, the pilot should select "override" ignition, then engine and propeller heat for one engine (to ensure that the engine is operating satisfactorily), and then engine and propeller heat for the other engine.
