Rail Accident Investigation Branch

# Rail Accident Report

## **Collision between a tram and road vehicle at New Swan Lane Level Crossing on Midland Metro**

**8 June 2006**

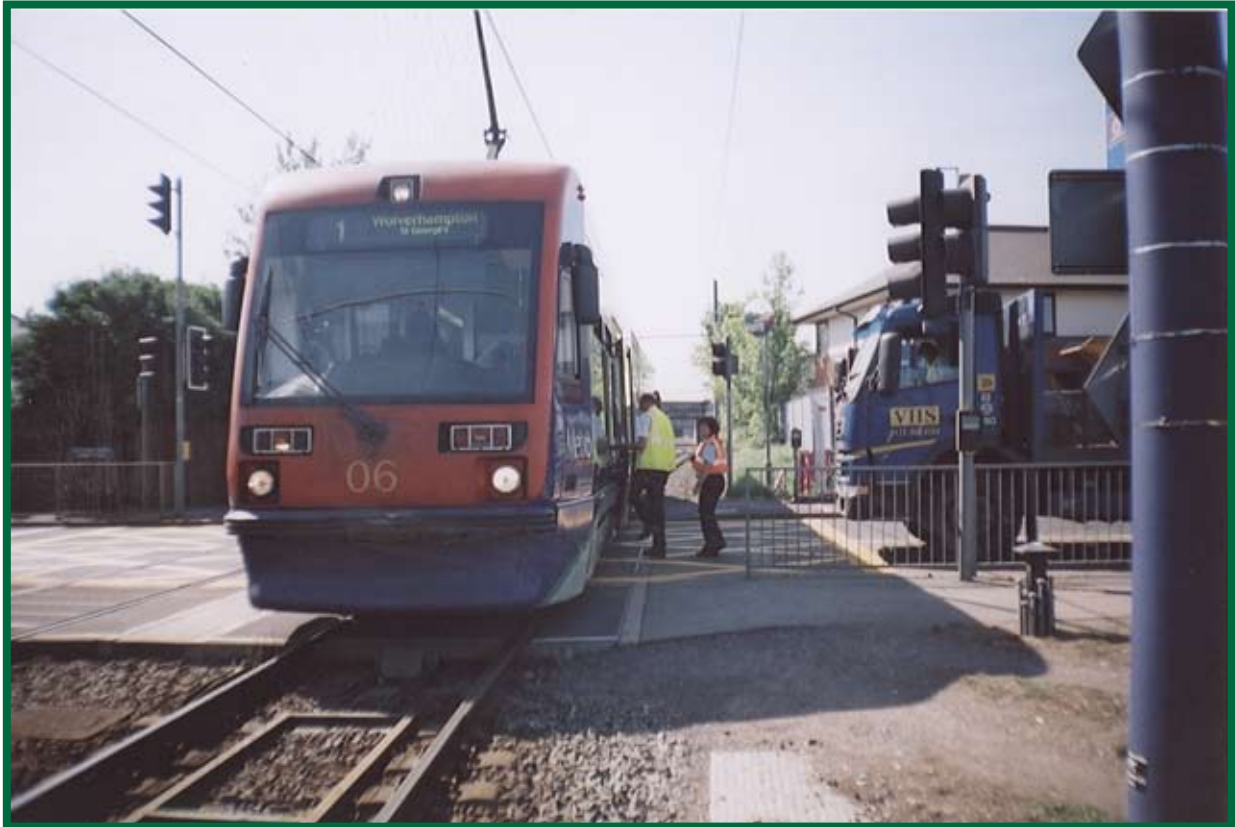
Figure 3: The scene after the collision at New Swan Lane.

- 42 The two occupants of the taxi were taken to hospital and released after two hours.
- 43 Neither the tram passengers nor the lorry driver suffered any injuries.
- 44 The taxi sustained rear impact damage to both sides, and the lorry suffered impact damage to the front-off side. The tram sustained minor superficial damage to its 'A end' bumper.

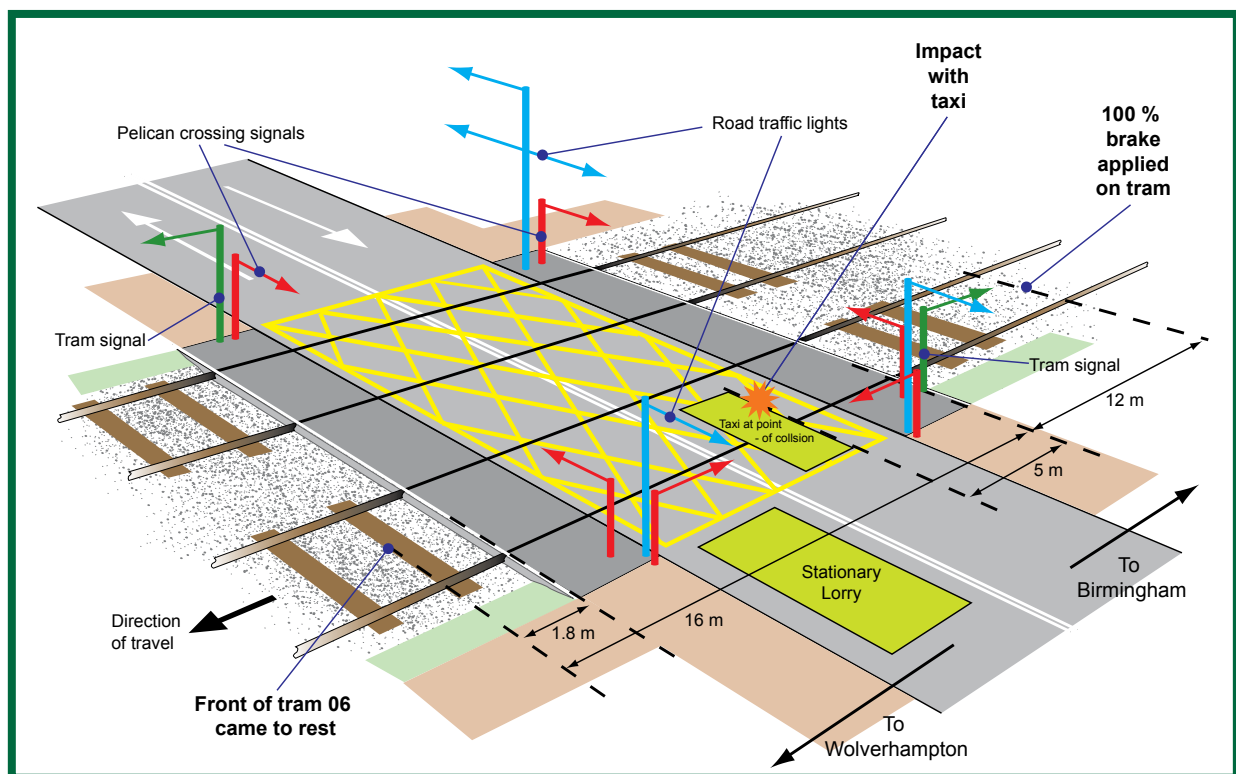
- 25 At New Swan Lane Level Crossing, the approach of a tram from Birmingham is detected by 'Prepare' and 'Demand' loops located in the track. When these receive a signal from a tram mounted transponder a timed sequence is initiated that results in the road traffic signals showing a stop (red) aspect and the tram signal showing a proceed aspect approximately 10 seconds after demand detection. This arrangement normally results in the tram receiving a proceed aspect before it reaches the crossing. An additional 'Stop' loop is provided immediately before the crossing at which a tram driver may request a manual intervention of the signals using the *Tram Ready To Start* (TRTS) function. A further 'Clear' loop is provided after the crossing indicating that the tram has passed the crossing.

Figure 4: Layout of New Swan Lane Level Crossing.

- 107 TMM have reviewed the crossing layout arrangements and approach speed signage locations. The road and tram signals at the junction have now been replaced with high intensity signal heads and the Wolverhampton bound speed board for the 30 km/h permanent speed restriction has been moved 25 m further away from the crossing.

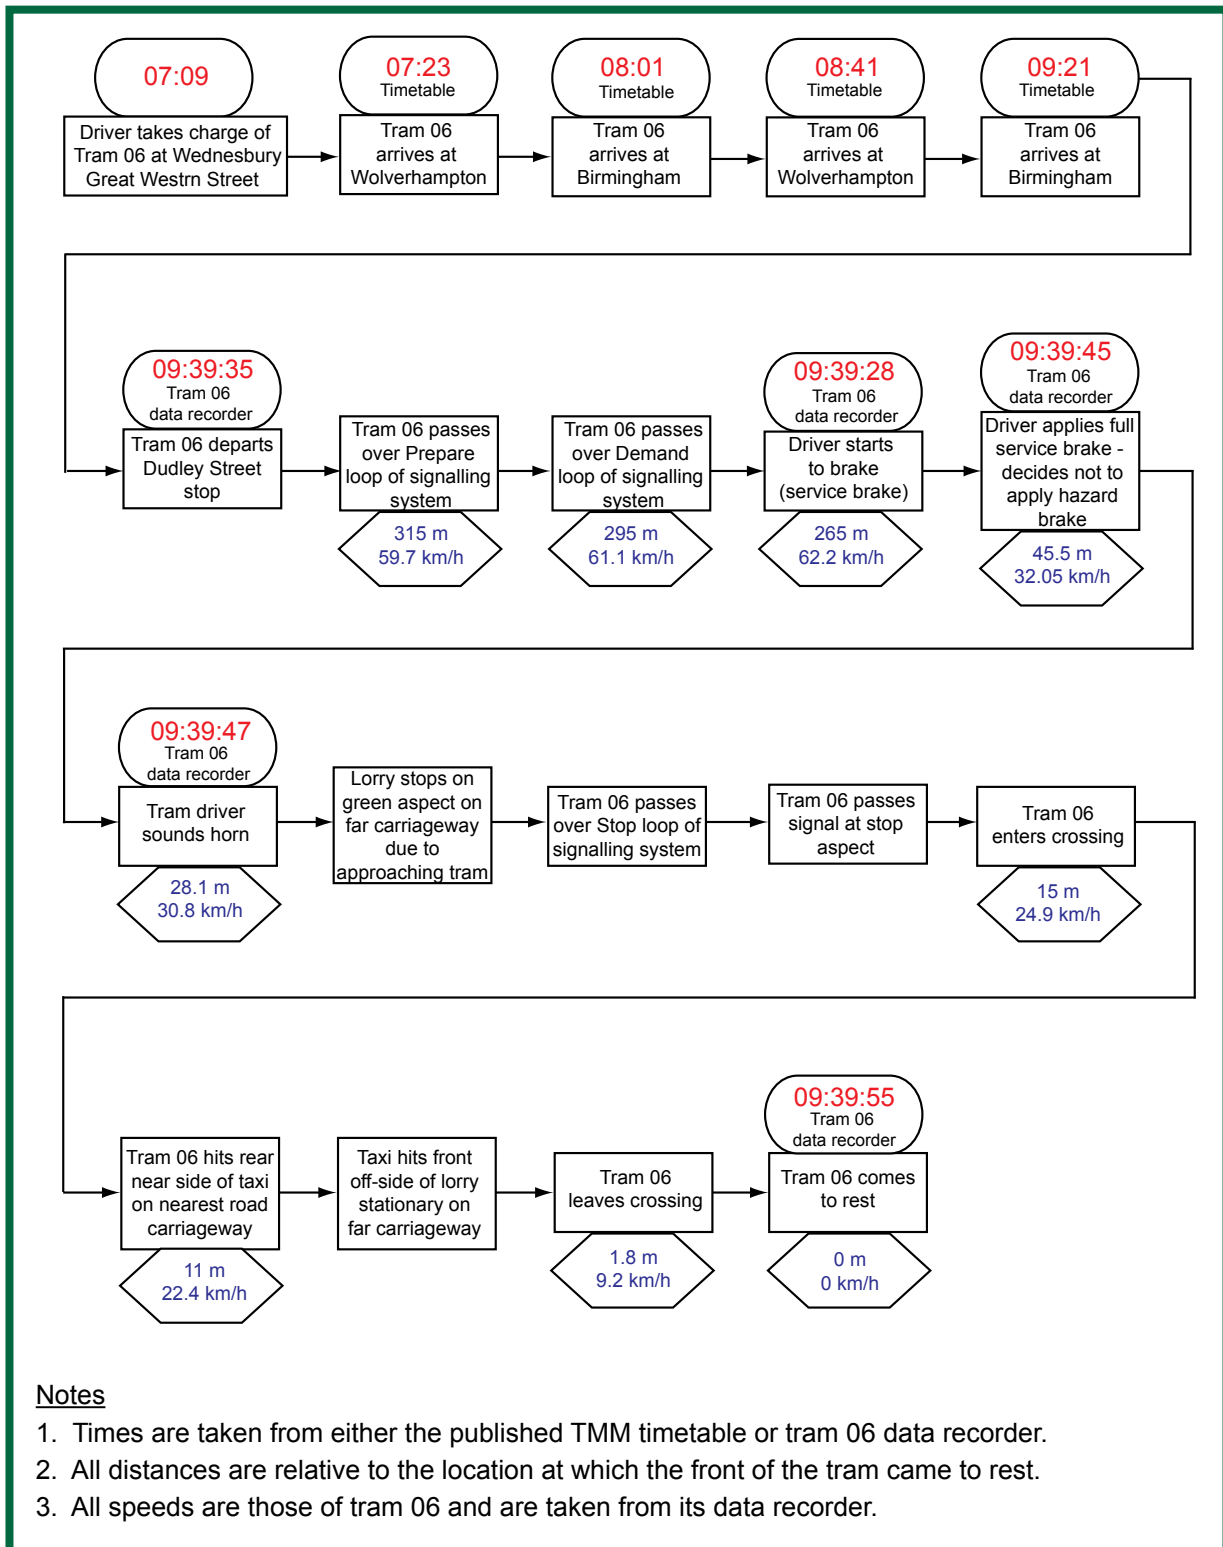
The chain of events from the time at which the driver took charge of tram 06 is presented below.:
