This document is an English translation of the Final Report on the accident on 10 April 2010, on Smolensk "Severny" airdrome, to the Tupolev Tu-154M tail number 101 of the Republic of Poland.

**INTERSTATE AVIATION COMMITTEE
AIR ACCIDENT INVESTIGATION COMMISSION**

FINAL REPORT

Type of occurrence	Accident
Type of aircraft	Airplane, Tu-154M
Registration	Tail number 101, Republic of Poland
Owner	Republic of Poland
Operator	Ministry of Defense, Republic of Poland
Site of occurrence	Between the middle marker and runway 26 threshold, Smolensk "Severny" Airdrome, N 54°49.450' and E 32°03.041'
Date and time	10.04.2010, 06:41 UTC, 10:41 local time, daytime

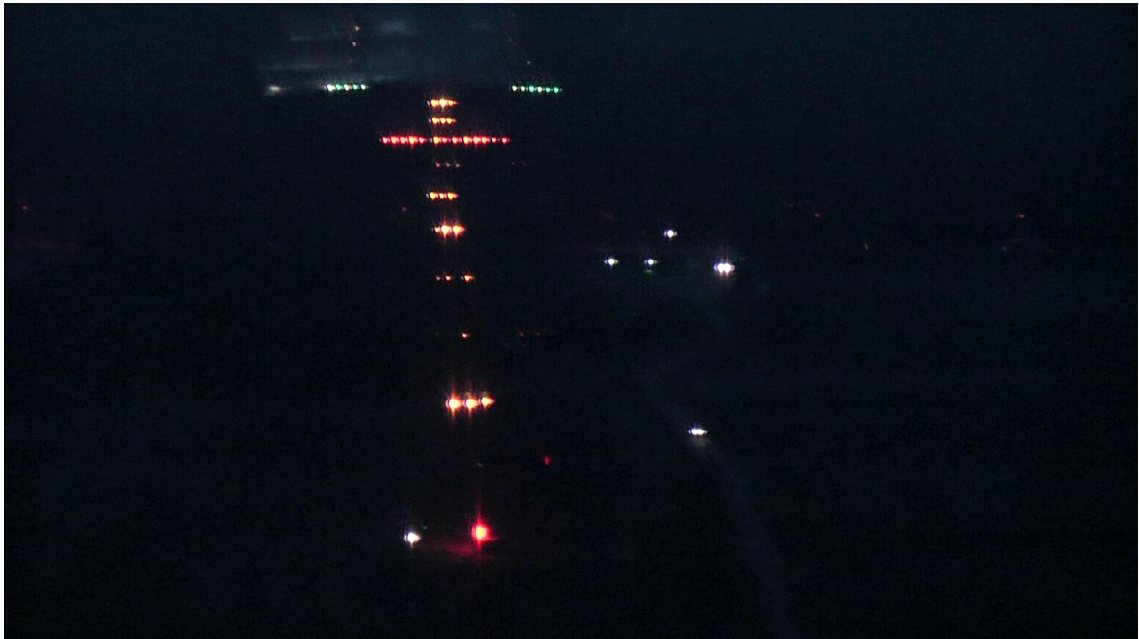
The fly-around check on 15.04.2010 (Figure 12, Figure 13) revealed that in comparison with the shown scheme, there is one more light line at a distance of 100 m from RWY 26 threshold, the actual number of threshold lights (green) is 6 instead of the 8 lights specified in the RTP. The lighting equipment check also revealed that depending on the aircraft position and

The lighting system was recovered on 14.04.2010 which is confirmed with the data of a fly-around on 15.04.2010.

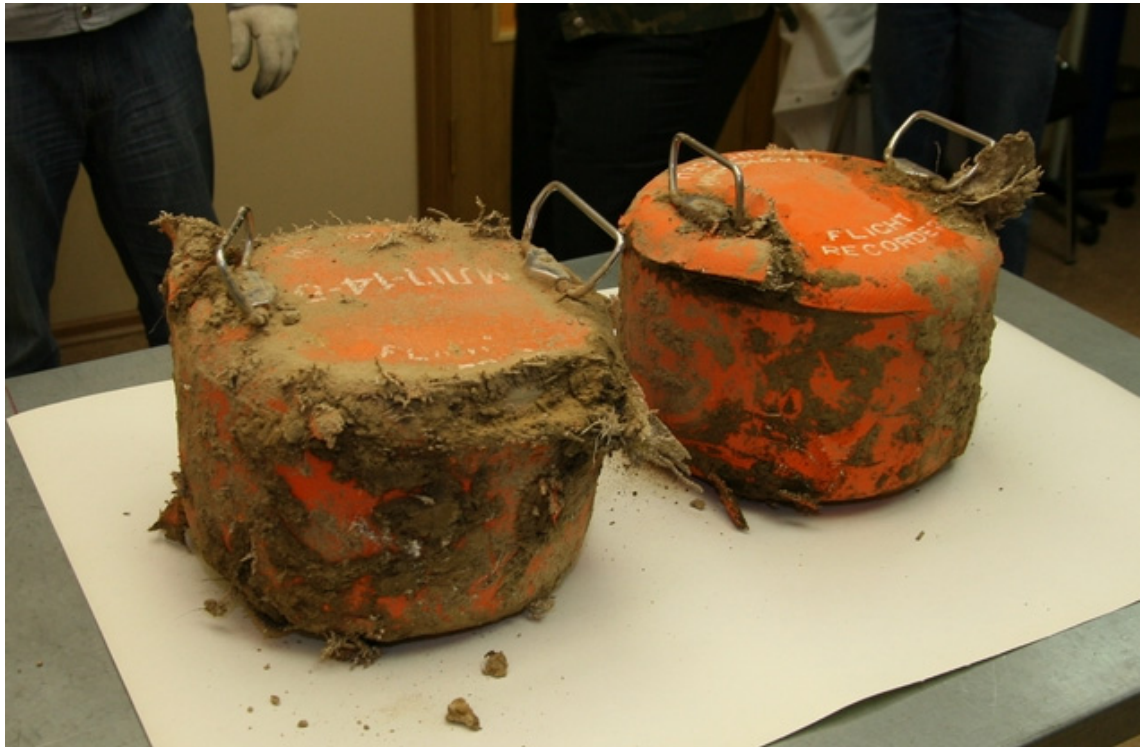
Figure 17

The casing of the tape moving mechanism 70A-10M № 323025 of the MARS-BM system was mechanically damaged, the cables were torn, the base and number plate were missing, no traces of high temperature influence was found (Figure 17).

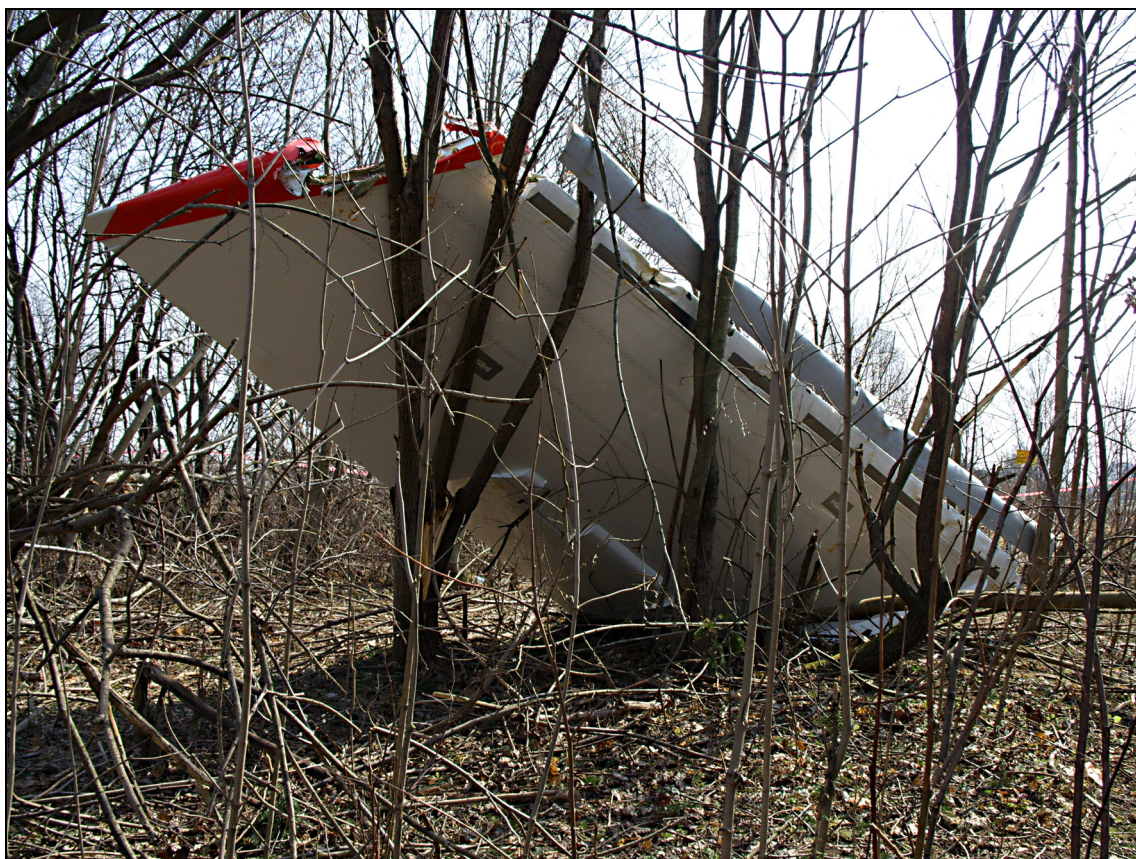
Figure 28

In the area of the impact the investigation team found fragments of the left detachable part of the wing including: fragments of left detachable part of the wing panel jammed in the tree trunk, a fragment of the left aileron spoiler, the fairing of the flap jack screw, fragments of the left slat, fairing of the left outer flap, the left flap track, a flap housing. All the fragments found along the aircraft flight path for the following 150-200 m were elements of the left detachable part of the wing (Figure 28).

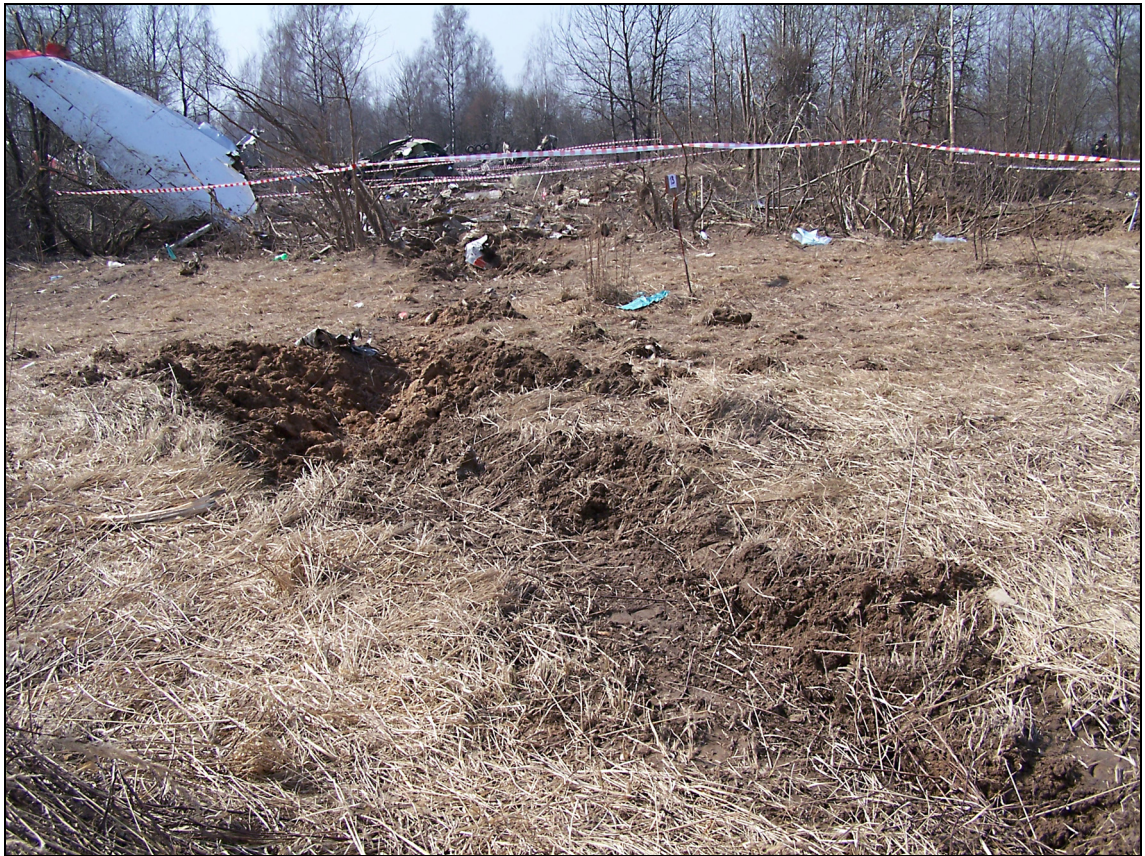
Figure 30

The first ground impact was at a distance of about 580 m from the first impact (Figure 30).

The site of ground impact has a furrow made by the stabilizer and fin leading edges up to 0.5m deep and 22 m long with fragments of the SI-2U light of the SMI-2KM lighting set as well as a furrow made by the left wing up to 0.4 m deep and 22 m long with fragments of the left wing panel and rod №154.83.5711-090-009.
