**THE STUDY
ON
URGENT REHABILITATION PLAN
IN
EAST TIMOR**

FINAL REPORT

VOLUME 2: MAIN TEXT

August 2000

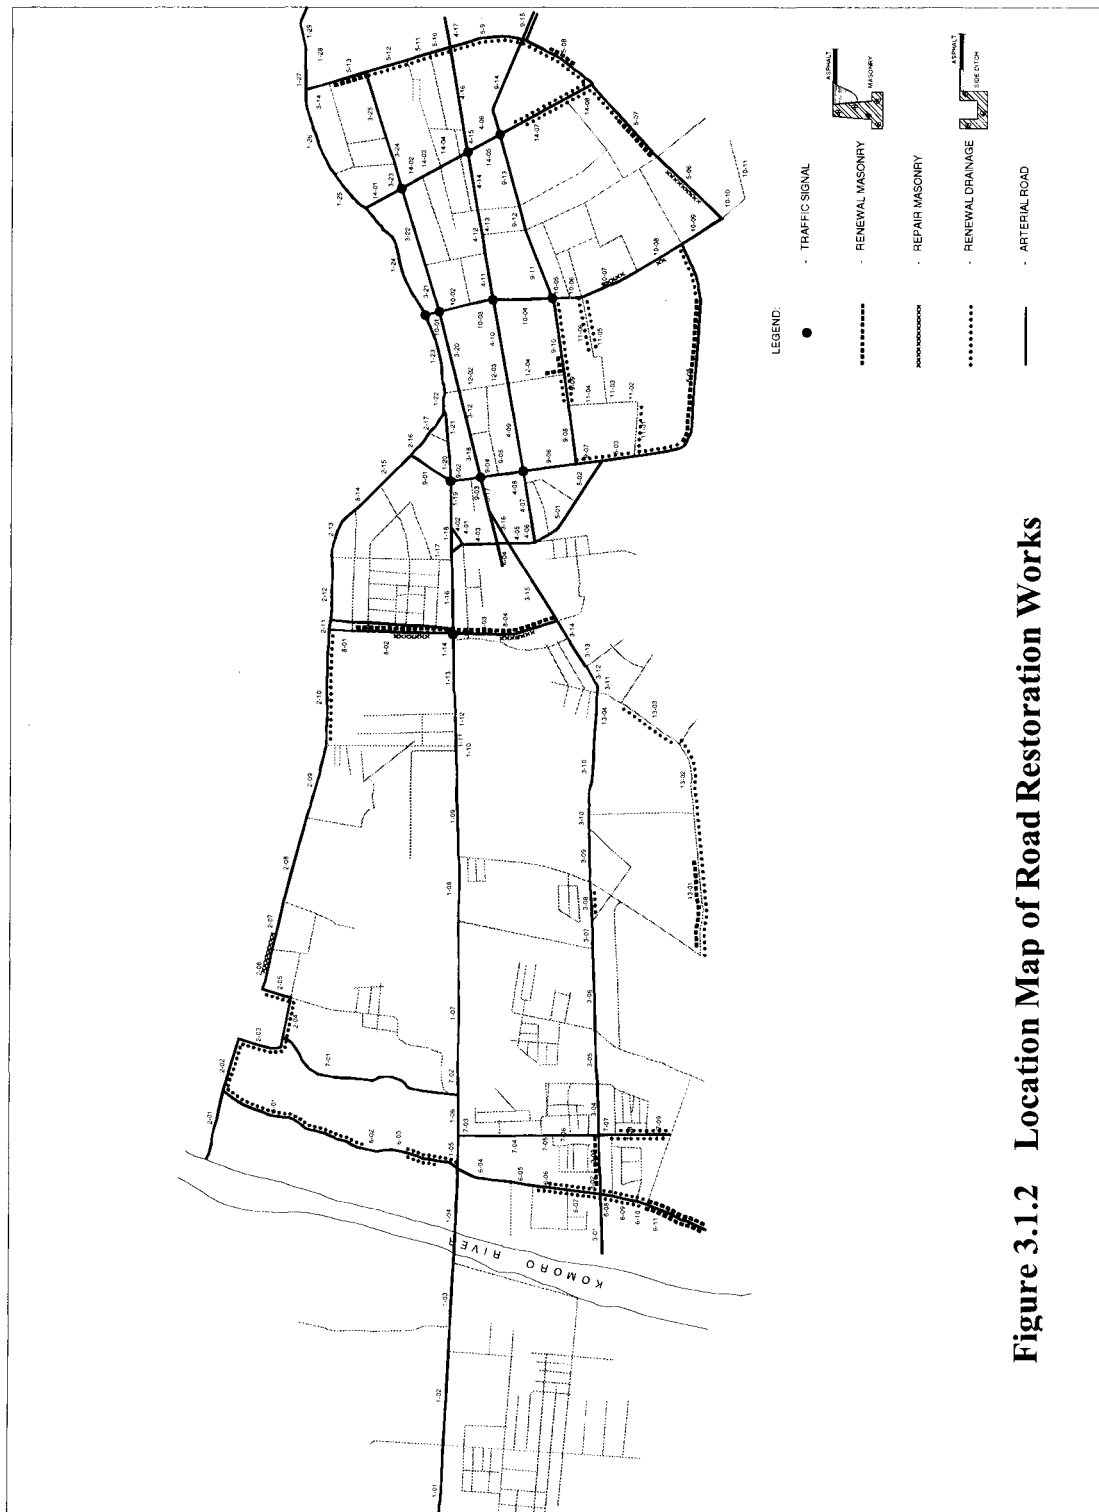
The locations of link number, restoration works required derived from the road inventory survey are shown in Figure 3.1.2.

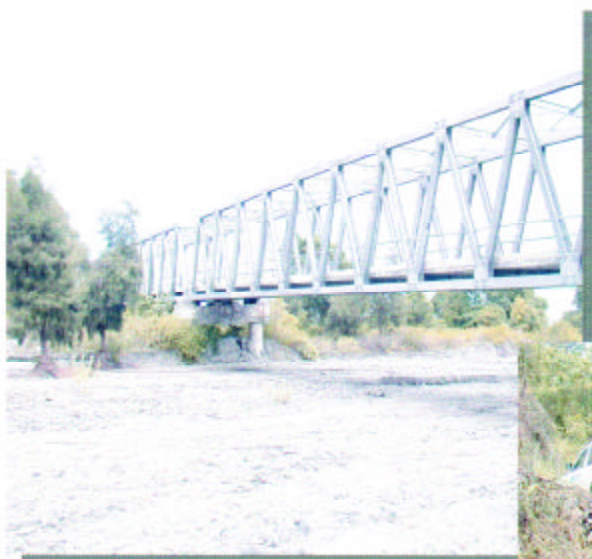
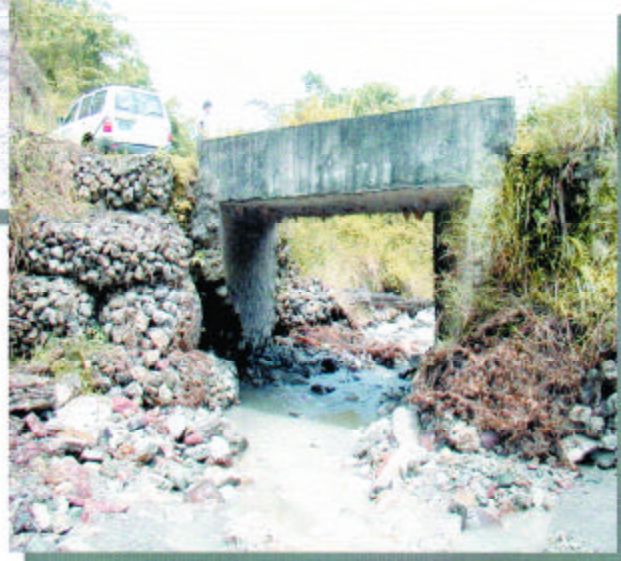
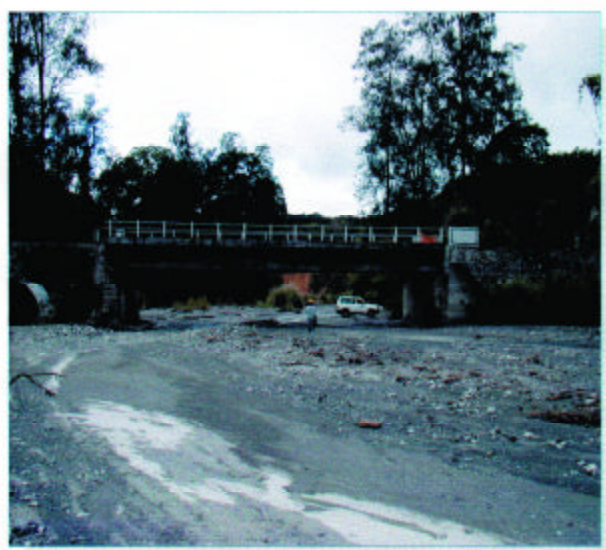
Photo 3.1.1 Typical Bridges in East Timor

- None of the bridges have been damaged by the post consultation destruction, and all the bridges have suffered from a long term lack of maintenance in general.

- Most of the existing bridges are in very poor from the anti-seismicity aspect, even through East Timor belongs to a moderate seismic zone.
- There are typical concrete bridge defects such as sagging at bridge center, flaking exposed rebars probably resulting from poor workmanship of supporting /scaffolding work and poor concreting work.

- Typical defects in steel bridges such as steel truss and I shape beam are corrosion, deformation and rupture due to vehicle collision.
- A signboard showing allowable loading is not provided at all.
