MISHAP INVESTIGATION REPORT 01-07

- 1. THIS IS THE FINAL INVESTIGATION REPORT OF AN INCIDENT (WITH POTENTIAL).**
- 2. SUBJECT: MULTIPLE ENGINE FAILURES DUE TO SALT INGESTION AT LOW ALTITUDE OVER NORTH ATLANTIC AT NIGHT**
- 3. EQUIPMENT:**
 - a. Aircraft: Lockheed WP-3D
 - b. Registration: N42RF
- 4. PILOT-IN-COMMAND:**

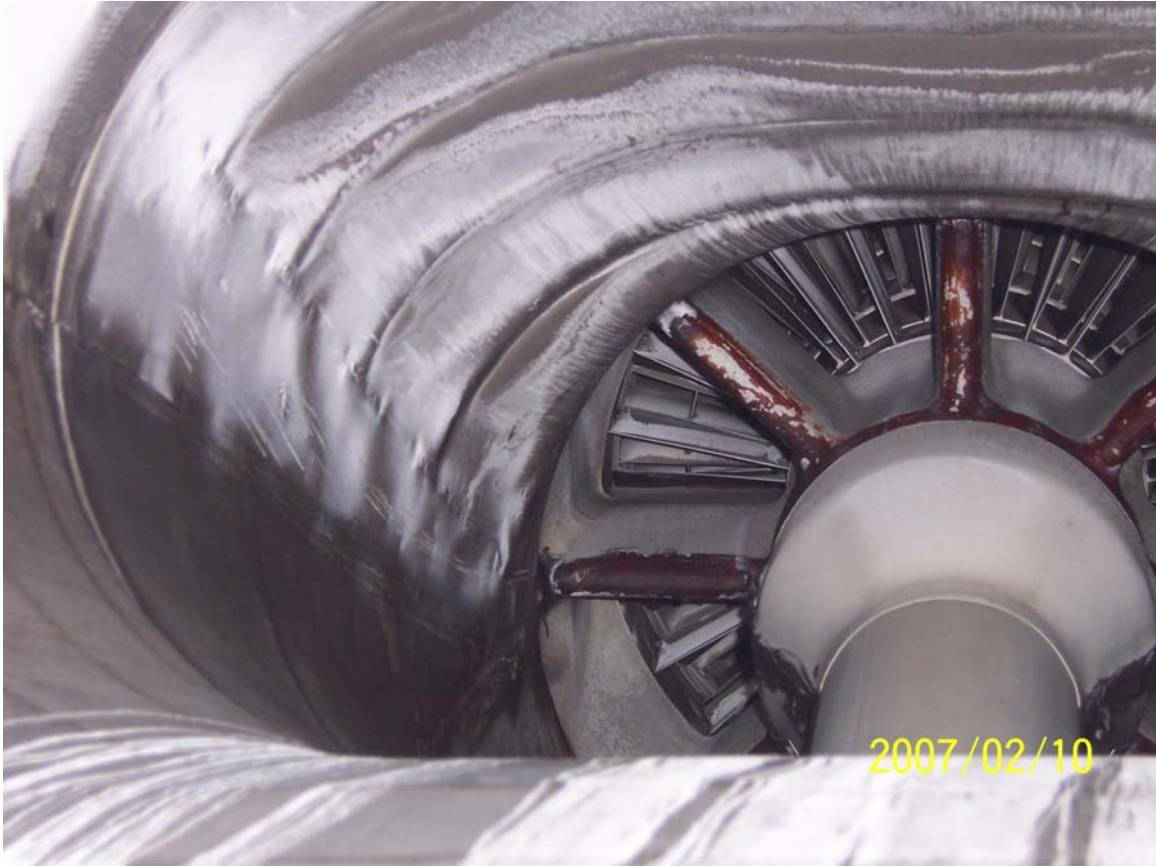
Postflight inspection of engines revealed significant white build up on intakes, first stage compressors, and CIP probes of all four engines. Subjectively, the #2 engine appeared to be the worst coated of all engines. Aircraft fuselage and windows were also heavily coated. Engine covers were installed and engines left as found.

View of #2 engine intake from 10 February, 2007. Note white buildup not only on walls of intake, but also on 1st stage compressor stator and rotor blades.

- The degradation of the number 1, 3, and 4 engine compressor efficiencies and subsequent unscheduled engine rundowns were caused by the accretion of sea air salt on the compressor stator and rotor blades. The accretion caused deformation of the compressor airflow resulting in compressor efficiency degradation until an unscheduled engine rundown event occurred.

Salt accretion on the compressor stator and rotor vanes of the engines during the incident flight is considered a causal factor in this incident. - *If accretion of salt is observed, exit the high salt aerosol environment and abort the mission.* Flying through precipitation can remove some accreted salt and potentially restore some engine efficiency. However, maneuvers requiring large power setting changes should be avoided. Rapid power changes in salt contaminated engines may cause compressor stalls.

Salt accretion on later stage compressor rotor and stator vanes of the engines from previous flights is considered a possible causal factor in this incident. - *Fresh water engine washes should be conducted after every flight where salt accretion or engine degradation is suspected.* At minimum, engine washes will be conducted in accordance with the Maintenance Operating Instructions. Engines should be motored over, not running, when washes are conducted. The intent of the wash is to rinse clear any accumulated salt on later stage rotors and stators which may not be observable from outside the engine. If the engine is running, temperatures at later stages of the compressor are sufficient to boil the water and reduce the effectiveness of the rinse. This runs the risk of resulting in the deposit of salt and other contaminants from the early stages onto the later stages potentially leaving the crew with the false impression that they had cleaned the engine when, in fact, they had exacerbated the situation by priming the engine for a catastrophic failure later. As long as the engines are not running, fresh water rinses should aid in preventing later stage buildups of salt from decreasing the engine's surge margin and contributing to catastrophic failures without warning.

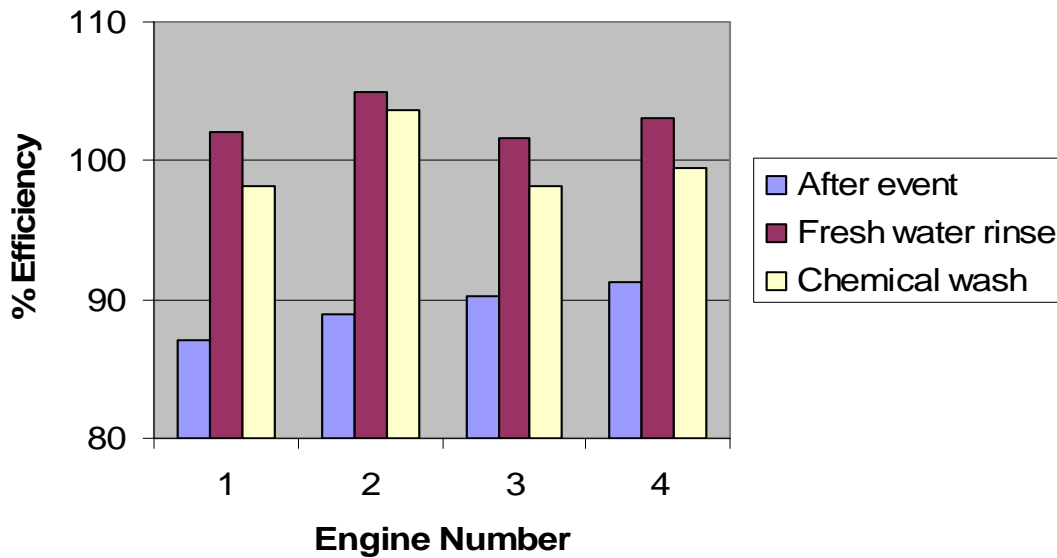
Engine Efficiency Run Results

This represents a significant drop in efficiencies from the norm for these engines and would produce power well below abort criteria for any takeoff attempt. The engines were not washed initially as the investigation team wanted the technical representatives from Rolls-Royce to have an opportunity to see them as they were. Unfortunately, tech reps would not arrive until Thursday morning February 15th and the decision was made, with the approval of the tech reps over the phone, to rinse the engines on Wednesday to prevent permanent corrosion damage. Engines were rinsed according to Rolls-Royce

These are slightly lower than they were in St. John's after the fresh water rinse but the difference can be attributed to the temperature and density difference between Jacksonville and St. John's. The various engine efficiency runs are depicted graphically below.
