# Delta 269 (Delta III)

## Investigation Report

**MDC 99H0047A  
16 August 2000**

This report was prepared by The Boeing Company and is a record of the investigation into the 4 May 1999 failure of the Delta 269 vehicle carrying the Orion-3 communications satellite.

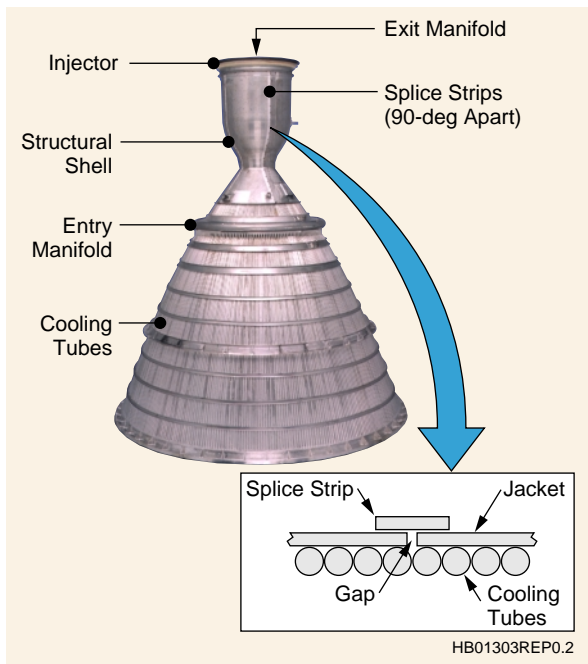
**Figure 1-2. Combustion Chamber Construction**

As shown in Figure 1-2, the combustion chamber is constructed from a series of 180 cooling tubes that are formed on a mandrel in the shape of the convergent/divergent nozzle and then brazed to a segmented structural jacket. A splice strip is installed every 90 deg over the four seams in the jacket. The entire assembly is furnace brazed. The chamber is X-ray inspected and

leak tested to ensure adequate tube-to-tube, tube-to-jacket, and splice strip-to-jacket braze coverage. The jacket carries more than 90% of the combustion chamber hoop load, so the splice strip braze structural integrity is of critical importance.

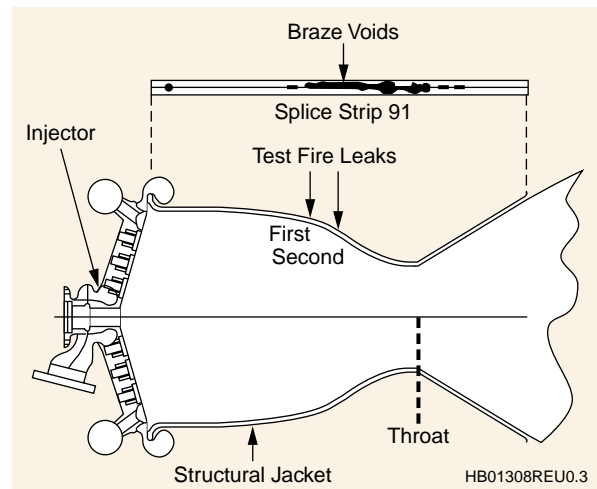
**Figure 1-3. Combustion Chamber Test Leaks/Braze Voids**

vehicle. Finding two leaks in the same vicinity on the same jacket strip after different hot fire tests is unique within the RL10 history.

A review of the radiographic inspection records of the combustion chamber BXA804 revealed jacket strip braze defects far in excess of the design intent. In some local areas, braze coverage was found to be as low as 20% per linear inch—a factor of four below design intent. The discrepancy has been attributed to an error in the translation of the braze coverage requirement. The engineering requirement was for a braze coverage requirement of 80% per linear inch. The drawing specified a 80% minimum coverage requirement, which was interpreted by the product inspectors as 80% coverage averaged over the entire length of the strip. The less stringent criterion was applied to chamber BXA804. In addition, the X-ray inspection techniques were shown to be inadequate. Ultrasonic evaluations of braze samples have detected the presence of braze voids not reported in X-ray records of the high-pressure, cylindrical section of the chamber. Given the X-ray inspection limitations, the actual condition of the BXA804 chamber strip braze is unknown; however, based on the ultrasonic findings, it was likely worse than recorded in the X-rays. In addition to the defective strip-to-jacket braze described above, X-rays also revealed that chamber BXA804 had poor tube-to-jacket braze in the throat area where the average braze coverage was 38% vs. a requirement of 60%.

The combustion chamber S/N BXA804 flown on Delta 269 Engine P692803 was assembled and furnace brazed in January 1998. It was initially found to be leak free. During the course of its acceptance firing history, two leaks were discovered at Strip 91 as shown in Figure 1-3. The first was found after hot firing No. 9. This leak was repaired by hand brazing. After hot firing No. 12, another leak was discovered a short distance from the earlier leak. Because no additional ground firings were planned, this leak was repaired with RTV for moisture protection per standard procedure and the engine was then installed on the Delta 269

defective braze. These included the cleaning solvent change made subsequent to engine qualification, fit up of the parts, tooling, and the amount of braze material. No single cause was identified, but these factors together caused large variations in braze quality.

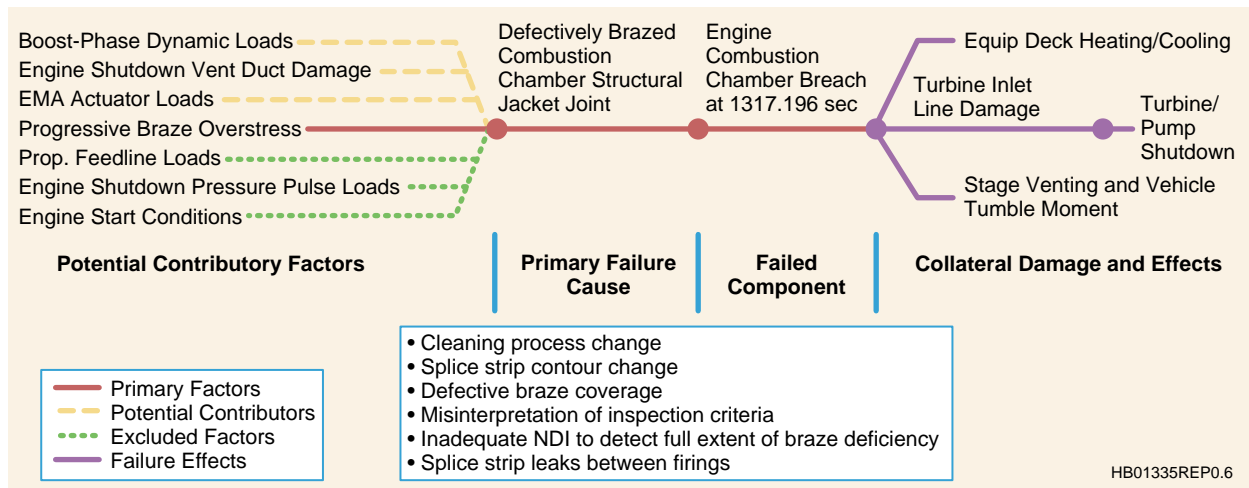
**Figure 1-4. Delta 269 Failure**

Figure 1-4 describes the failure scenario along with identification of potential vehicle and flight contributing factors that may have added stress to the engine and caused it to fail when it did. The investigation extensively pursued each of these possible contributing factor scenarios. This work was also intended to establish conclusively whether or not each of these conditions could be a possible failure cause. These scenarios included boost phase dynamic loads, propellant feedline loads, and EMA loads as well as the engine start thermal conditions and the possibility for engine shutdown pressure pulse and related hydrogen vent duct damage.

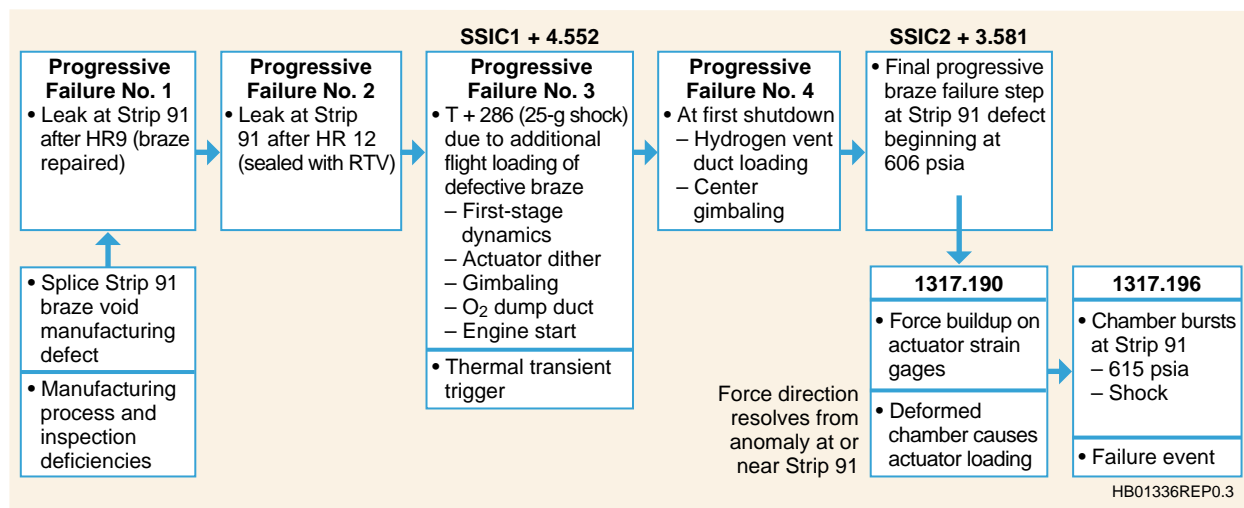
Figure 1-5. Most Probable Failure Scenario

This most probable failure scenario, shown in Figure 1-5, begins with the initial deficient brazing at combustion chamber jacket Strip 91. The first anomalous performance of this joint was noted as a leak occurring during the leak test performed after engine acceptance hot run test No. 9. The leak location was braze repaired. Later, after hot run test No. 12, another leak on the same

strip was discovered. This was repaired with RTV. During the initial phases of flight, the braze joint may have suffered some additional deterioration due to a combination of nominal flight-loading conditions, which resulted in a partial braze fracture at 4.6 sec after the first-burn ignition when triggered by the thermal transient associated with engine start. The T+286 shock on vehicle accelerometers represents this event. At first-burn shutdown, the braze may have sustained further damage due to loadings from the hydrogen vent duct thrust or the rapid engine centering. Because of the progressive braze failure effects, the chamber no longer had the capability to hold the full pressure at the second start and failed during a period of rapid thermal and pressure changes. The initial indication of the failure onset was a force buildup in the pitch and yaw actuators 6-8 ms prior to the actual chamber rupture. This precursor anomaly was caused by a slight deformation in the chamber as the strip braze began its final failure, slightly redirecting a small portion of the thrust force. The final rupture caused all the remaining flight data responses.

The most probable failure scenario describes the only credible means to match the known evidence, investigation results, and flight data. Redesigns and requalifications have been accomplished to assure that this possibility will not recur.
