**MARINE CASUALTY REPORT**

**SS V. A. FOGG; SINKING IN THE GULF OF MEXICO  
ON 1 FEBRUARY 1972 WITH LOSS OF LIFE**

**U.S. COAST GUARD  
MARINE BOARD OF INVESTIGATION REPORT  
AND COMMANDANT'S ACTION**

**REPORT NO. USCG/NTSB - MAR-74-8**

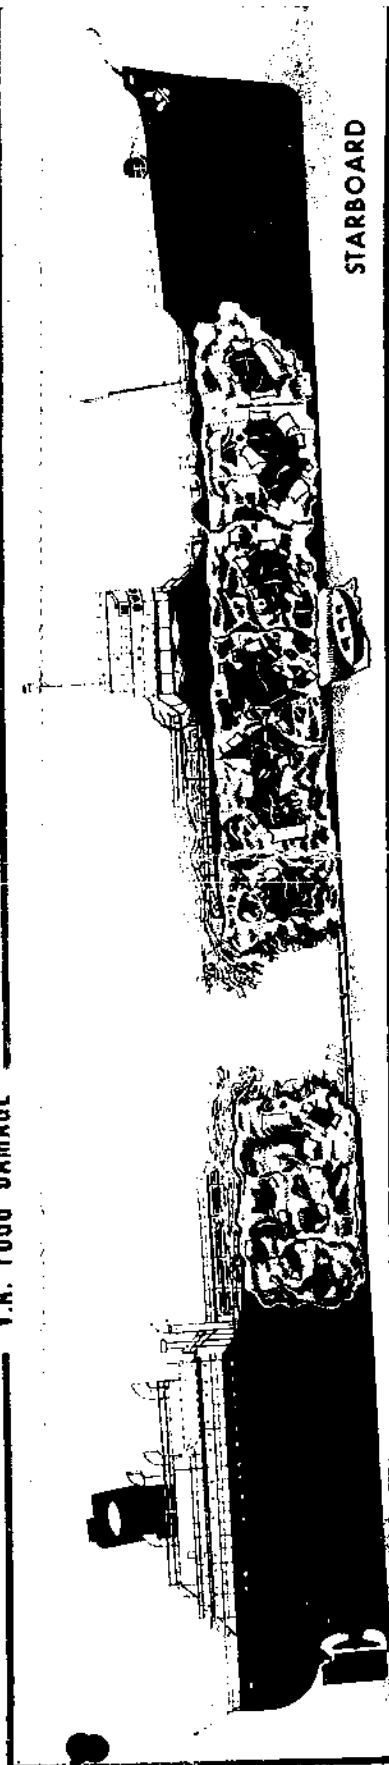
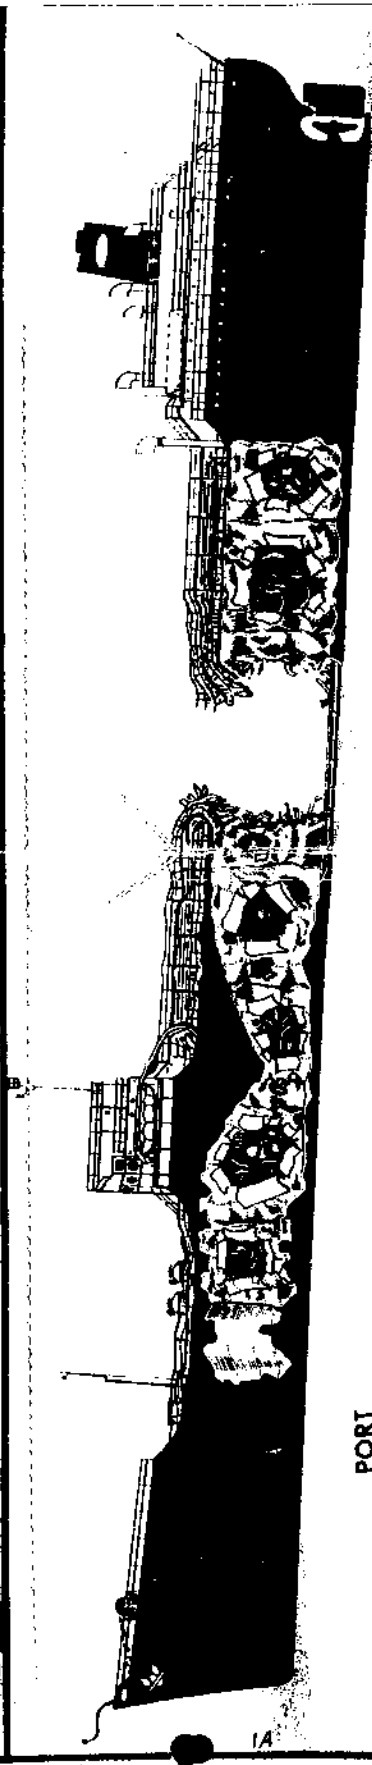
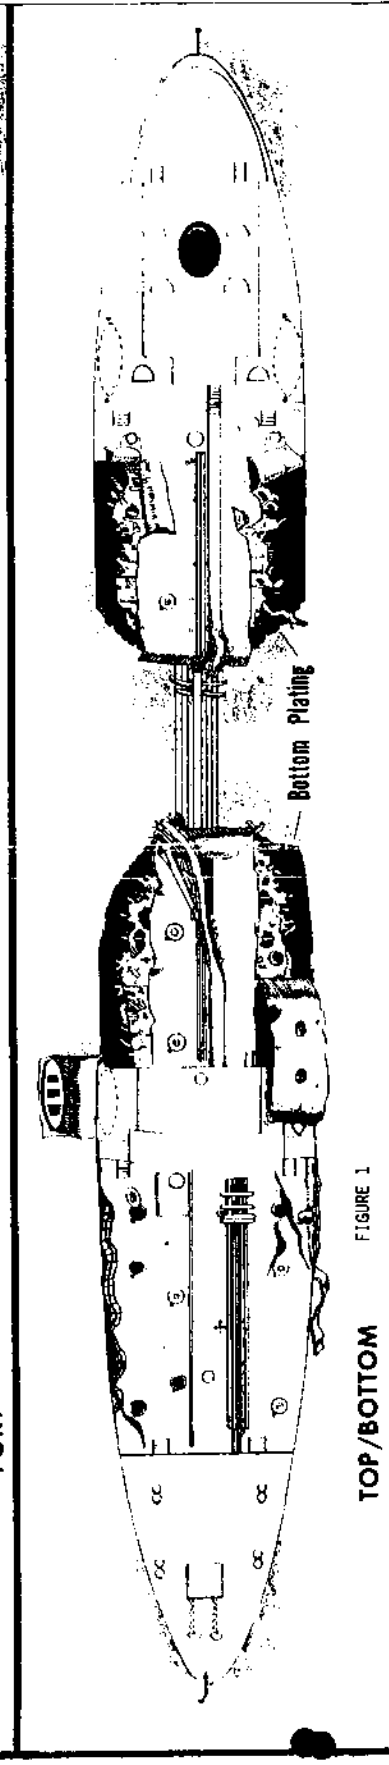
FIGURE 1

Only by viewing the vessel or the exhibits to this report can a true appreciation of the extent of vessel damage be gathered. To help the reader appreciate the gross damage an artist's interpretation is attached. This interpretation does not claim complete accuracy but is illustrative of the massive damage sustained by the vessel. Attached for reference purposes is a photograph of the vessel taken prior to the casualty.

V.A. FOGG DAMAGE
