AIRCRAFT ACCIDENT REPORT

DELTA AIR LINES, INC.

MCDONNELL DOUGLAS DC-9-14, N3305L
GREATER SOUTHWEST INTERNATIONAL AIRPORT
FORT WORTH, TEXAS
MAY 30, 1972

REPORT NUMBER: NTSB-AAR-73-3

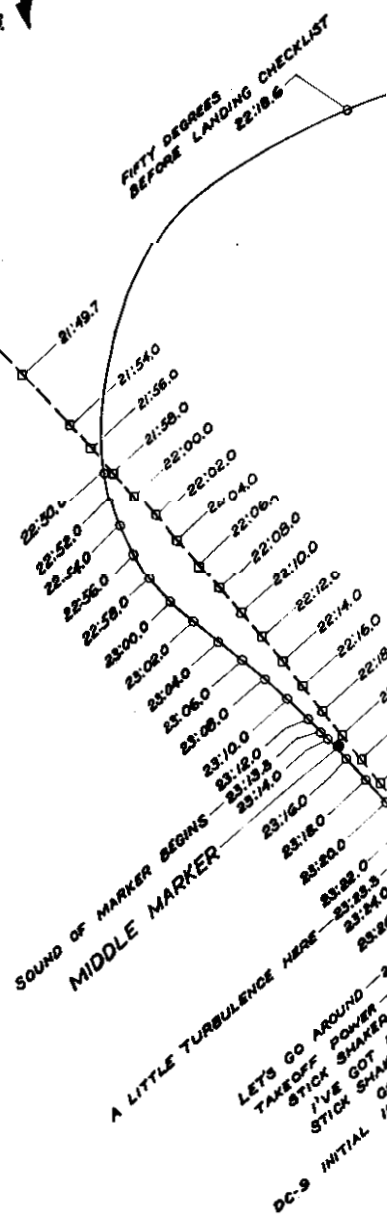
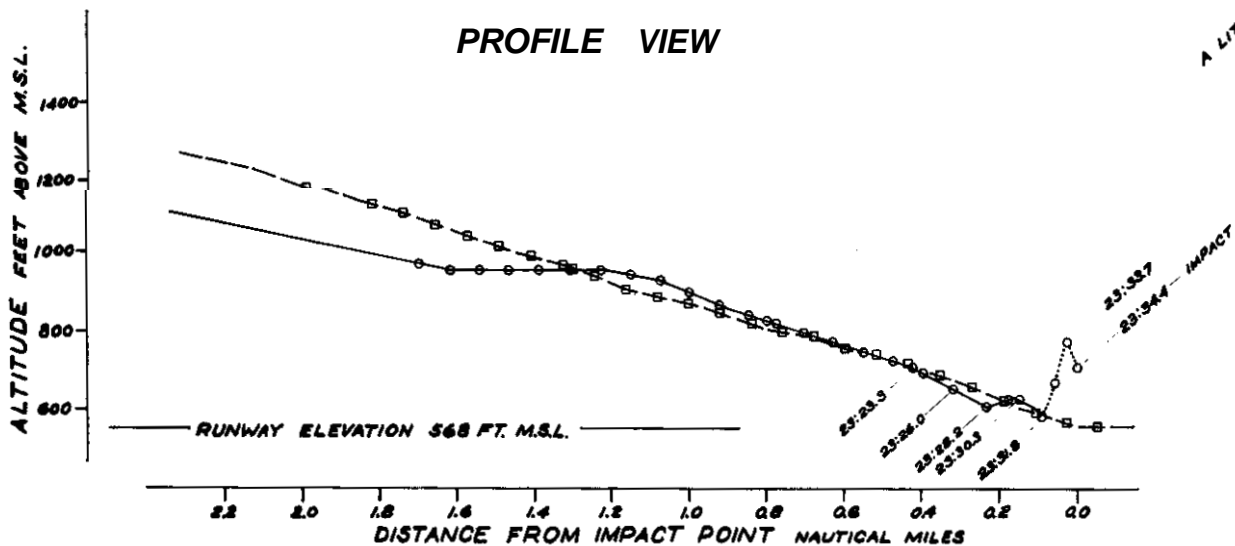
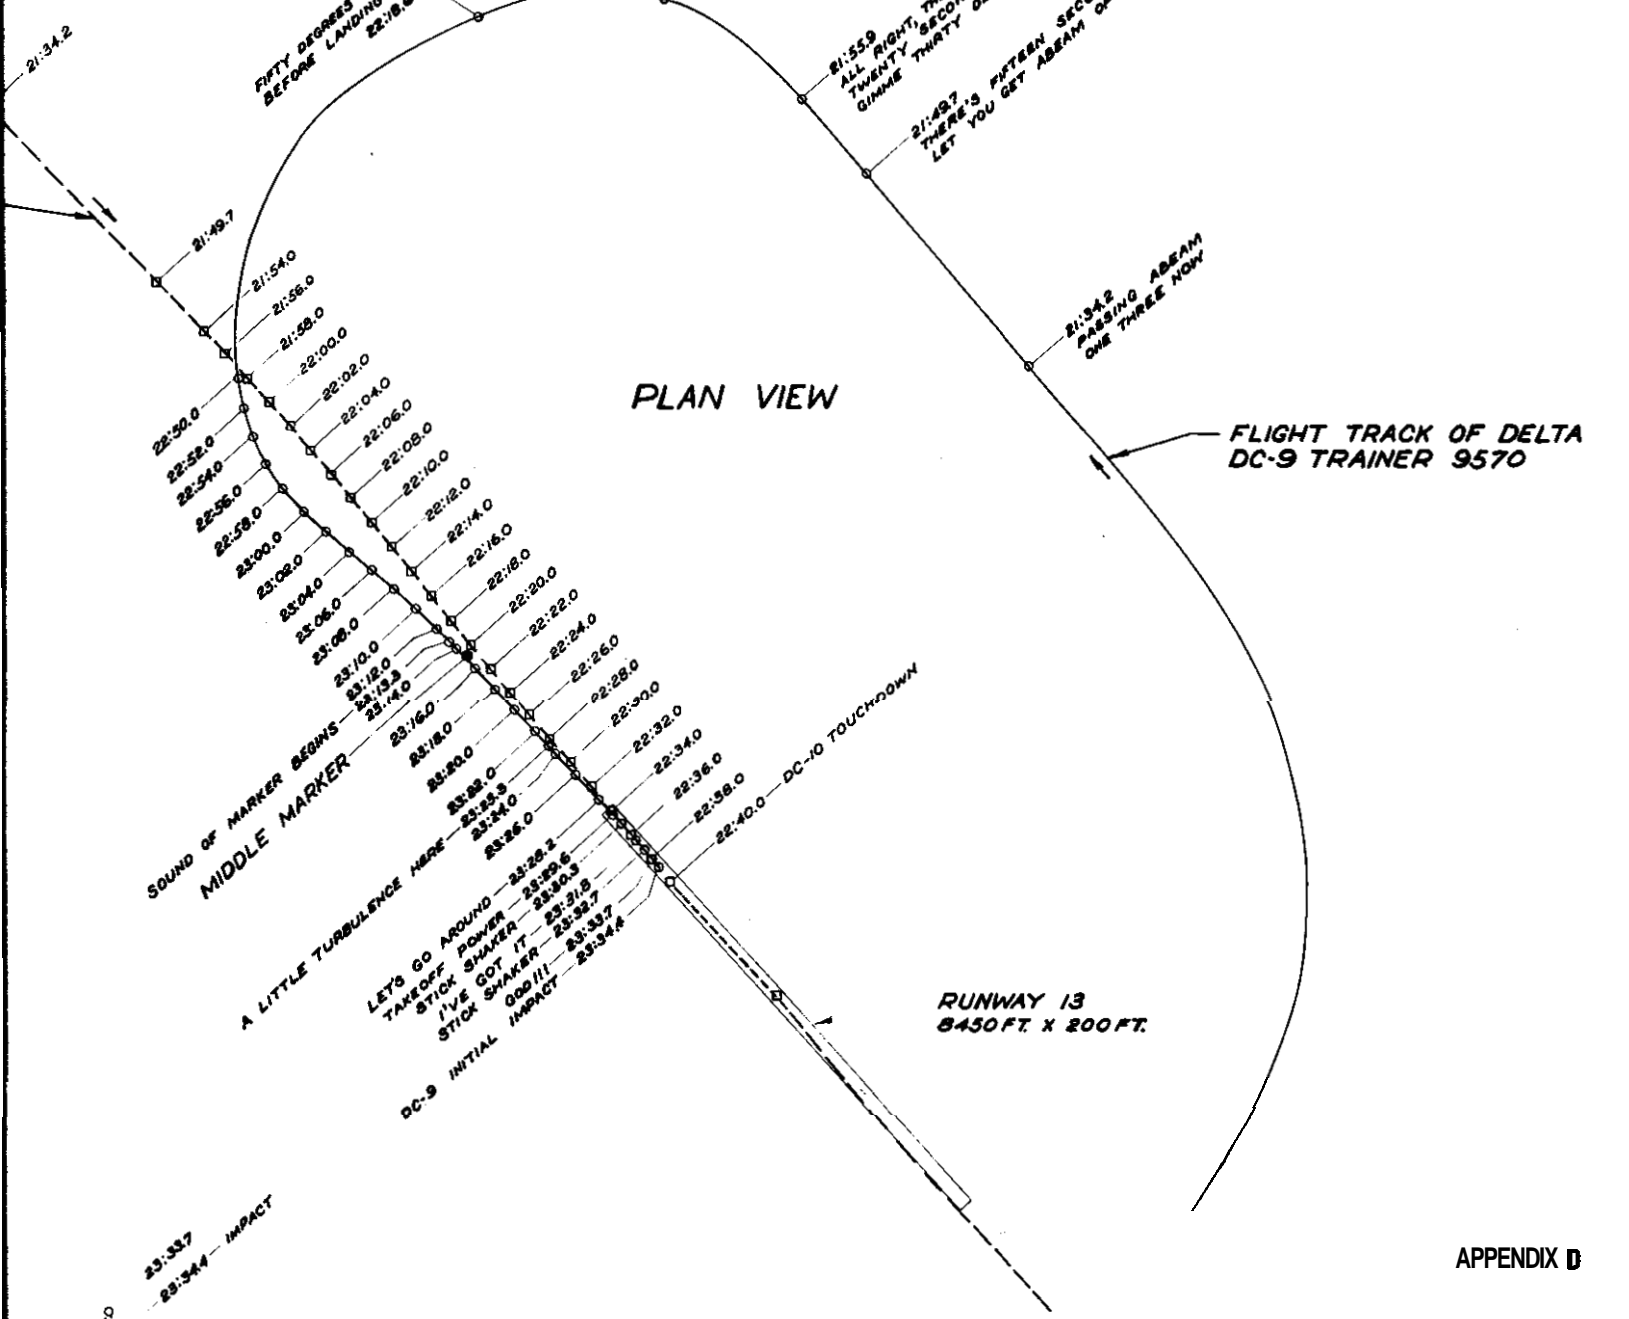
FLIGHT TRACK OF AMERICAN
DC-10 TRAINER 1114

The program, when applied to the DC-9/DC-10 position relationship and existing meteorological conditions, indicated that the DC-9 descended into the influence of the left vortex generated by the DC-10, approaching the vortex from the left at a convergence angle of 7°. This calculation also indicated that the encounter occurred at an altitude of approximately 60 feet above ground level.

The crosswind component caused the vortex to remain in the runway centerline area by preventing the lateral motion normally produced by ground interaction. The slight tailwind component further aggravated the situation by moving the turbulent air mass back into the runway threshold area.

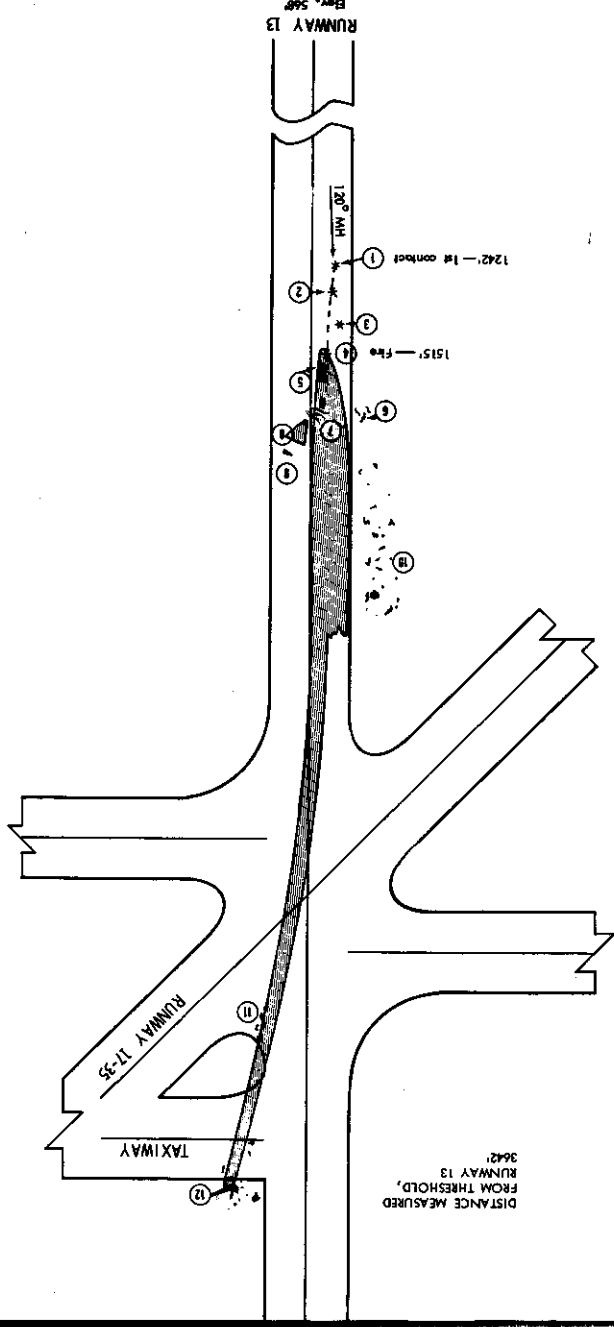
WRECKAGE DISTRIBUTION CHART
DELTA AIRLINES, INC.
DC-9-14, N 3305L
GREATER SOUTHWEST INTERNATIONAL AIRPORT
FORT WORTH, TEXAS

The initial marks on the runway continued in a slight curve to the right for approximately **340** feet down the left side of the runway. A fuel stain on the runway originated **84** feet from the initial impact mark, and ground fire originated **273** feet beyond the point of initial contact.

A continuous trail, made by fire, extended from that point to the main wreckage site. The parts of the airplane, including right wing fuel system components, outside of this trail were neither burned nor sooted. (See Wreckage Distribution Chart, Appendix F.)

Fire propagated from the ruptured wing fuel tanks to the airplane's fuselage subsequent to initial impact. The airplane's integral fuselage tank did not sustain mechanical damage during impact.
