1. Report No. NTSB-AAR-78-8		2. Government Accession No.		3. Recipient's Catalog No.	
4. Title and Subtitle Aircraft Accident Report -- United Airlines, Inc., Douglas DC-8-54, N8047U, near Kaysville, Utah, December 18, 1977.		5. Report Date July 27, 1978		6. Performing Organization Code

AIRCRAFT ACCIDENT REPORT

UNITED AIRLINES, INC.
DC-8F-54, N8047U
NEAR KAYSVILLE, UTAH
DECEMBER 18, 1977

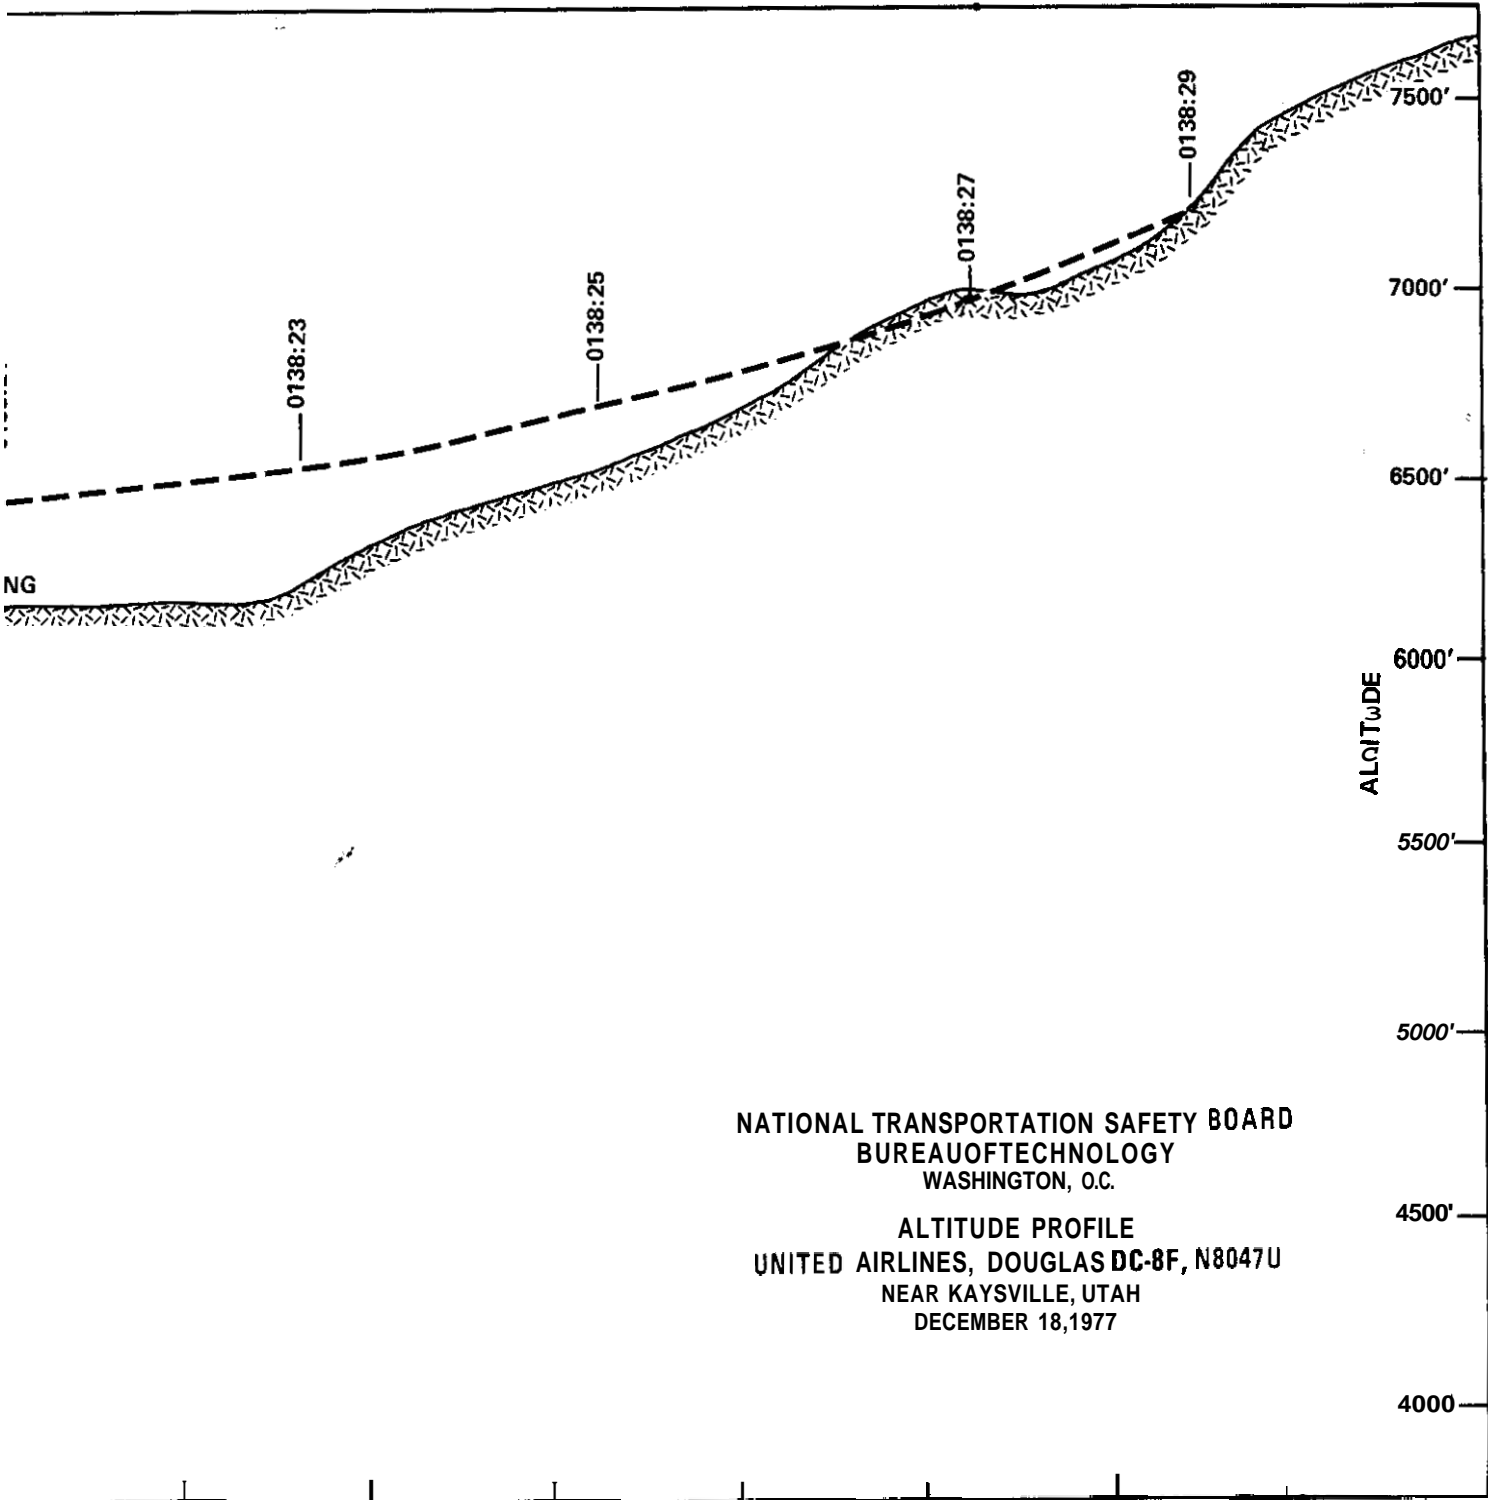
ALTITUDE PROFILE
UNITED AIRLINES, DOUGLAS DC-8F, N8047U
NEAR KAYSVILLE, UTAH
DECEMBER 18, 1977
