## Title: INVENTORY AND COMPLETION OF CASE STUDIES SURVEY

Date: January 2005

Project Title:
 IMPROVING THE SEISMIC RESISTANCE OF CULTURAL HERITAGE BUILDINGS

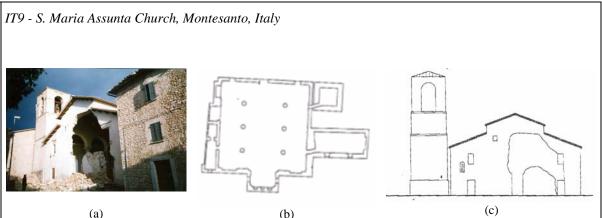
Figure A.9 – Geometry: (a) photo (after the 1997 Umbria earthquake); (b) plan; (c) elevation [Source:]. Umbria Superintendence for the Architectural Heritage

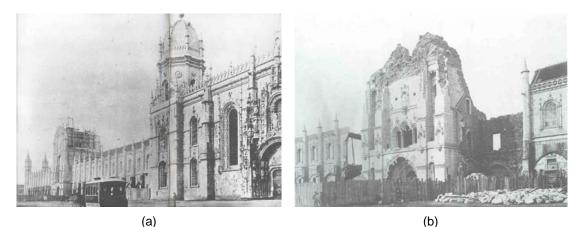
Figure 6 - Homage Tower: (a) the construction; (b) aspect of its collapse (Marques de Carvalho, 1984).

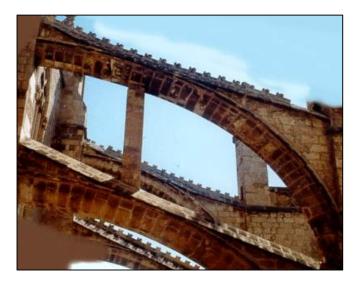
Figure 8 - Flying arch propped on a masonry pillar

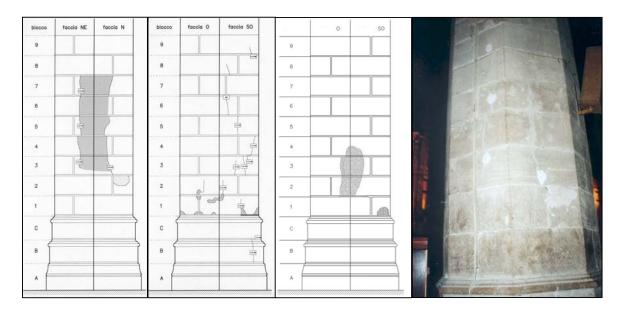
Figure 12 – Examples of cracking in pier faces. The photograph corresponds to the wedge developed in the pier face sketched at the left

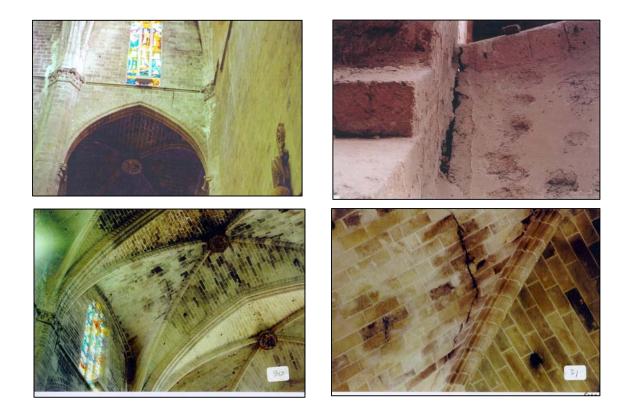
Figure 13 – Examples of cracking in (left, above) the clerestory, (right, above) between vault and transverse arch and (below) in the vaults of the central

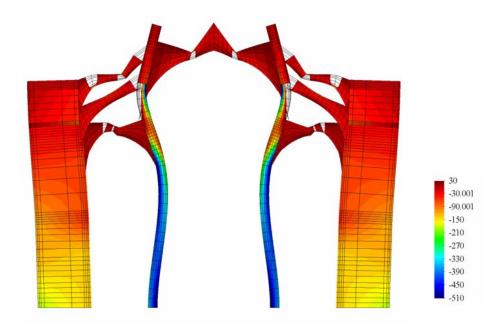
Figure 17- Distribution of stresses (20xMPa) and cracking at failure, occurring at 1.7x the dead load and deformed shape x 1000

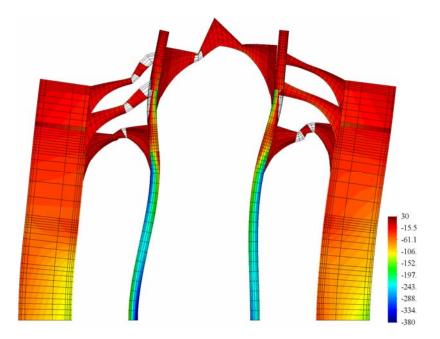
Figure 19 - Distribution of normal stresses (100xMPa), cracking and deformation x 1000 for the structure subjected to a wind pressure corresponding to a return period of 1000 years
