Rupture of Hazardous Liquid Pipeline
With Release and Ignition of Propane
Carmichael, Mississippi
November 1, 2007

Accident Report
NTSB/PAR-09/01
PB2009-916501

Pipeline Accident Report

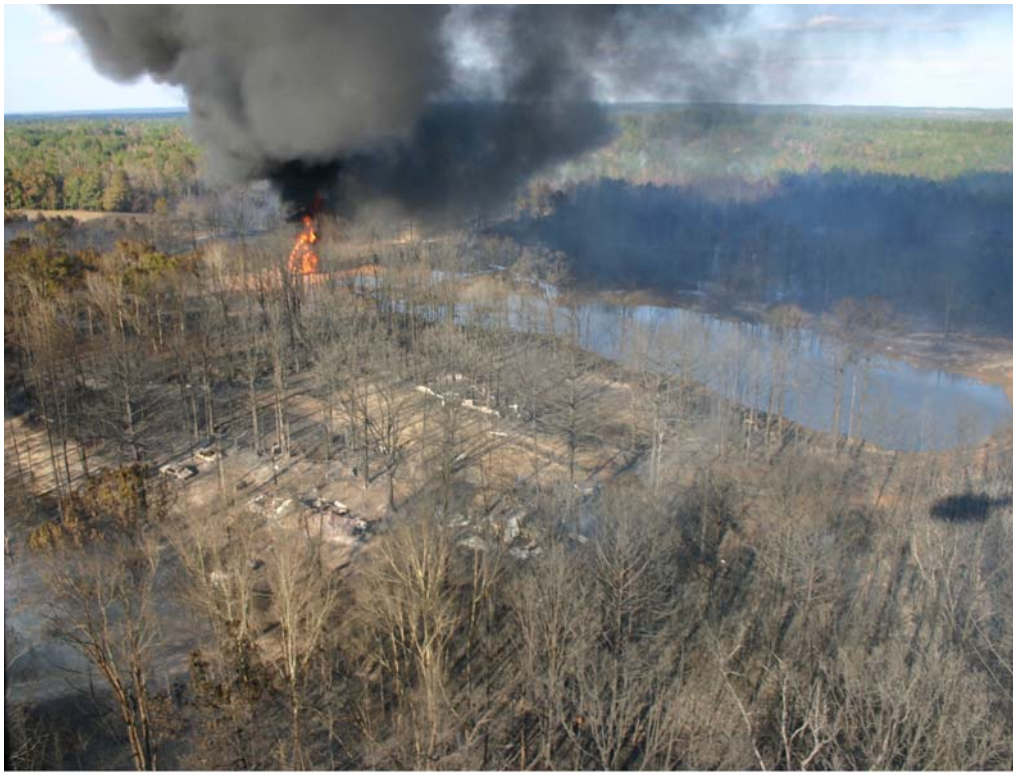
Figure 2. Aerial view of fire from pipeline rupture showing nearby destroyed houses.

The fire destroyed four houses and caused structural damage to several others. The burned area encompassed an area of about 71.4 acres of grassland and woodland. Dixie reported that property damage resulting from the accident, including the loss of product, was \$3,377,247.

A cluster of six houses located on County Road 621 began about 512 feet southwest of the pipeline rupture site and extended west for about 500 feet. Two of the six houses were moderately damaged. The other four houses were fully consumed by fire. The two fatalities were found in and near, respectively, two of these houses.

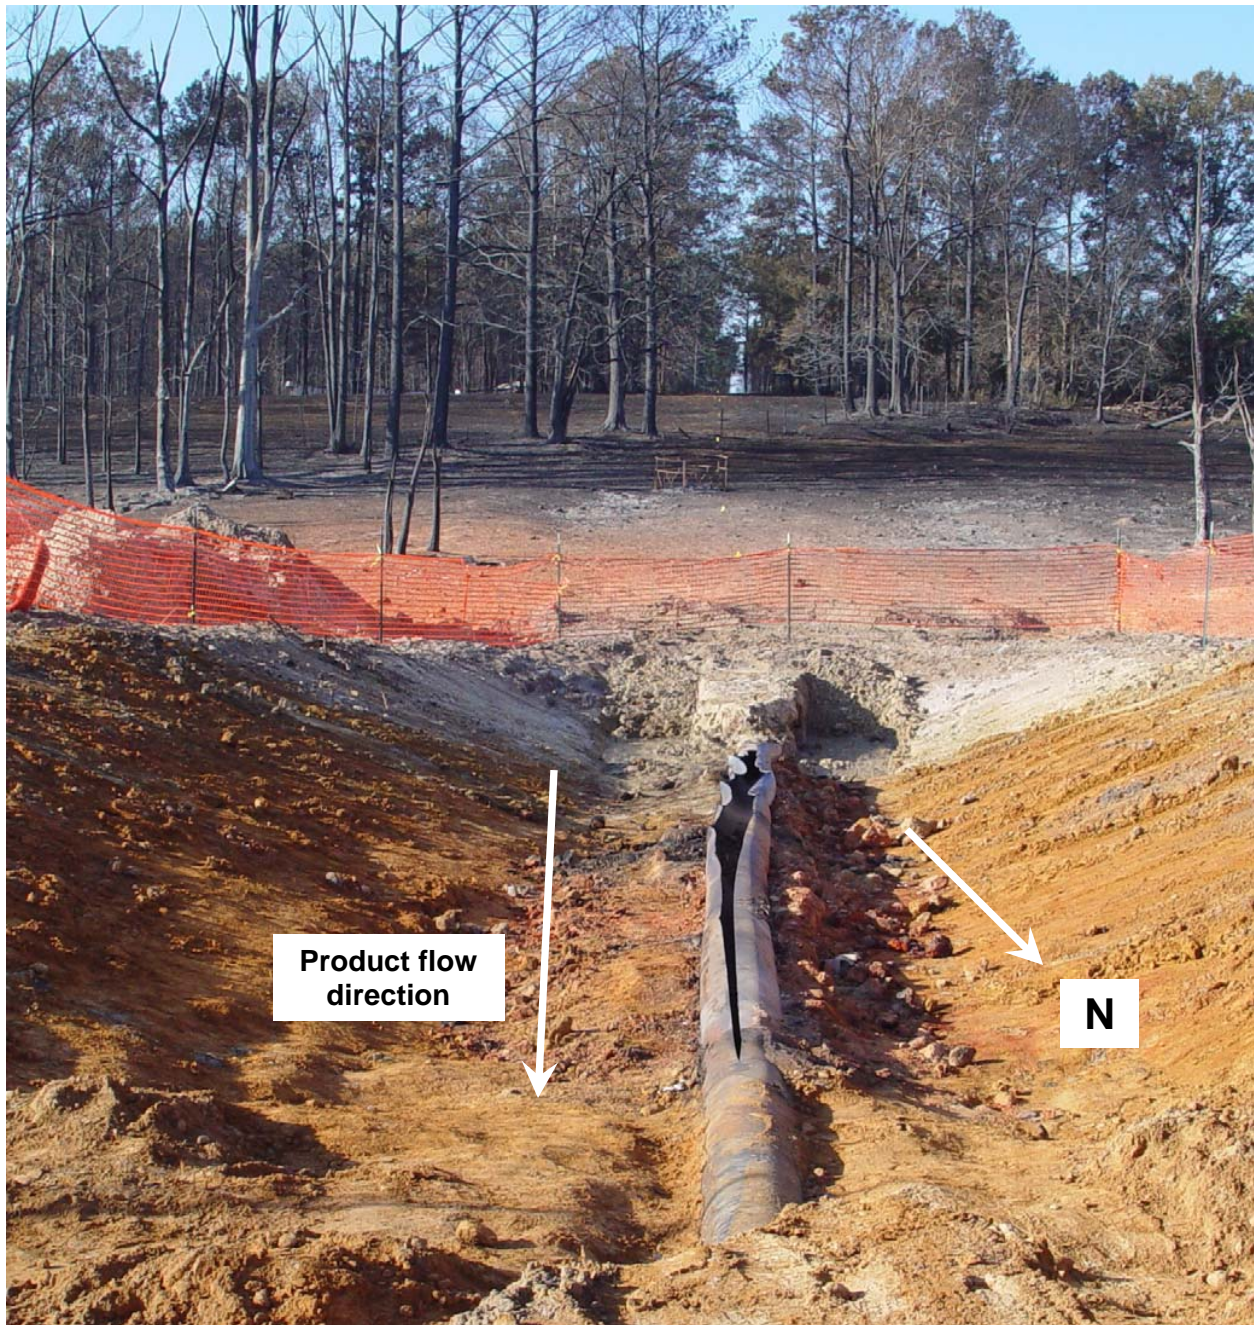
NTSB investigators and representatives of organizations participating in the investigation conducted a joint visual examination of the ruptured pipeline beginning about 11:00 a.m. on November 2. The ruptured segment of Dixie's 12-inch-diameter steel pipeline was visible in a narrow ditch. (See figure 3.) A longitudinal fracture of the pipe at about the 12 o'clock position was visible. At the rupture location the pipeline ran in a southwest to northeast direction, and the product flow was in the same direction. Flames about 3 to 5 feet high, resulting from residual fuel burnoff, were visible at the northeast end of the ruptured pipeline. Flames contained within the pipeline were also visible at the southwest end of the pipeline. A circumferential weld (girth weld) was visible at the upstream end of the fractured pipeline segment. The topsoil had covered a portion of the downstream end of the segment. In addition, some debris was present in the middle of the exposed pipeline segment.

Figure 3. Ruptured pipe at Carmichael looking southwest. (Soil has been removed from around pipe to facilitate on-site examination.)

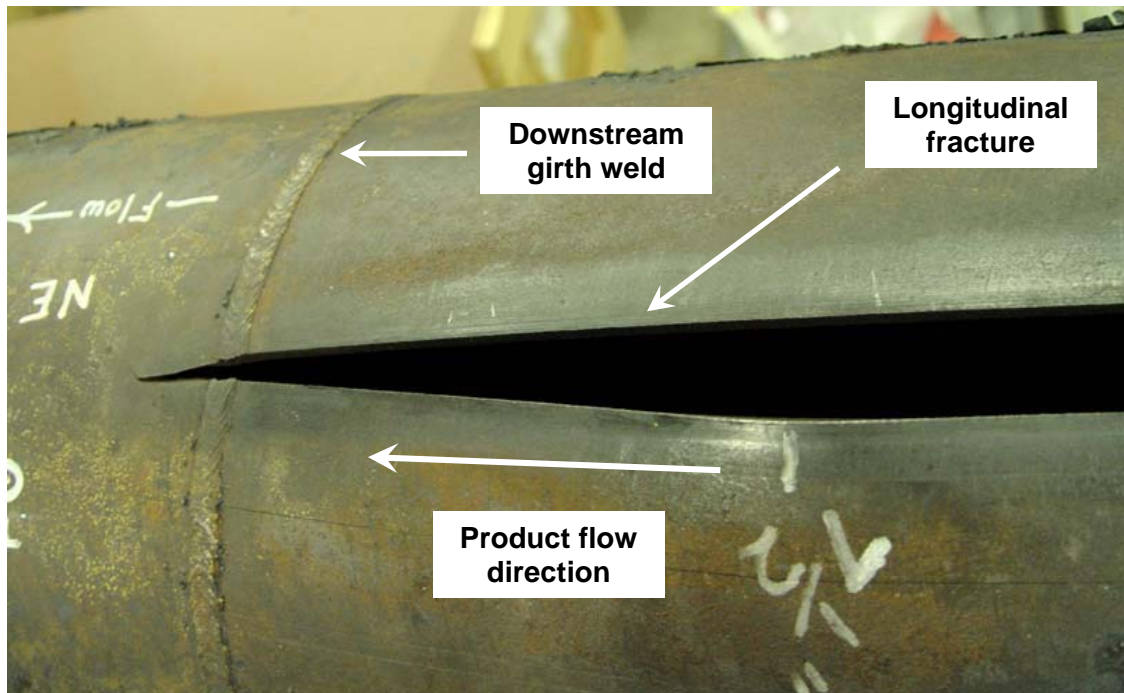
The rupture extended over a longitudinal distance of about 52 feet 4.75 inches. A major portion of the fracture extended through the longitudinal ERW seam. The downstream end of the fracture crossed a girth weld and continued about 1 inch into the body of the adjoining pipe joint. (See figure 4.) On the upstream side of the ruptured pipe joint, the fracture followed the downstream edge of the circumferential girth weld for about 1.8 inches. At this point it ran longitudinally across the girth weld and then progressed another 1.2 inches along the upstream edge of the girth weld. The fracture then continued along a curved trajectory for about 12 inches into the base metal of the upstream pipe joint, leaving an open flap of pipe at the upstream girth weld. (See figure 5.)

Figure 4. Downstream end of rupture.

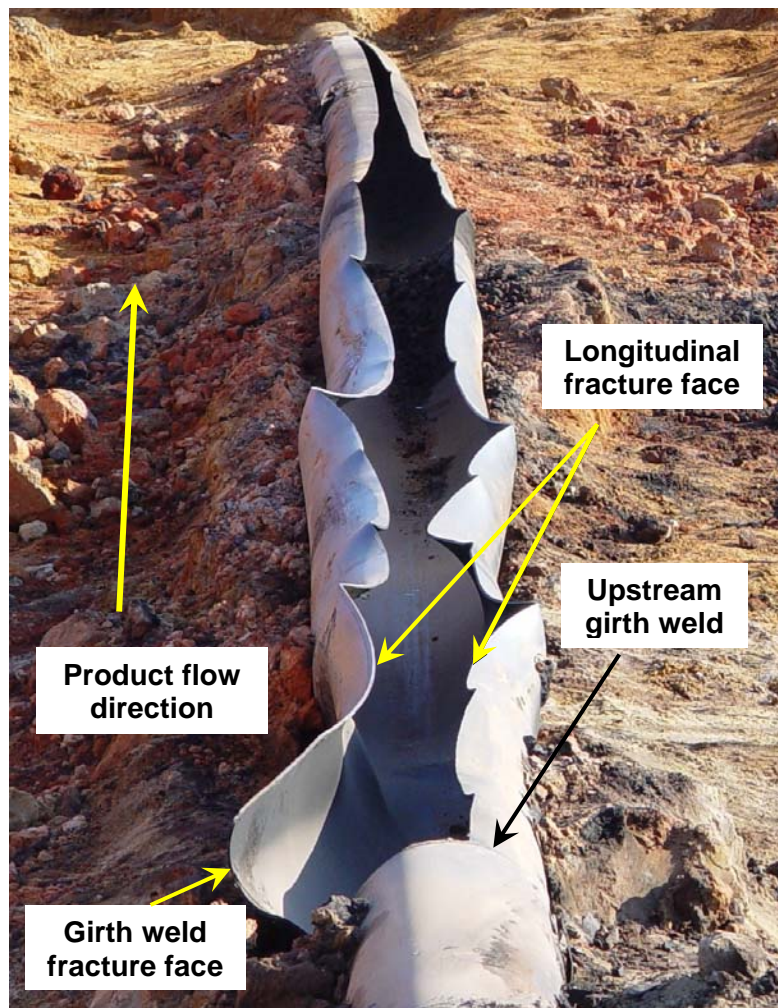
Figure 5. Ruptured pipe.

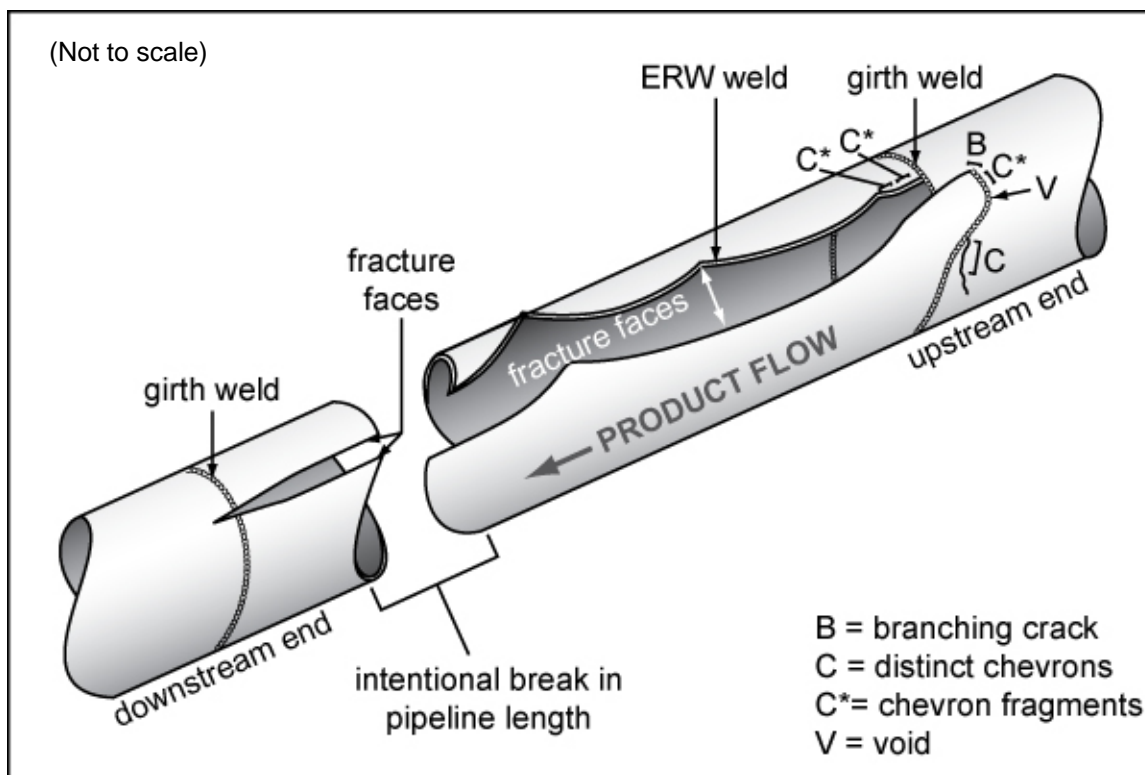
a fracture path similar to a hook crack. Inspection of the longitudinal weld seam fracture faces also showed faint repeated patterns that extended transversely across the wall in many areas consistent with features called stitching in ERW seam welds.

Examination of the fracture faces of the longitudinal ERW seam fracture revealed chevron pattern fragments in areas located about 2.5 inches and 4 inches downstream from the upstream girth weld. (See figure 6.) The orientation of the chevron patterns indicated that the fracture was propagating in the upstream direction, along the longitudinal seam weld toward the girth weld. The longitudinal ERW seam fracture and the upstream girth weld fracture intersected at about a right angle. At the transition between the fractures was a branching crack, which also indicates fracture propagation in the upstream direction, toward the girth weld.

Figure 6. Schematic drawing of accident pipe identifying welds and showing fracture features of interest.

Fractographic examination of the girth weld showed no evidence of a preexisting crack (such as radial or crack arrest marks that originate from a specific location). Examination of the downstream face of the girth weld fracture revealed that a 1-inch fracture portion adjacent to the ERW seam fracture contained faint chevron fragments indicating that the fracture was propagating away from the seam. A void²⁴ found in the upstream girth weld was about 0.05 inches in cross section at the fracture surface. Welding standards in effect both at the time
