BULLETIN 31

THE TUPELO TORNADO

By
WILLIAM CLIFFORD MORSE, Ph. D.
STATE GEOLOGIST

1 9 3 6

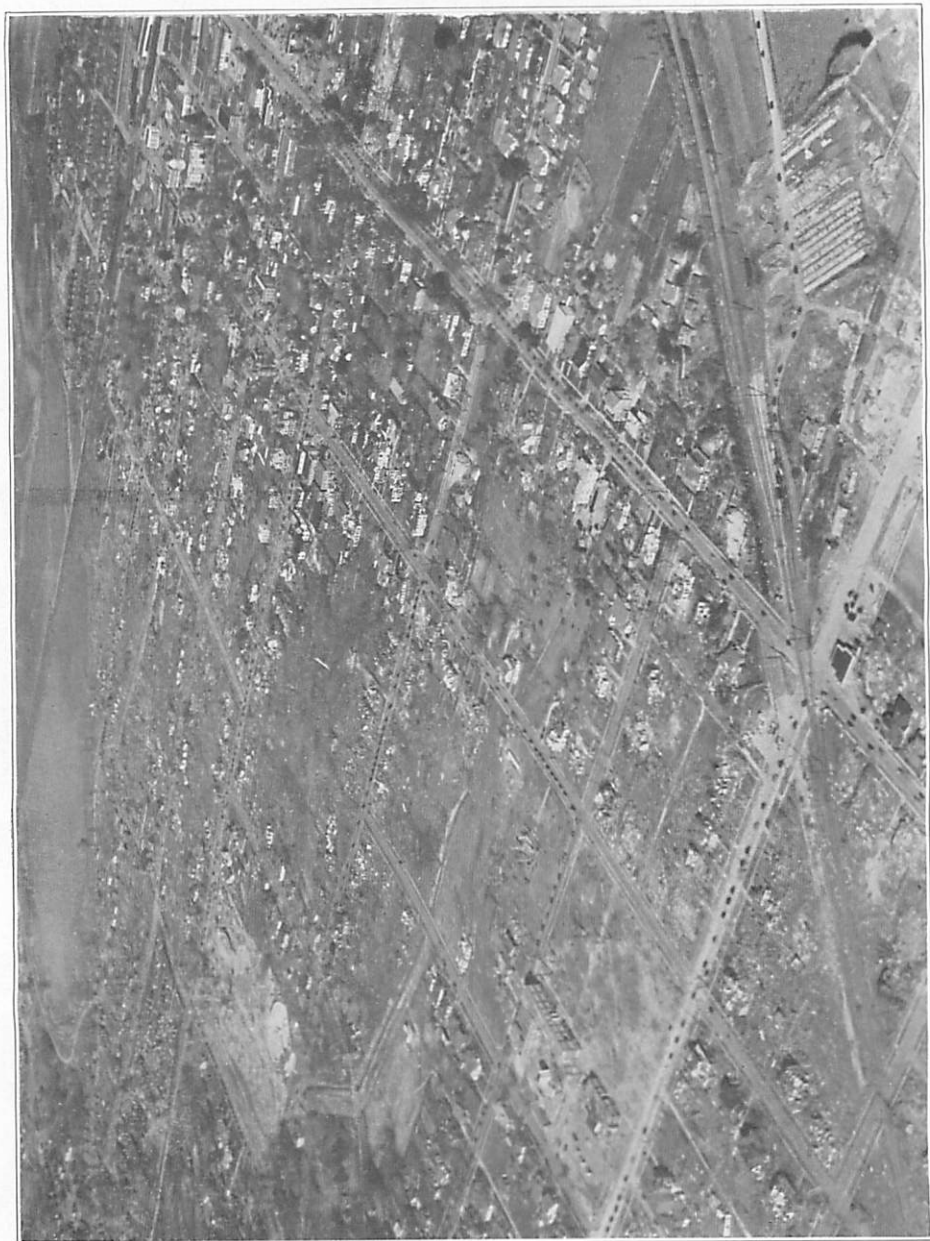
FRONTISPIECE

A northeasterly view of the path of the tornado that swept across Tupelo, Miss., from the intersection of Main Street and the Frisco Railroad to Gum Pond, April 5, 1936. In addition to the devastated swath, from which much of the wreckage had been cleared by hundreds of relief workers, the photograph shows the line of visiting automobiles that was permitted to enter the city Sunday, April 12, 1936, for the first time. -- Courtesy of The Commercial Appeal, Memphis, Tenn., air service.

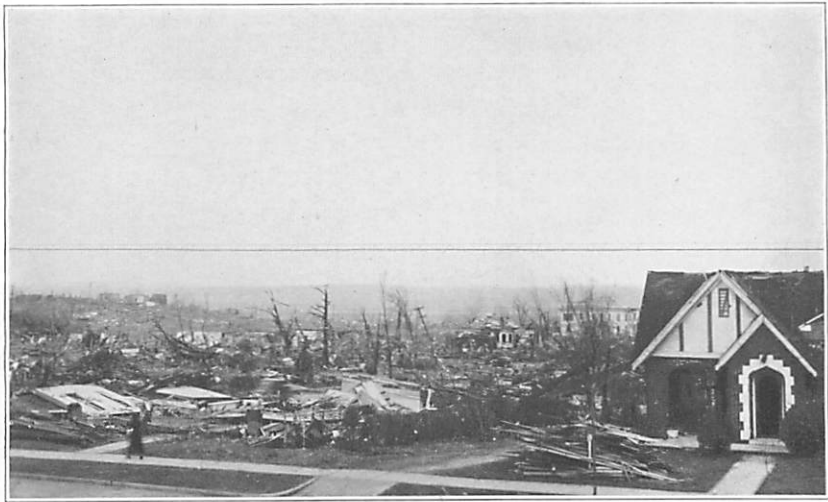
Figure 1.—A northeasterly view of the tornado path of April 5, 1936, from Church Street, Tupelo, Miss.--Photographed April 10, 1936.

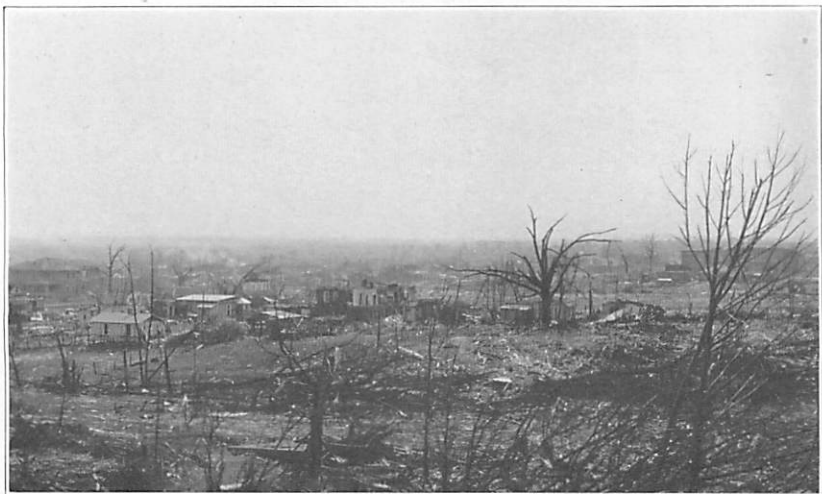
Figure 2.—A southwesterly view of the tornado path of April 5, 1936, from the same place on Church Street, Tupelo, Miss.--Photographed April 10, 1936.

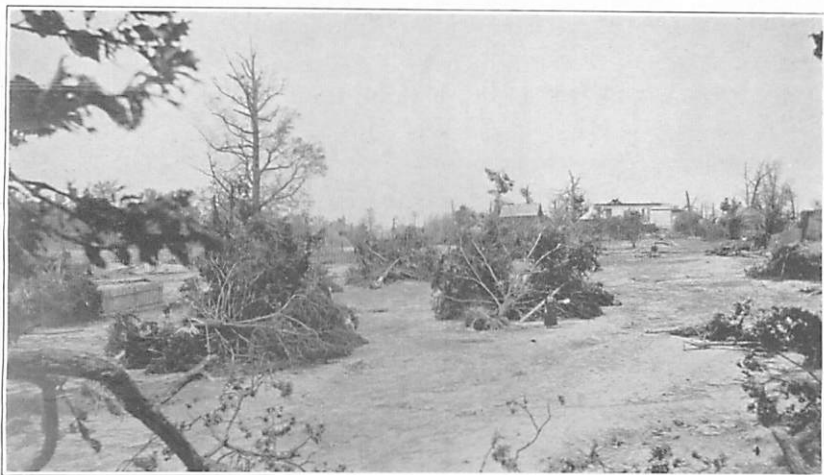
Figure 3.—Cedar trees which were blown down by tornadic winds at Bell School House, Oktibbeha County, Miss., on April 20, 1920.--Courtesy of Prof. F. E. Burt.

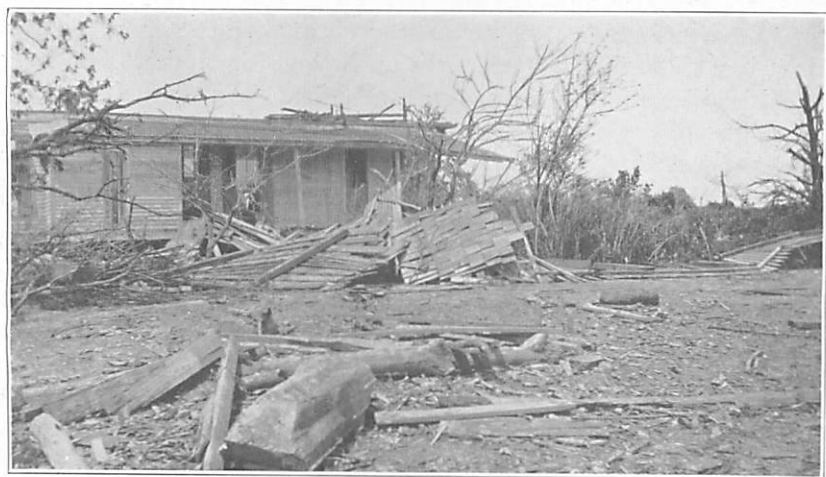
Figure 4.—A farm house which was destroyed by tornadic winds at Bell School House, Oktibbeha County, Miss., on April 20, 1920.--Courtesy of Prof. F. E. Burt.

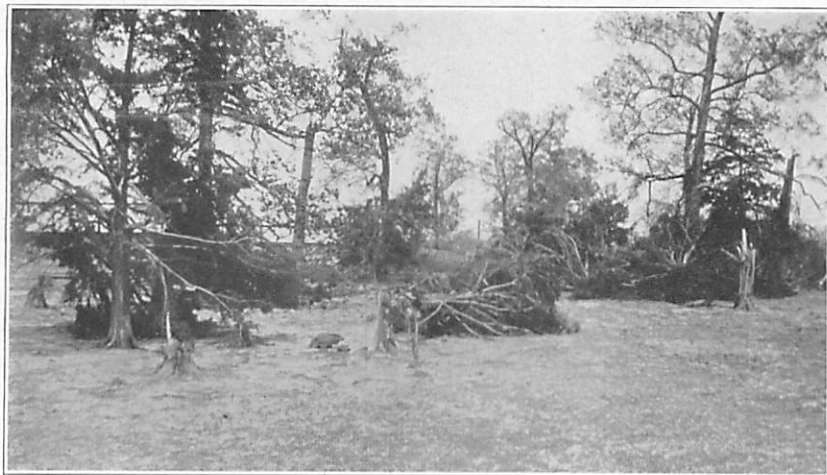
The tornado that dipped near Bell School House, Oktibbeha County, Mississippi, in the spring of 1920 up-rooted, twisted off, and otherwise destroyed practically every cedar tree in its path (Figure 3), as well as a farm house (Figure 4) and a barn, whereas it scarcely broke the limbs from the giant oaks (Figure 5) extending twice as high. The tornado had no particular aversion to cedar trees. Rather these trees, because of the number of their branches and the manifold number of their leaves offered so much obstruction to the swift passage of the wind that their trunks and root systems could not withstand the wind pressure which the limbs and the leaves largely developed. The oaks stood because their trunks and their root systems were more than adequate to resist the small pressure which their few open limbs developed.

Figure 5.—Oak trees left standing among cedar trees that were destroyed at Bell School House, Oktibbeha County, Miss., on April 20, 1920.--Courtesy of Prof. F. E. Burt.

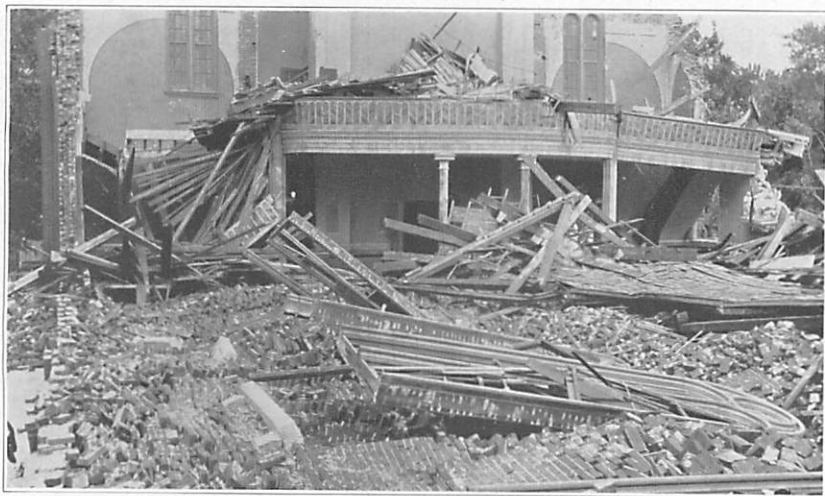
Figure 6.—The west wall of Borrromeo Church, St. Charles, Mo., which was blown across the pews by the tornado of July 7, 1915.
--Photographed July 9, 1915.

The west wall of Borrromeo Church was blown onto the pews and the floor, as shown in Figure 6. The entrance and the altar end remained practically intact (Figures 7 and 8). Even though the steeple extended nearly twice as high as the comb of the roof, it stood with scarcely the loss of a brick, because of the strength which its closely spaced four walls imparted to it. In a similar manner, the pulpit end remained nearly intact, because of the support which even the minor partitions gave to it. The east wall fell out; the west wall caved in; both because of no adequate braces. Had the storm struck during service when the church was filled, the photographs show how complete the destruction of life would have been.

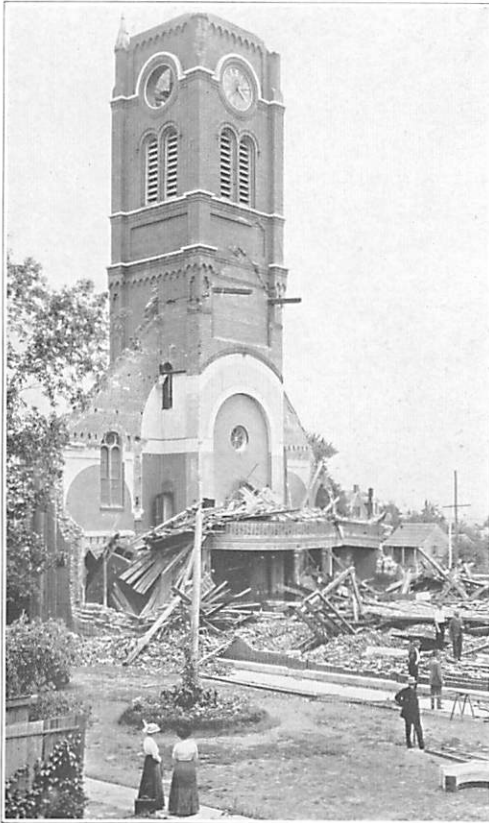
Figure 7.—The tower of Borrromeo Church, St. Charles, Mo., scarcely lost a brick in the tornado of July 7, 1915.--Photographed July 9, 1915.

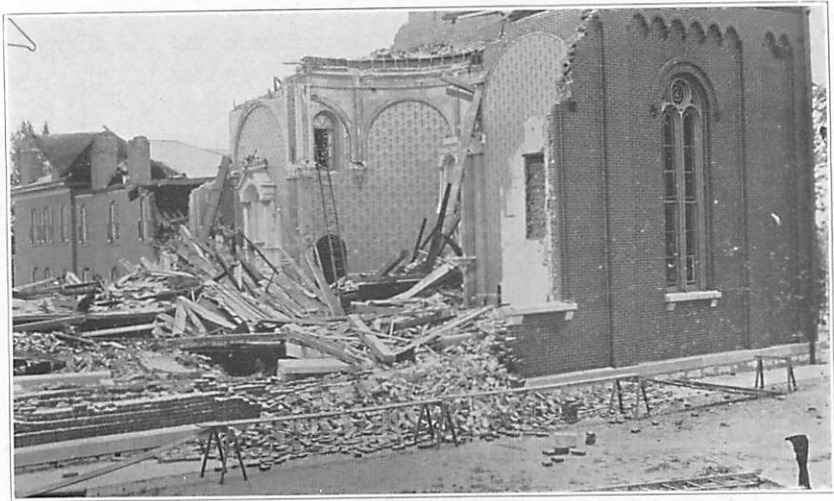
Figure 8.—Even frail partitions of the altar end of Borromeo Church, St. Charles, Mo., held the walls against the onslaught of the tornado of July 7, 1915. -- Photographed July 9, 1915.

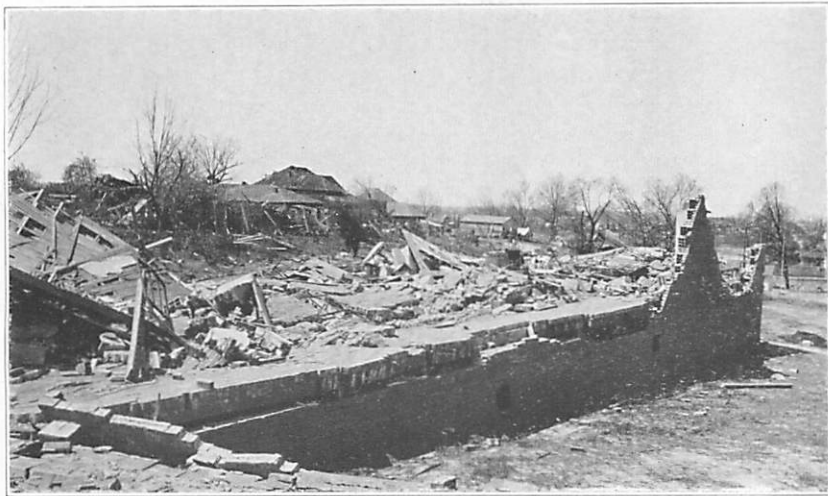
Figure 9.—The north wall of the south wing of the Church Street Grammar School, Tupelo, Miss., was blown southward flat across the small desks by the tornado of April 5, 1936.--Photographed April 13, 1936.

The old Grammar School consisted of a long narrow edifice facing east on Church Street and two long narrow wings extending westward from the front. It was built of large hollow tile blocks veneered with a single brick course which was tied to the inner tile construction only at every tenth course. The mortar was largely without strength, for most of it peeled from the bricks and could readily be broken with the fingers. The long north wall of the south wing was absolutely without partition support, because a narrow hallway extended along its full length. The partitions which divided the wing into rooms were frail frame structures which extended from the hallway partition to the south outer wall. Consequently, the north wall of this wing was without the brace even of frail frame partitions. When the tornado struck, this wall offered more obstruction to the passage of the wind than it possessed construction strength to resist. Accordingly it fell southward across the hallway partition and seats, mashing all to the floor over an area of more than three-fourths of the floor space (Figure 9). Had the storm struck when the rooms of this wing were filled with pupils, the loss of life would of necessity have reached at least 75 per cent of those present.

Because of dead mortar, or mortar without strength, and especially because of inadequate braces from solid masonry cross partitions, in one and the same storm the north walls of the two wings and the west wall of the front portion fell southward and eastward respectively across the floor, thus forcing the opposite walls outward.

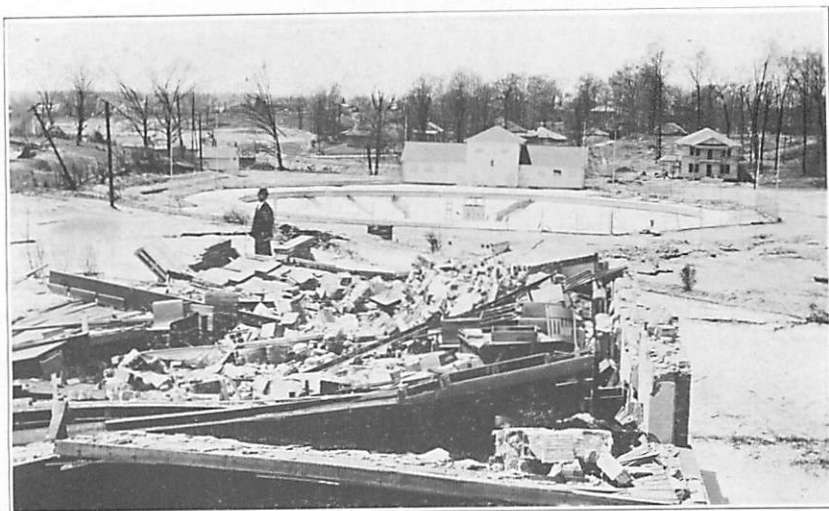
In a similar manner, the north wall of the north wing failed, falling inward, across three-fourths of the floor space of this wing (Figure 10) and much of the west wall of the front portion failed, falling inward across three-fourths of the floor space of this portion of the building (Figure 11). Therefore with the exception of the pupils in two rooms at the northeast corner and in one room at the southeast corner, at least three-fourths of all of the pupils of the whole floor would have been killed, had the storm struck during school hours.

Figure 10.—The north wall of the north wing of the Church Street Grammar School was likewise blown southward across the small desks of that wing by the tornado of April 5, 1936.--Photographed April 13, 1936.

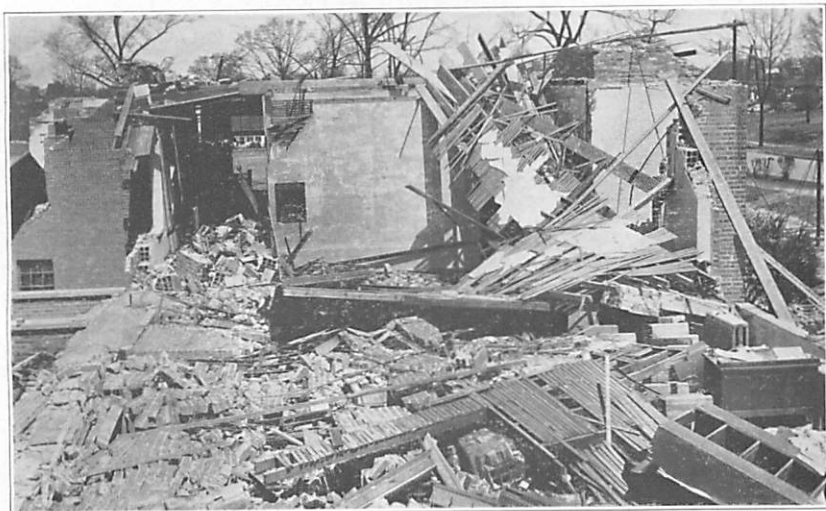
Figure 11.—A part of the west wall of the front section of the Church Street Grammar School was blown eastward across the small desks of that section by the tornado of April 5, 1936.--Photographed April 13, 1936.

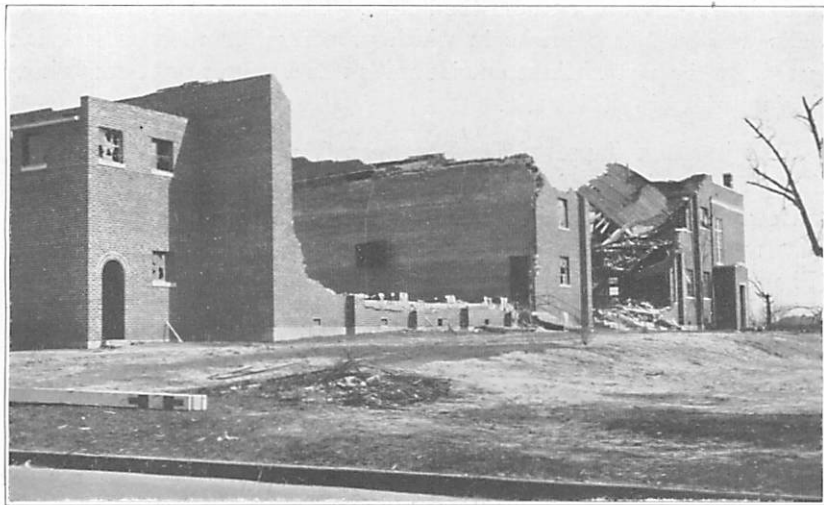
As in the collapse of the Borromeo Church in St. Charles so in the partial collapse of the Tupelo High School, the main cause was inadequate cross partition braces, for the part that failed was the west wall, which was common to the auditorium and the gymnasium (Figure 12). In falling, this wall crushed the seats of the auditorium (Figure 13) to the floor and covered the free floor of the gymnasium (Figure 14). The opposite wall, also common to each of these rooms, was forced outward. The remainder of the building, the front (Figure 15) and the east wing, stood more or less completely intact. When one views the crushed seats of the auditorium and the floor of the gymnasium covered with bricks of the common wall, which stretches entirely across the two rooms, one shudders at the thought of how nearly complete annihilation would have been had these rooms been filled with pupils when the tornado struck.

Figure 12.—The gymnasium and auditorium sections of the west wall of the west wing of the High School, Tupelo, Miss., were blown eastward across these rooms by the tornado of April 5, 1936.--Photographed April 13, 1936.

In the face of the evidence accumulated in the St. Charles, the Tupelo, and other tornadic storm areas, it would seem scarcely short of criminal negligence to construct large churches, auditoriums, and school assembly rooms, that of necessity must be free from partitions, without providing them with adequate buttresses, without using the best of cement mortar, and without properly re-enforcing the concrete, brick, and stone construction, and without using adequate structural steel re-enforcements.¹

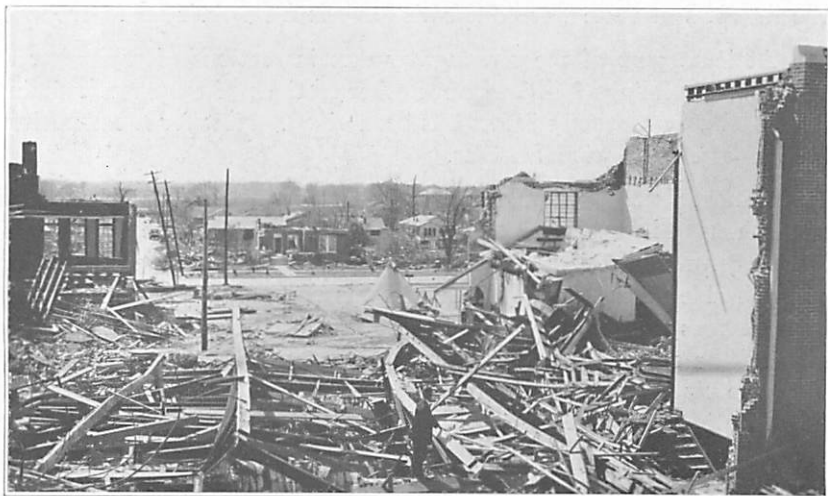
Figure 13.—The wreckage of the west wall and roof was thrown across the seats of the auditorium of the High School by the tornado of April 5, 1936.--Photographed toward the west, April 13, 1936.

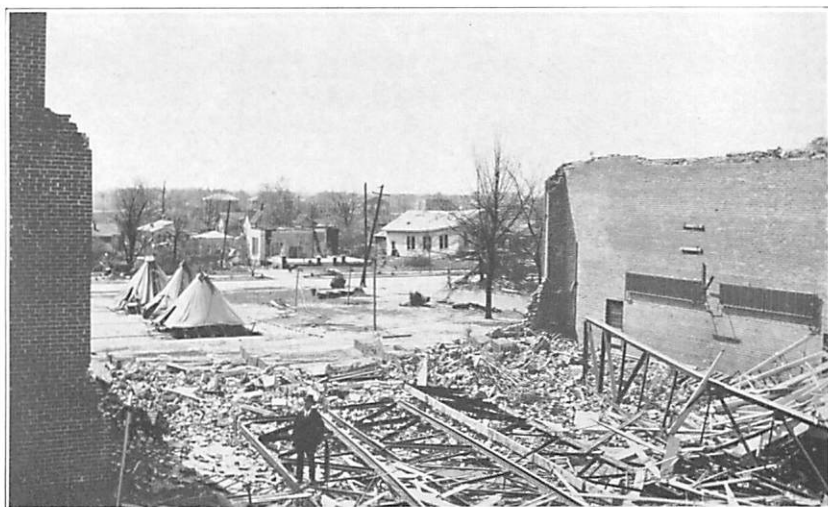
Figure 14.—In a like manner the wreckage of the west wall and the roof was thrown across the floor of the gymnasium of the High School by the tornado of April 5, 1936.--Photographed toward the west, April 13, 1936.

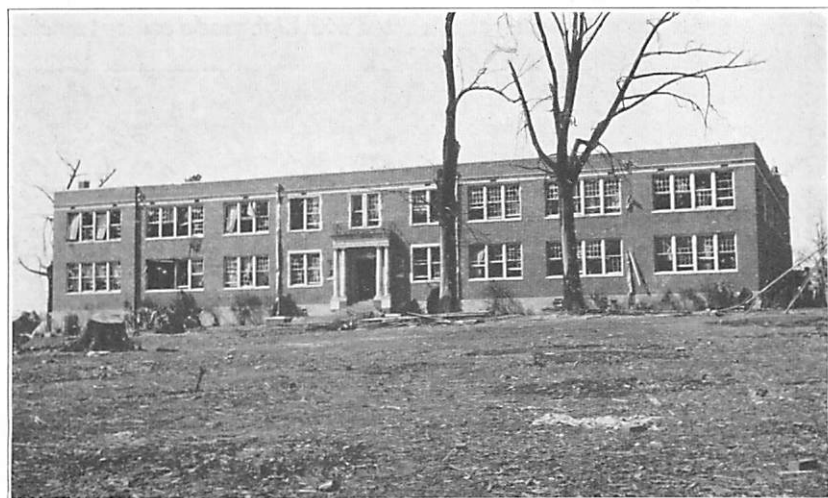
Figure 15.—The windows and drain pipes of the south front of the High School were badly battered by flying wreckage as were the trunks and the limbs of these two trees, but this part of the building, and the east wing as well, scarcely lost a brick in the tornado of April 5, 1936.--Photographed toward the north, April 13, 1936.

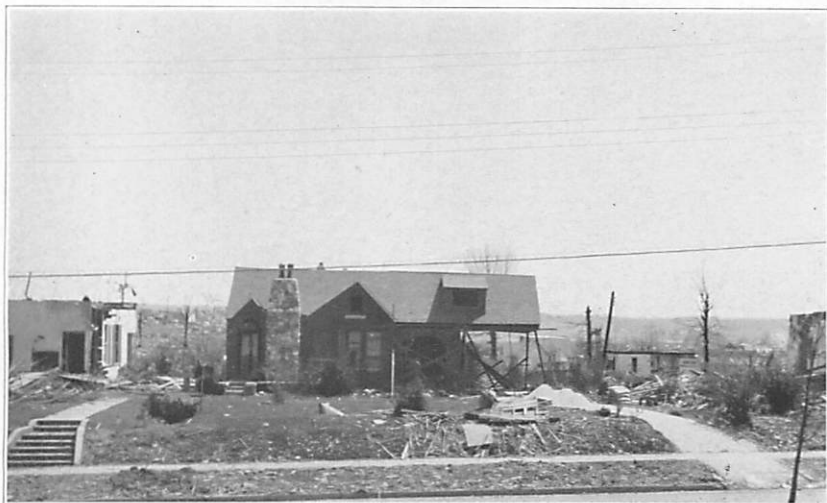
Almost directly in front of the Church Street Grammar School is the house of Mr. Vincent Carnaggio (Figure 16) of the Dixie Cafe. Not only was the Grammar School completely wrecked, but the house on each side of the Carnaggio house was demolished (Figures 17 and 18), whereas the Carnaggio house stood almost completely intact. To be sure the spear-like lumber strips, that man had so carefully sawed from the virgin tree, shot its roof full of holes which permitted the rain to pour through; and broke its window panes; but the structure remained otherwise largely undamaged, except that one of the two supporting columns of the roof of the automobile entrance (portecochere) was thrown down, perhaps by some heavy flying object, and that a small portion of the top of the east wall near the southeast corner was forced two or three inches out of plumb by a terrific blow from some heavy timber which struck it endwise. All in the Carnaggio house

Figure 16.—Aside from a badly punctured roof, which had been replaced prior to the taking of this photograph on April 13, 1936, and shattered window panes, this brick veneer house of Mr. Vincent Carnaggio on Church Street opposite the Grammar School suffered only a battered down column and a dented rear wall, solely because it was excellently constructed with high grade cement mortar.

escaped injury except Mrs. Carnaggio who suffered a small forehead cut from flying window glass. The ready answer to the question as to why the Carnaggio house escaped when the house on each side was demolished is that the Carnaggio house was brick, or rather brick veneer, whereas the other two were frame structures. This is true, but it is not the complete answer.

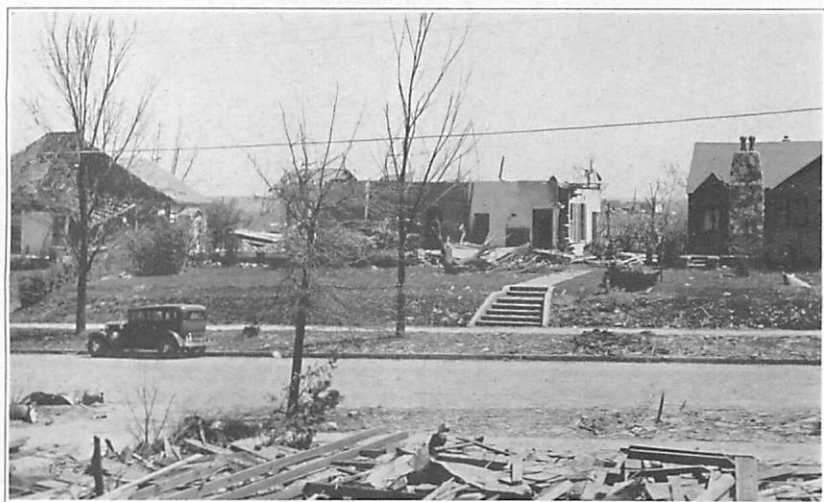
Figure 17.—This frame house on the north side of the Carnaggio house almost completely collapsed in the tornado of April 5, 1936
--Photographed April 13, 1936.

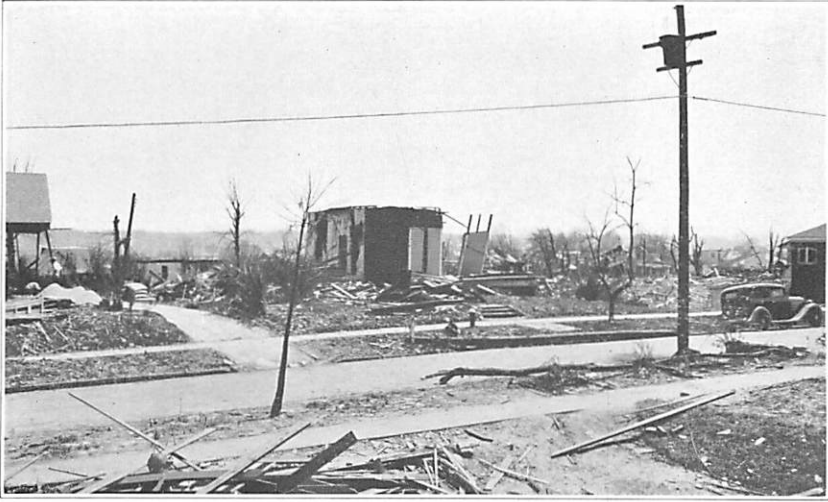
Figure 18.—This frame house on the south side of the Carnaggio house likewise almost completely collapsed in the tornado of April 5, 1936.--Photographed April 13, 1936.

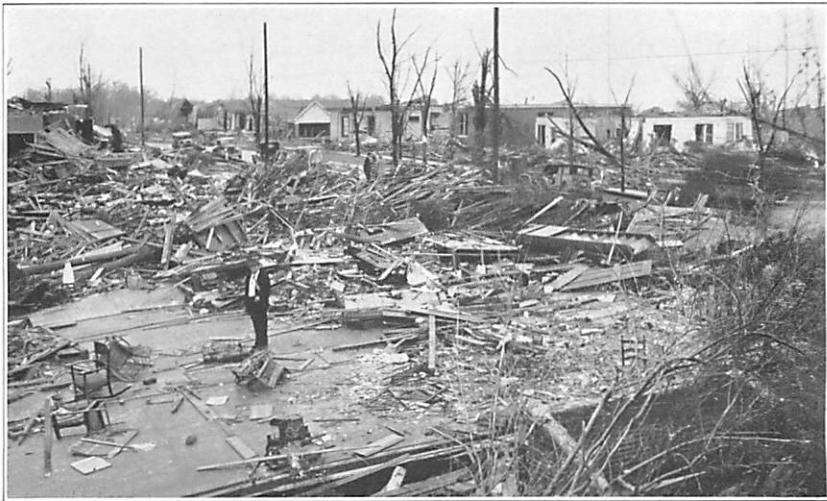
Figure 19.—Mr. J. J. Huffman stands at the spot where his sister and he escaped death on the floor deck of his house, the only part of the frame structure that was not blown away from the site at 365 North Church Street by the tornado of April 5, 1936.--Photographed April 13, 1936.

Farther south on the same street was the frame house of Mr. J. J. Huffman, who with his sister and a deceased sister's husband was in the home when the tornado struck. The brother-in-law who was swept with the wreckage four or five houses away was so badly injured that he died some five hours later; the sister was injured, but is recovering; and Mr. Huffman, although badly cut by flying material, escaped with minor injuries. For the photograph, he posed on the deck of the floor (Figure 19), the only remaining part of his home, near the spot where his sister and he were when the house crashed. How the two escaped death is as much of a mystery to him as to others. He says the wind must have lifted the walls clear of them.

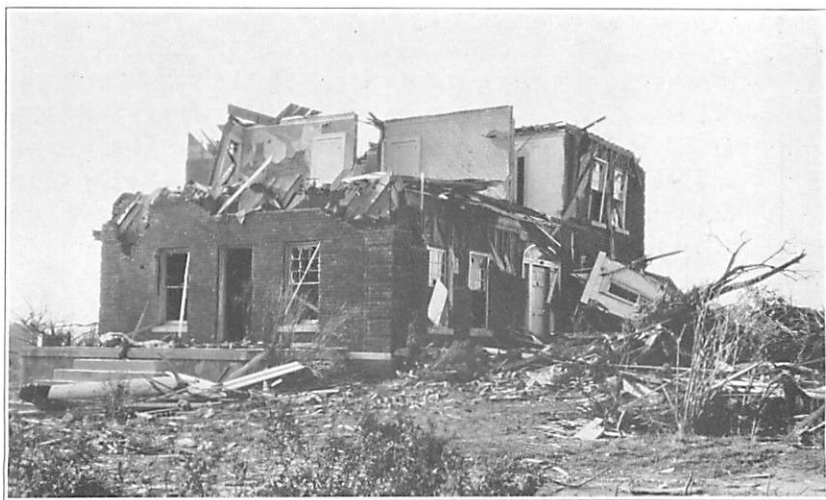
Next door was a two-story brick-veneer house, which was more pretentious than the Carnaggio brick bungalow, and which did not collapse as did the Huffman home, but which was badly wrecked (Figure 20). The roof was carried away toward the northeast; the porch roofs, wrecked; and at least three or four second floor rooms were torn down. One would expect this brick house to withstand the storm better than the Huffman frame house next door, but there is no reason why it should have been wrecked while the Carnaggio bungalow escaped largely unscathed, even though it was a two-story house and was nearer the middle of the tornado path. Perhaps the answer to this problem lies in the evidence in the State Geologist's Office, where brick and mortar from the two school buildings and the two brick houses are preserved. The brick of the two houses is the same, but the cement mortar of the Carnaggio house adheres even to the broken brick and requires a blow from a hammer to break it, whereas the mortar from the two-story house crumbles between the fingers.

Figure 20.—This next door house, a brick veneer, was not completely blown away in the tornado of April 5, 1936, as the Huffman house was, but it is largely a wreck when compared with the Carnaggio house. Mortar so inferior as to crumble in the fingers is probably the chief reason.--Photographed April 13, 1936.

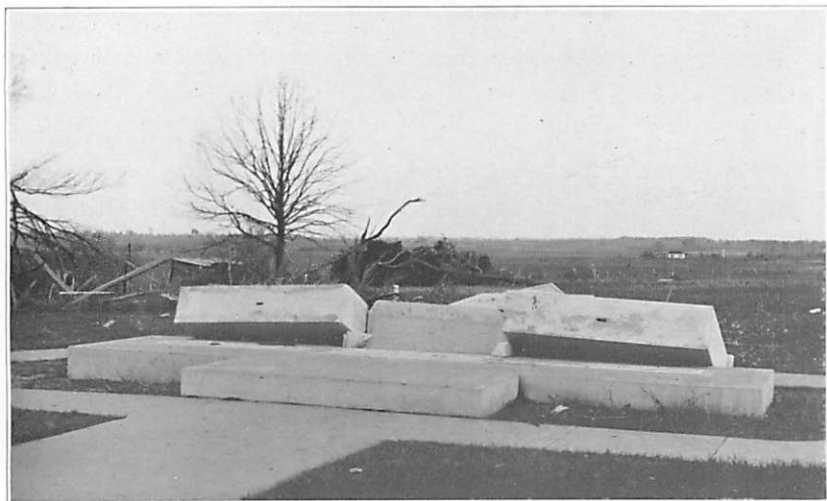
Figure 21.—The Battle of Tupelo Monument was blown down toward the south by the tornado of April 5, 1936, because its obstruction to the wind passage was too great to be overcome by the resistance of its two 14-inch and one 18-inch bases.--Photographed April 13, 1936.

Within the small cemetery of the western suburb stood a beautiful granite Battle Monument facing the north. It consisted largely of two rectangular wings, approximately 14 inches thick, 5.5 feet wide, and 4.5 feet high, and a rectangular median part, having a basal member approximately 22 inches thick, 4.5 feet wide, and 1.5 feet high, and a main member, approximately 18 inches thick, 4.5 feet wide, and 9.0 feet high, the whole presenting a comparatively broad surface to the wind. It was toppled over toward the south, for it had only its two 14-inch bases and one 18-inch base to brace it (Figure 21). The tall, slender tubular flag-staff was bent to the ground, because at least one fairly large piece of metal roofing increased its area of

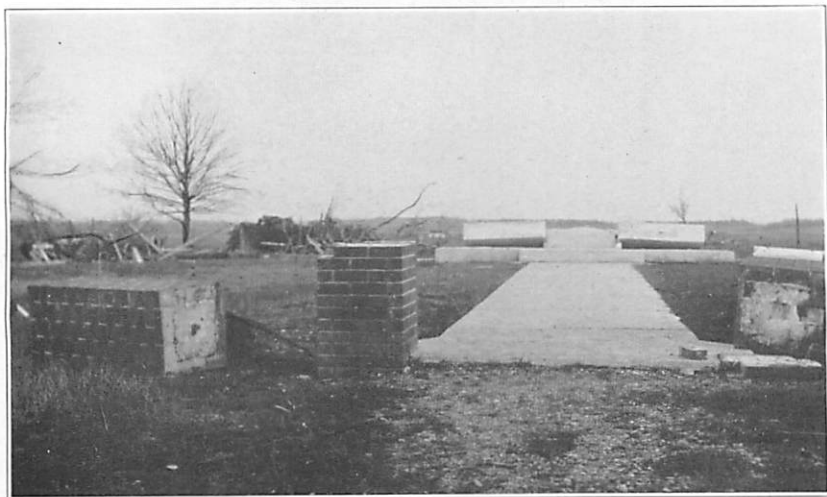
Figure 22.—Besides the Battle of Tupelo Monument, the two brick gate posts were blown down by the tornado of April 5, 1936.--Photographed April 13, 1936.

obstruction without increasing its power of resistance. Stranger still is the fact that two square solid brick gate posts were broken off (Figure 22), even though the nearer post stood only 16 feet from a tree which had only three limbs or twigs broken and which had a metal tub lodged in its branches (Figure 23). The nearby cedars were uprooted, broken, and twisted off while the larger open deciduous trees were left standing largely undamaged (Figures 21, 22, and 23).

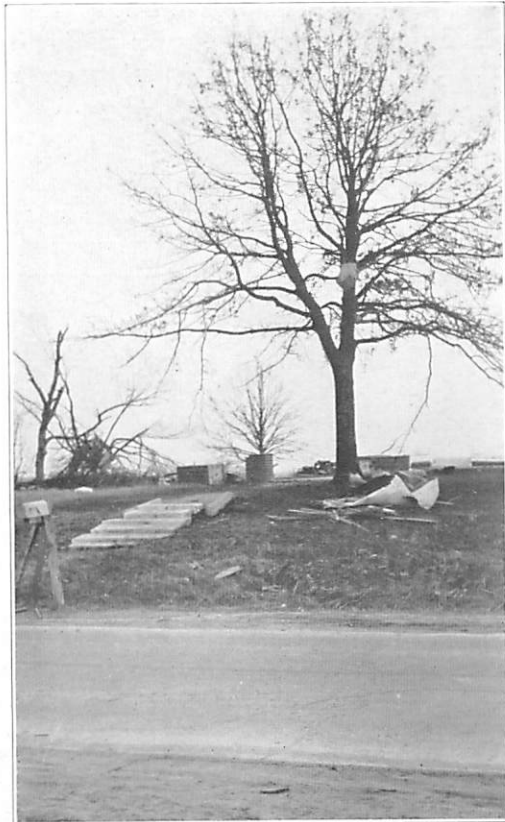
Figure 23.—Only 16 feet away from the nearest gate post stood this tree, which escaped with only slight damage to three or four limbs, because it offered so little obstruction to the passage of the tornadic winds of April 5, 1936.—Photographed April 13, 1936.

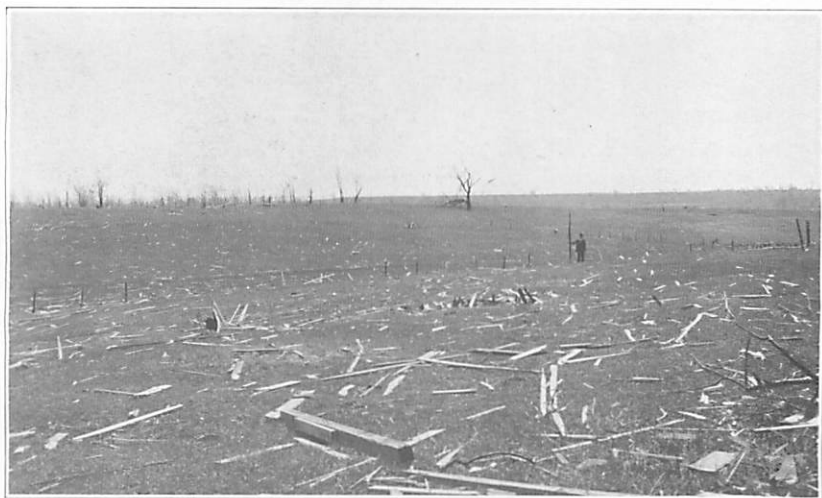
A large field on the windward side of the adjoining hill was strewn with timbers and smaller pieces of linear wreckage, all pointing toward the southeast as though every soldier in an army had thrown spears in the same direction (Figure 24). These are the missiles that man furnishes the elements to hurl against his frail body -- as if the tumbling walls were not deadly enough. Scarcely a man rushing from his crumbling home into the open could have escaped injury or death from these darts.

Figure 24.—Fields were covered with spear-like strips which lay as if they had all been thrown in one direction by an advancing army. The Tupelo tornado of April 5, 1936.--Photographed April 13, 1936.
