### ***Preservation Assessment of Totem Poles***

**Preservation Assessment of Totem Poles  
Totem Bight State Historical Park  
Ketchikan, Alaska**

**May 11-21, 2008  
Ron Sheetz, Conservator**

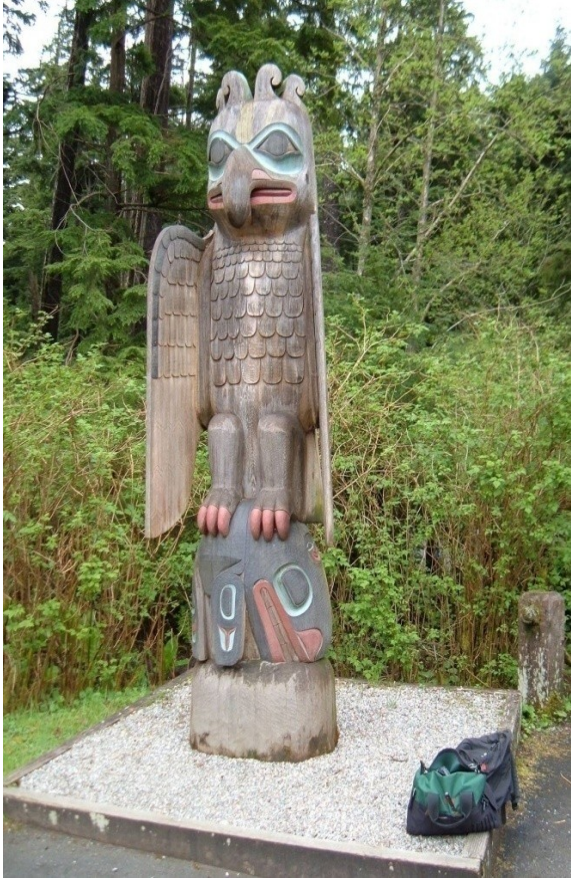
**Thunderbird and Whale**

- Totem pole is 9' tall with a 34" diameter base that is buried in the ground. The pole is in good condition.
- The top of thunderbirds head and curly projections have a well constructed copper cap applied.
- There are vertical natural drying cracks in the center of beak and on right side of face.
- A vertical natural drying crack, 1/8" at widest point runs from under the chin down to the feet. Another natural crack is located between whales head and the fin 1/8" at widest point.
- Very small, less than 1/16" opening, natural cracks run the length of the back of totem.
- A small amount of vegetative growth and mold are located inside of each wing next to the thunderbirds body and around the base of totem.

- Remove the vegetative growth on thunderbird with water and fiber brushes. Roundup or similar herbicide could be used to kill the vegetative growth around base of totem.
- Apply Bora-Care, a sodium borate based fungicide/insecticide to kill fungi and wood boring insects and to prevent re-infestation. Application can be made by spraying, brushing or both to all wood surfaces to a point of saturation, giving particular attention to end grain surfaces.
- Apply X-100 Natural Seal water repellent or similar paraffin oil based water repellent to retard water infiltration and slow leaching of the Bora-Care. Application with can be made by spraying or brushing. Re-apply both the Bora-Care and water repellent on a five year cycle.

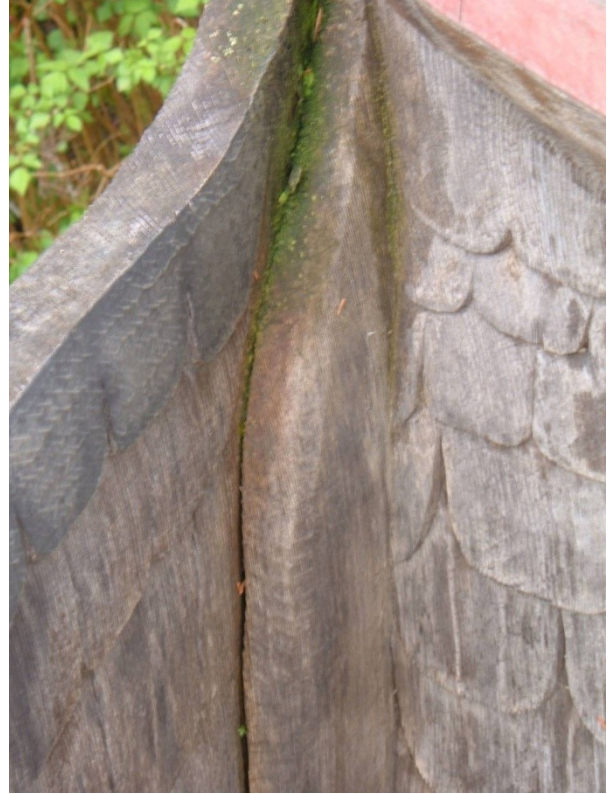
**Vegetative growth inside of wing**

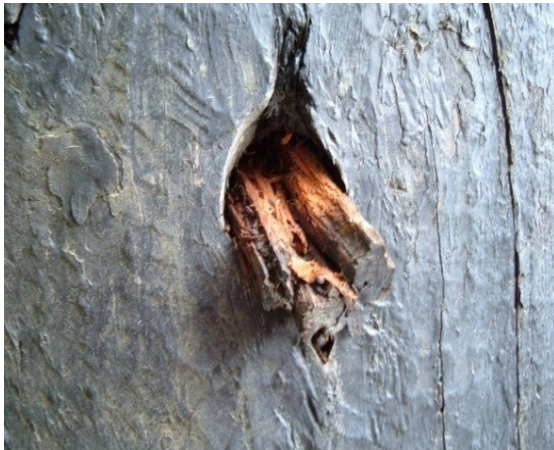
**Decayed knot**

- A sheet lead or copper cap should be re-attached on top of head.
- The tongue can be adhered with an epoxy.
- Remove as much of the decayed wood as possible from behind the patches, in knot holes and splits, that can be removed with out causing further damage to totem pole. An air compressor fitted with a narrow nozzle works well to blow out debris from the cracks and splits.

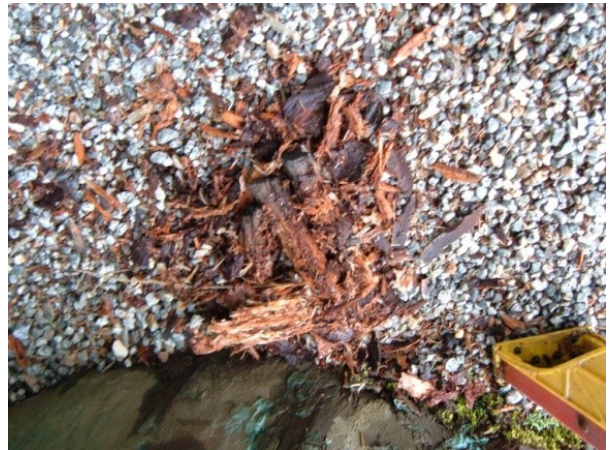
**Decayed wood removed from behind knot**

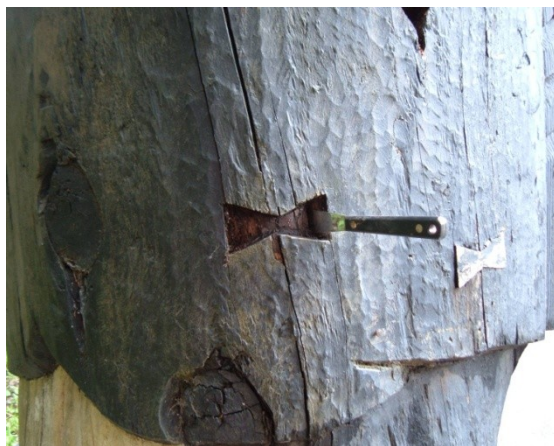
**Butterfly patch removed**

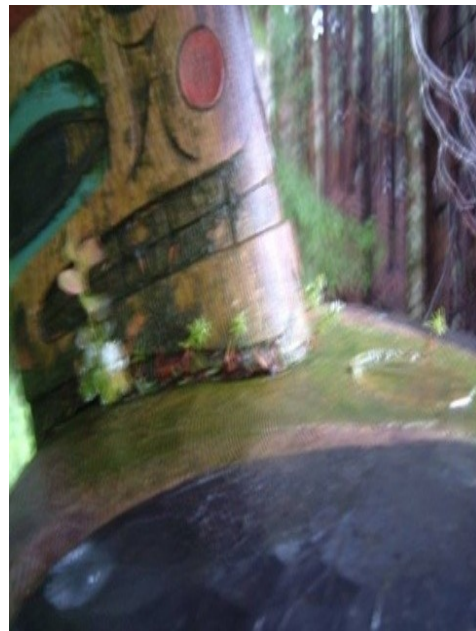
- Totem is 14ft. 6" tall with a 27" base buried in the ground. The pole is in good condition.
- A small amount of vegetative growth is located around the base of fin where it joins into mortise joint of hat.
- Several natural drying cracks run vertically down the pole.
- There is a small amount of vegetation around the base.

**Vegetative growth around fin**

- Clean totem with water and a fiber brush.
- Remove the vegetation around base of fin where it joins into hat.
- Roundup or similar herbicide can be used to kill the vegetation around base of totem.
- Apply Bora-Care to kill fungi and wood boring insects. Application can be made by spraying or brushing to a point of saturation, giving particular attention to end grain surfaces. Apply X-100 Natural Seal water repellent or similar paraffin oil based water repellent to retard water infiltration and slow leaching of the borates. Application can be made by spraying or brushing. Re-apply both on a five year cycle.

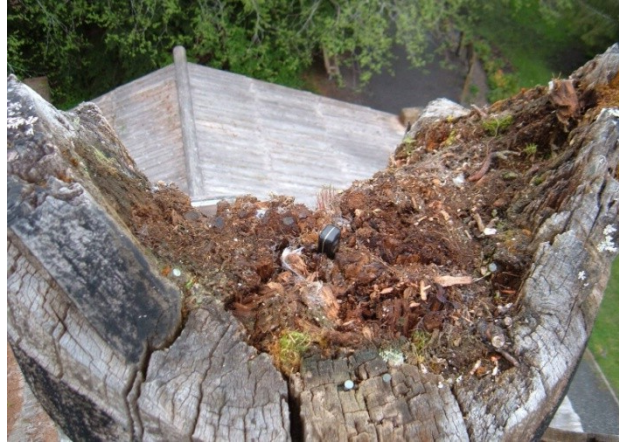
- A copper cap is covering a portion of the top of Ravens head. The copper cap was removed to observe the deteriorated condition under cap. The cap was not replaced for it was helping to channel moisture into an extensive split through the ravens head and body and downward between the feet to bentwood box the raven is standing on. The split appears to penetrate all the way from front to back of totem. Top of Ravens head and ears are deteriorated past repair. A 12" long spatula can be buried in deteriorated head.

**Spatula buried 12" into deteriorated head of Raven**

- The raven`s head at top of pole is too deteriorated to repair. The body also has some serious problems. I would suggest removing the beak before it falls. The head of the raven could be removed above the wings in order to check condition of wood for joining a reproduction head at the neck. It may be less complicated to cut the raven figure off where his feet join the bentwood box and carve a full figure reproduction to be joined above the bentwood box. Note: Apply a temporary waterproof cap that covers the deteriorated top of the head, until treatment can be determined. Install 2 to 3 impel rods in decay area and install cap as soon as possible.

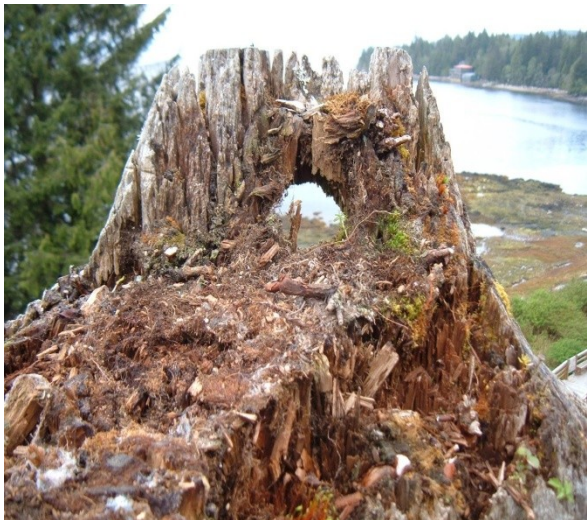
**Ocean view through deteriorated ear of Raven**

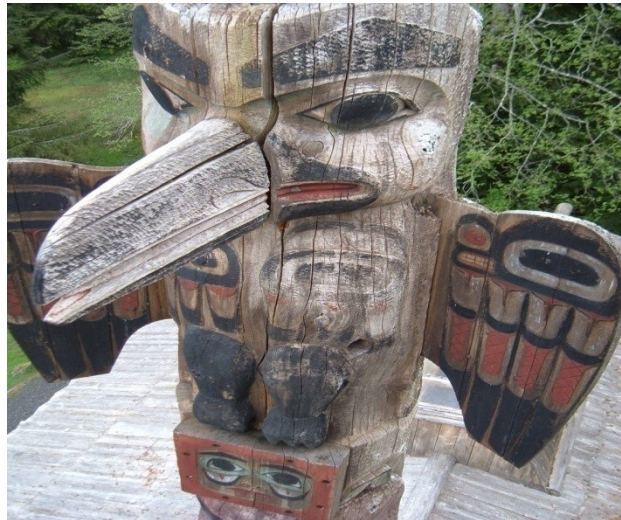
- The beak is hanging loose, appears to be attached only by wooden dowels that are going through the mortise and tenon joint. The wide split, through ravens head and face, follows beside the beak and through the mortise joint leaving a very loose fitting joint. The beak could fall.

**Split through face of Raven**

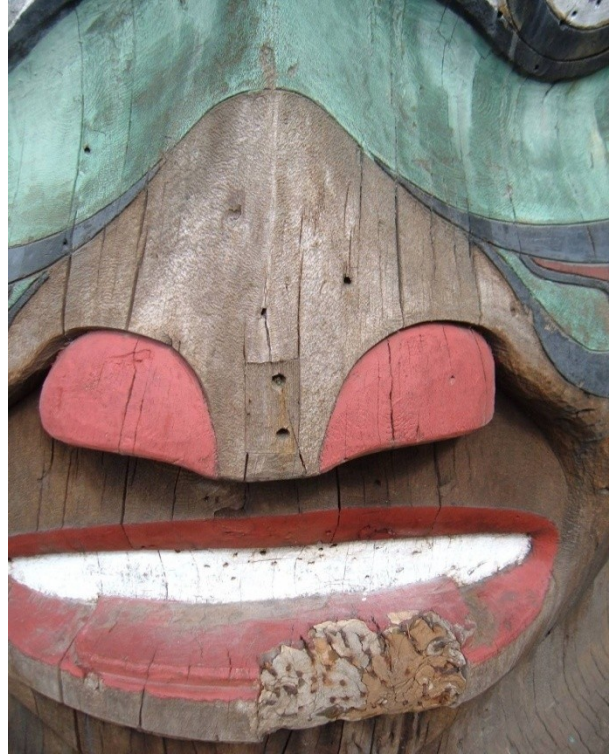
- The wings are in good condition. Top brace on left wing is split but wing is secure.
- Below the chief, is the raven's mother with a labret in her lower lip. A previous repair fill of nails and plaster has been used to fill a missing segment of the labret.

**Raven`s mother labret repair**

- Remove the previous repair of nails and plaster in the labret located in lower lip of Raven`s mother. An epoxy could be used to restore the lost portion of the labret with a more pleasing appearance.

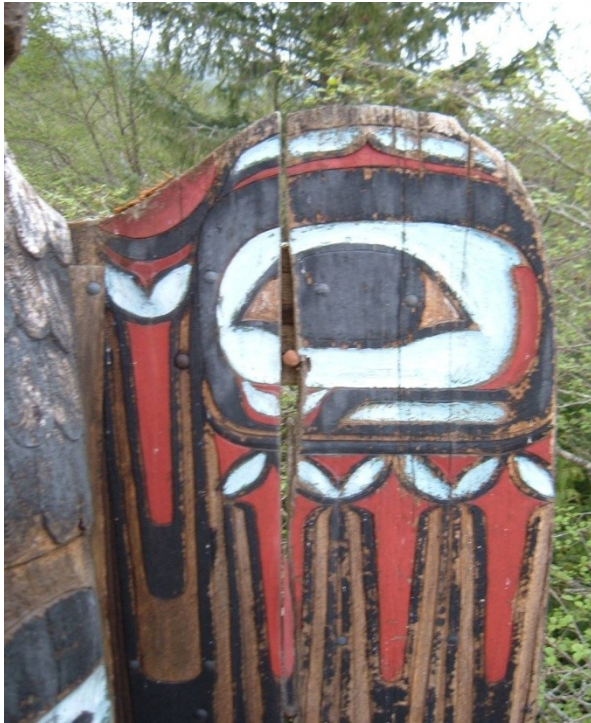
- The left wing of the eagle has a segment missing.
- The right breast, beside the beak of the cormorant is riddled with woodpecker holes.
- There is a ¼" wide crack through breast of cormorant down to head of raven.

**Segment missing from left wing of eagle**

- The totem will have to be lowered due to the deterioration of the base.
- Clean totem and remove the vegetation from head of shaman.
- To replace or not, the missing segments from the totem, such as the nose from face on shamans club and segment from wing of eagle is usually the Park Curators decision.

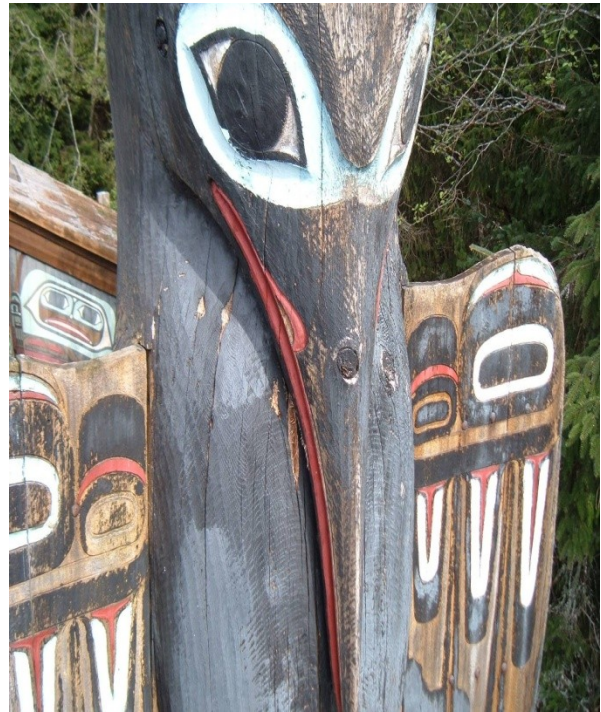
**Woodpecker holes in cormorant**

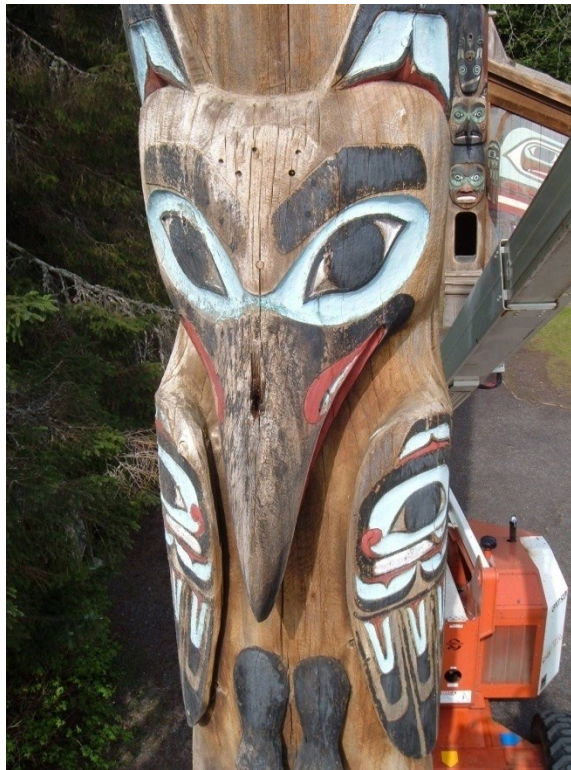
- The raven has a replacement forehead and beak. A split and decay has occurred around large spike driven through center of beak. Numerous nails were used for attaching the forehead.

**Decay in beak of raven**

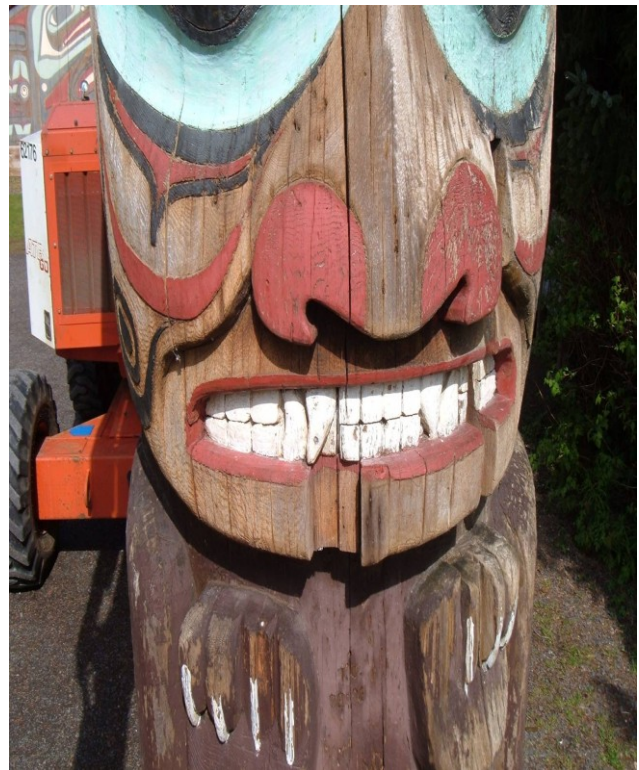
- A previous repair segment, 2" wide X 15" high is missing from left cheek of bottom figure, a bear, and a segment is missing from chin. A segment 3 ½" wide X 3 ½" high is also missing where it was split out of right hip. Two claws are missing from the right front paw and the left paw has two claws of a previous repair missing

**Missing segments from bears mouth and paws**

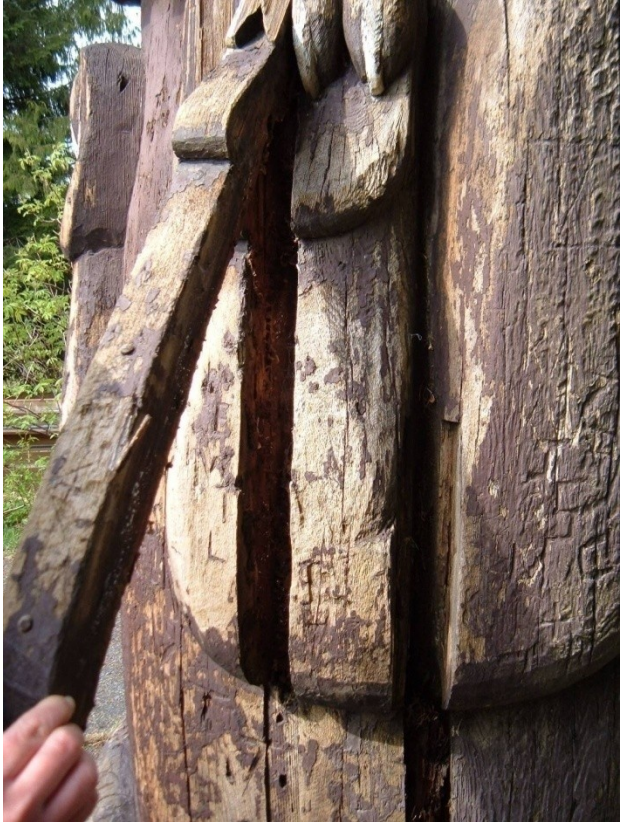
- The body of the bear is deteriorating both from fungi decay and previous insect infestation. There are numerous repair patches in the body of the bear. Several patches were removed to expose the extensive decay of the wood and insect damage from carpenter ants.

**Decayed wood and insect damage behind patches**

- Once the totem is lowered it can be thoroughly examined and extensive treatment can be determined.
- Having the totem lying horizontal is an advantage when applying Bora-Care. Application can be made onto all areas of the wood surface with little run off. Do not apply a water repellent at this time for some repairs will require the use of epoxies and the paraffin oil in the water repellent may interfere with the adhesion of the epoxies.

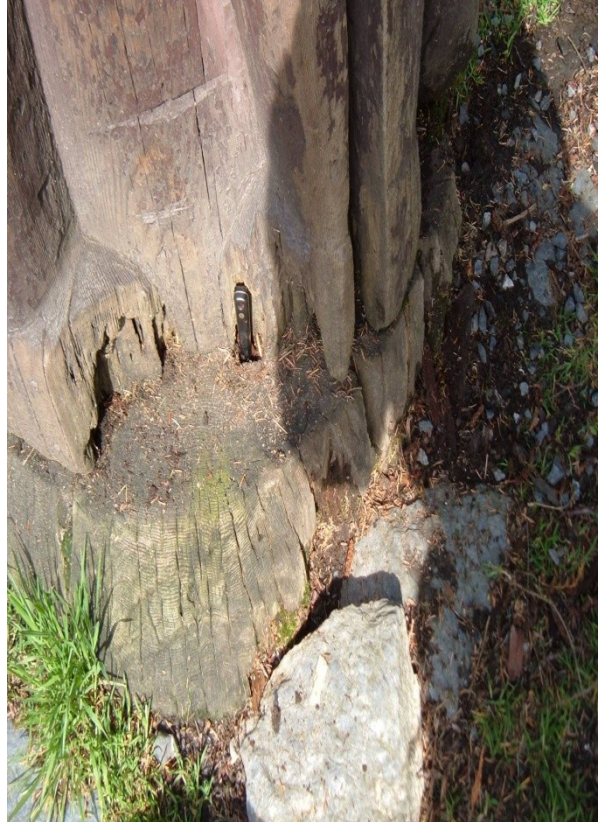
- The base of the totem is also deteriorating where it enters the ground. A 10" blade of a spatula can be buried in the wood on several locations.

**Spatula buried at base of totem**

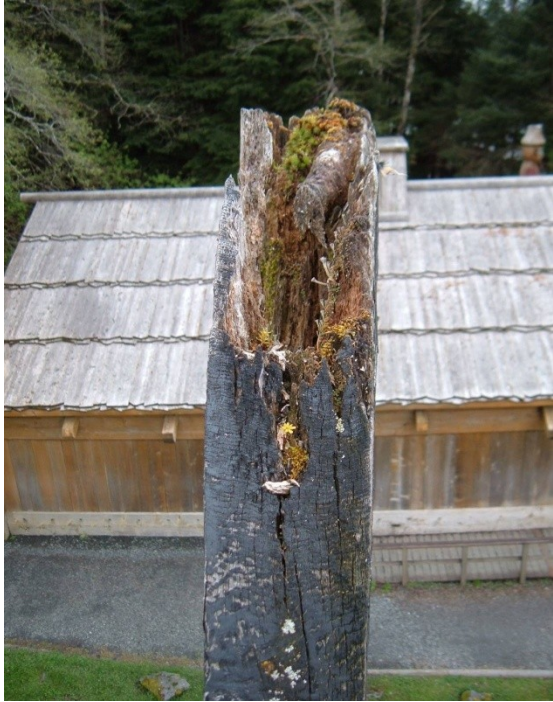
- The tip of dorsal fin has serious deterioration and a heavy accumulation of vegetation is also growing in the hollow decayed tip. A split runs the full height of dorsal fin.

**Vegetation and decay in tip of dorsal fin**

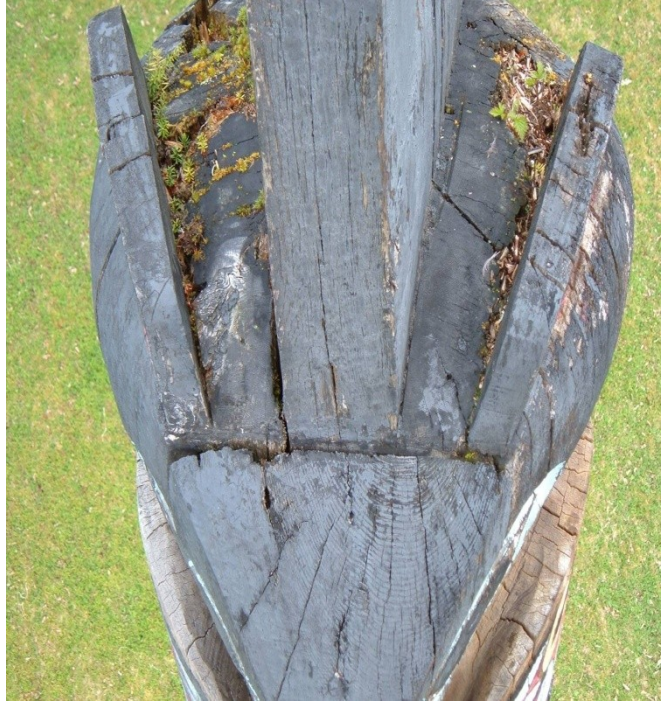
**Vegetation and decay in head of raven**

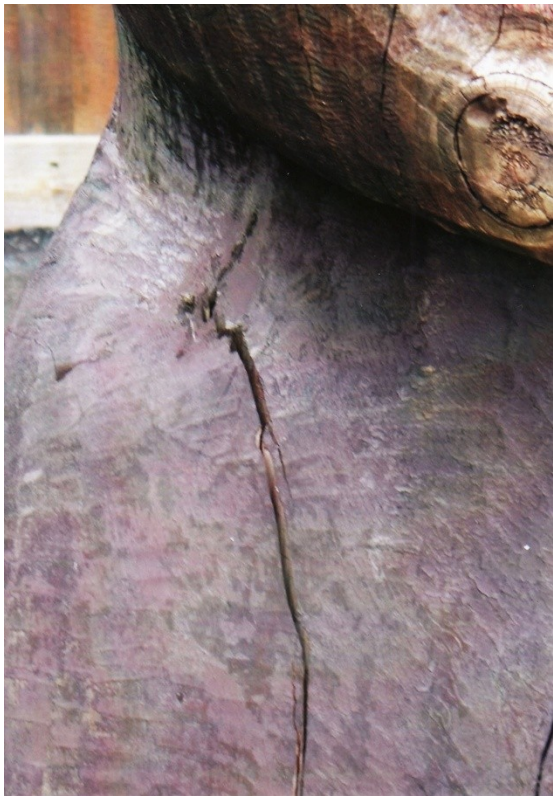
- There is a extensive split in the right shoulder of the.
- The front of pole has decay 1 ½" to 2" deep at the base just below ground level. **Note:** The base of totem is wicking water that is leaking out of a knot hole on right side, 44 inches above ground level. There is vegetation around base of totem.

**Split in right shoulder of human figure**

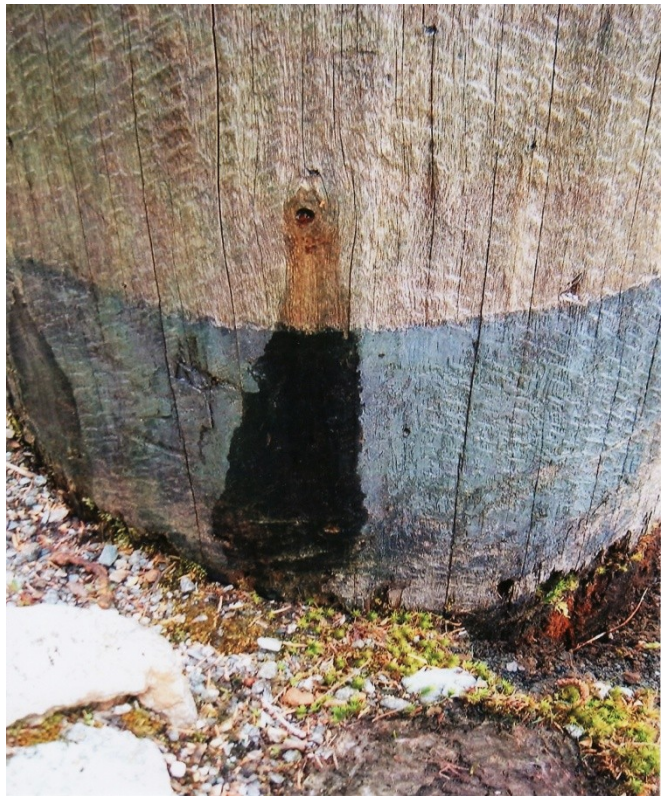
**Water running out of knot hole**

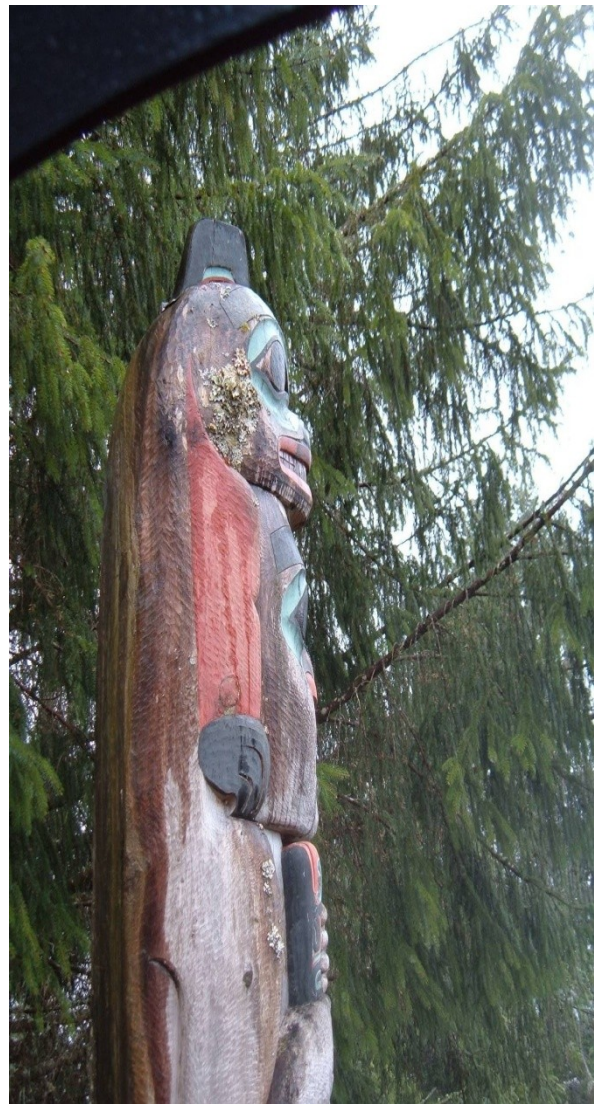
**Lichen along right side**

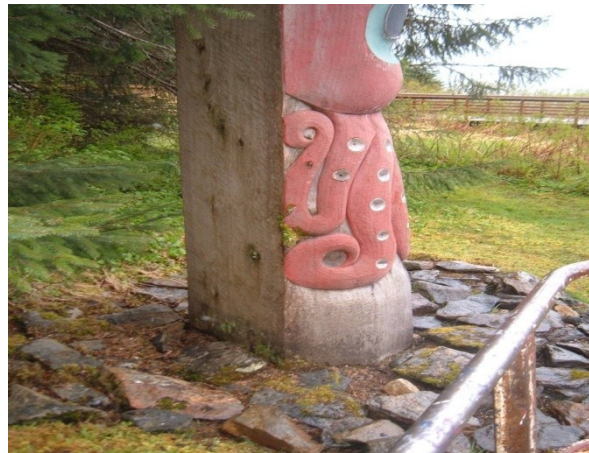
**Lichen growth on devil fish**

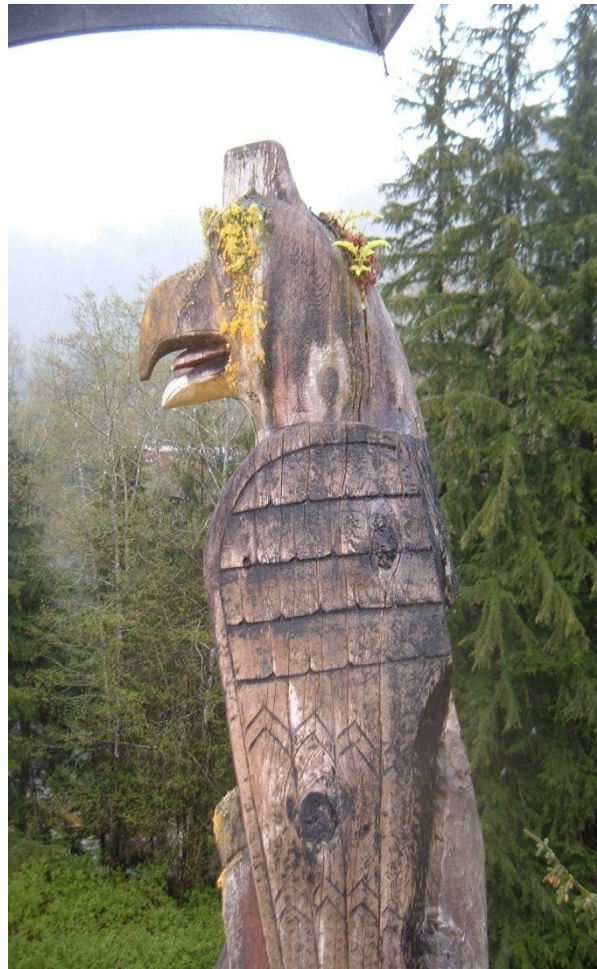
**Lichen and vegetation growth**

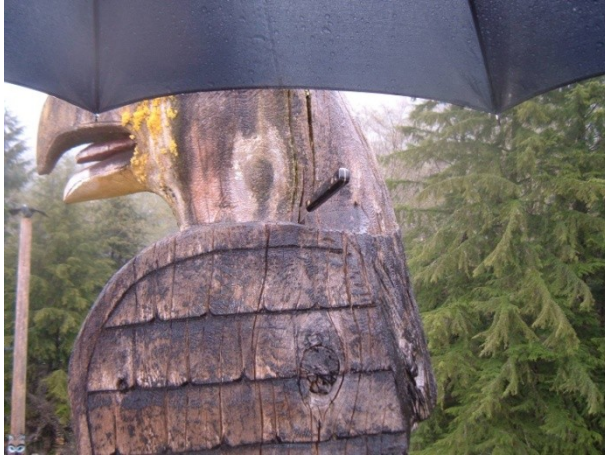
**Eight inches of penetration into decayed wood**

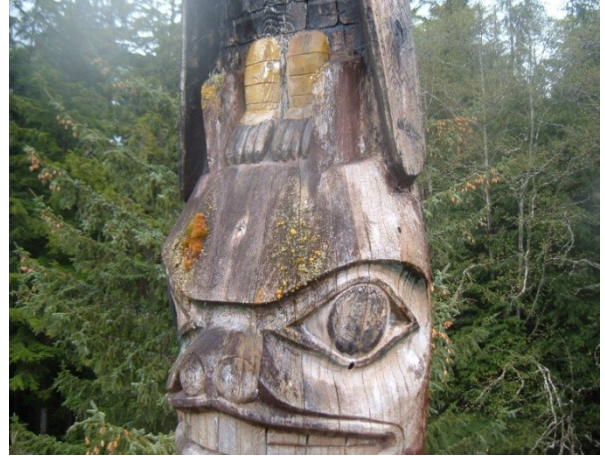
**Lichen on forehead of beaver**

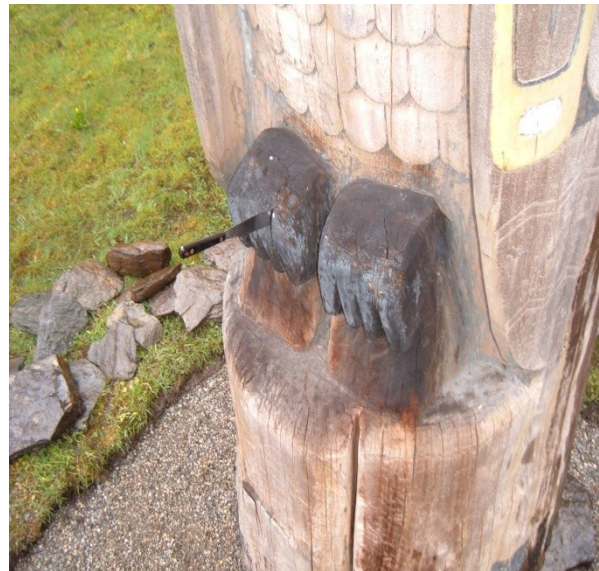
- The master carver has cracks full length of his body but is in good condition for his age.
- The feet of bottom figure, the eagle, have numerous cracks due to the end grain carving being exposed to the weather.

**Cracks in the feet of eagle**

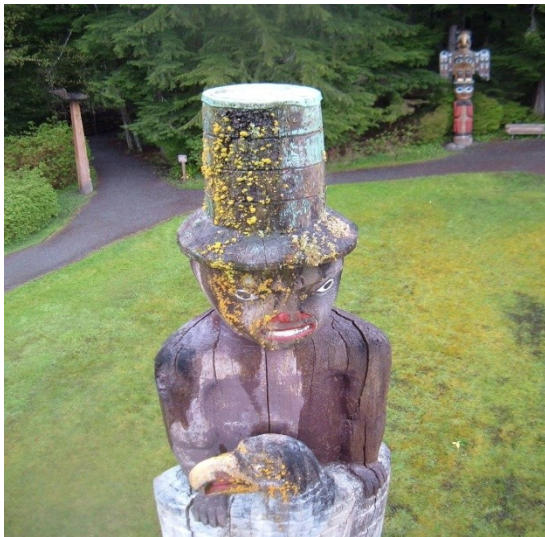
Lichen on face of village watchman and eagle  
Sea Monster Pole:

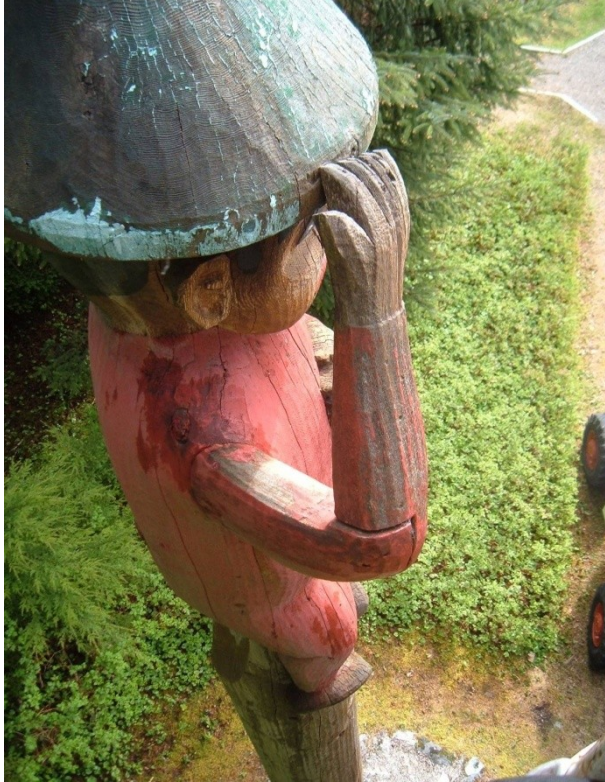
Note stable condition of hat

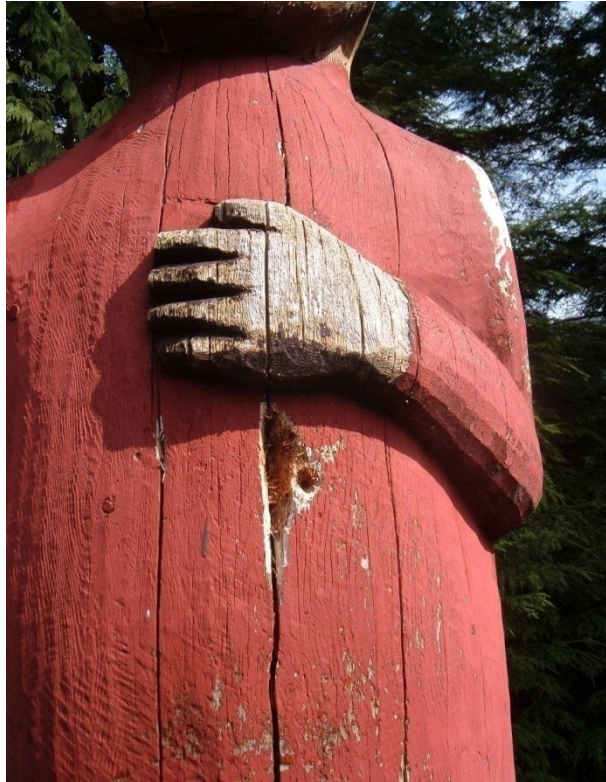
Woodpecker made hole in breast

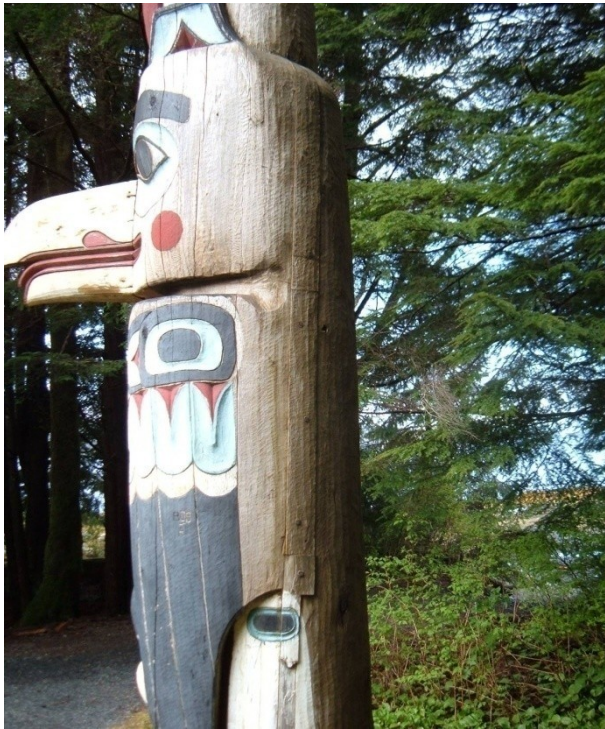
- Three patches are located on the left back side of pole. Two of the patches, one stacked on the other, measure a length of 67½" X 3½" wide. The third patch is 24" long X 3½" wide. There is fungal decay behind all three patches.

Replacement patches on back of pole  
Raven-at-Head-of-Nass

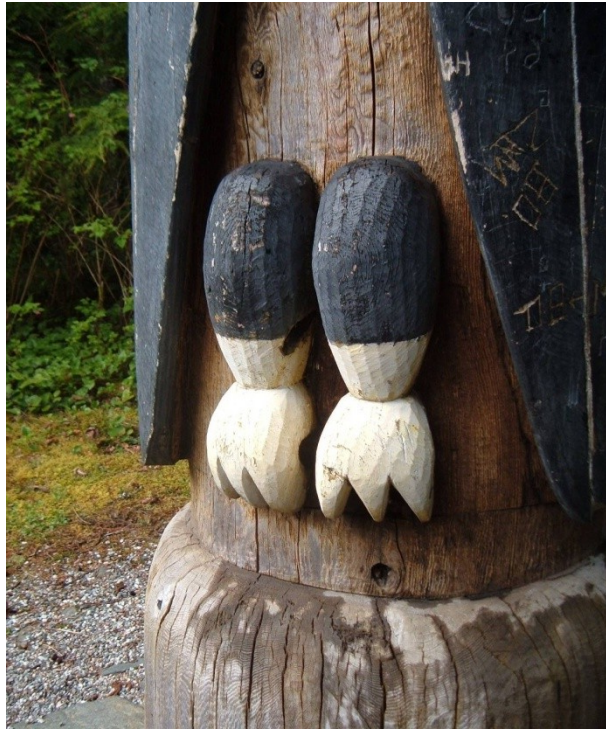
Hole on inside of right leg and graffiti on wing

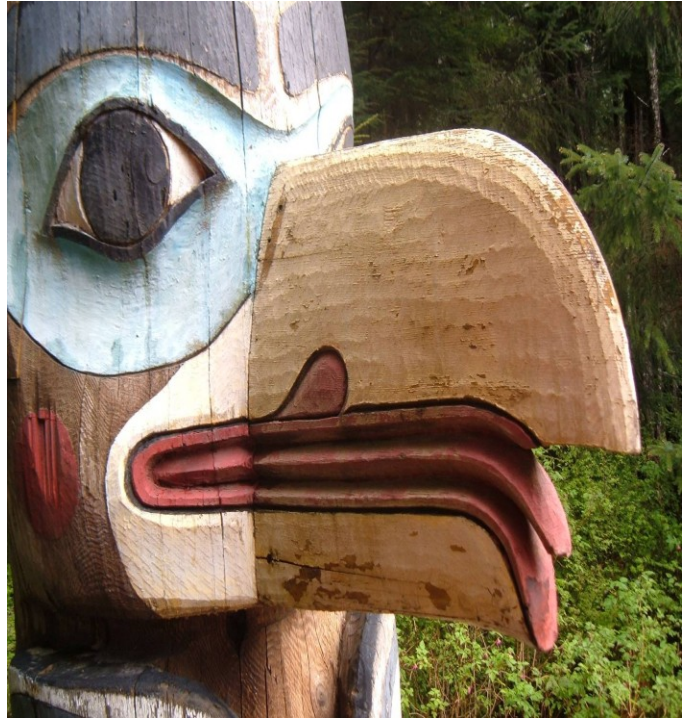
**Tip missing from Raven's beak**

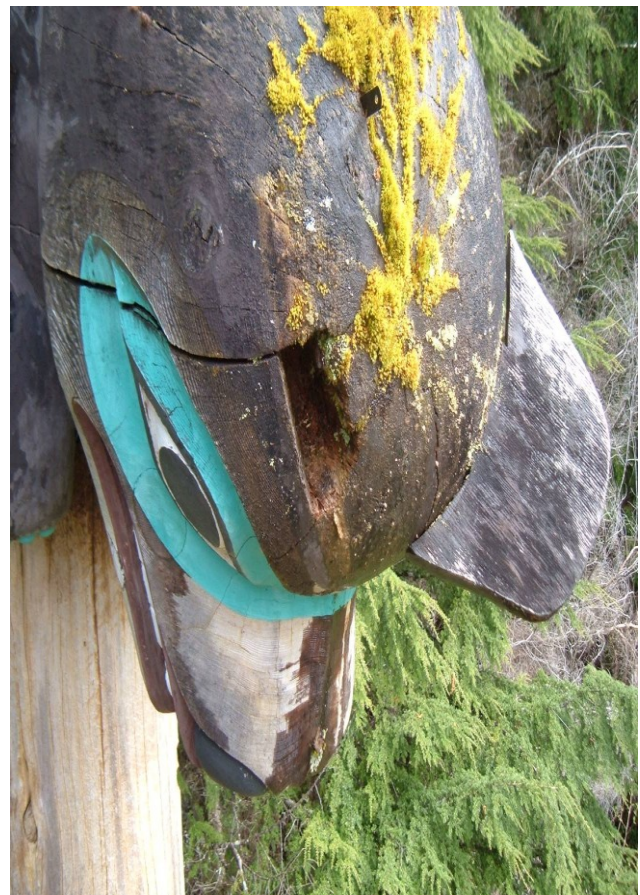
Missing ear and lichen growth

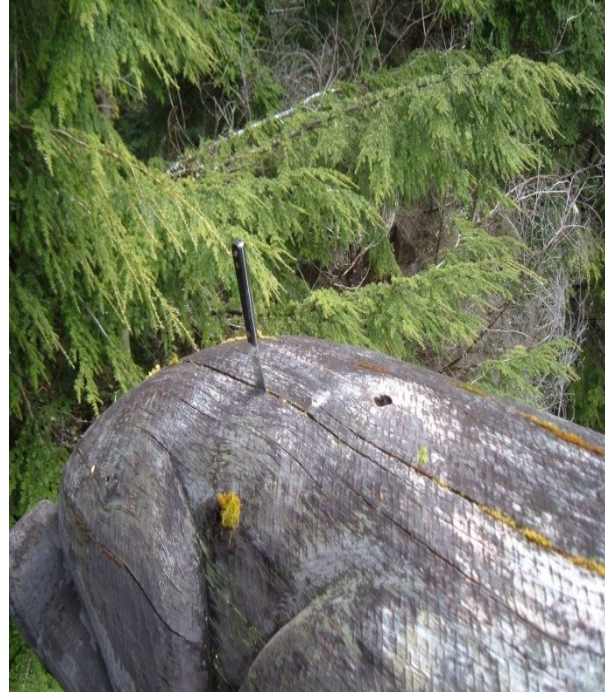
**Deterioration in back of bear**

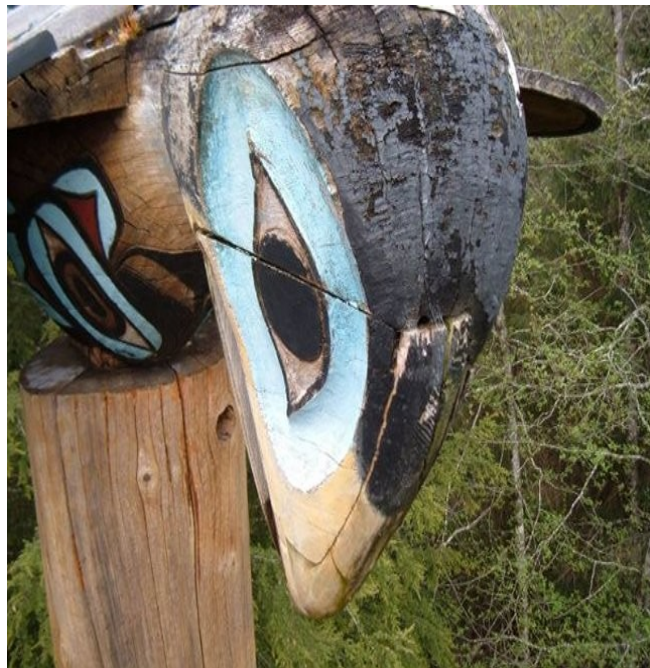
Patch repair and splits in head of Kadjuk Bird

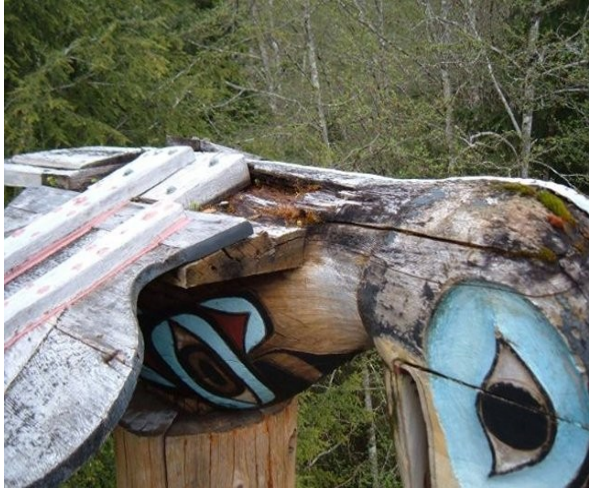
**Vegetative and lichen growth on back and head**

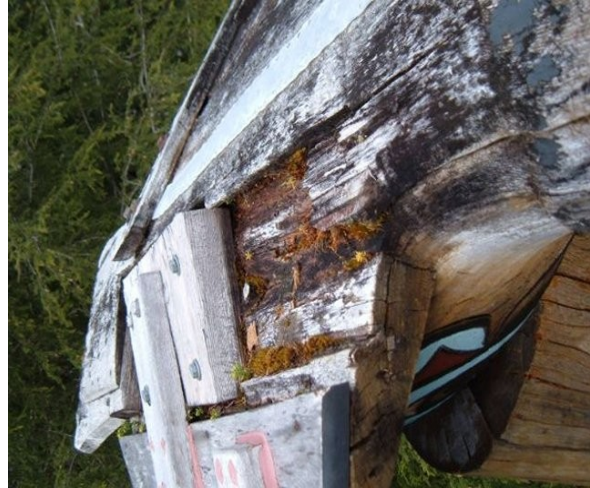
**Fungi decay and splits in back of Kadjuk Bird**

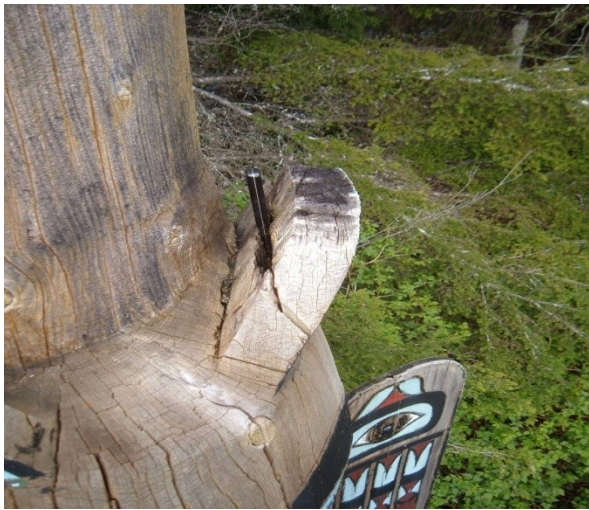
- The second figure, the raven, has a split forming in the right ear that could break off. The left ear is split across full width of ear. Numerous nails are driven into the ears. Both ears set up on the head and are joined to the head by a mortise and tenon joint. This leaves a pocket for the moisture to seep down into mortise and start fungal decay that is evident in the joint. There are ¼" wide cracks on the forehead and face. A spatula can be inserted to a depth of 6". The wood is solid at that depth. There are other surface cracks on the pole with less depth. The beak is attached with a mortise and tenon joint that is loose. It is being held in place by a nail on top of beak and a nail on each side. The tip of beak is missing.

**Split and decay in left ear of raven**

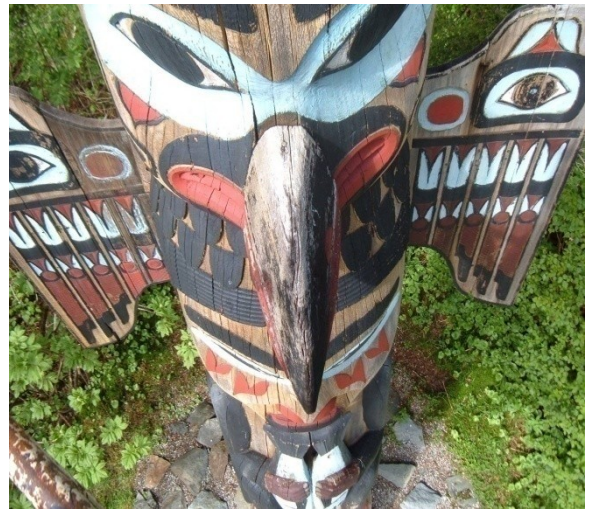
**Cracks in forehead and face of raven**

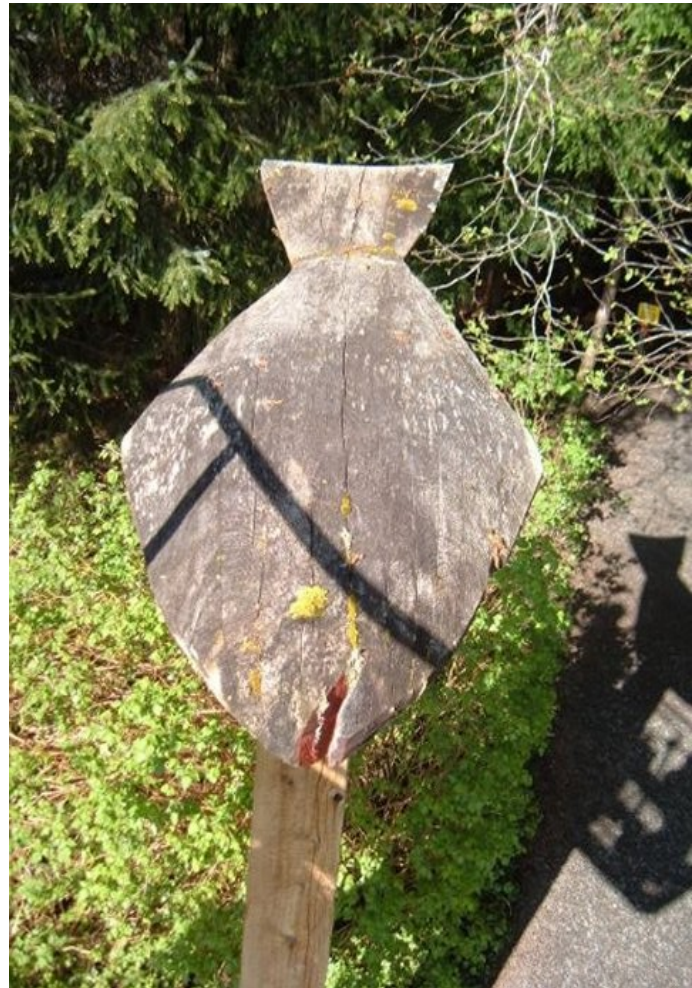
**Lichen growth in cracks in left side of halibut**

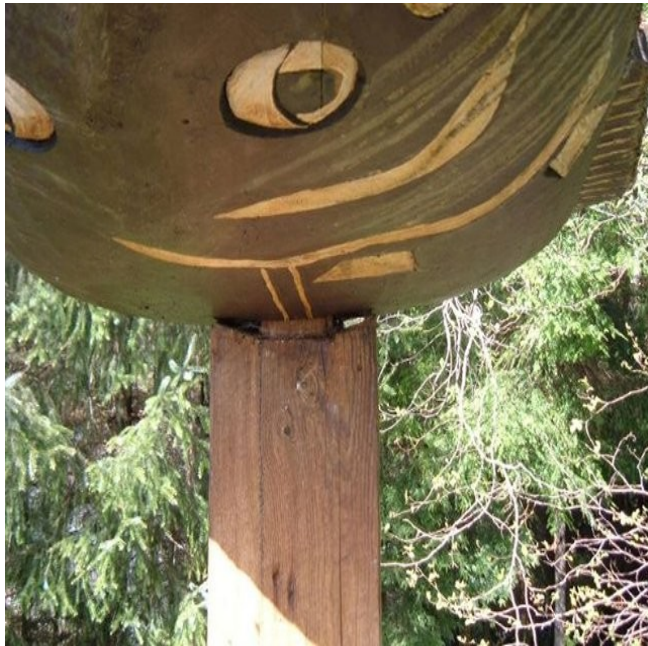
- The right side of halibut, side with eyes, is mounted to the pole with a mortise and tenon joint. This side of the halibut is in good condition.
- Note: In Mary's condition report in 1993, mold was the only fungal growth and located only on mouth and tail.

Mortise and tenon joint

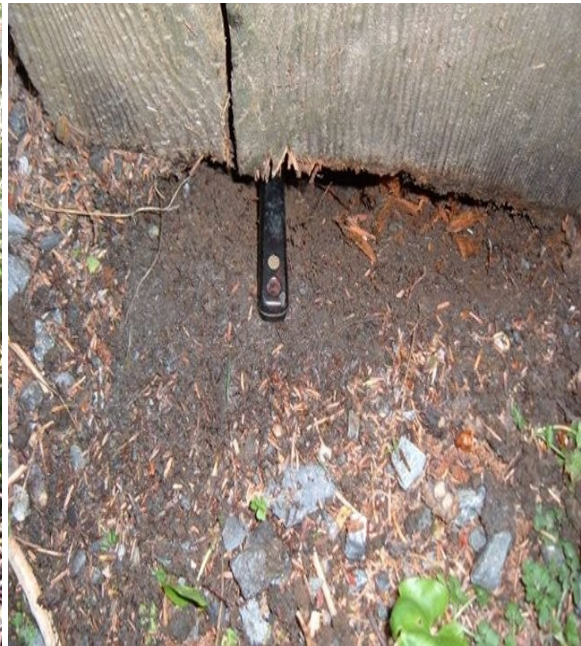
- The base of pole is very unstable, can be moved when light pressure is applied. Several inches of dirt was removed at back of totem base to find extensive deterioration in the core of the pole. A spatula can be inserted 10½" from back to front, which leaves only a 4" thick wall left of the pole supporting a 6' long X 3' wide halibut figure.

Extensive deterioration at base of pole

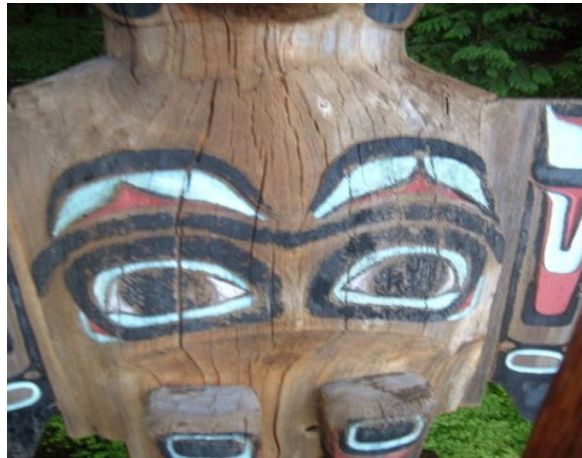
Cracks in chest of Thunderer

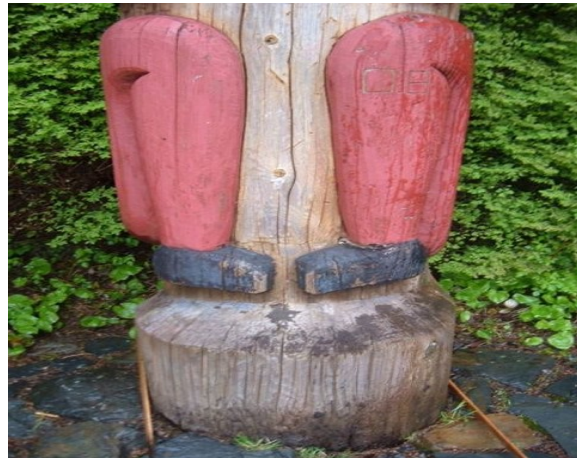
- Extensive cracks have formed on the end grain surface of the knees.
- Segments of wood are missing from both arms and legs of human figure. Old graffiti is located on left leg. Vegetative growth is located around base of totem.

Graffiti and vegetative growth

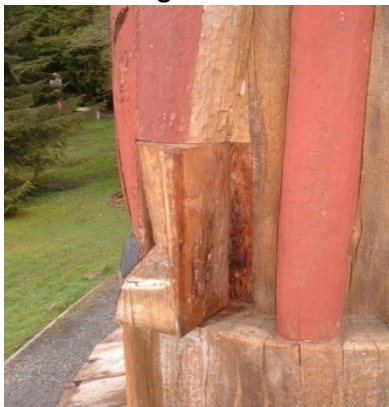
- A replacement right leg and foot is loose.
- Graffiti is cut into the left side of watchman.
- A copper shield circles the totem at roof line. Base of pole is stable.

**Revealing loose right leg**

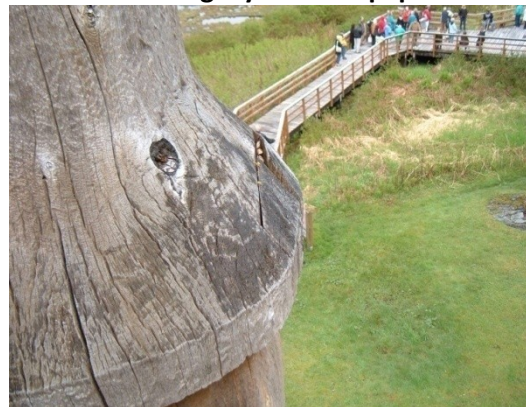
**Repair patch that is loose**

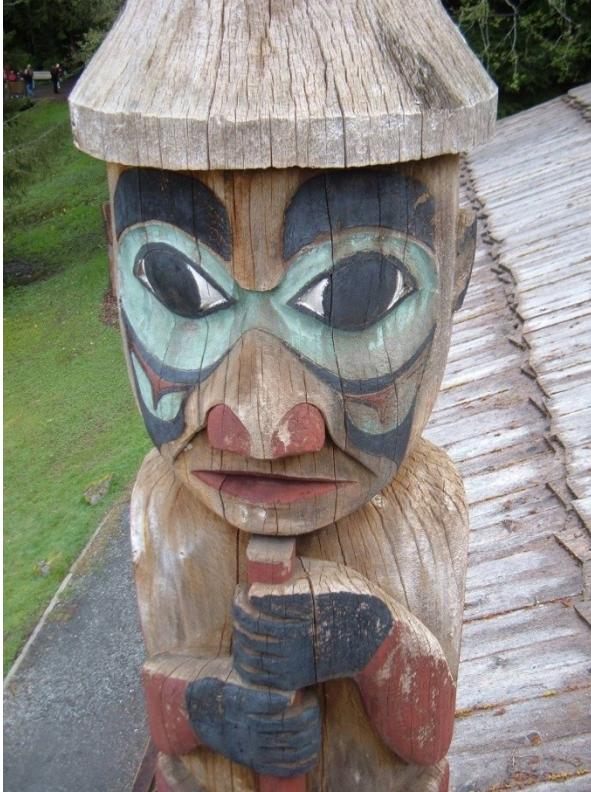
- Numerous surface cracks run through each shoulder. A ¼" wide crack starts on the right side of face, through arm and down past roof to ground. Deepest penetration with spatula is 5" and the wood appears solid at that depth. The top of legs have numerous surface cracks.

**Surface cracks in hat and body**

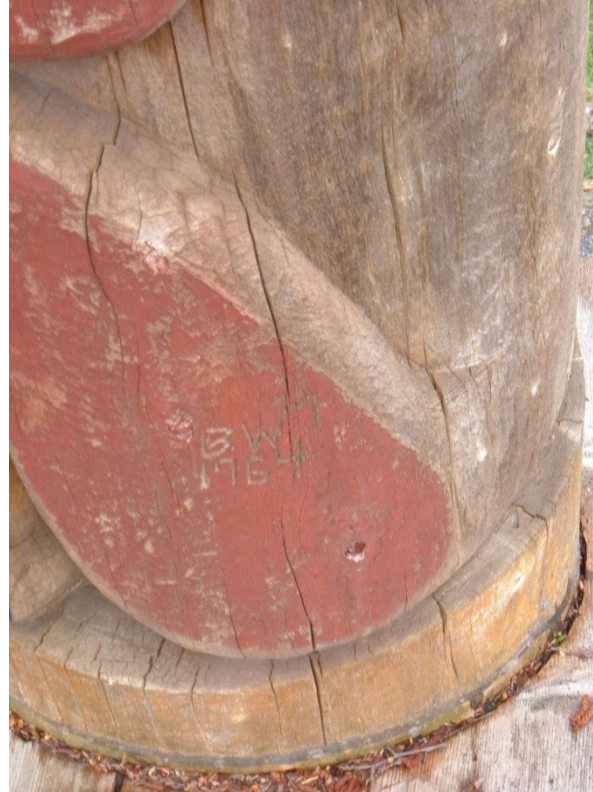
**Graffiti on left side**

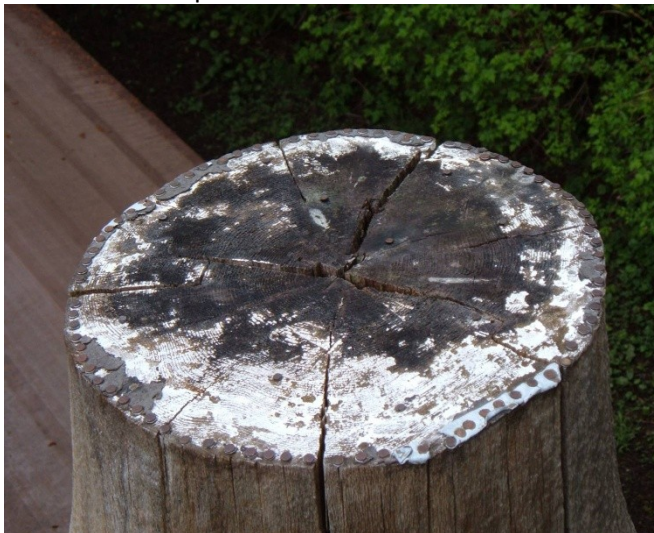
- Corner post is 22'8" tall with a 30" diameter base buried in the ground. It is a corner post and structured into the clan house.
- The end grain on top of hat is split four ways to the center. Remnants of a lead cap remain around outer edge.
- One of the more noticeable splits is 3/8" wide. It starts in the front rim of hat, continues down through right eye, right wrist, around right knee and foot to ground.
- There is graffiti carved into the right shoulder, hip and leg of the watchman.
- The left shoulder has a 1/4" crack.
- A piece 5" wide is starting to flake off on backside of watchman. There is less flaking occurring at base of watchman figure.
- A copper shield completely circles the totem at roof line.
- Located directly under the roof line is a repair patch, (10 1/2" wide X 24 1/2" high).
- Base of pole is atable.

**Split end grain of hat with remnants of lead cap**

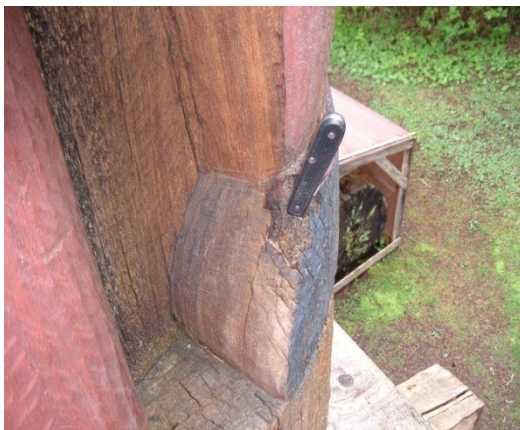
**Deterioration in left foot**
