### ***Preservation Assessment of Totem Poles***

**Preservation Assessment of Totem Poles  
Totem Bight State Historical Park  
Ketchikan, Alaska**

**May 11-21, 2008  
Ron Sheetz, Conservator**

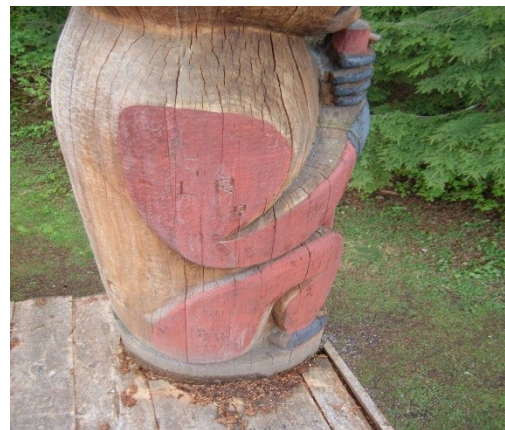
**Graffiti on right side**

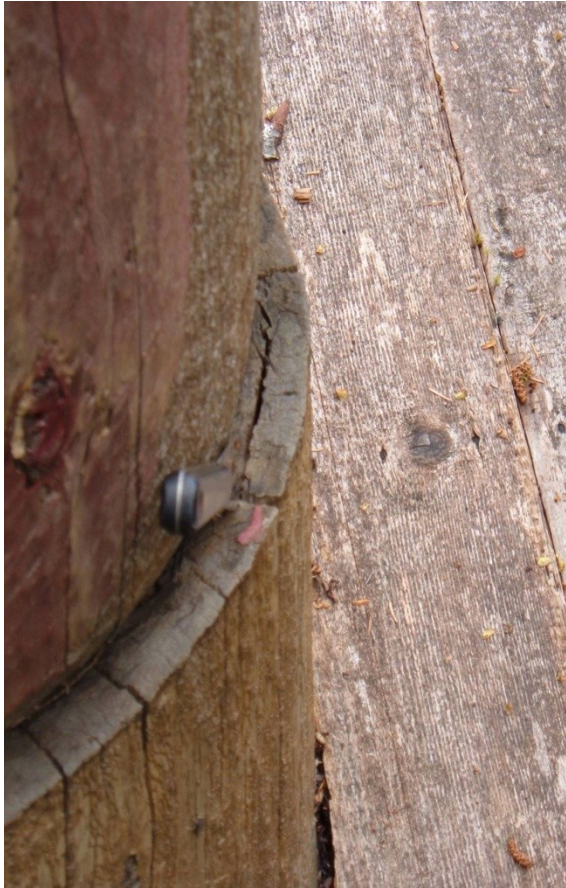
**Wood flaking at base of watchman**
