**Oil Spill Incident Report**

**Oil Spill Incident at the CITGO Petroleum Refinery in Sulphur,  
Louisiana, June 19, 2006**

**Facility:** CITGO Petroleum Corp.  
4401 Highway 108 S.  
Sulphur, LA 70669

**Report Date:** 07/25/2006

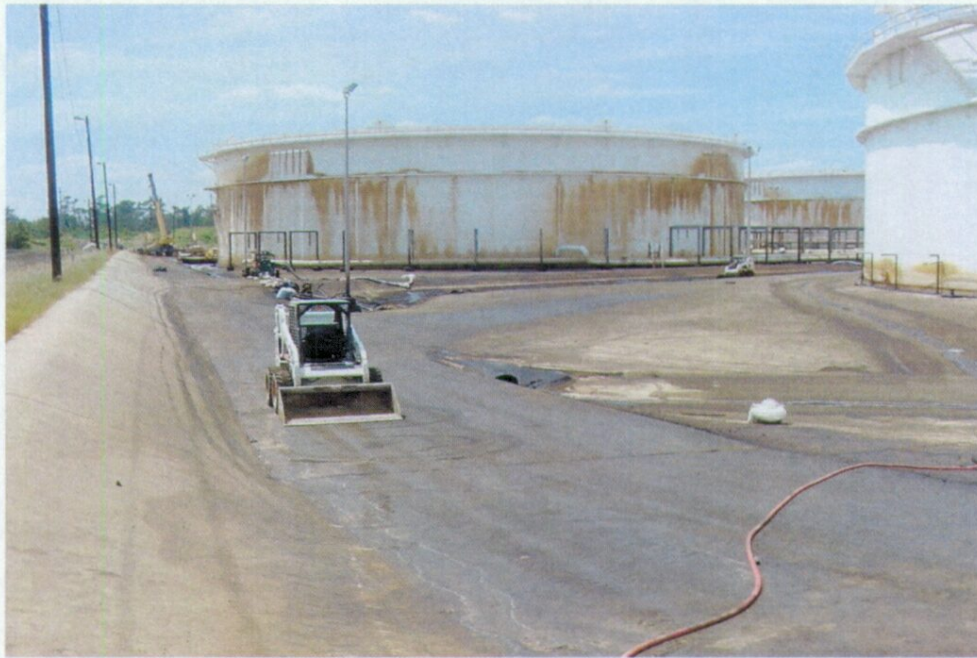
**Photo:** # 1 of 6      **Time:** 15:51

**Description:** Picture taken from the Southeast area overlooking a portion of the containment area of the storm water tanks.

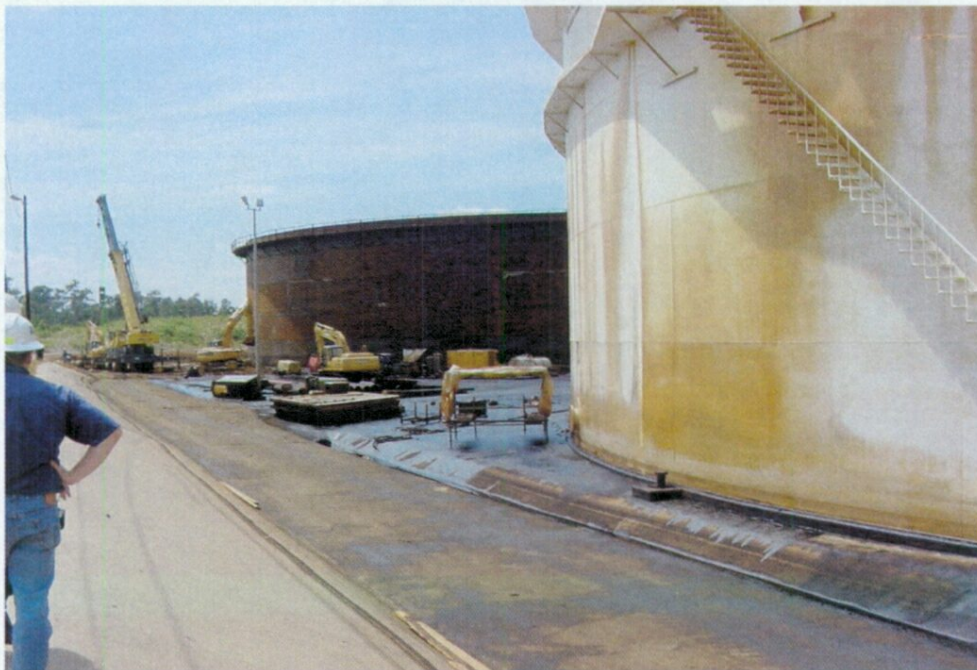
**Photo:** # 2 of 6      **Time:** 15:51

It was determined that the oil inside the containment berm seeped at various locations through the walls and/or gates of the berm. In addition, oil had escaped through a junction box that was located inside the berm. This containment berm did not serve as appropriate containment and/or diversionary structures of equipment to prevent an applicable spilled substance from reaching waters of the state in violation of **LAC 33:IX.907.D**. According to Louisiana Oil Spill Coordinator's Office (LOSCO) Executive Summary #25 report, it is estimated that approximately 47,595 bbls (1,998,990 gal) escaped the berm, discharging approximately 25,595 bbls (1,074,990 gal) into the Calcasieu River and 20,000 bbls (840,000 gal) into the Indian Marais, a tributary of the Calcasieu River.

**Description:** South area of the containment berm.

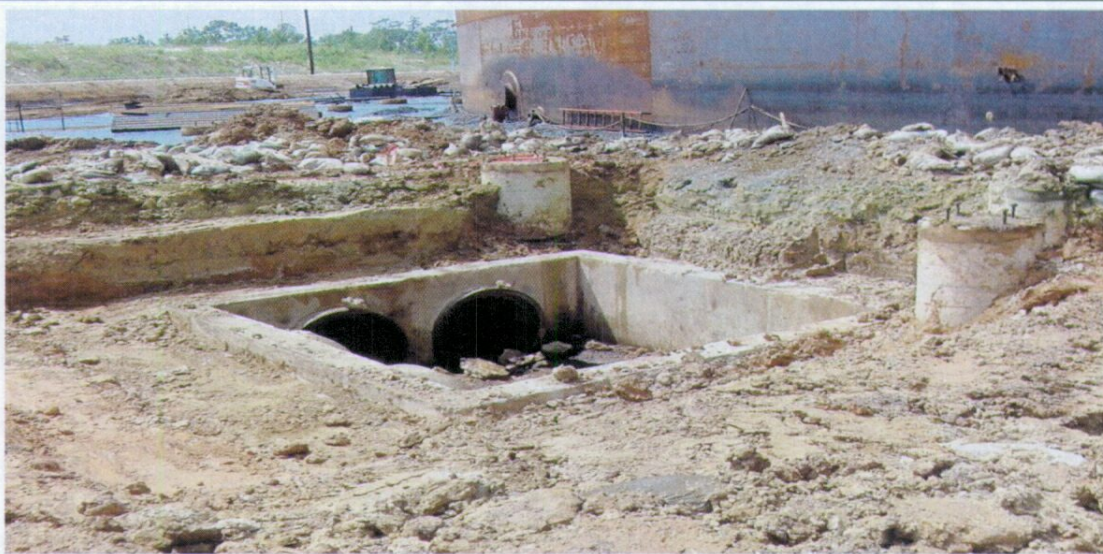
**Photo:** #3 of 6

**Description:** Junction box located within the south containment area berm.

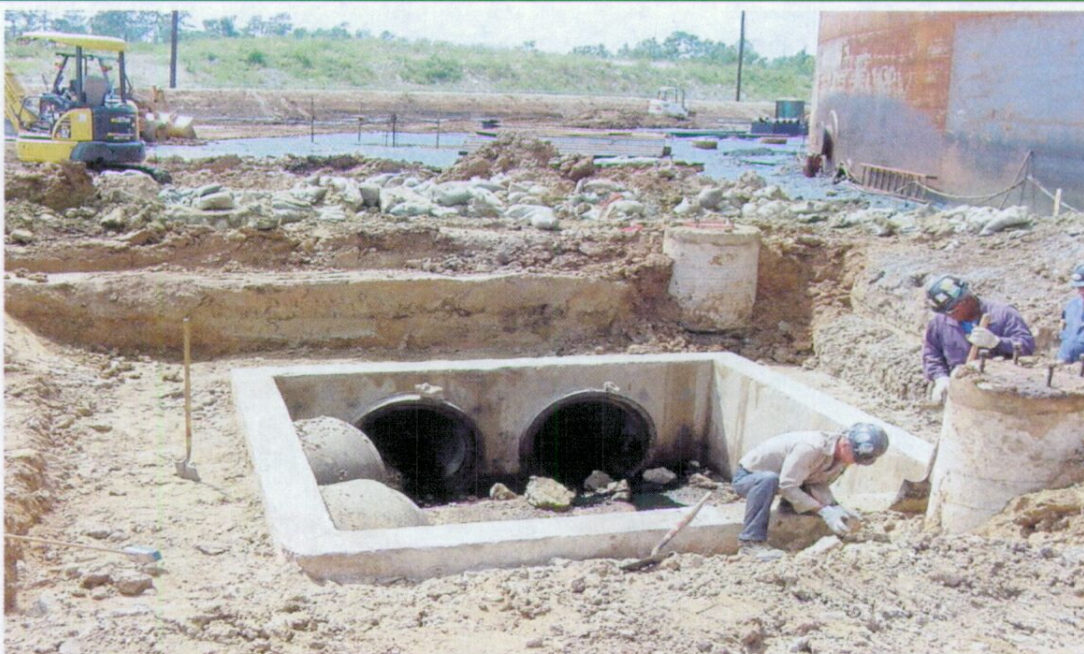
**Photo:** #4 of 6

**Description:** Junction box located within the south containment area berm.

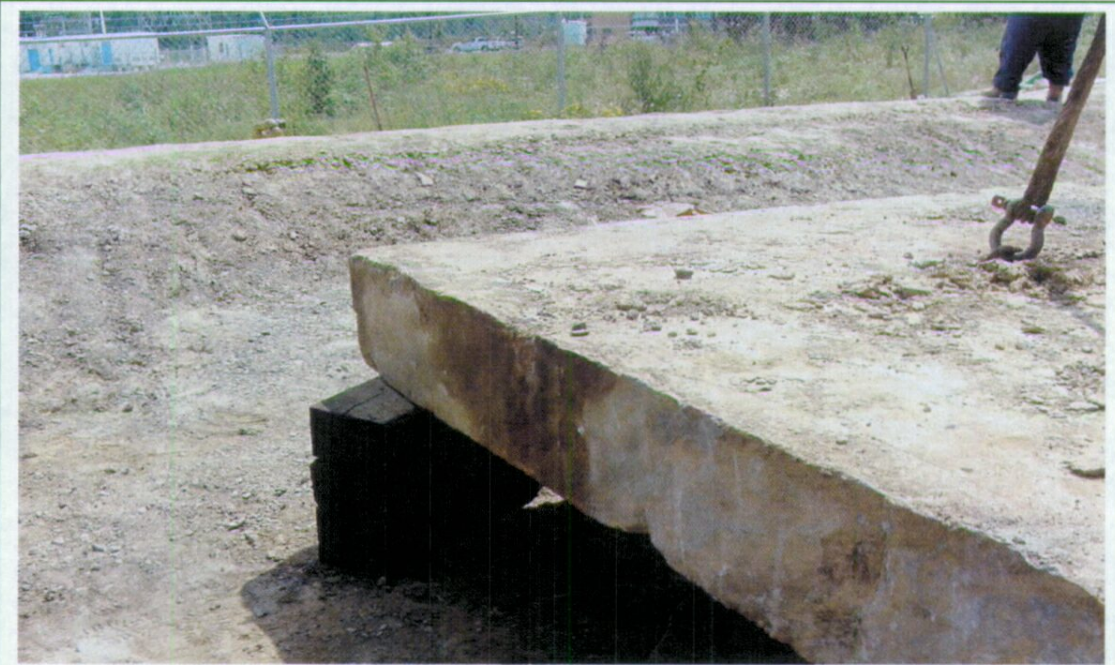
**Photo:** #5 of 6

**Description:** Northwest corner of the junction box cover/top.

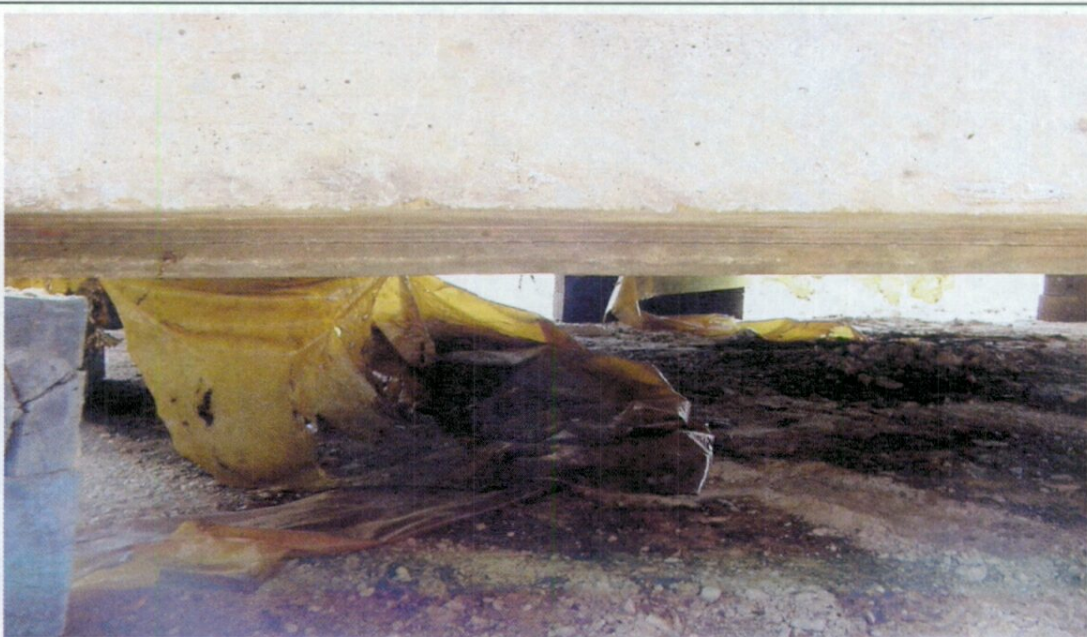
**Photo:** #6 of 6

**Description:** Underneath the junction box cover.
