2 *WTC 1 and WTC 2*

2.1 Building Descriptions

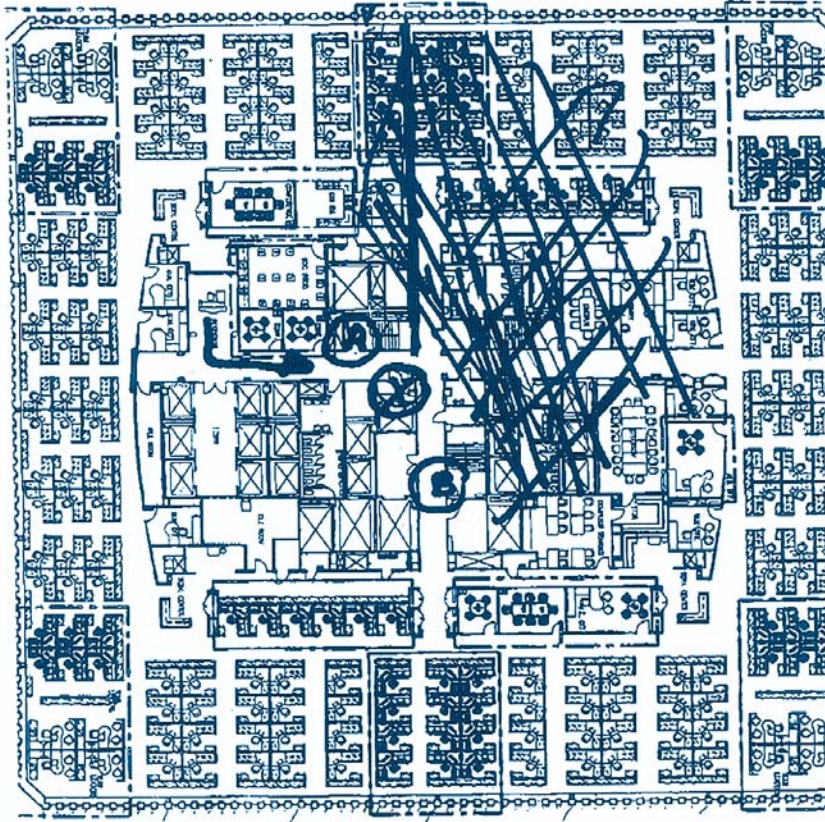
Figure 2-17
Approximate debris location on the 91st
floor of WTC 1.

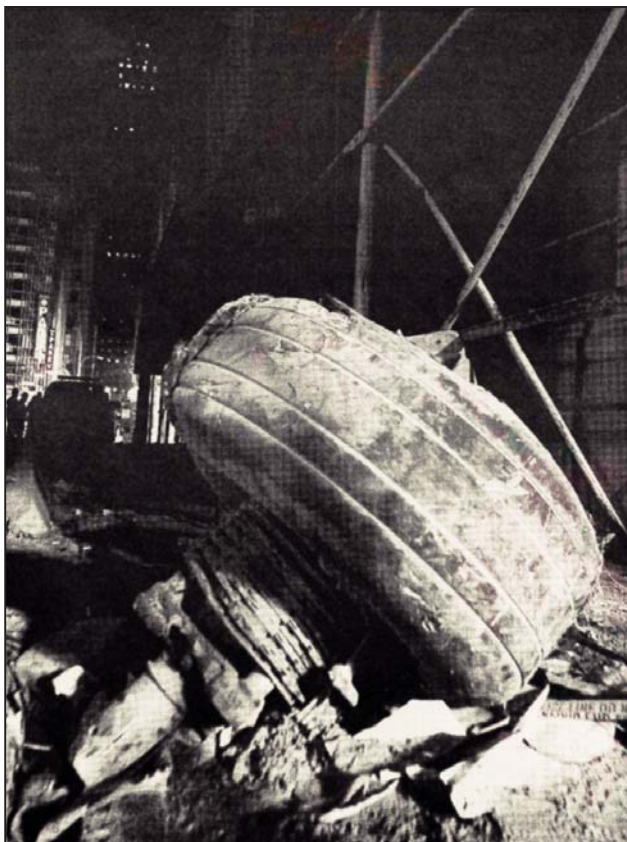
Figure 2-18
Landing gear found at the corner of West and Rector Streets.

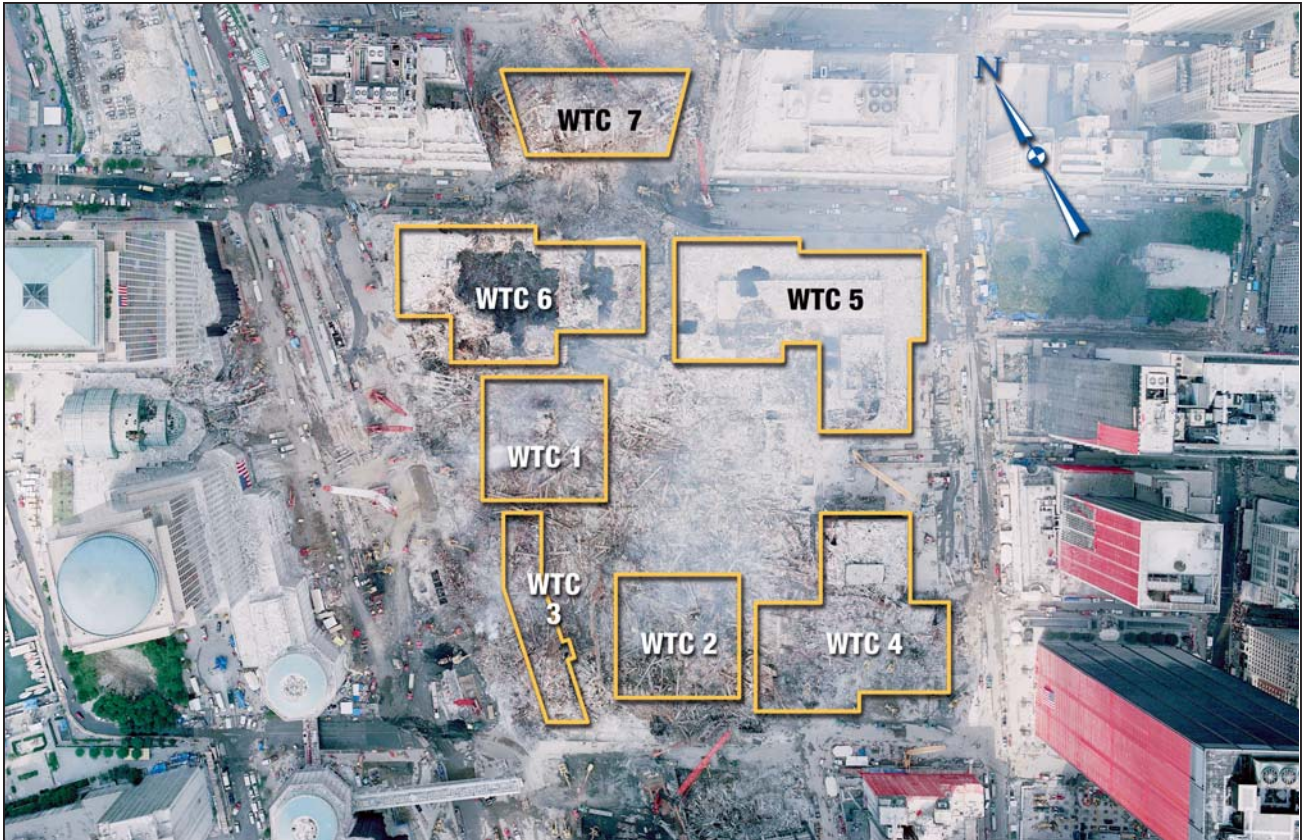
Although the building appeared to collapse within its own footprint, a review of aerial photographs of the site following the collapse, as well as damage to adjacent structures, suggests that debris impacted the Marriott Hotel (WTC 3), the Customs House (WTC 6), the Morgan Stanley building (WTC 5), WTC 7, and the American Express and Winter Garden buildings located across West Street (Figure 2-23). The debris field extended as far as 400–500 feet from the tower base.

Figure 2-23 Aerial photograph of the WTC site after September 11 attack showing adjacent buildings damaged by debris from the collapse of WTC 1.

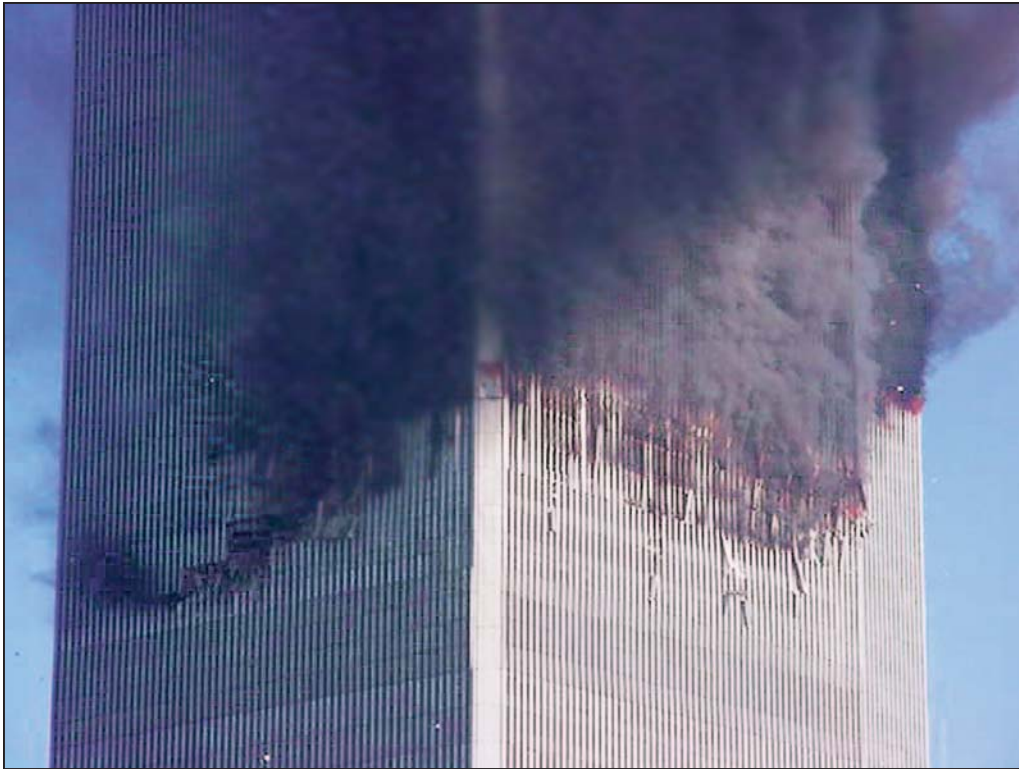
Figure 2-26 Impact damage to the south and east faces of WTC 2.

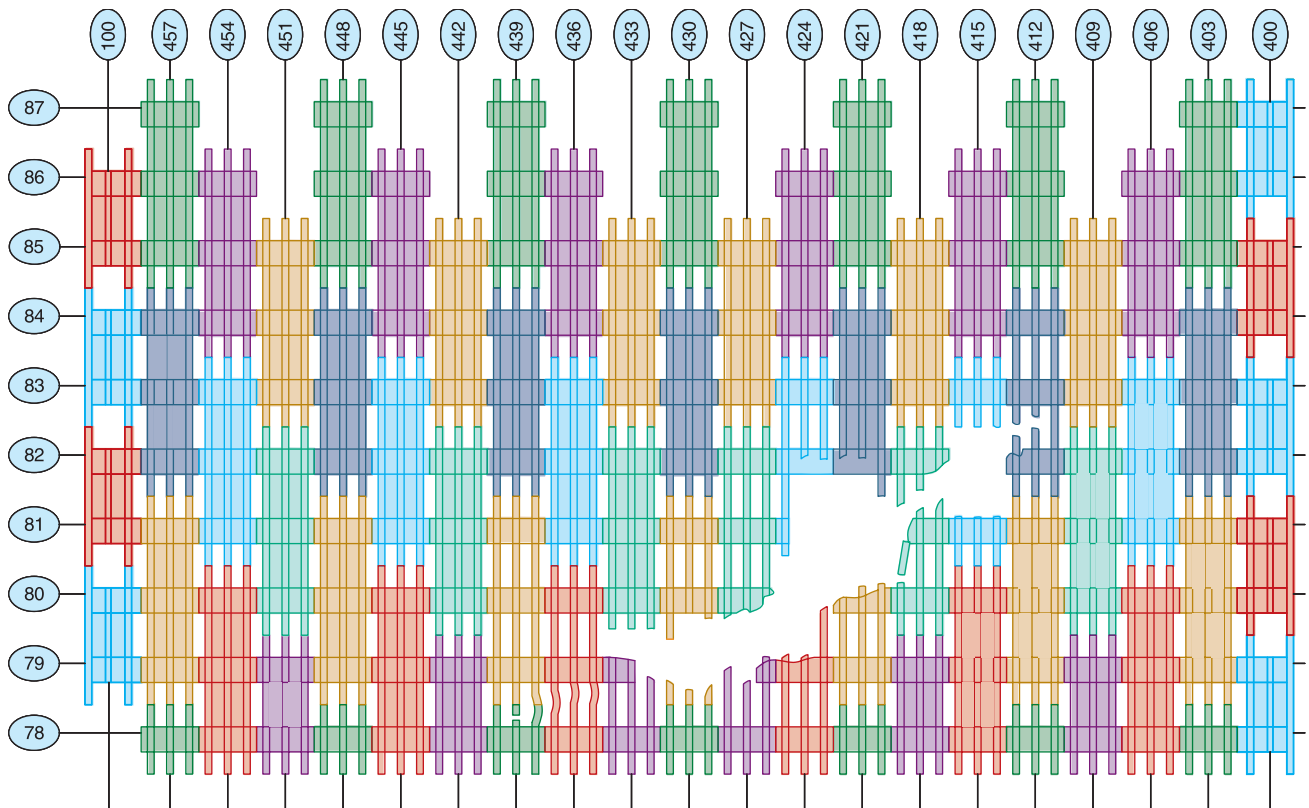
GENERAL NOTES: (1) Column damage captured from photographs and enhanced videos. (2) Damage to column lines 413-418 at levels 81 and 82 is estimated.
 (3) There is not sufficient information to detail damage to column lines 408-411 at levels 83-84.

Figure 2-27 Impact damage to exterior columns on the south face of WTC 2.

A second analysis was conducted to estimate the demands on columns immediately following aircraft impact and before fire effects occurred. Exterior columns were removed from the model to match the damage pattern illustrated in Figure 2-27. Although some core columns were probably damaged by the aircraft impact, the exact extent of this damage is not known and therefore was not considered in the model. As a result, this analysis is thought to underestimate the true stress state in the columns immediately after impact. The analysis indicates that most of the loads initially carried by the damaged exterior columns were transferred by Vierendeel truss action to the remaining exterior columns immediately adjacent to the impact area. If the floors at this level are assumed to remain intact and capable of providing lateral support to the columns, this raised the utilization ratio for the most heavily loaded column immediately adjacent to the damage area to approximately a value of 1.0. At a value of 1.0, columns would lose stiffness and shift load to adjacent columns. Based on this analysis, it appears that the structure had significant remaining margin

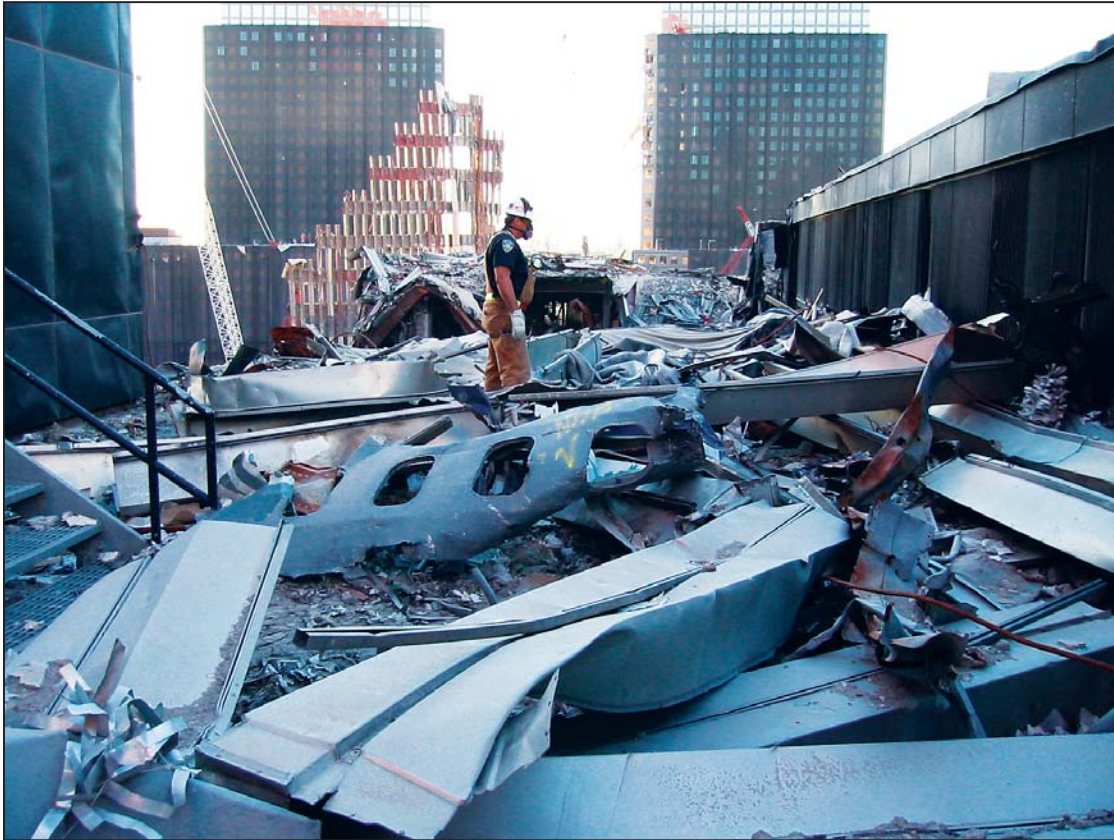
It is known that debris from the aircraft traveled completely through the structure. For example, a landing gear from the aircraft that impacted WTC 2 was found to have crashed through the roof of a building located six blocks to the north, and one of the jet engines was found at the corner of Murray and Church Streets. The extent to which debris scattered throughout the impact floors is also evidenced by photographs of the fireballs that occurred as the aircraft struck the building (Figure 2-28). Figure 2-29 shows a portion of the fuselage of the aircraft, lying on the roof of WTC 5.

Figure 2-29 A portion of the fuselage of United Airlines Flight 175 on the roof of WTC 5.

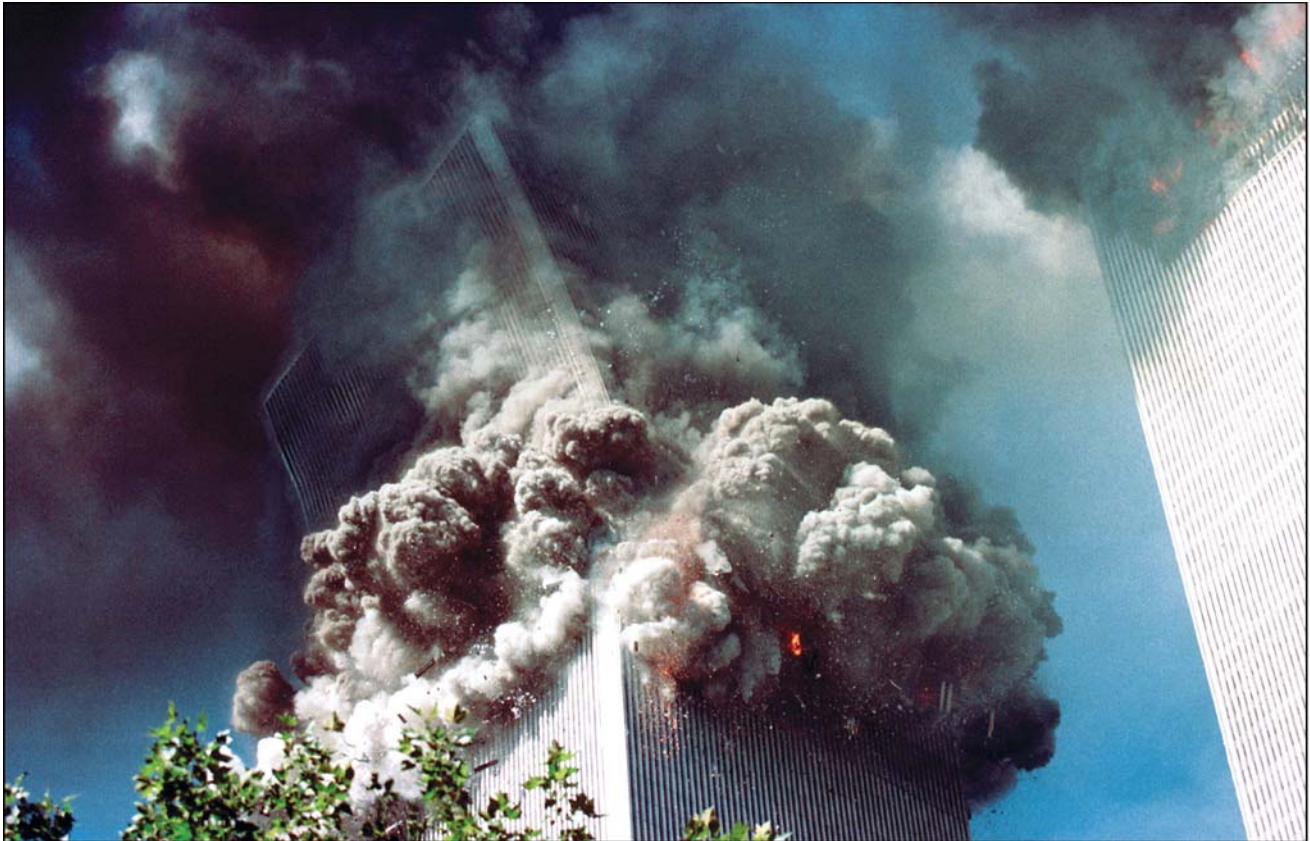
Figure 2-32 The top portion of WTC 2 falls to the east, then south, as viewed from the northeast.
