MINISTRY OF TRANSPORT AND CIVIL AVIATION

CIVIL AIRCRAFT ACCIDENT

Report of the Court of Inquiry
into the Accidents to
Comet G-ALYP on 10th January, 1954
and Comet G-ALYY on
8th April, 1954

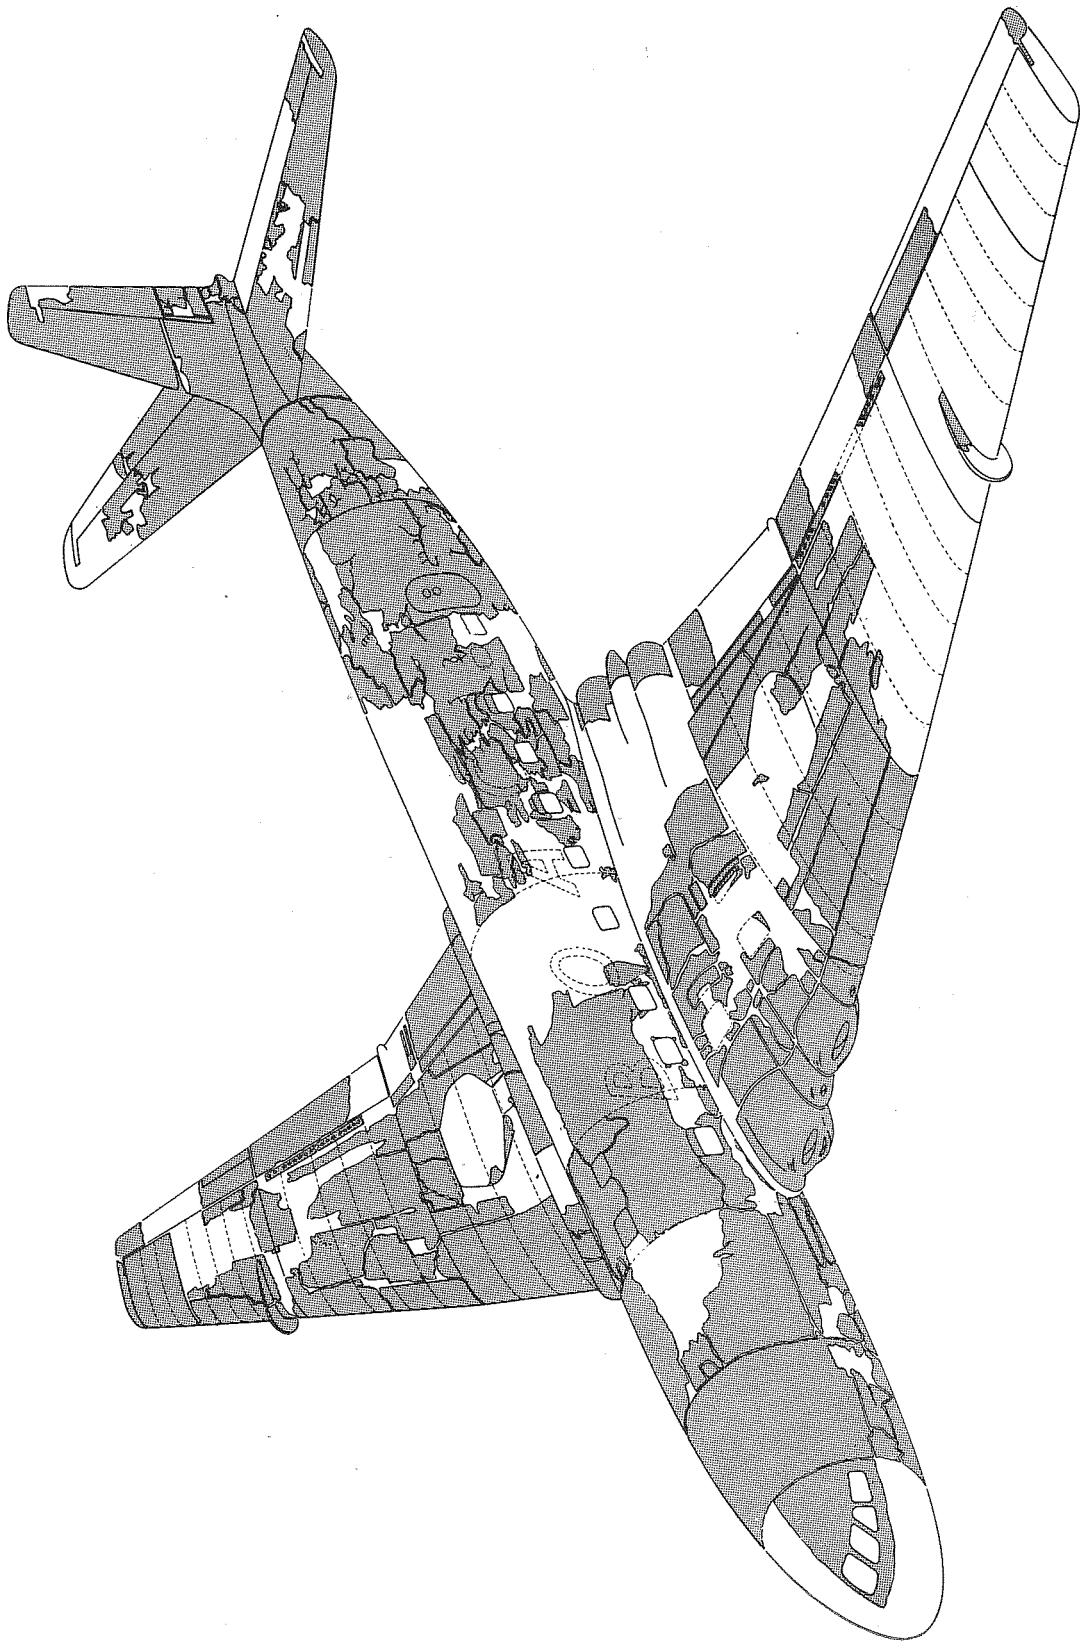
FIG. 2. DIAGRAM SHOWING AMOUNT OF WRECKAGE RECOVERED—G-ALYP.

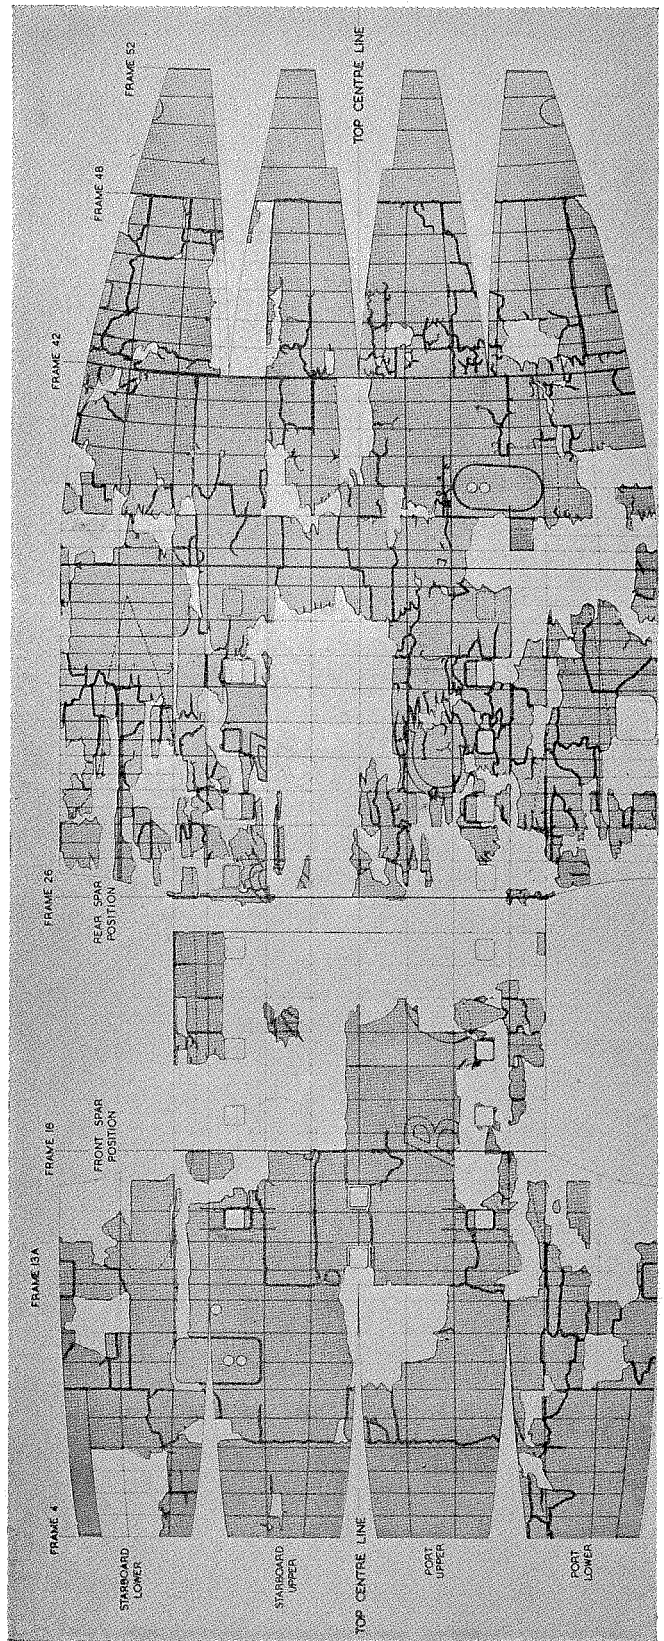
FIG. 3. DEVELOPMENT DRAWING OF FUSELAGE SHOWING AMOUNT OF WRECKAGE RECOVERED—G-ALYP.

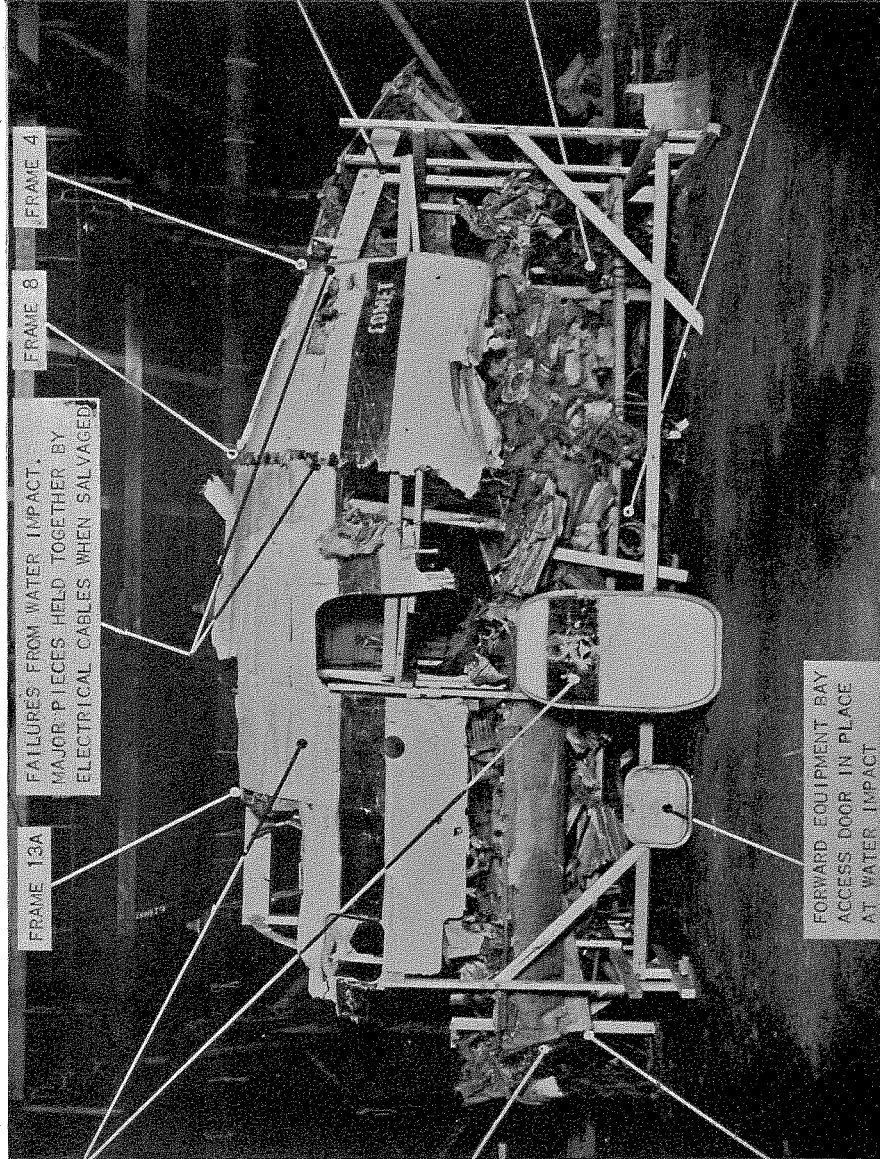
STARBOARD WINDSCREEN MISSING.

EXTENSIVE CRUSHING OF WHOLE UNDERSIDE OF FRONT FUSELAGE BY WATER.

FORWARD EQUIPMENT BAY ACCESS DOOR IN PLACE AT WATER IMPACT

FIG. 5. FRONT FUSELAGE—VIEW ON STARBOARD SIDE—G-ALYP.

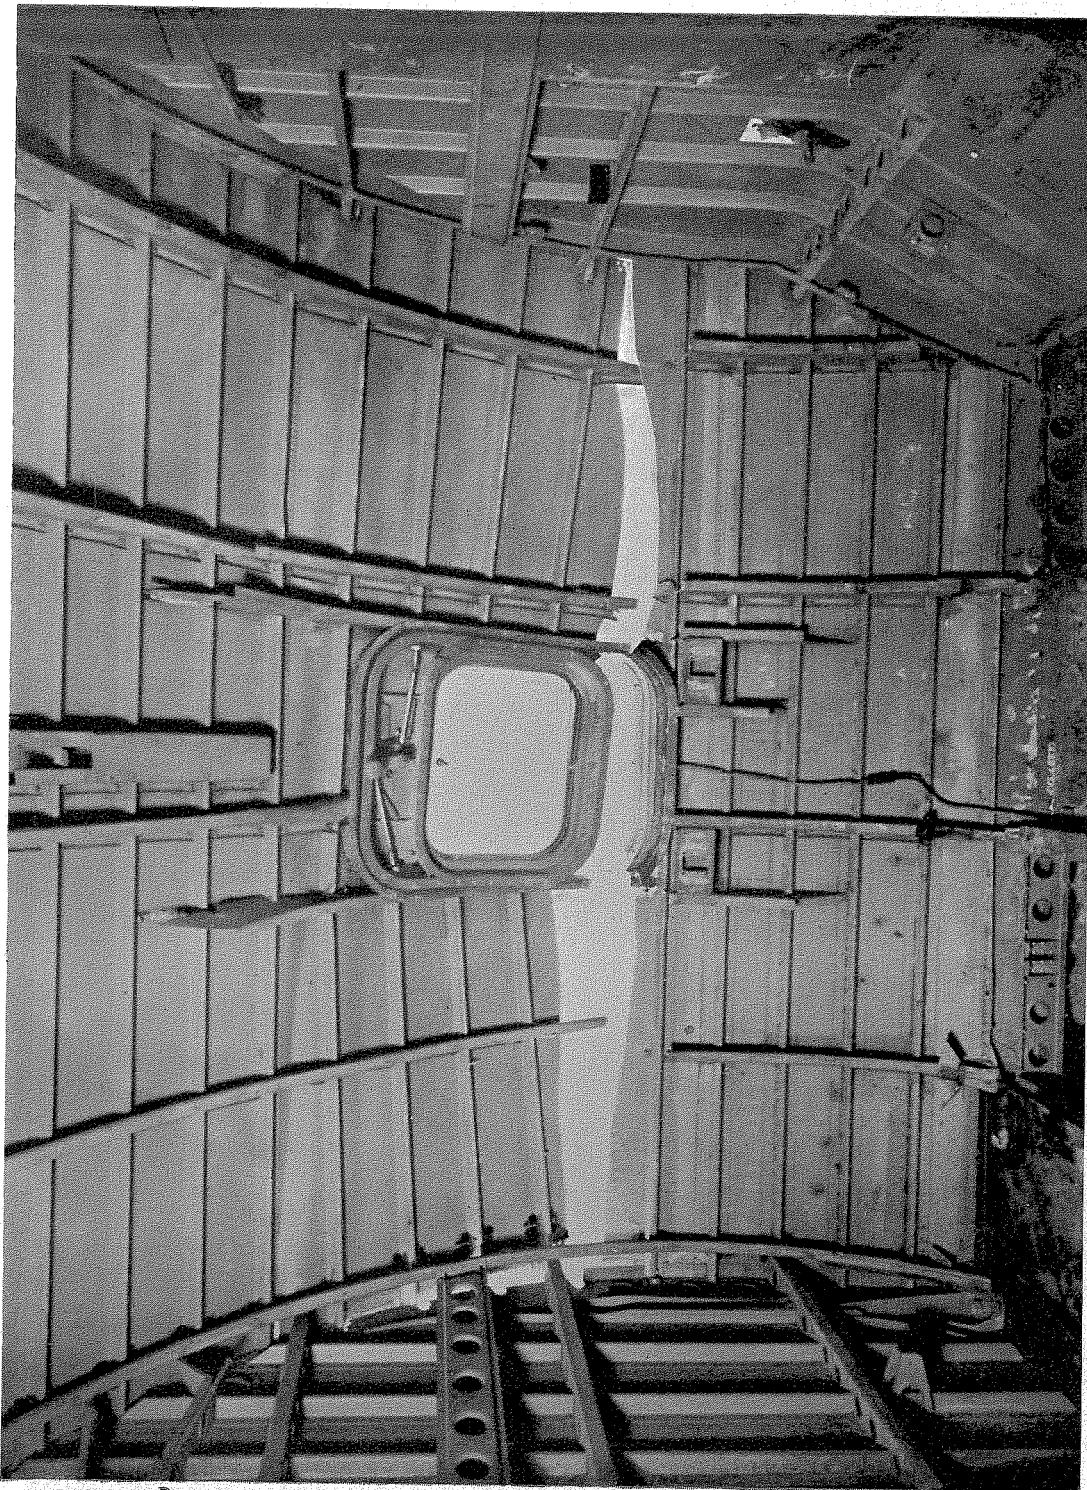
FIG. 7. VIEW FROM INSIDE OF FAILURE AT THE FORWARD ESCAPE HATCH ON THE PORT SIDE—COMET G-ALYU

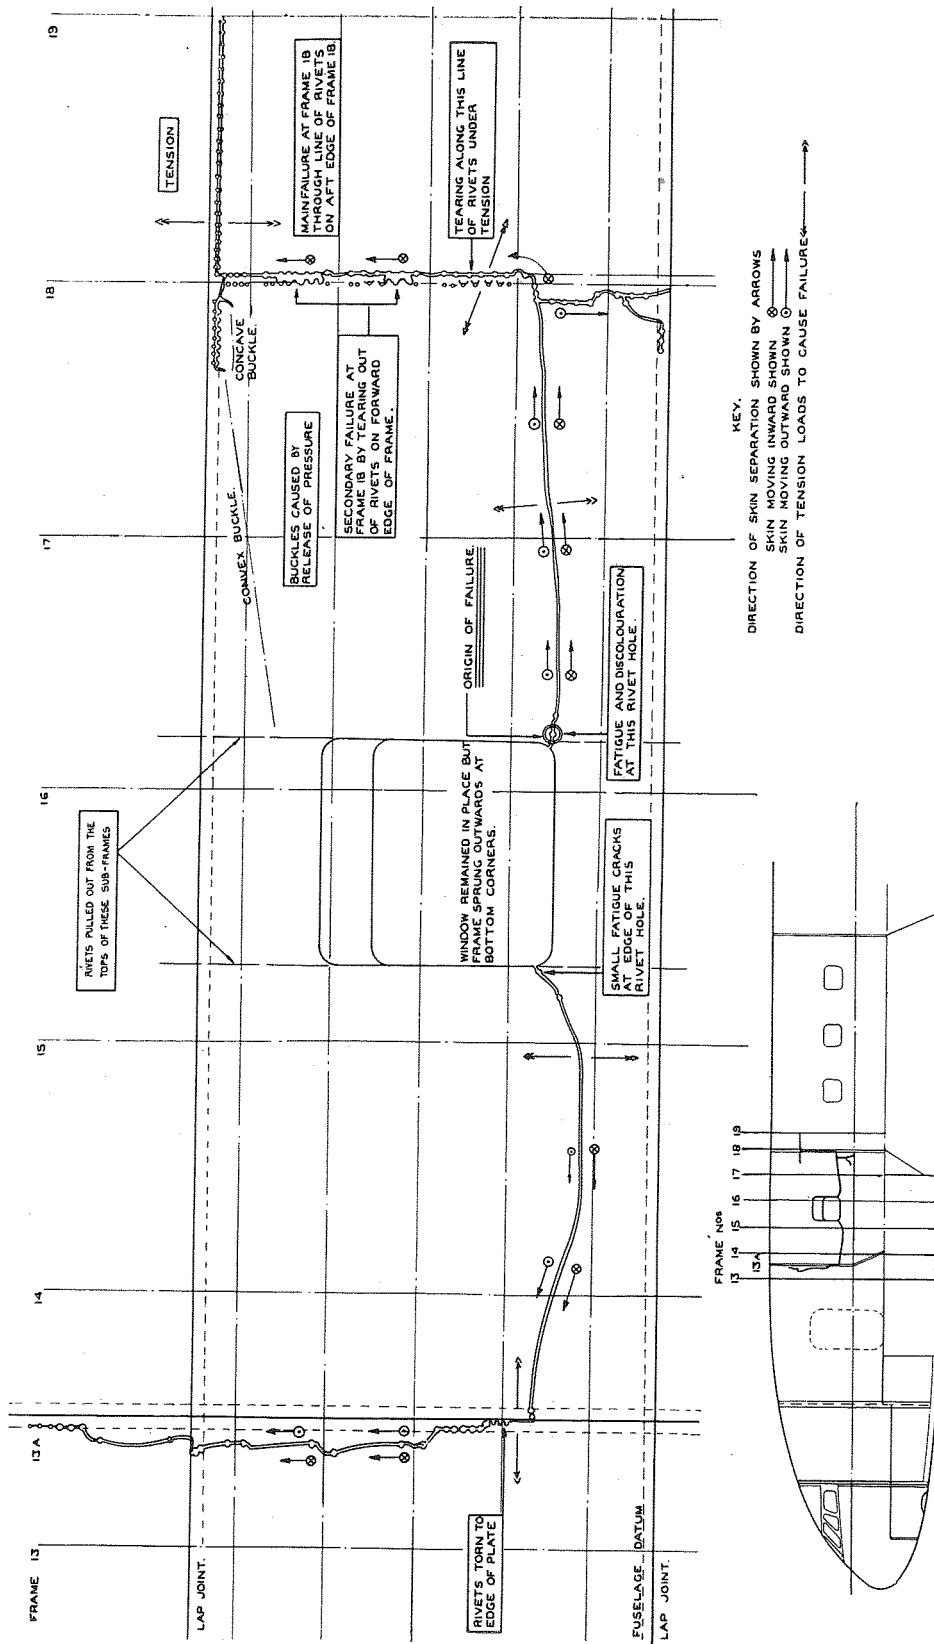
FIG. 8. THE PROGRESS OF THE FAILURE OF THE FORWARD ESCAPE HATCH ON THE PORT SIDE—COMET G-ALYU.

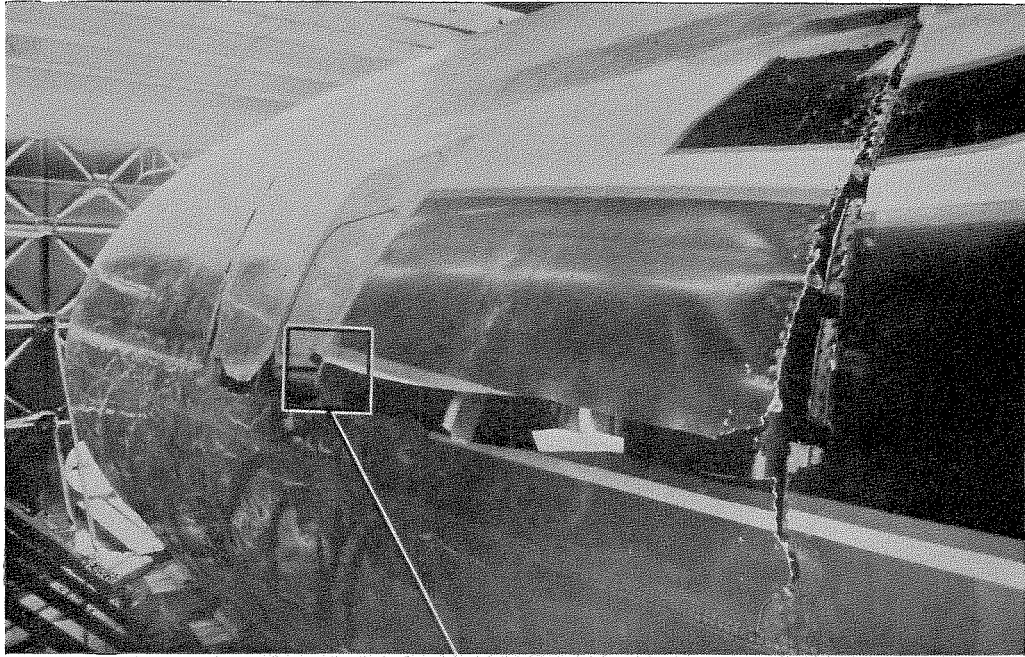
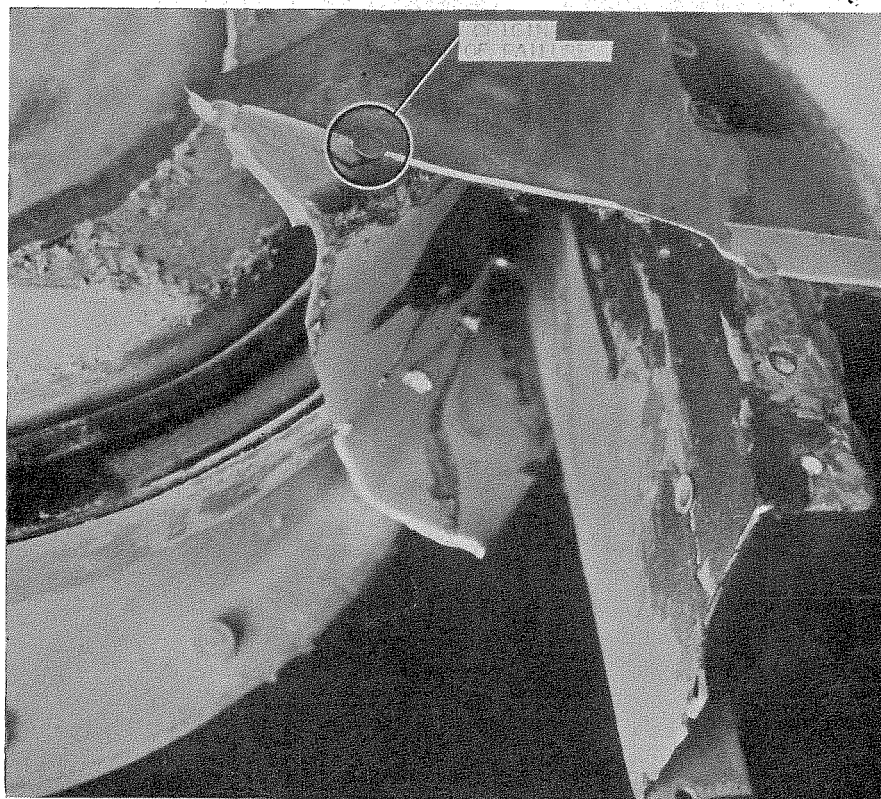
64. Yoke Uncle had made 1,230 pressurised flights before the test and after the equivalent of a further 1,830 such flights, making a total of 3,060, the cabin structure failed, the starting point of the failure being the corner of one of the cabin windows (see Figures 7 and 8). The fact that the failure occurred during one of the proving tests to 11 lb/sq. in. is not thought significant since the crack would have spread in very much the same way after a few more applications of the working pressure. Examination of the failure provided evidence of fatigue at the point where the crack would be most likely to start, namely near the edge of the skin at the corner of the window (see Figures 9 and 10). This was revealed

by the discolouration due to algae in the water which made it clear that the crack had endured several pressurisations before it spread catastrophically. It is important to note here that the sources of fatigue mentioned above, which were not reproduced in the tank test, all tend to increase the burden of fatigue and that, therefore, the life of a fuselage deduced from the test is longer than would be expected in service. It is not possible to do more than estimate the magnitude of this effect but it was suggested by Dr. Walker that a "life" of 3,060 flights in the test might be equivalent to about 2,500 in practice.

a. GENERAL VIEW LOOKING FORWARD.

b. CLOSE-UP OF SKIN AT BOTTOM REAR CORNER OF ESCAPE HATCH.

FIG. 9. FAILURE OF FRONT FUSELAGE AT 10.4 lb/in² (3057 TOTAL FLIGHTS)—G-ALYU.

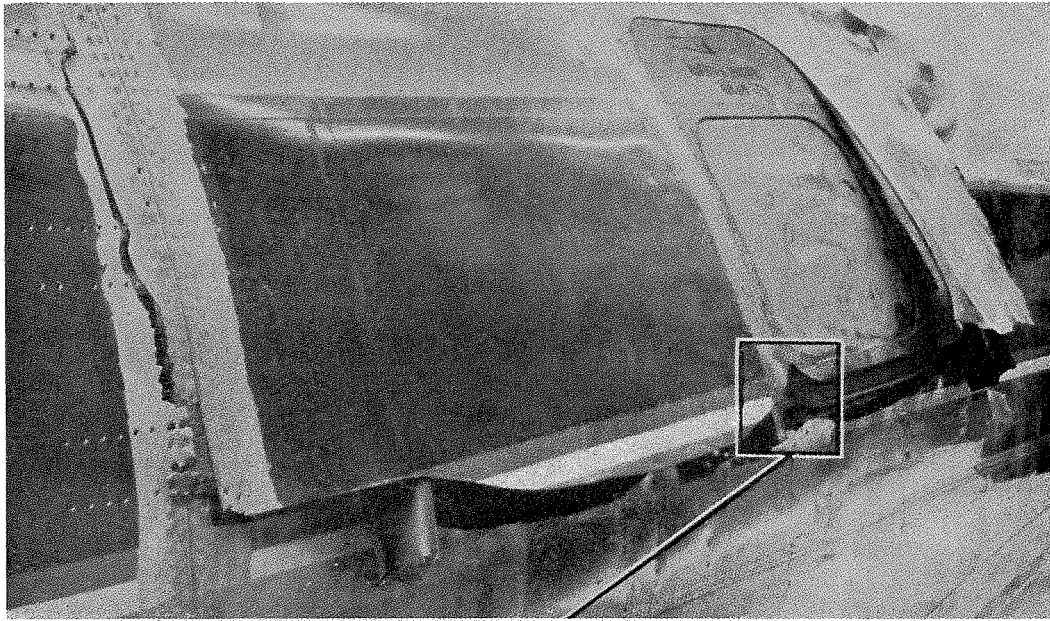
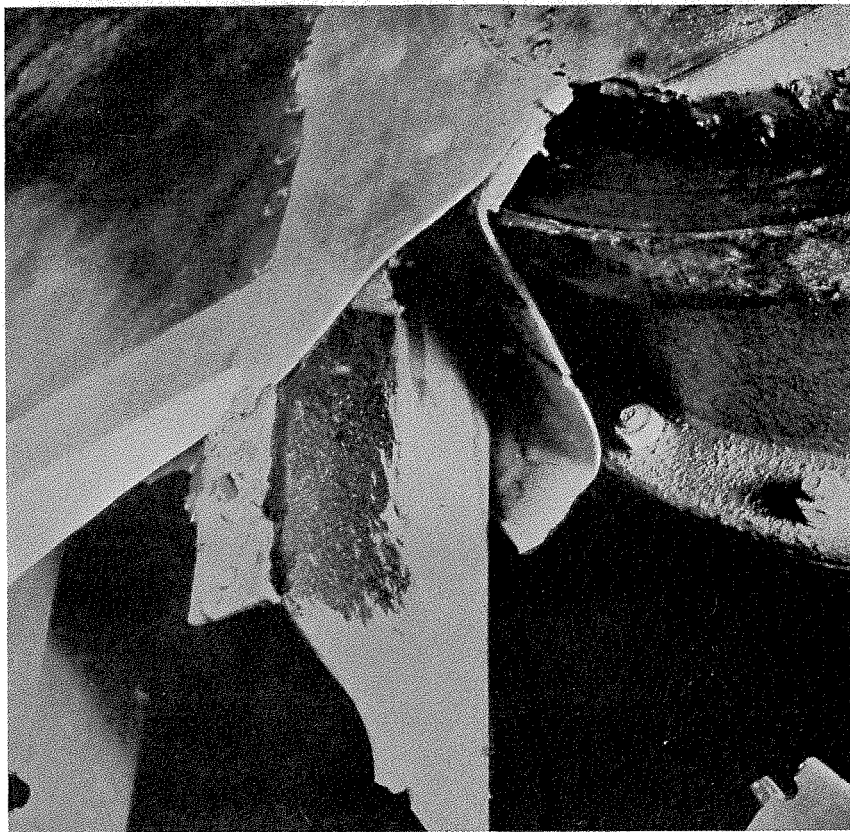
a. GENERAL VIEW LOOKING AFT.

b. CLOSE-UP OF SKIN AT BOTTOM FRONT CORNER OF ESCAPE HATCH.

FIG. 10. FAILURE OF FRONT FUSELAGE AT 10.4 lb/in^2 (3057 TOTAL FLIGHTS)—G-ALYU.

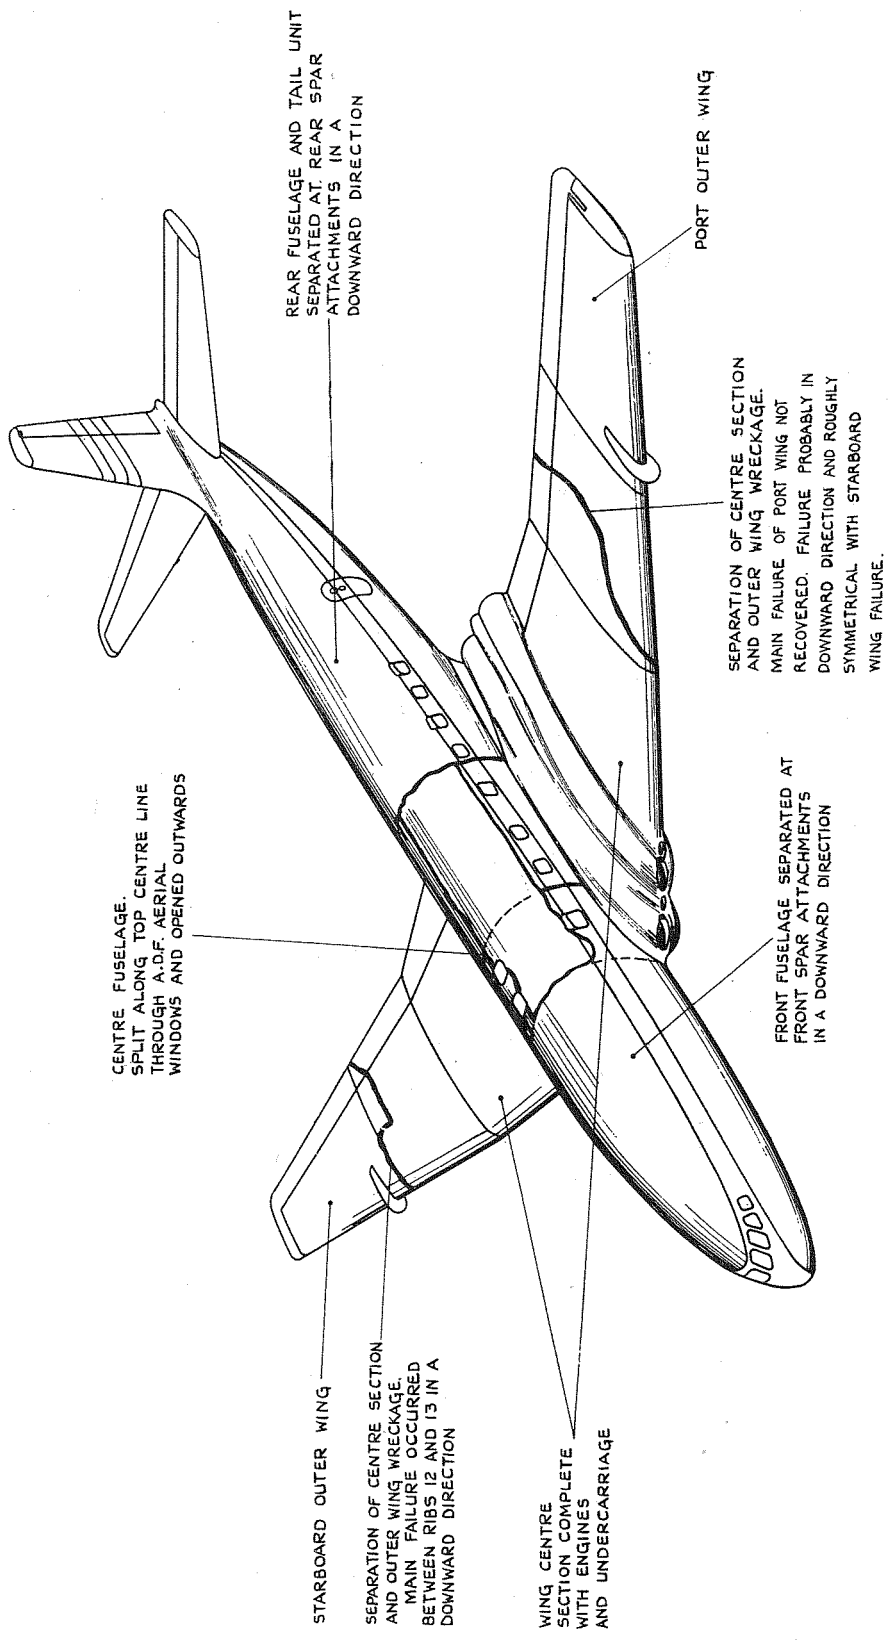
FIG. 11. LOCATION AND DIRECTION OF MAIN FAILURES—G-ALYP.

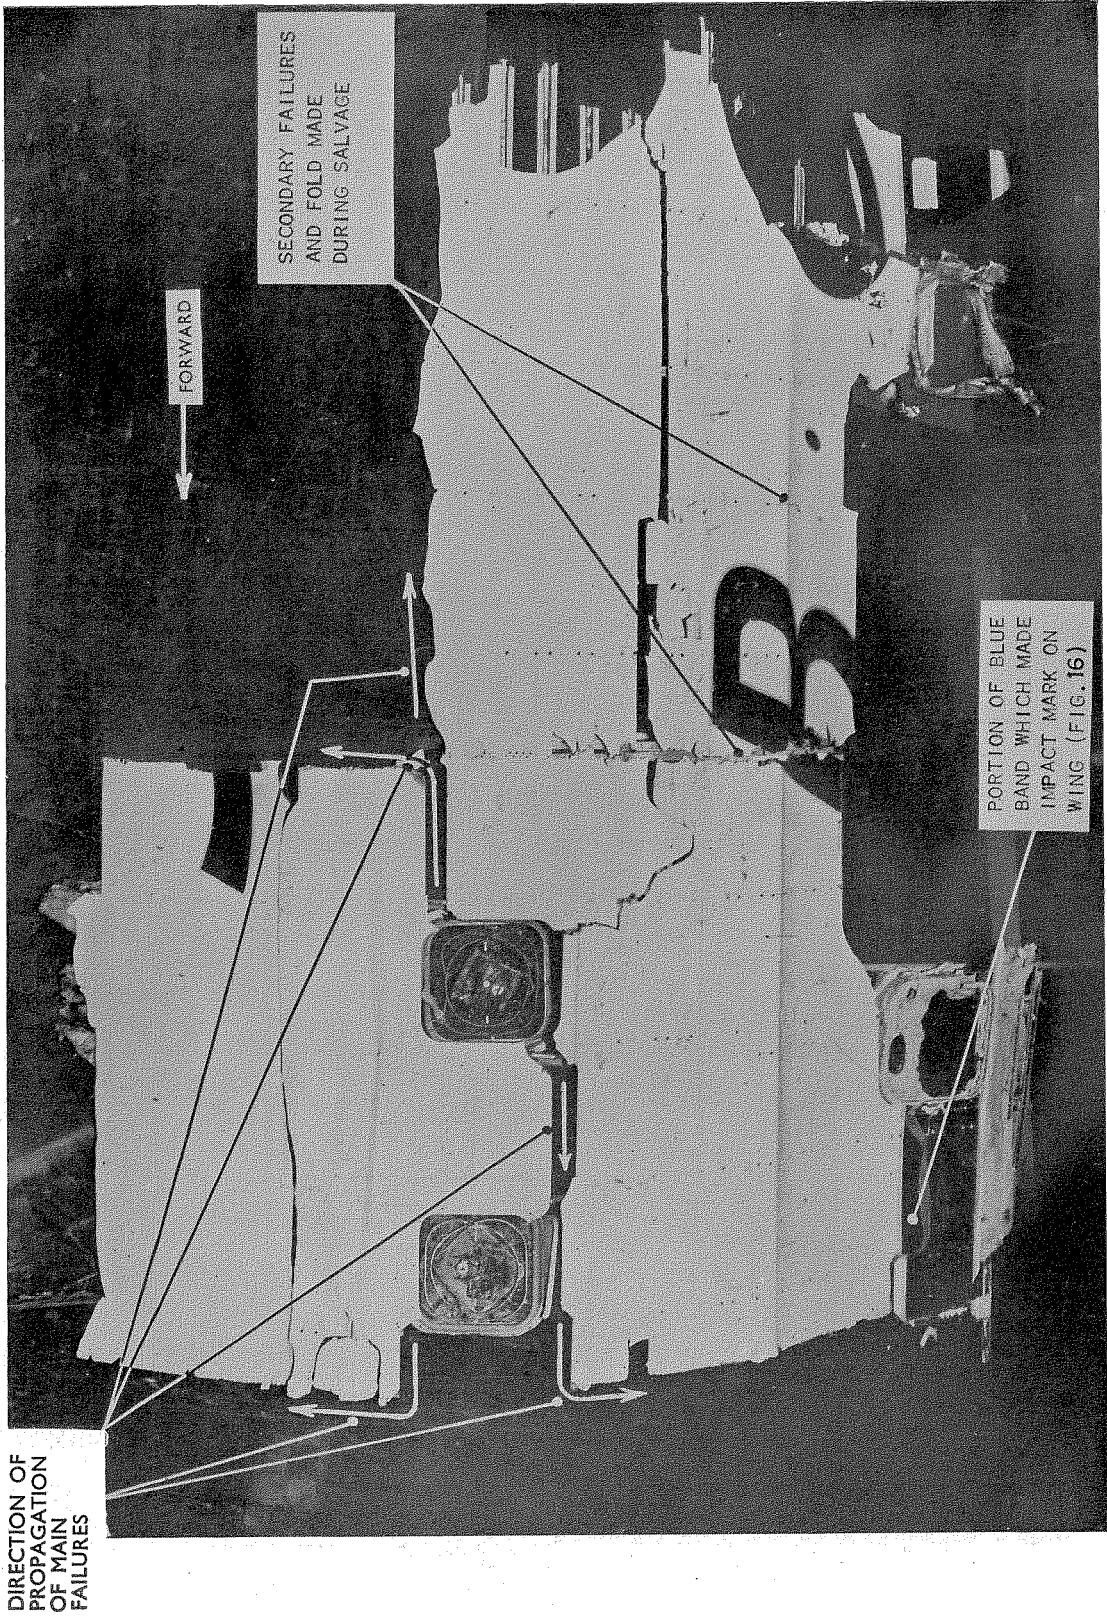
DIRECTION OF PROPAGATION OF MAIN FAILURES

PORTION OF BLUE BAND WHICH MADE IMPACT MARK ON WING (FIG. 16)

FIG. 12. PHOTOGRAPH OF WRECKAGE AROUND ADF AERIAL WINDOWS—G-ALYP.

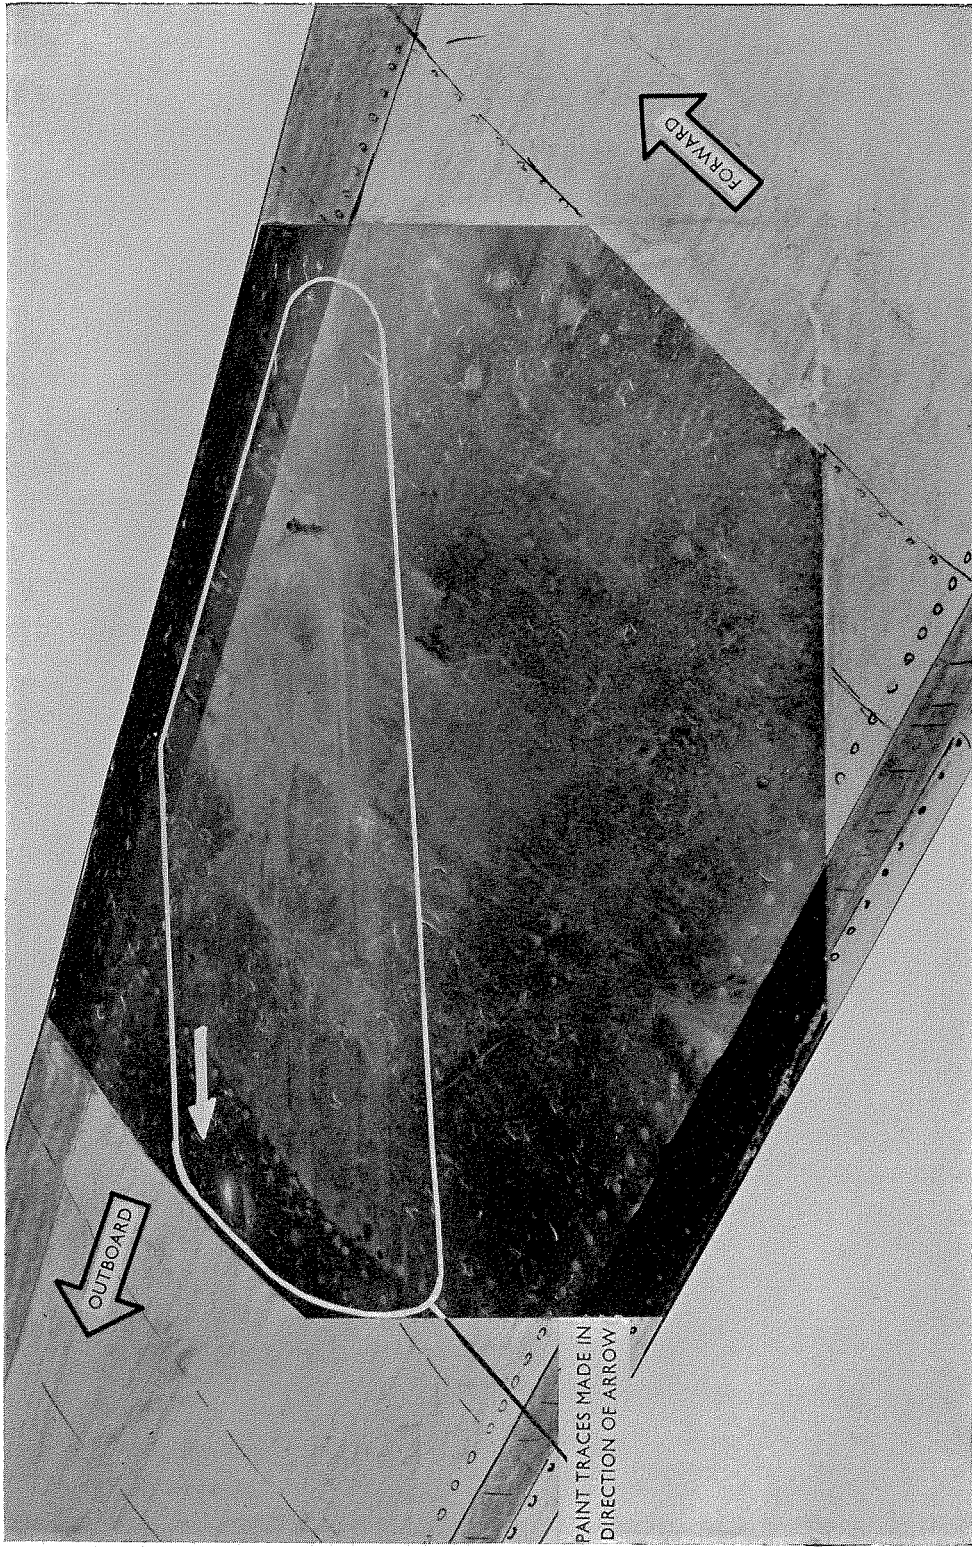
(FOR LOCATION ON AILERON SEE FIG. 16.)

FIG. 13. PAINT TRACES OVER PORT AILERON UPPER SURFACE—G-ALYP.

PARTICLES OF FIBREGLASS AND WOOD JAMMED INTO SKIN AND UNDER LAP JOINT PROBABLY FROM FUSELAGE CABIN FLOORING

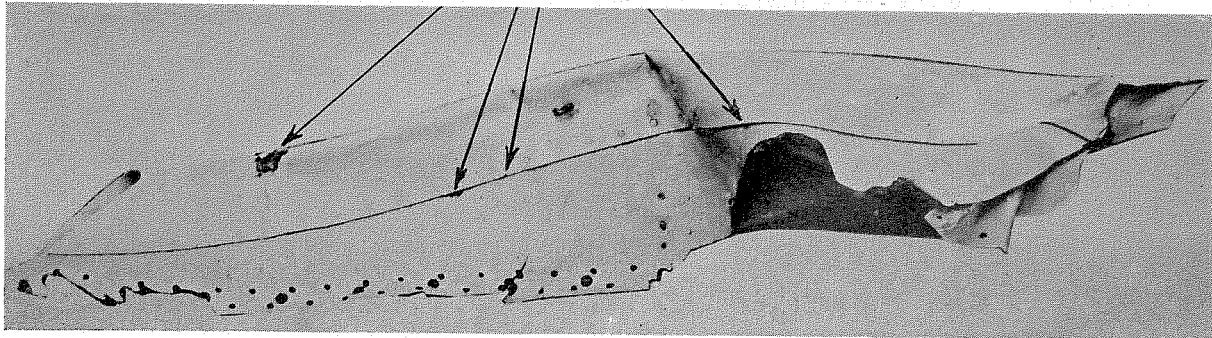
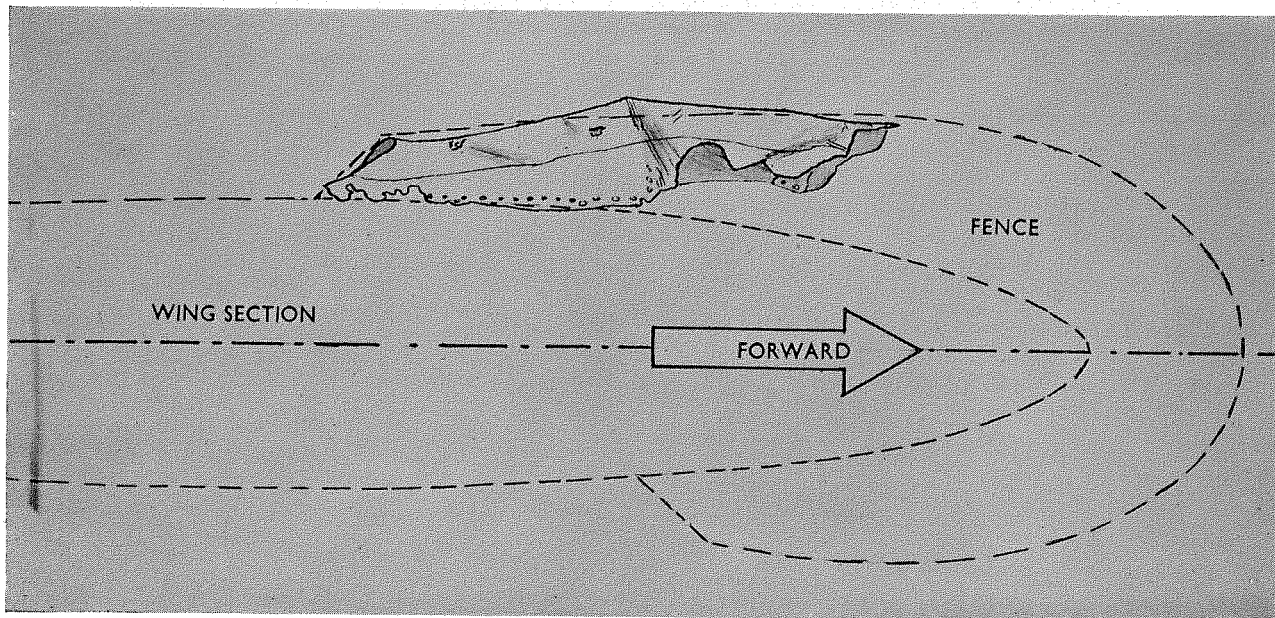
GENERAL PATTERN OF METALLIC SCORES AND PAINT TRACES OVER INBOARD FACE PROGRESSING FROM WING SKIN TO UPPER EDGE OF FENCE

NO COMPARABLE DAMAGE ON OUTBOARD FACE OF FENCE

FIG. 14. PORT BOUNDARY LAYER FENCE, IMPACT DAMAGE TO INBOARD FACE—G-ALYP.

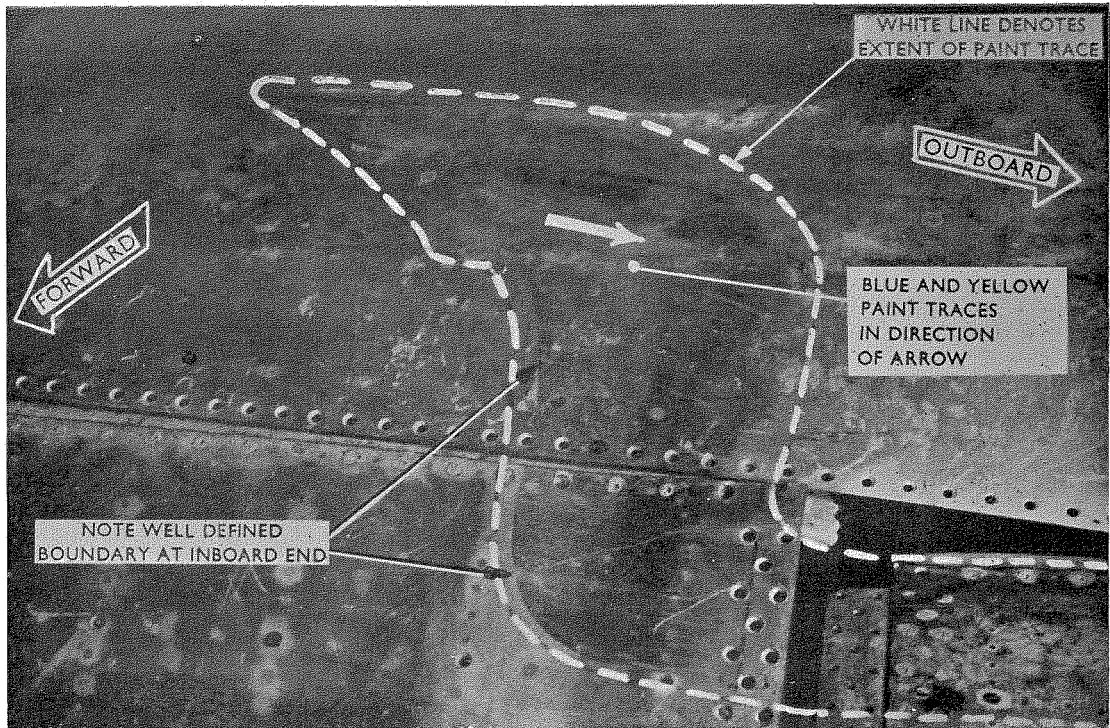
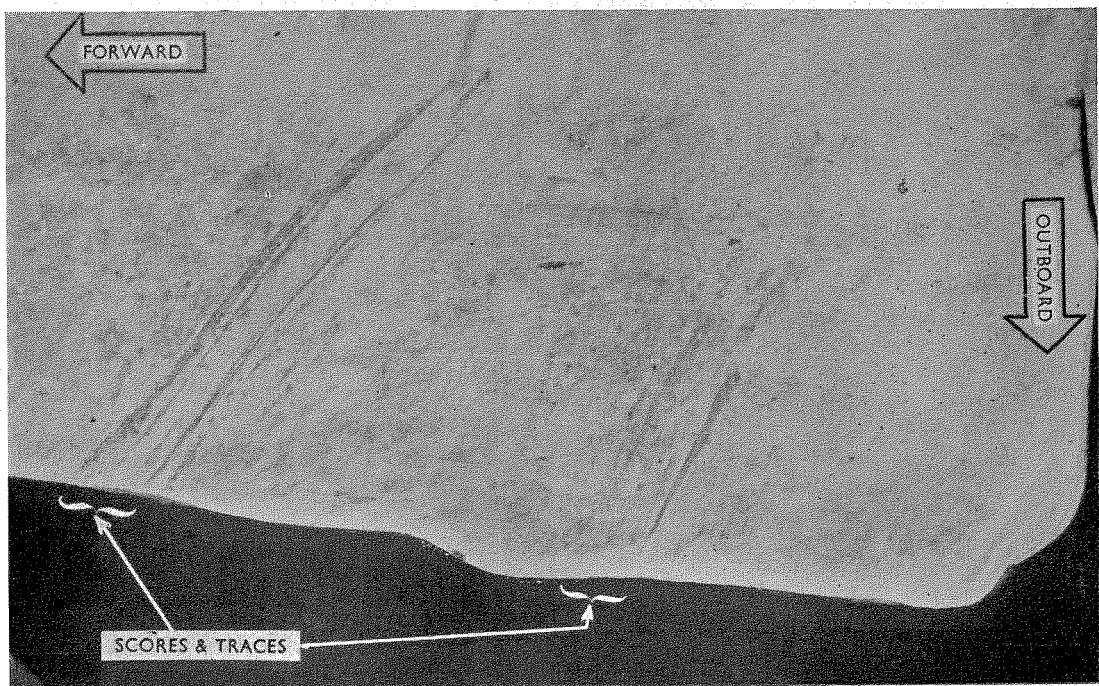
PAINT TRACES MADE BY PORTION OF CABIN WALL
(FOR LOCATION SEE FIG. 16).

HEAVY METALLIC SCORING WITH BLUE PAINT TRACES CONTINUOUS OVER FRACTURE EDGE
(FOR LOCATION SEE FIG. 16).

FIG. 15. PAINT TRACES ON PORT WING UPPER SURFACE—G-ALYP.

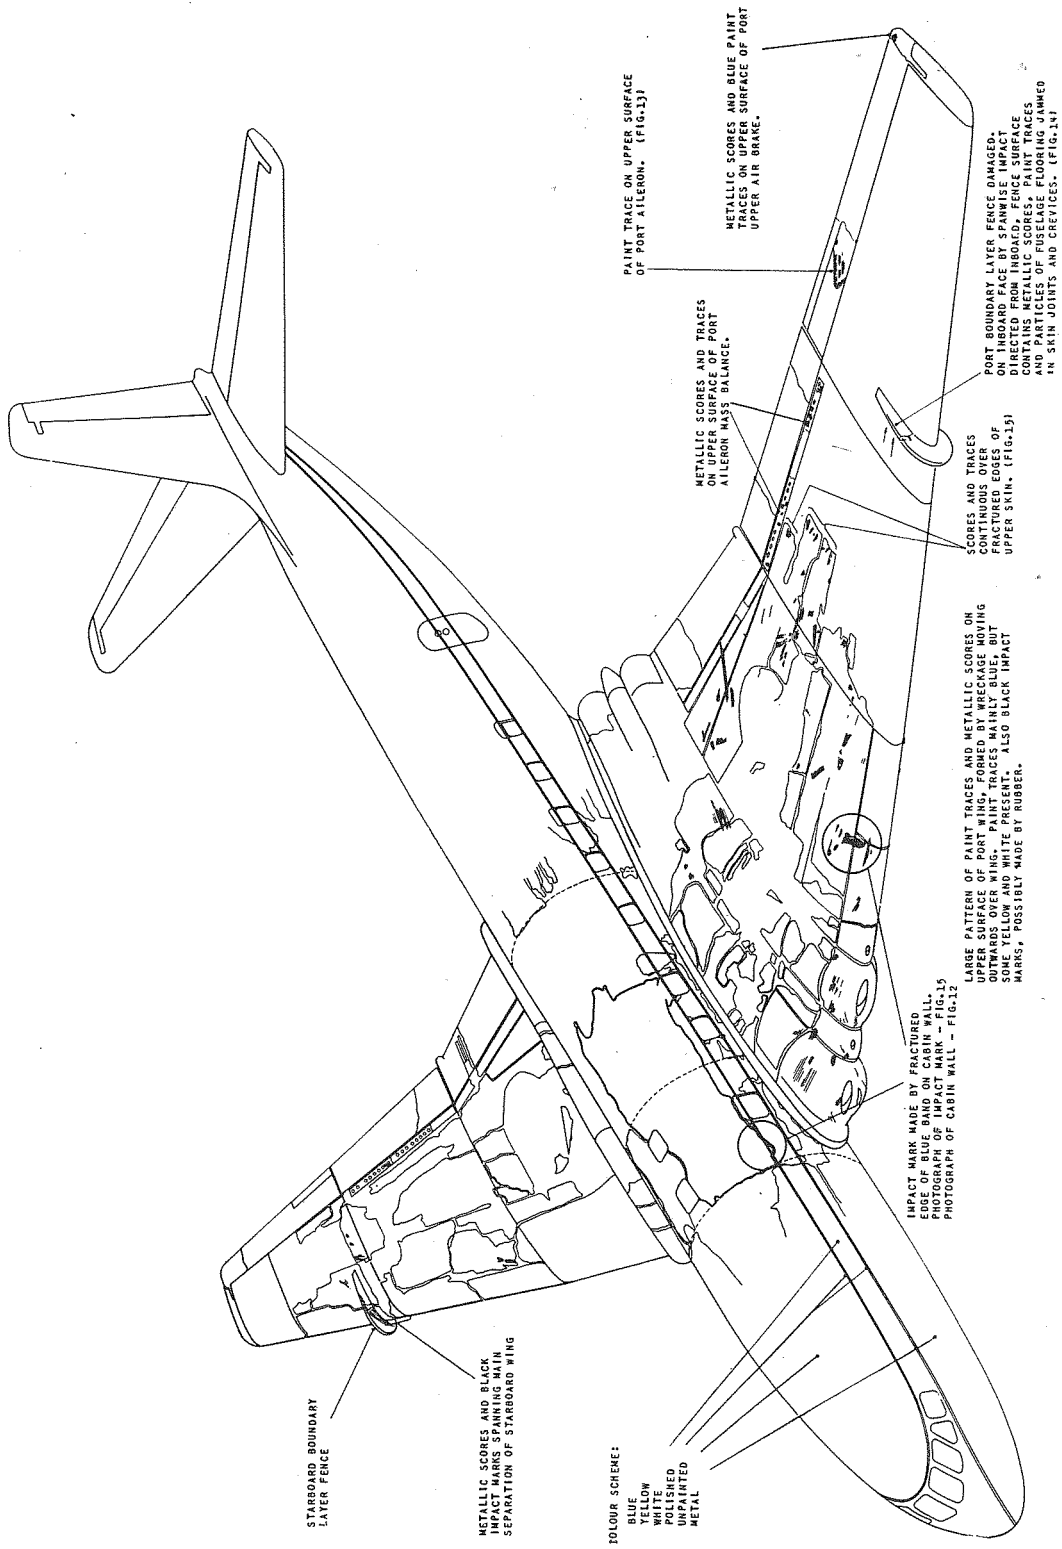
FIG. 16. IMPACT DAMAGE TO UPPER SURFACES OF WINGS—G-ALYP.

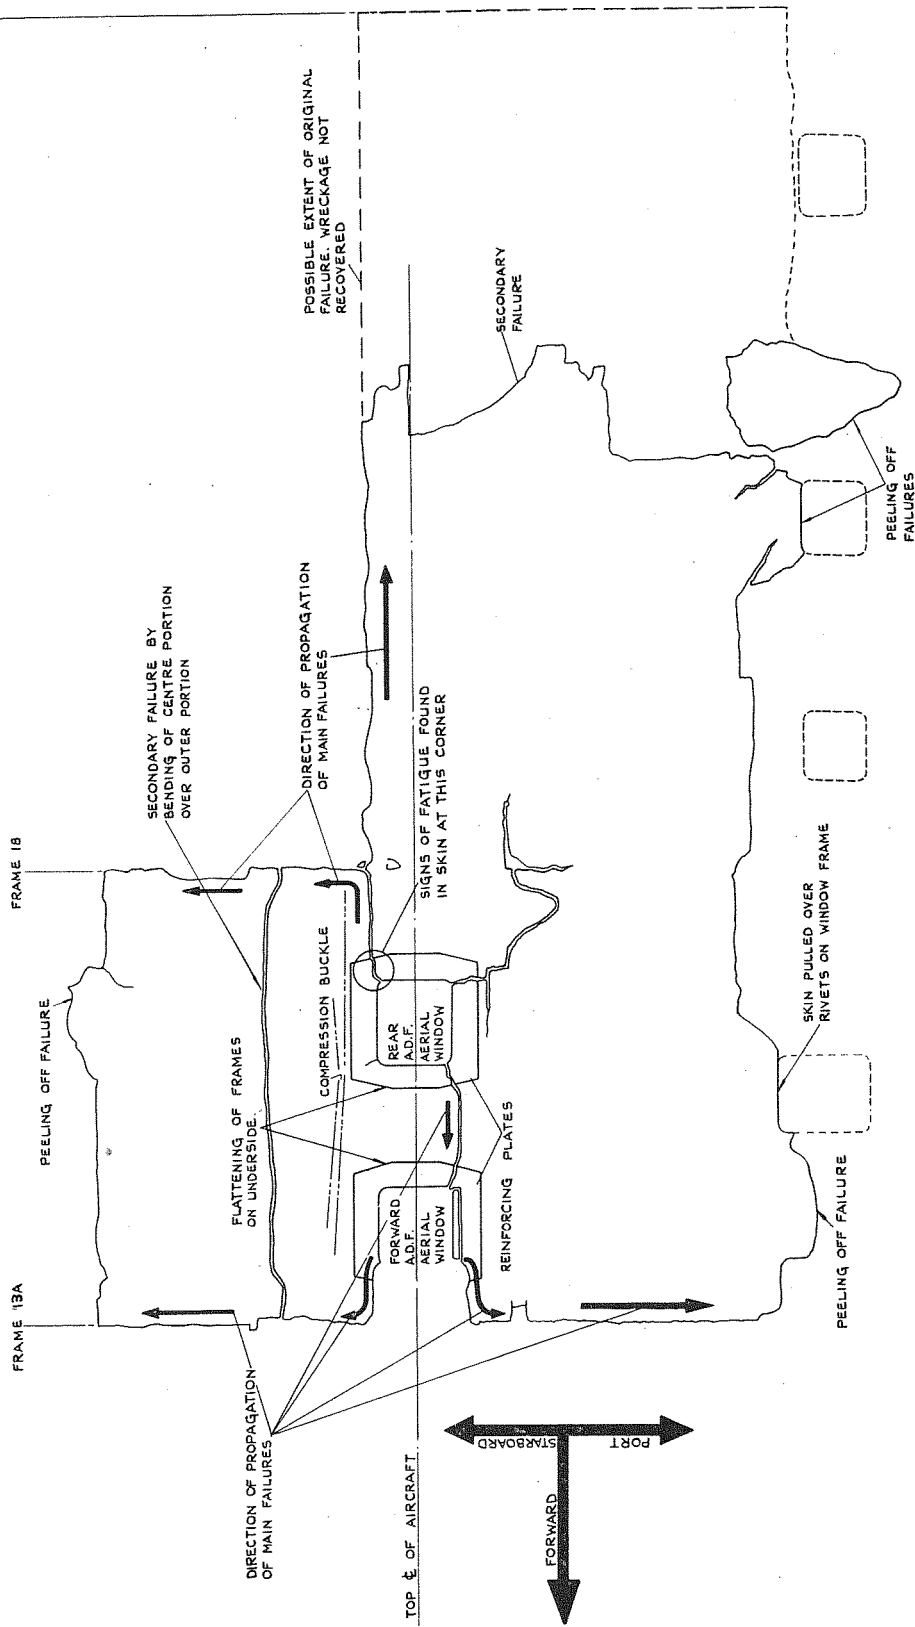
FIG. 17. SALIENT FEATURES OF DISRUPTION OF PRESSURE CABIN—G-ALYP.

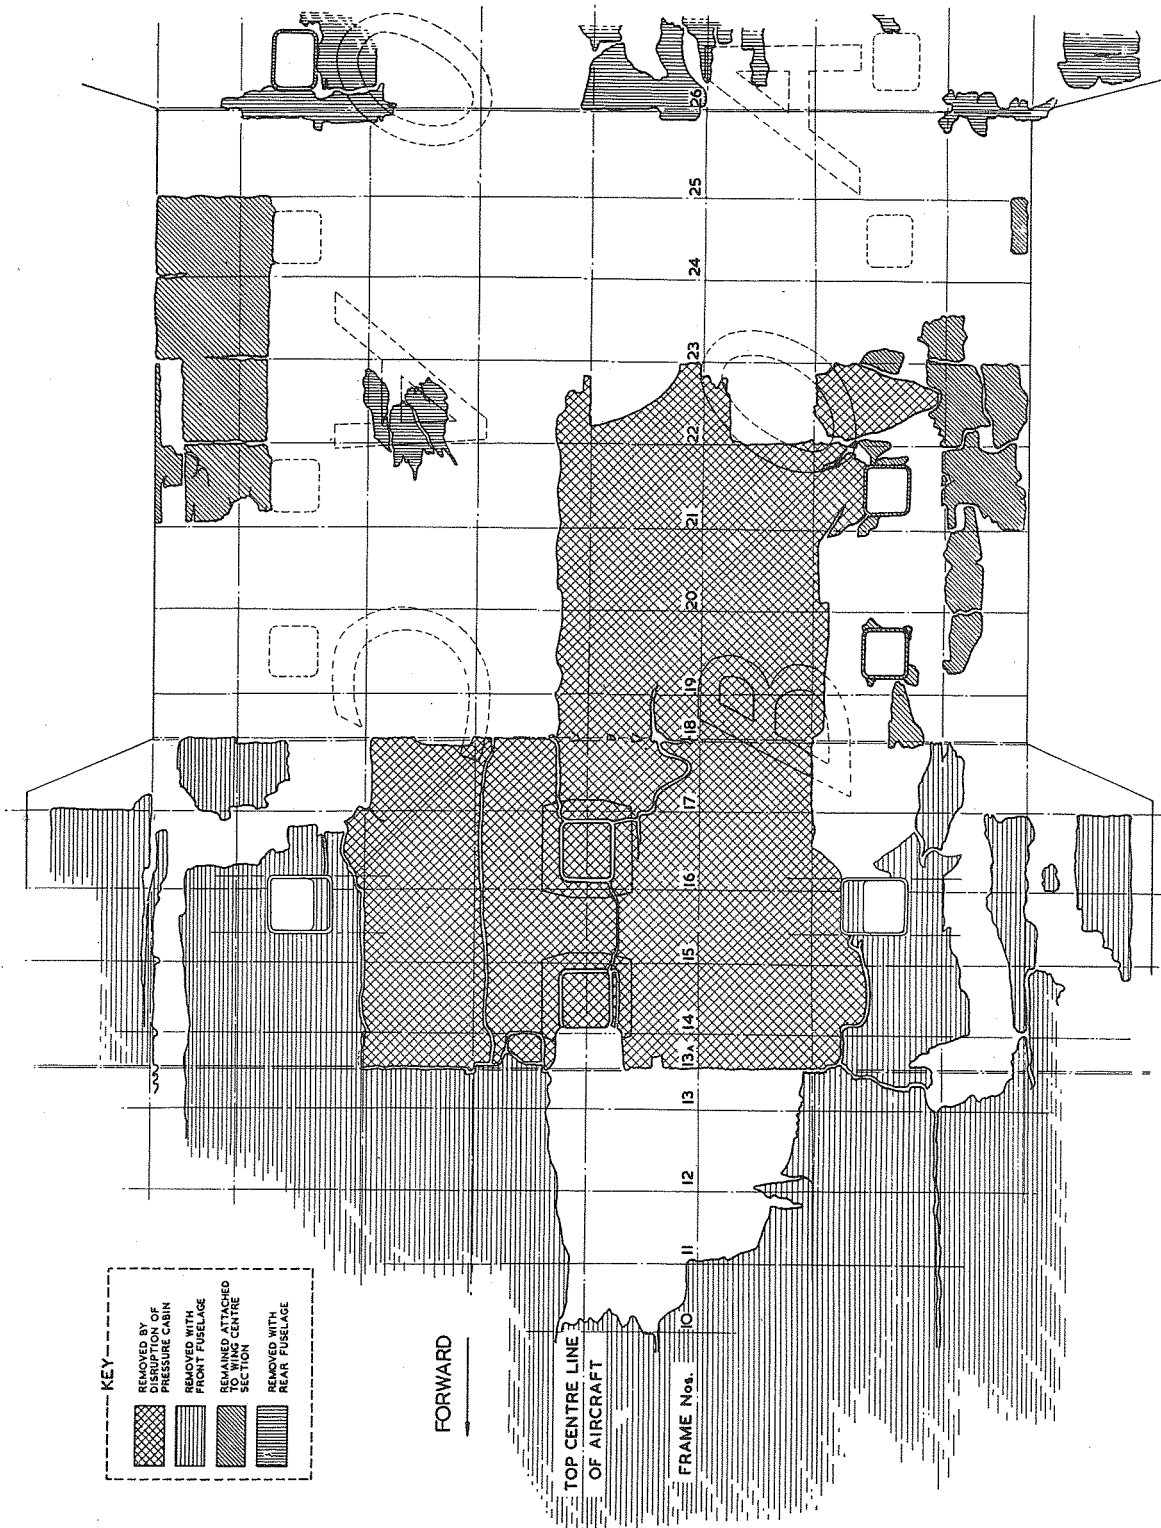
FIG. 18. DEVELOPMENT DRAWING OF WRECKAGE AROUND ADF AERIAL WINDOWS—G-ALYP.
