MINISTRY OF TRANSPORT AND CIVIL AVIATION

CIVIL AIRCRAFT ACCIDENT

Report of the Court of Inquiry
into the Accidents to
Comet G-ALYP on 10th January, 1954
and Comet G-ALYY on
8th April, 1954

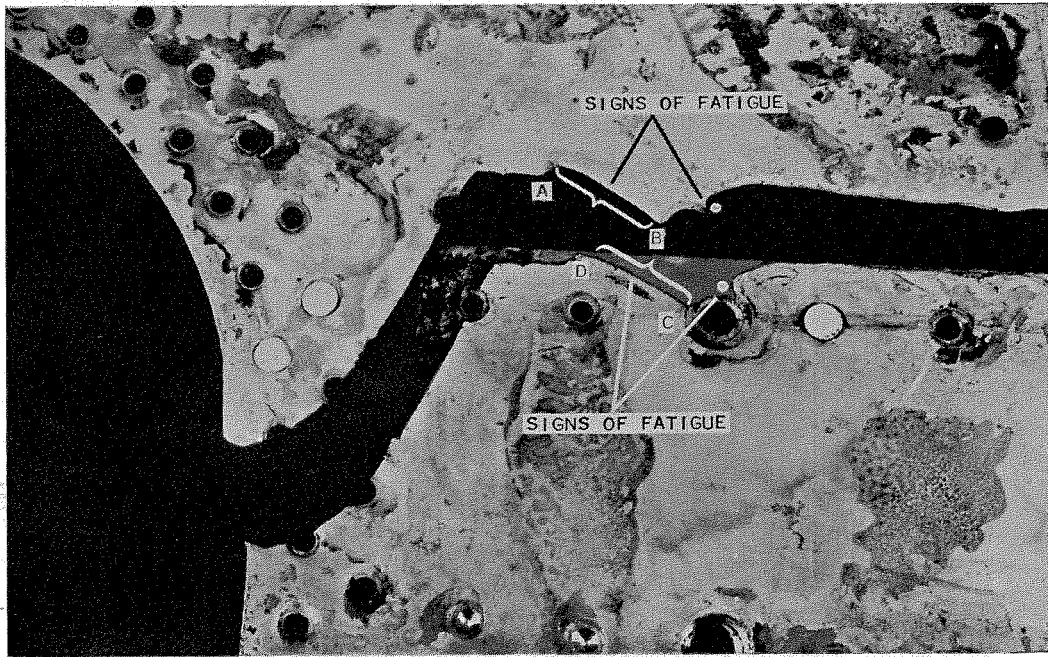
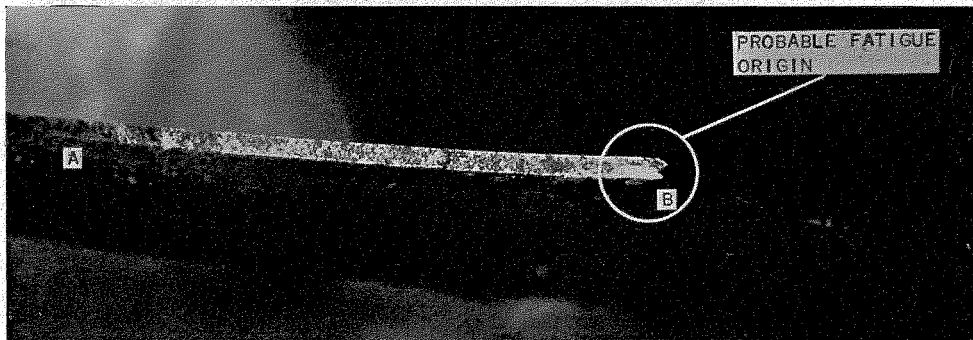
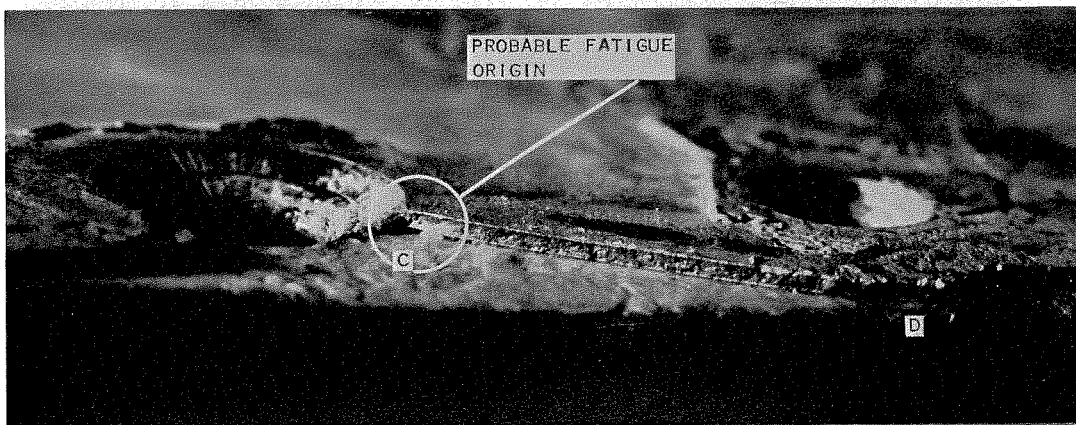
(a) PLAN VIEW OF FAILURE IN SKIN.

(b) VIEW OF EDGE A B.

(c) VIEW OF EDGE C D.

FIG. 19. SIGNS OF FATIGUE IN SKIN AT STARBOARD REAR CORNER OF REAR ADF AERIAL WINDOW—G-ALYP.
