Initial Report on 23 June 2001 Arequipa, Peru Earthquake

Observations from Locations Reporting Most of the Damage

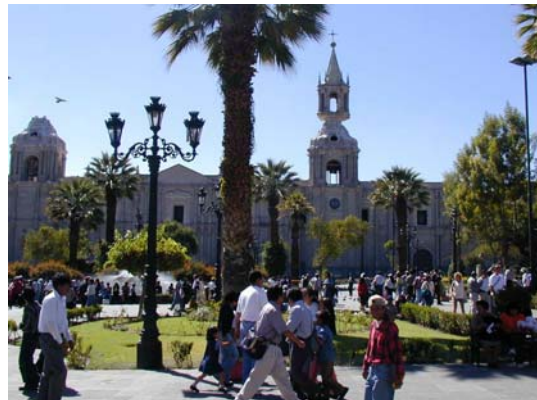
The city's historic Cathedral of Arequipa sustained heavy damage, mainly due to the collapse of one of its towers. The cathedral is situated on the Plaza de Armas in Arequipa's historic center, a UNESCO World Heritage site. The cathedral, founded in 1612, was damaged by previous earthquakes and fire and was substantially rebuilt in the 19th century. Both towers of the cathedral were apparently damaged in previous earthquakes and rebuilt most recently in about 1940. This cathedral is the symbol of Arequipa and an important part of the architectural heritage of Peru.

Figure 5. Cathedral of Arequipa as it appeared on June 28, 2001. (Photo by E. Fierro)

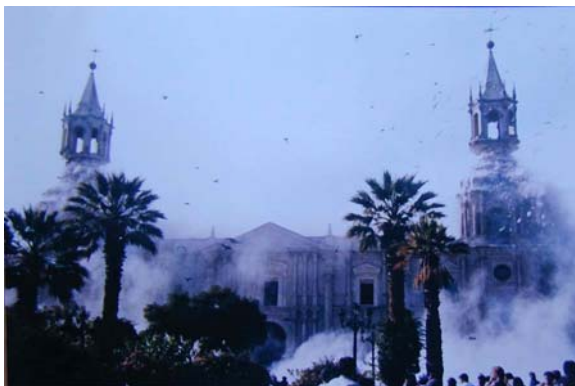
Figure 6. Cathedral of Arequipa, first still photo from sequence taken during main event on 23 June 2001.

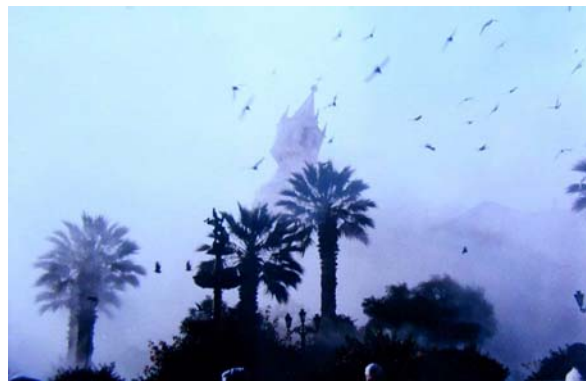
Figure 7. Cathedral of Arequipa, subsequent still photo showing impending collapse of left tower shown in Figure 6.

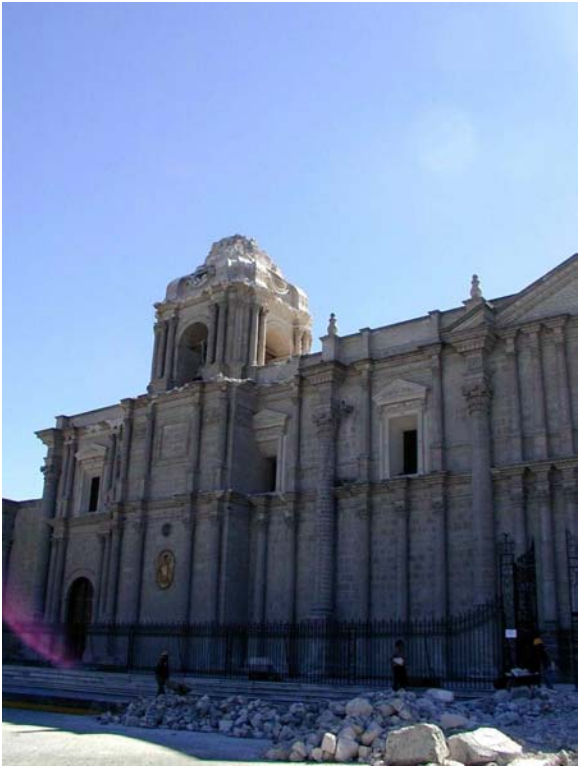
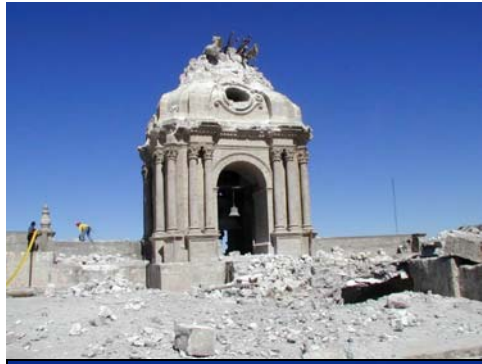
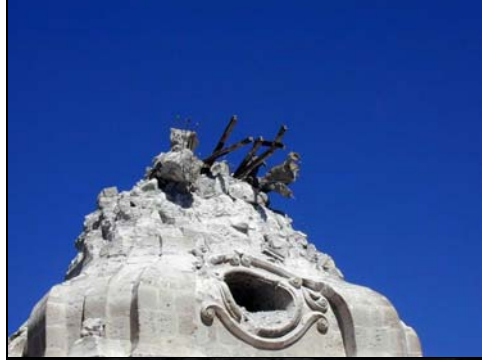
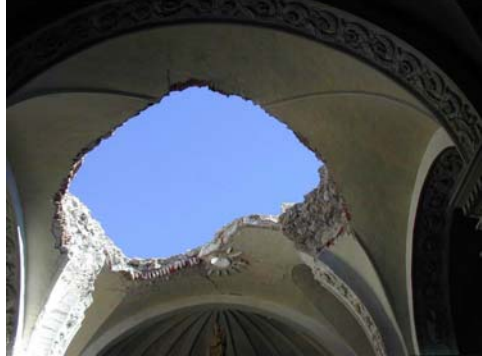
Figures 8, 9, 10, 11. Cathedral of Arequipa. [Clockwise starting above] View from the main square (Plaza de Armas); view from the roof; bent rails used to support the upper tower; collapsed tower punctured the vaulted dome above the main altar. (Photos by E. Fierro)

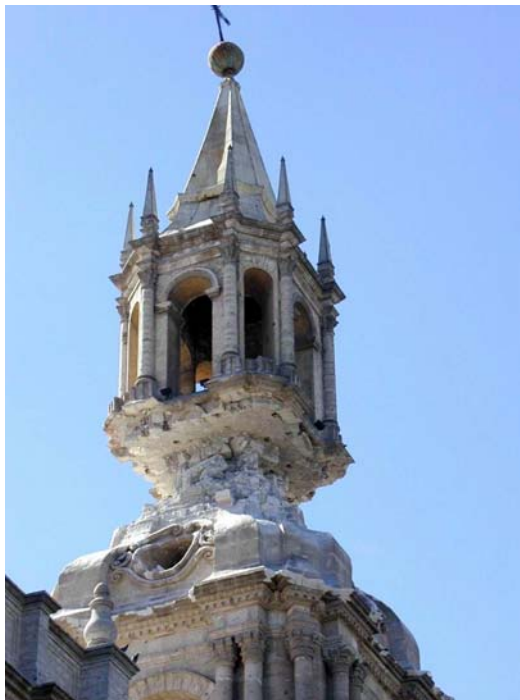
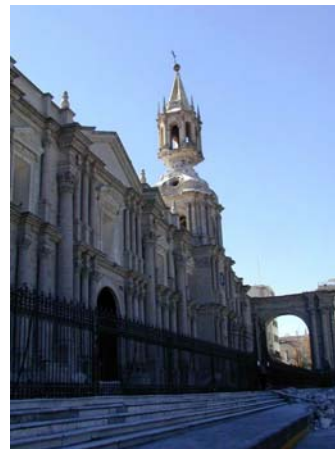
Figures 12 and 13. The precarious tower is supported by four 35 cm by 35 cm concrete columns and four steel rails. One of the steel rails buckled. Arches attached to the main structure were also damaged. (Photos by E. Fierro)

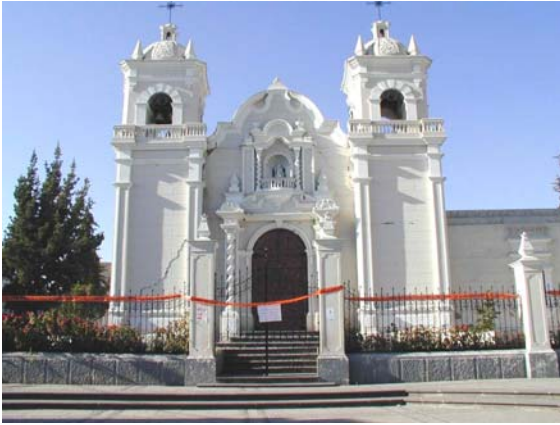
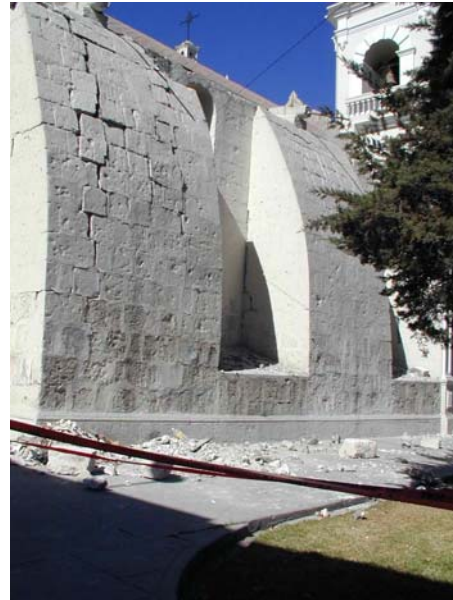
Figures 14 and 15. Church of Santa Marta; towers pulled away from the main structure. Buttresses supporting the main structure show signs of distress. (Photos by E. Fierro)

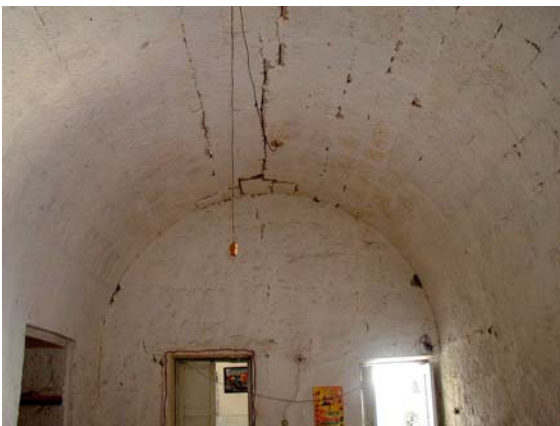
Figure 16. Typical historic dwellings with vaulted roof. (Photo by E. Fierro)

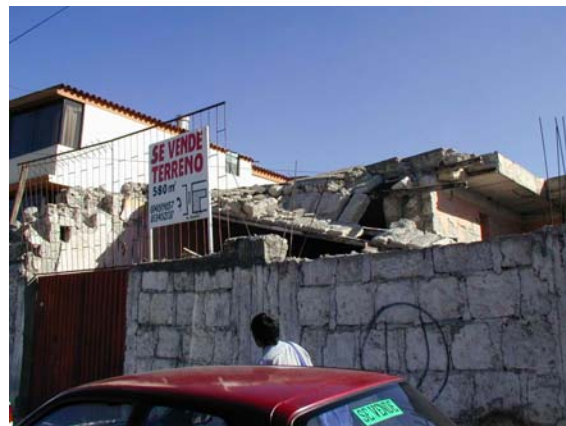
Figure 17. Rail supported “sillar” roofs suffered widespread damage. (Photo by E. Fierro)

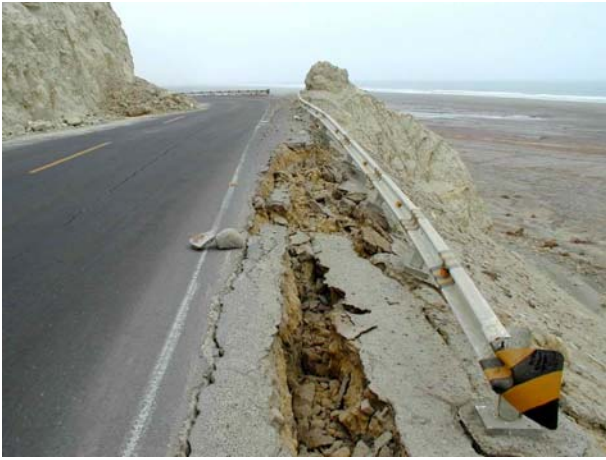
Figure 18. The Pan-American Highway south of Camaná sustained damage; no warning signs posted. (Photo by E. Fierro)

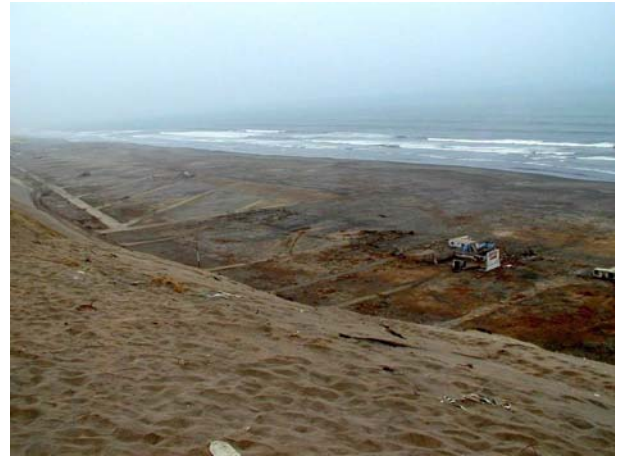
Figure 19. Tsunami swept away wooden summer houses over a 10 Km stretch of coastline between Camaná and Ocoña. Note the barren streets remaining. (Photo by E. Fierro)

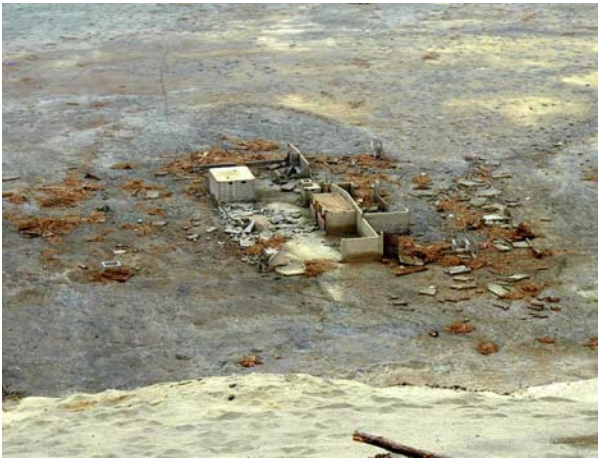
Figure 20. Tsunami damage near Camaná; wreckage remaining from masonry house damaged by tsunami. (Photo by E. Fierro)

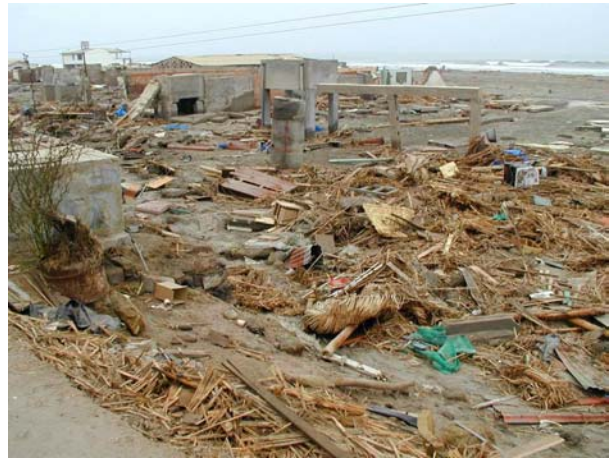
Figure 21. Tsunami damage near Camaná; about 30 Km of the coastline was heavily affected by the tsunami. (Photo by E. Fierro)

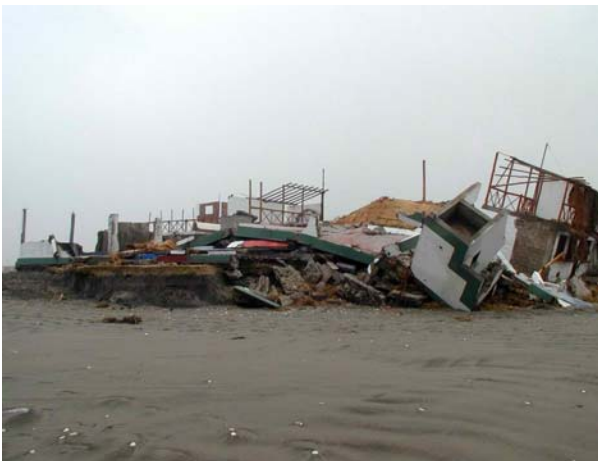
Figure 22. Tsunami damage near Camaná; collapse of beachfront property due to foundation failure. (Photo by E. Fierro)

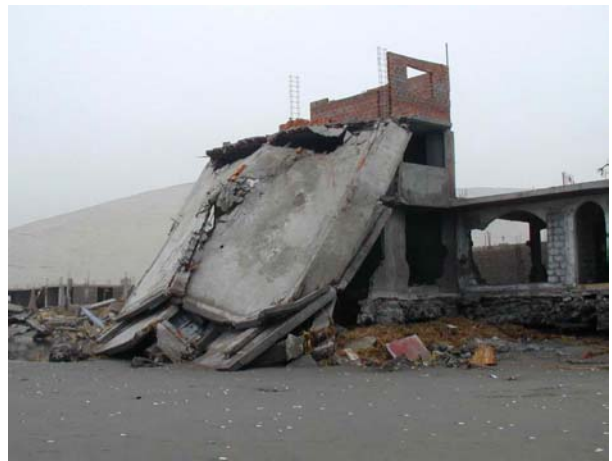
Figure 23. Tsunami damage near Camaná; foundation failure. Note the undamaged wall at top story indicating relatively weak ground shaking. (Photo by E. Fierro)

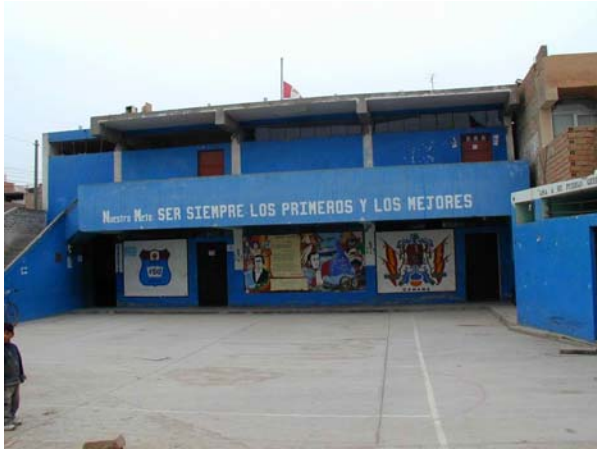
Figure 24. An old school in Camaná. Three columns failed in shear. (Photo by E. Fierro)

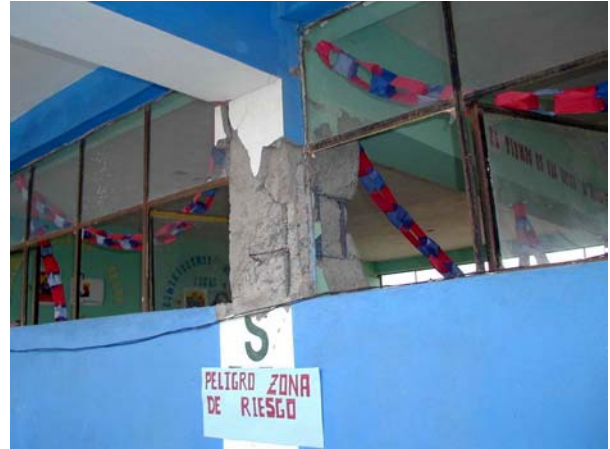
Figure 25. One of the failed columns at school shown in Figure 24. No special reinforcement in the short-column area; wide spacing of transverse reinforcement. (Photo by E. Fierro)

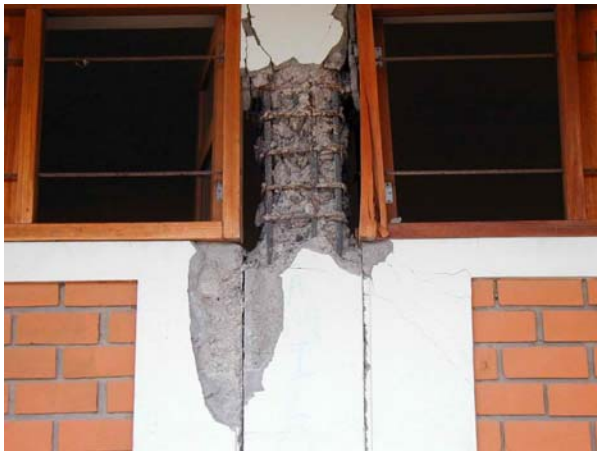
Figure 26. Short column at another school in Camaná. Even #3 at 4 in. o.c. transverse reinforcement did not prevent heavy damage. (Photo by E. Fierro)

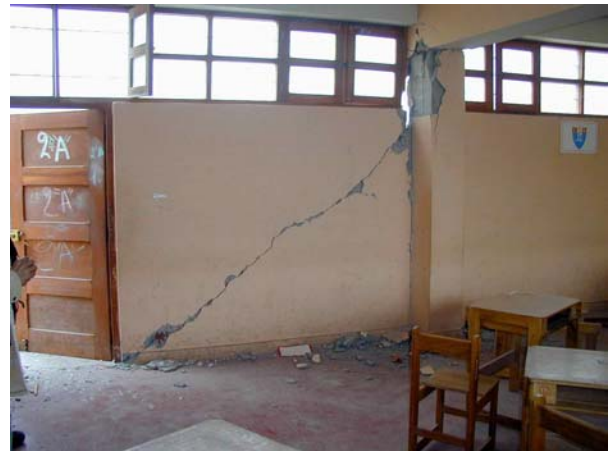
Figure 27. Another short column condition at school shown in Figure 26. Damage to both masonry infill and to short column. (Photo by E. Fierro)

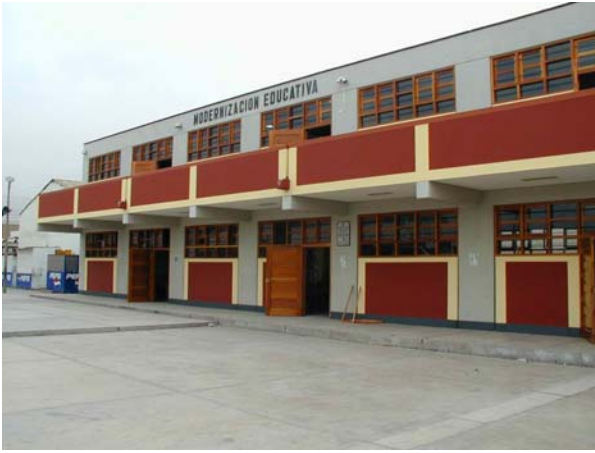
Figure 28. This school in Camaná built using the new Peruvian code did not suffer any damage. (Photo by E. Fierro)

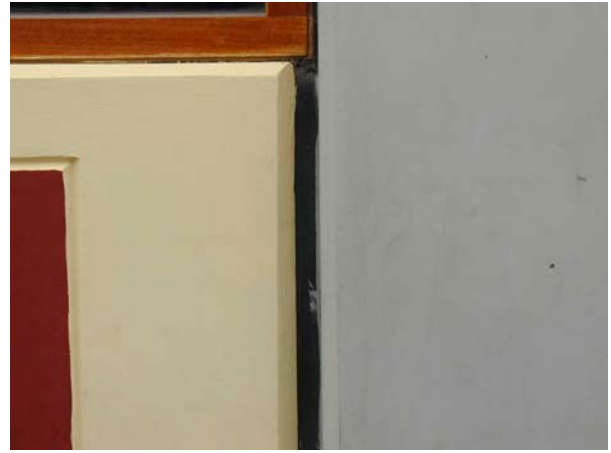
Figure 29. The walls were separated from the reinforced concrete frames by an elastomeric material to avoid short-column configuration. (Photo by E. Fierro)

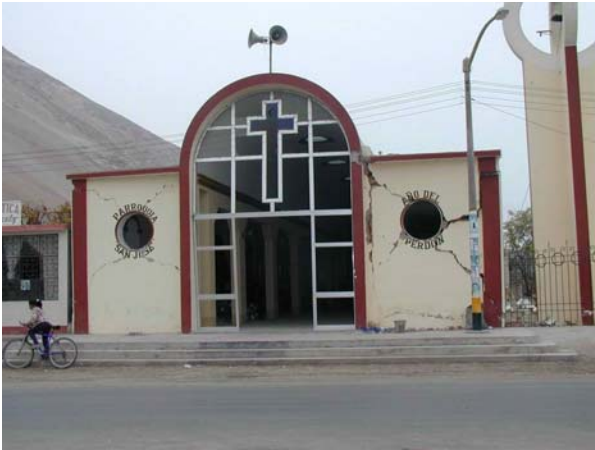
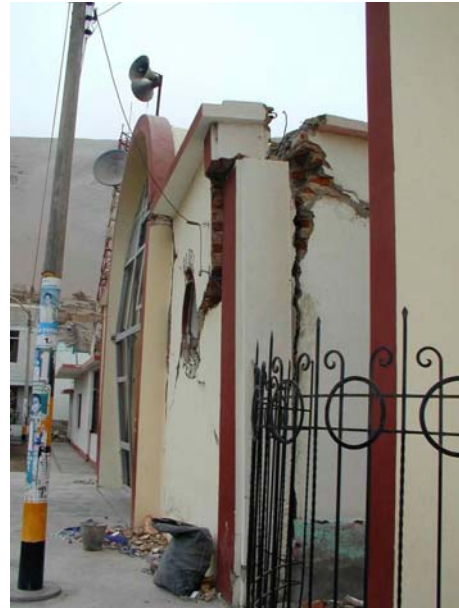
Figures 30 and 31. Church in Ocoña built using very poor construction materials; both the mortar and brick were weak. Previously damaged and patched following earthquake 4 years ago. (Photos by E. Fierro)
