**MASSACHUSETTS INSTITUTE OF TECHNOLOGY
HAYSTACK OBSERVATORY
WESTFORD, MASSACHUSETTS 01886**

September 30, 2022

To: EDGES Group
From: Alan E.E. Rogers
Subject: Contact corrosion as a probable cause of intermittent S11 observed at Devon Island

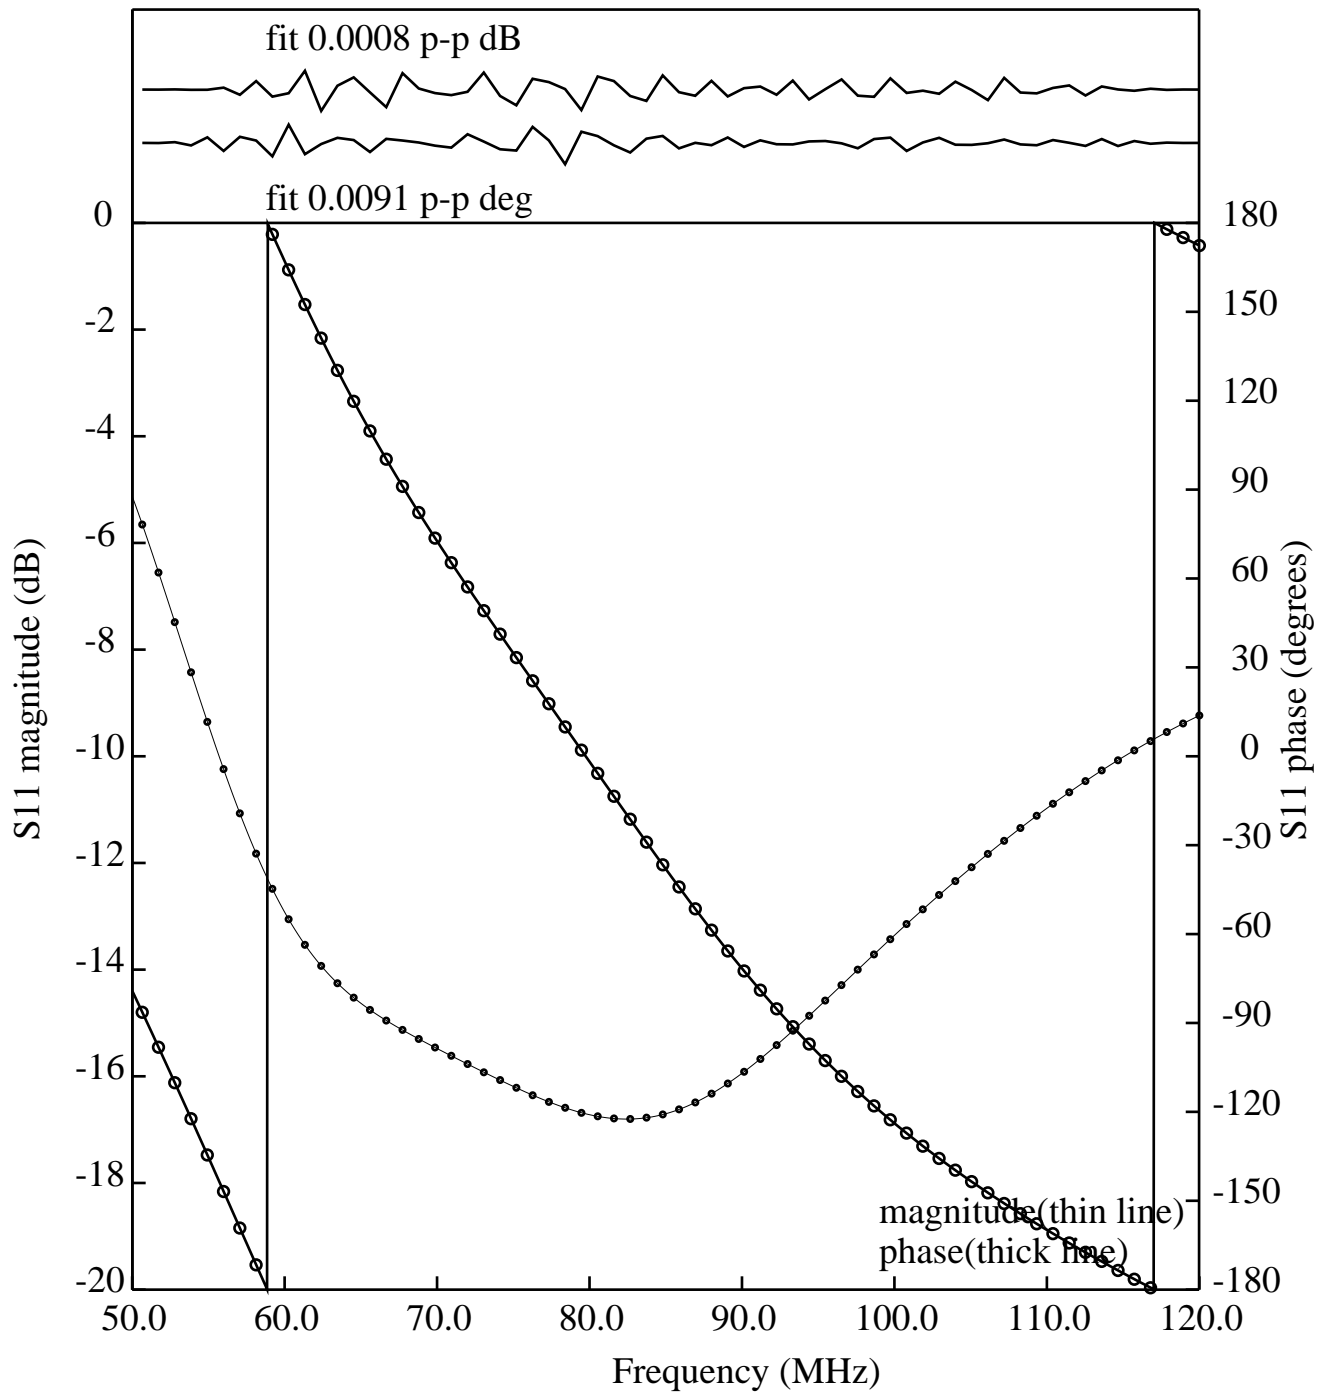
Figure 1 shows the antenna S11 taken on day 235 at 14 hrs UT and Figure 2 shows the antenna S11 taken at 8 hours which is close to the S11 from a FEKO simulation shown in Figure 3. The simulation was made for an added 0.05 microH inductance to the antenna port to account for the inductance of approximately 2.5 inches of 0.9 mm inner conductor of the 0.141 semi-rigid coax cable to the 3-position switch ground which would result from the missing ground at the front panel. The spectrum for day 233 in Figure 11 of memo 397 shows the “resonances” at about 72 and 104 MHz which occurred in addition to the large change in S11. These resonances are most likely the result of the increased coupling to the inside of the electronics box which would also have resulted from the missing ground connection at the front panel.

Figure 1. Antenna S11 from EDGE-3 on Devon Island day 235 at 14 hours UT.

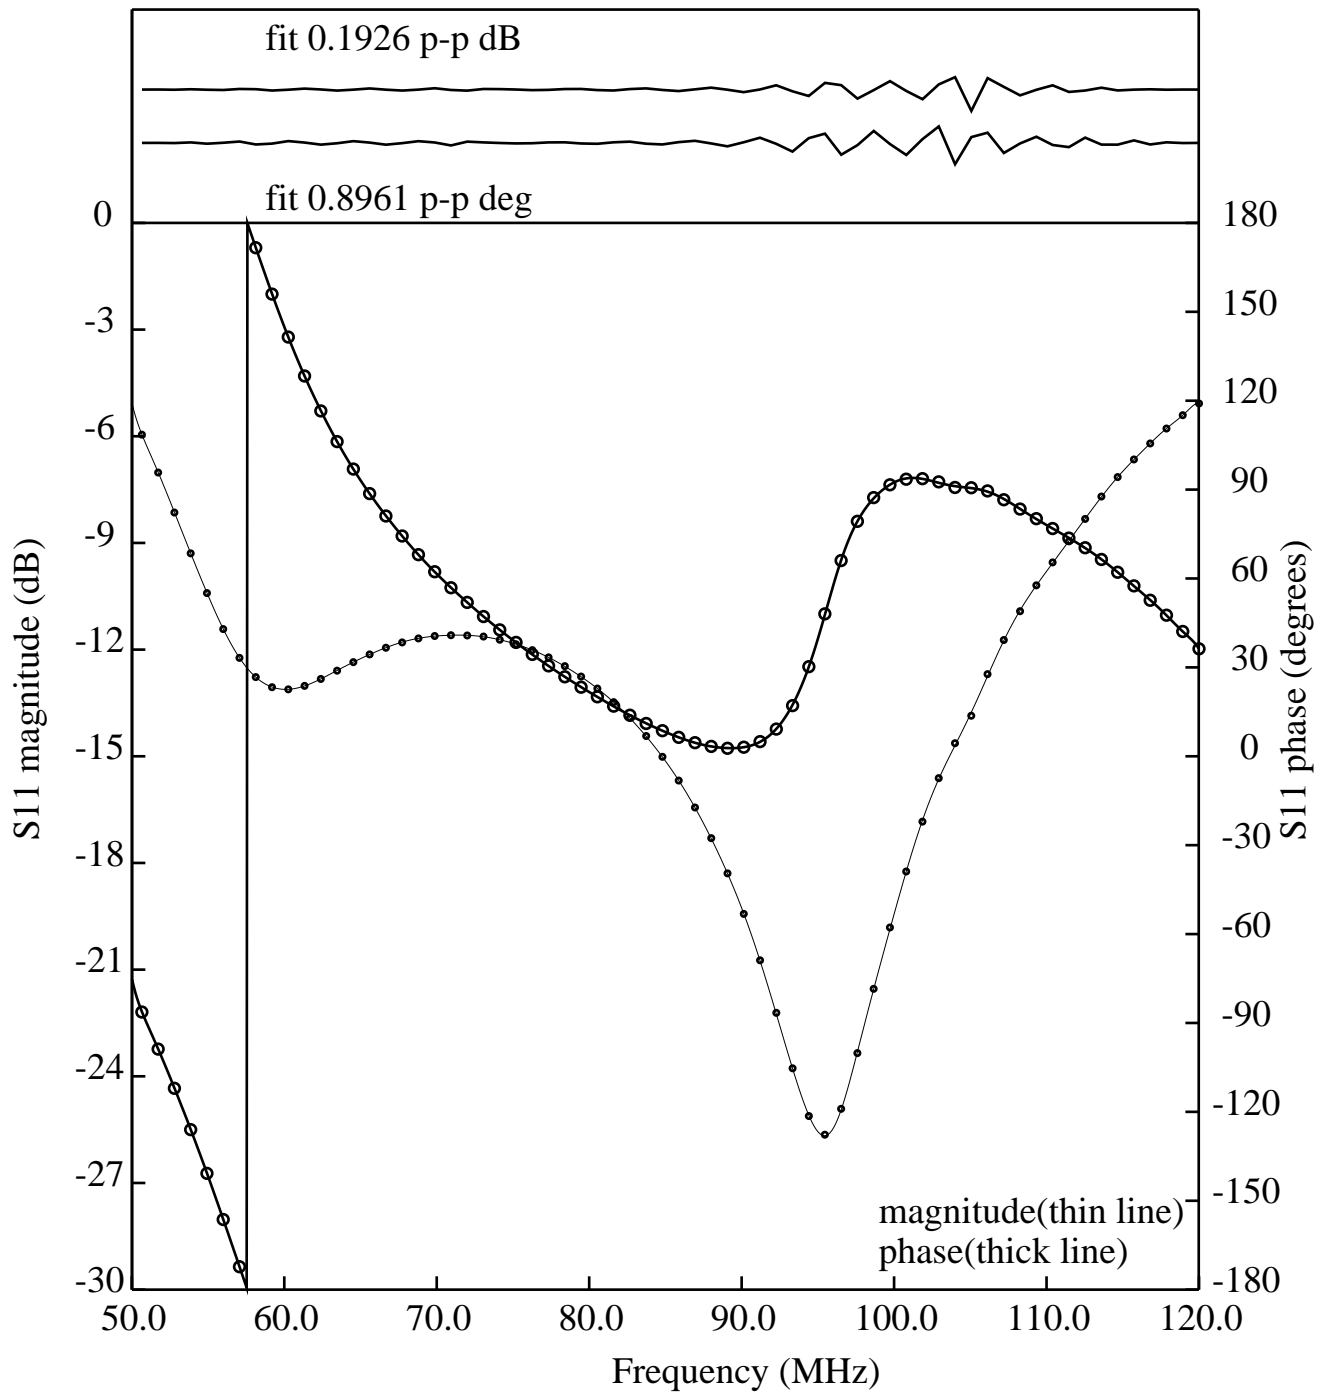
Figure 2. Antenna S11 on day 235 at 08 hours showing large change from the expected S11

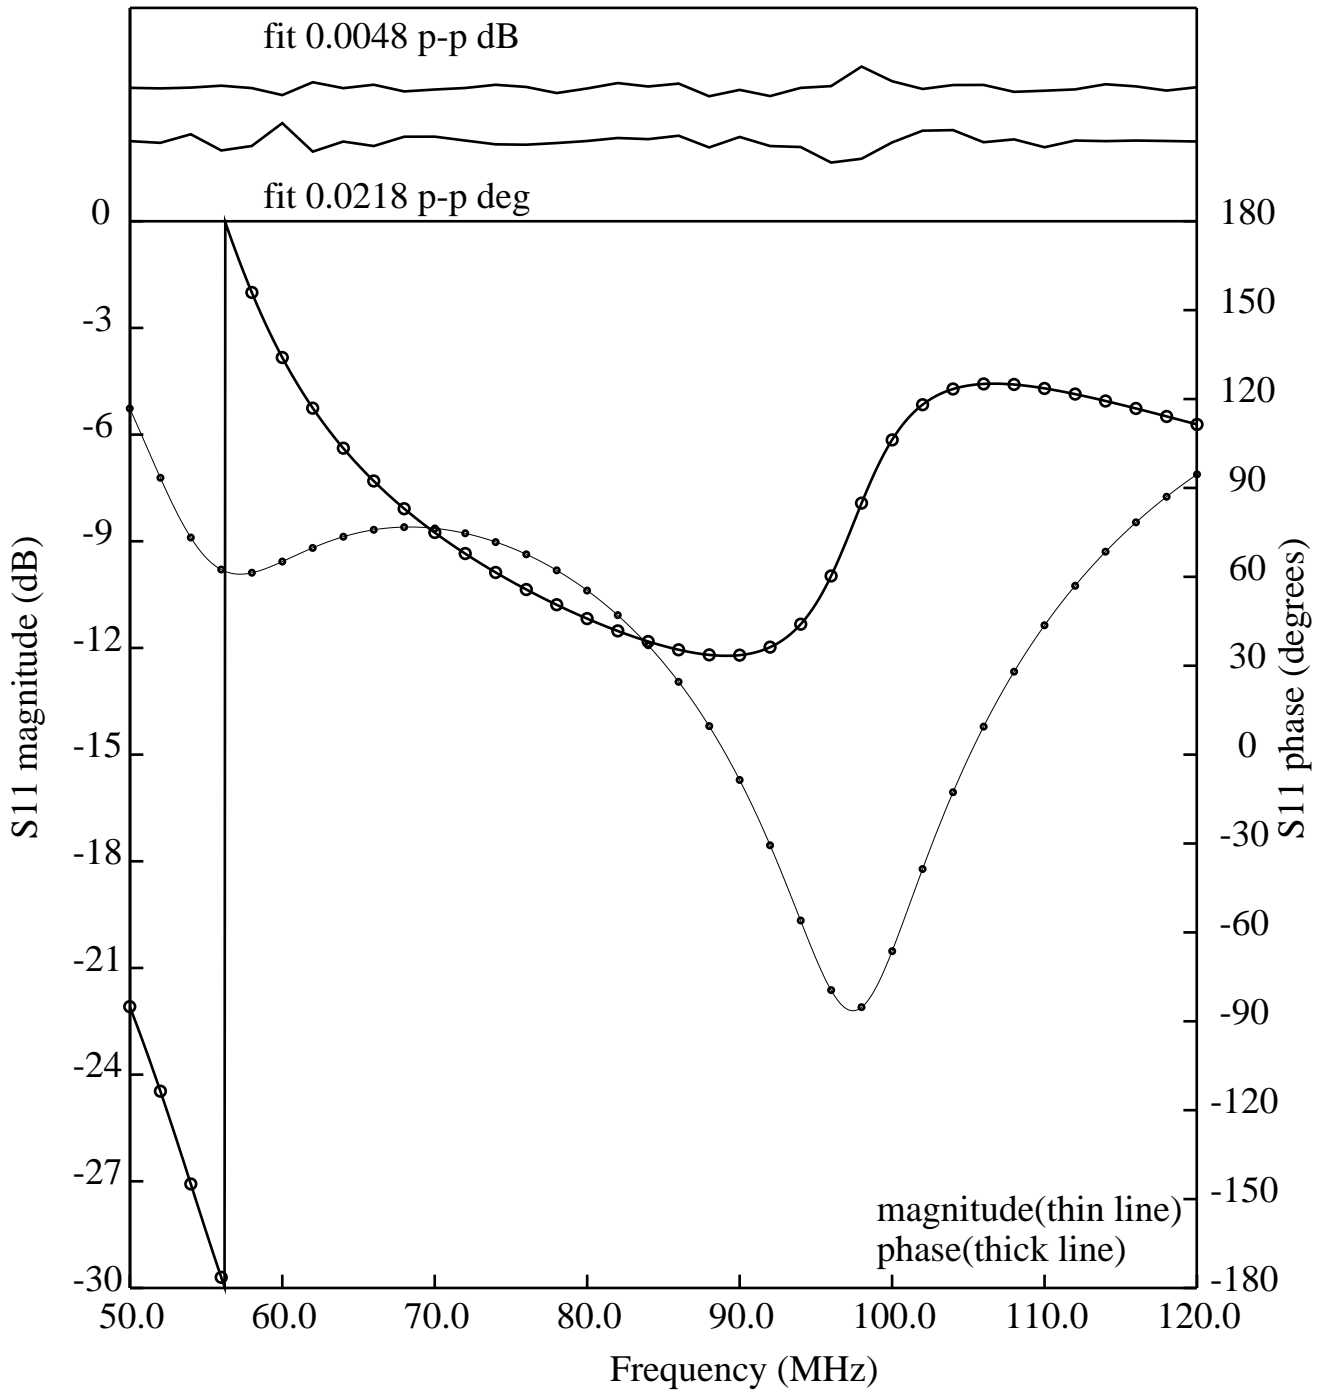
Figure 3. FEKO simulation of antenna S11 with ground connection at 3-position switch

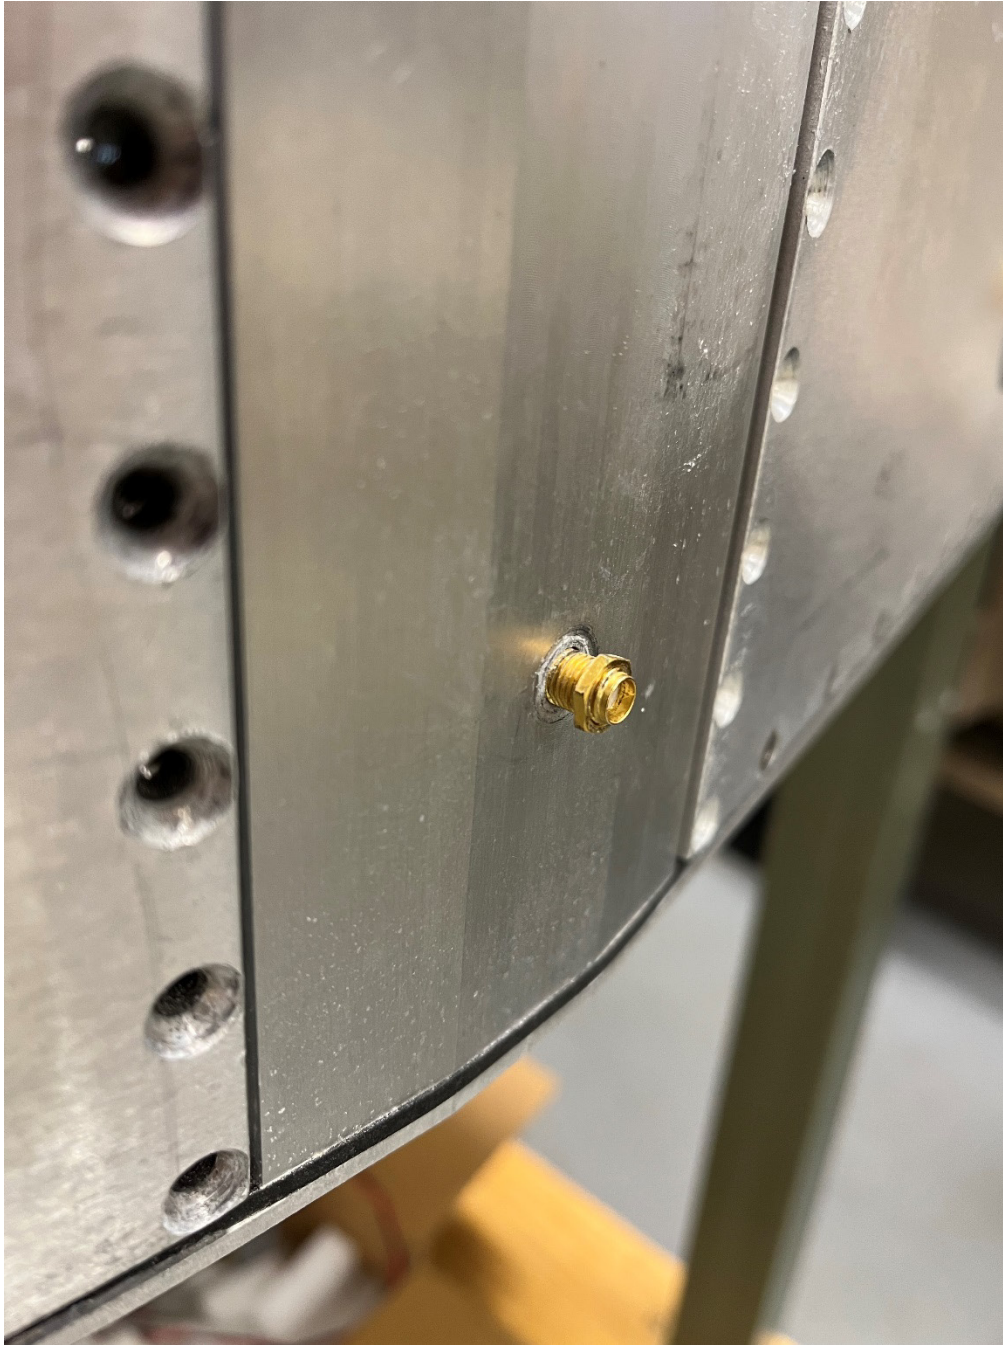
The large intermittent change in the EDGES-3 S11 which started at about 20 UT on day 233 reported in memo 397 was studied upon return of the antenna to Haystack. Initial tests of the resistance reported in memo 397 found a high resistance of 8 ohms between the chase nipple conduit and the box panel even though it was tightly screwed into the bottom plate. This detection of high resistance was an indication the corrosion is occurring in critical places. A look at the SMA input showed that corrosion may also have taken place on the SMA connection to the middle front panel but this could not be determined with a resistance check with a 2-terminal ohmmeter because a connection to ground is present at the 8-position switch in the front end box.

Figure 4. Photo of corrosion following the unscrewing of the nut on the SMA connector

As a result of this observed corrosion the front panel of the box will be counter sunk by an amount TBD (as suggested in figure 14 of memo 300) to allow the addition of the lockwasher of the SMA female Amphenol 132106 connector, which had been omitted to expose enough threads to connect to the other antenna box. In addition we should consider using an anti-oxident like Noalox on critical connections like the SMA input and pipe attachment pipes during the assembly of EDGES-3.
