Observations of MMOD Impact Damage to the ISS

James L. Hyde⁽¹⁾, Eric L. Christiansen⁽²⁾, and Dana M. Lear⁽²⁾

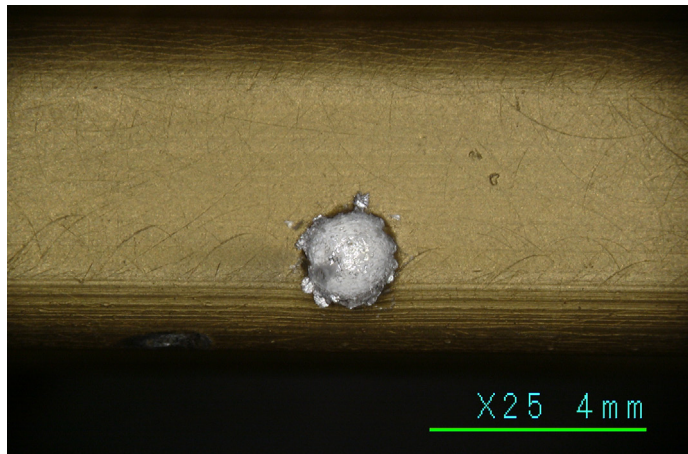
Fig. 1. MMOD impact crater on ISS handrail

Figure 1 illustrates one of the many MMOD craters observed on EVA handrails. Because the handrails are aluminum, the sharp edges that occur at the lips of the MMOD craters have caused cuts in the outer layers of EVA gloves and fingertips [6]. One cut glove example resulted in an early end to an EVA during the STS-118 mission (Fig. 11). Consequently, the EVA gloves were reinforced to reduce the risk of cuts from sharp edges of MMOD craters. In addition, a clamp was designed and used to isolate craters on handrails in highly traveled areas of ISS, such as near the airlock egress/ingress hatch. Figure 12 illustrates another MMOD crater found on a D-handle EVA tool that measured nearly 5 mm across. This tool had been stored on the ISS exterior, and was brought inside and repaired by the crew prior to use in March 2008, using adhesive tape wrapped around the MMOD damage.

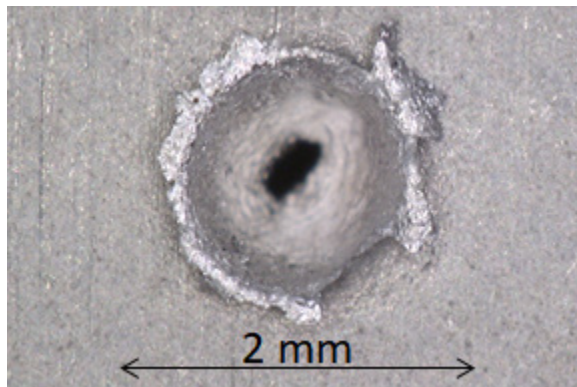
Fig. 5. Impact crater in aluminum MPLM shield

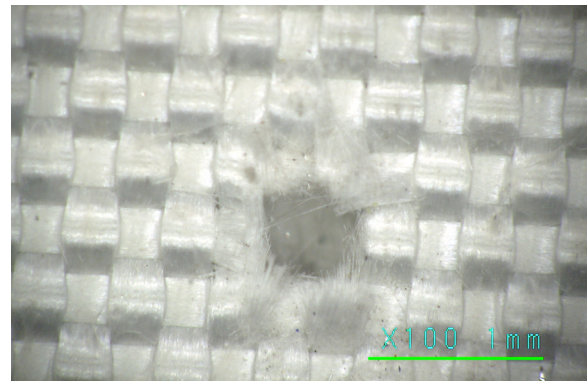
Fig. 6. Impact feature in betacloth

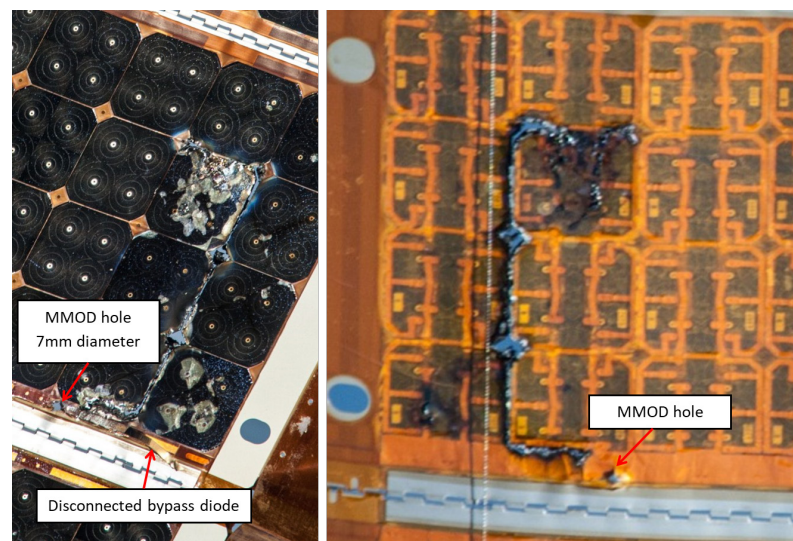
There are eight US solar array wings (SAWs) on ISS, each of which contain two solar array blankets and a supporting mast measuring 35 m long and 12 m wide. Many hundreds of MMOD craters and penetrations are apparent in high-resolution photos of the arrays. Figure 7 shows one of the largest damages observed on an ISS solar array due to MMOD impact, although most of the damage occurred from heating after MMOD impact on the solar array. A 7 mm diameter MMOD perforation resulted in a severed by-pass diode, which is a circuit device that protects a solar array string in normal operation. Because the by-pass diode was broken, a buildup of current occurred within the string and caused severe over-heating of the solar array in a local area, resulting in a nearly 40 cm long burn-through along the edges of 3 cells. The result of this excess heating was failure of an entire string of solar cells containing 400 cells. Although this is not a major loss considering there are over 250,000 cells in total for all SAWs, Fig. 8 illustrates other similar damage to the solar arrays. The steady degradation of power generated from the ISS solar arrays over time, due to MMOD and other causes, has necessitated planning to augment the ISS solar arrays in the future with additional solar array panel overlays.

Fig. 7. Damage observed to ISS solar array 3A, panel 58 (cell side on left, Kapton backside on right). Note by-pass diode is disconnected due to MMOD impact.

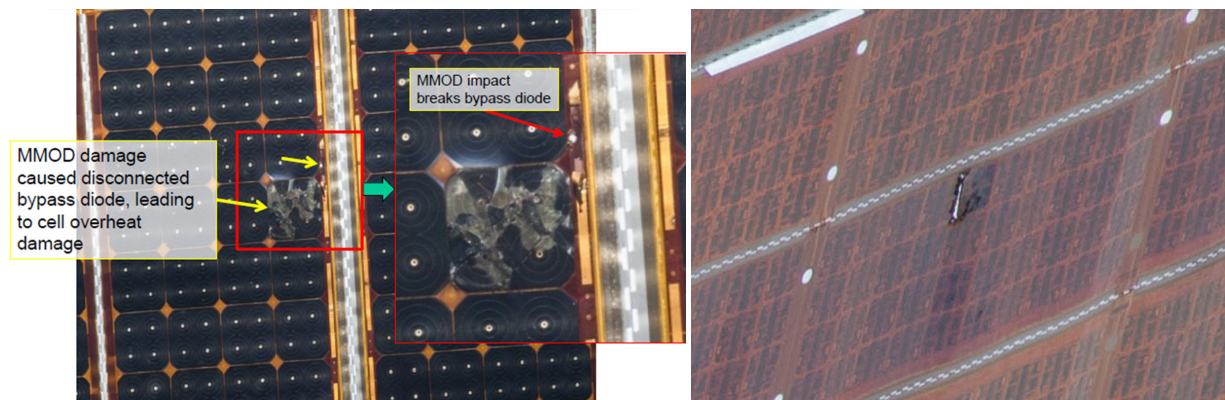
Fig. 8. Additional examples of ISS solar array overheat damage. On left, an MMOD strike caused a disconnected bypass diode resulting in loss of a string on solar array 2A panel 66. At right, an observed burn-through in solar array 3A panel 42; although no obvious MMOD damage is apparent, a failed bypass diode is a possibility.

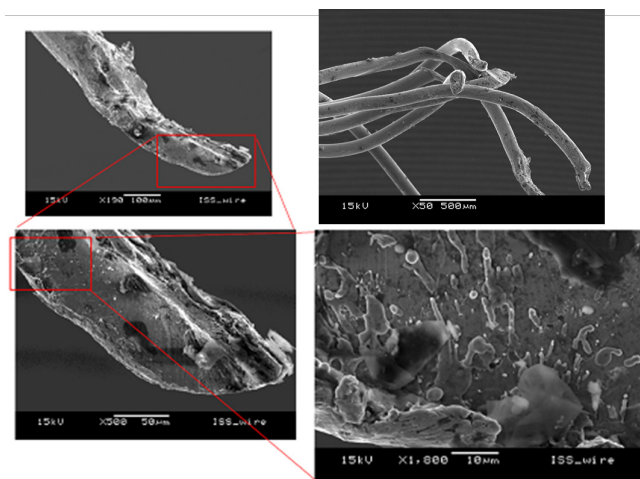
Fig. 10. The guidewire contains 21 twisted steel wires, seven (7) of which were severed. The lower images illustrate melted material at the ends of several of the severed wires, clearly indicating hypervelocity impact damage.

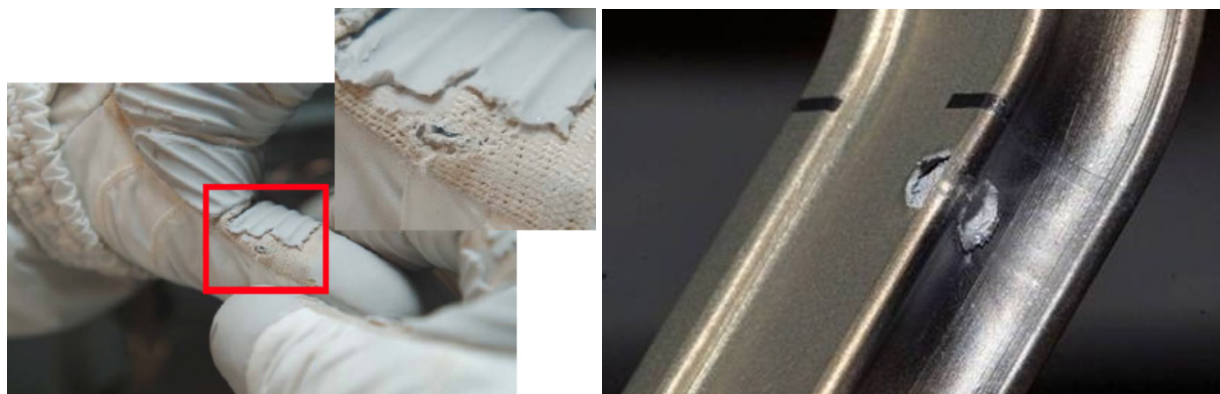
Fig. 11. Cut in outer layer of EVA glove (STS-118). Fig. 12. Crater and detached spall on EVA D-handle tool.

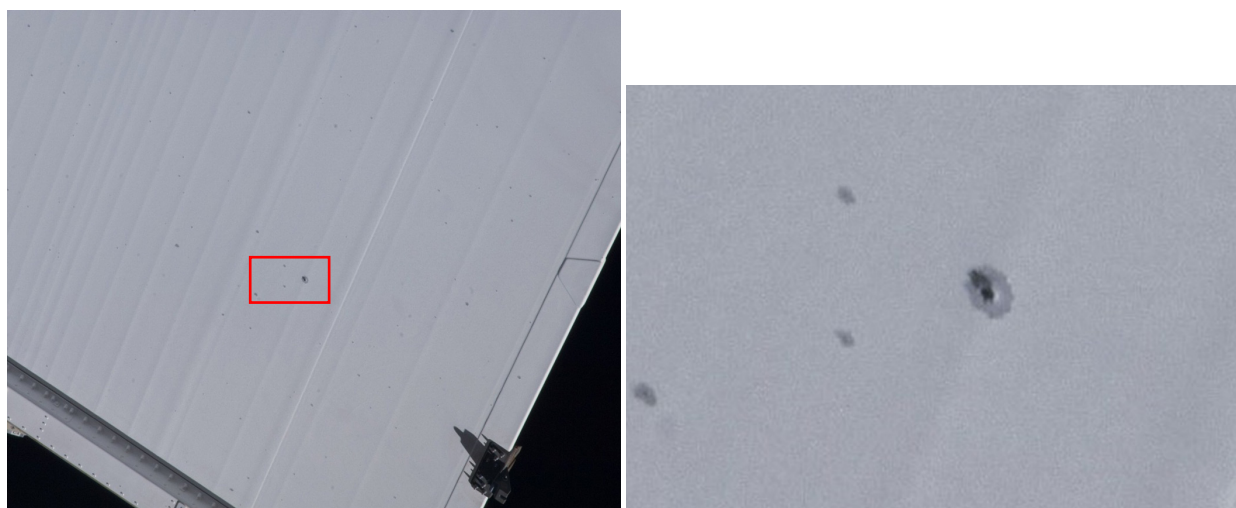
Figure 13 shows one of the ISS radiator panels, with several MMOD impacts observed on the radiator surface. The ISS radiator coolant flow-channels had been hardened before flight by locating the lines in the interior of the radiator panel [7] (not adjacent to the outer face sheet, which was common practice prior to ISS). So far, MMOD impacts have not been confirmed as the cause of any of the coolant leaks that have occurred to the thermal control system to-date. The largest damage observed on ISS radiators from MMOD impact (Fig. 14) measures 13cm by 10cm, with coolant flow channels visible, but unbroken.

Fig. 13. Surface of one ISS radiator panel photographed during increment 36 (dark spots are typical MMOD damages). Red outline area expanded on right.

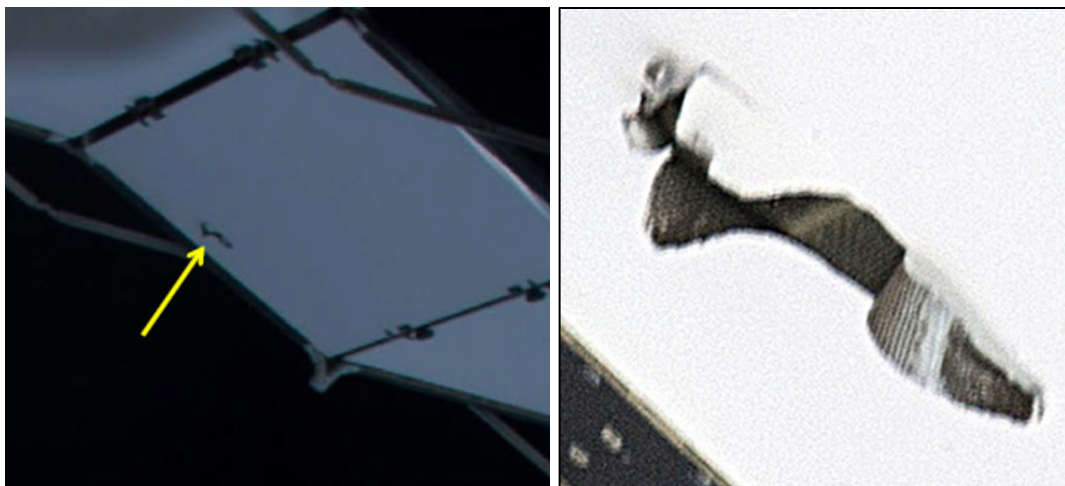
Fig.14. MMOD damage located on port photovoltaic radiator panel (exit damage).

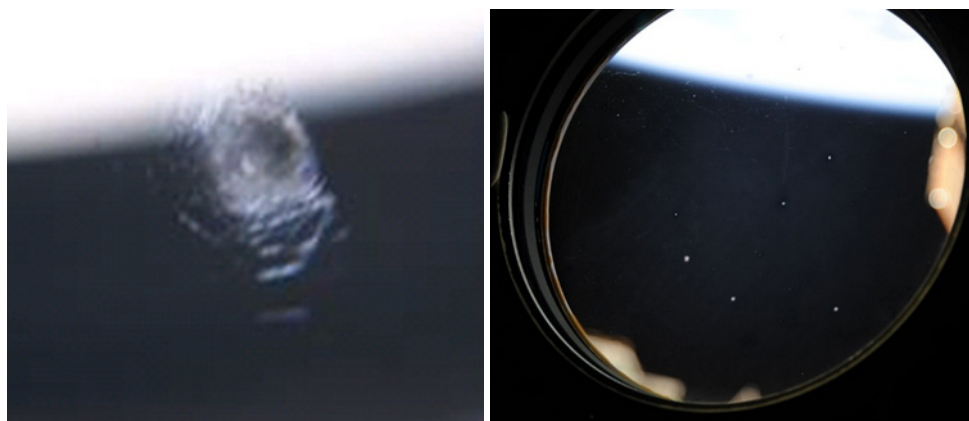
The current ISS configuration (late 2019) has 36 windows on nine different modules, usually consisting of multiple glass panes with the outer pane typically of silica glass. External shutters often (not always) protect the glass from MMOD damage [8]. MMOD strikes have occurred to the ISS windows leaving a crater on the exterior surface of the outer pane. None of these impacts have left more than a crater on the outer pane. Figure 15 shows a 3 mm to 5 mm diameter impact crater that occurred to window #7 on the Russian Service Module Zvezda.

Fig. 15. ISS window port on right. Service Module window #7 damage on left.

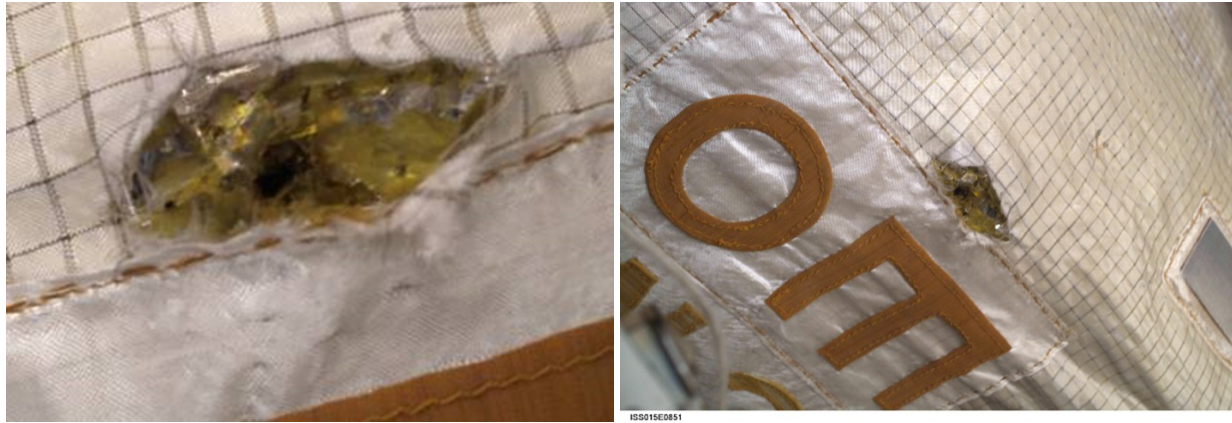
During Russian EVA-19 (7 June 2007), the crew reported MMOD damage to FGB thermal blanket over the forward compressor measuring 30mm x 60mm in the outer fabric cover of an multi-layer insulation (MLI) thermal blanket, and a 5mm x 9mm size hole in the underlying layers of the MLI thermal blanket (Fig. 16). Based on hypervelocity impact tests, the damage appears to be from an oblique MMOD impact of a millimeter or more in diameter.

Fig. 16. FGB compressor thermal blanket MMOD damage.
