CASE STUDY AND FORENSIC INVESTIGATION OF FAILURE OF DAM ABOVE KEDARNATH

Leonardo Souza¹, Tanvi Prakash Chanekar² and Grishma Sanjay Pandit³

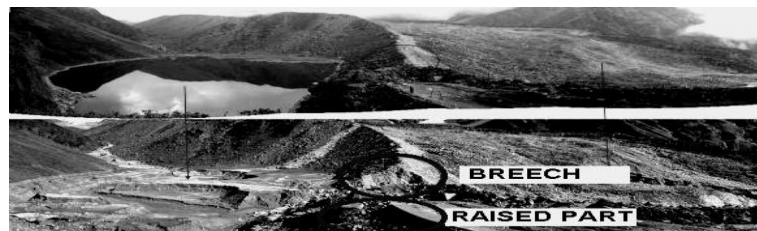
for consumption. As the area developed, the water from the Snowmelt Rivers was insufficient. The people prayed for divine intervention. It is said that one day as the parched people of Kedarnath prayed to Lord Shiva, and he sent his 'ling' down to dam the valley above Kedarnath and created a lake. Over the years the dammed portion was raised and *used for consumption*. When disaster struck it is claimed that that very giant stone (Ling) that had dammed the valley, tumbled down and came and stood between the temple and the mud flow thus protecting the shrine. A huge rock got stuck behind Kedarnath Temple and protected it from the ravages of the flood. The waters gushed on both the sides of the temple destroying everything in their path. Even eyewitness observed that one large rock got carried to the rear side of Kedarnath Temple, thus causing obstruction to the debris, diverting the flow of river and debris to the sides of the temple avoiding damage. (Wikipedia, 2016) It still stands there today a mute spectator to the destruction caused by mans greed and negligence. Deforestation and denudation of vegetation on the slope to feed the firewood-fuel-needs of the ever growing pilgrim population, hap-hazard development, unsustainable augmentation of reservoir height without provision of proper spillway and design freeboard, (see Fig. 2) and no effort to de-silt the reservoir caused and compounded this disaster.

Figure 2 the photo shows the raised part of the dam, the breach at the abutment and the silt accumulated in the dam (WIHG).

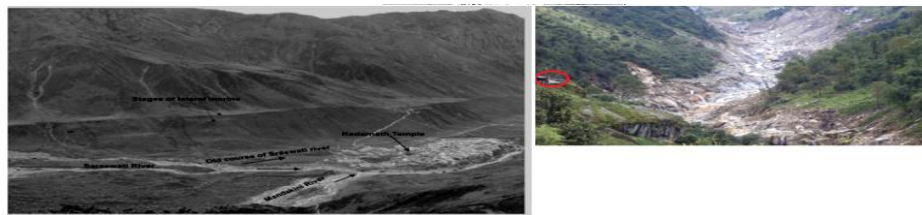
Figure 4: (a) Denuded Slope (Dobhal; May 2012 (b)Devastation of the valley See small house in middle left edge for comparison of size. (Gupta 2013)

There was very active erosion creating deep gulleys and causing excessive water and sediment accumulation in the rivers leading from that area (Fig 4). Subsequently, large volumes of water struck the towns down river which as a result of erosion simultaneously picked huge amount of loose sediment en route. The voluminous muddy water studded with debris from the surrounding regions and glacial moraines moved towards Kedarnath town, washing off all newly constructed structures that lay on and blocked the direct path of the flow - Sankaracharya samadhi, Jalnigam guest house, Bharat Seva Sangh Ashram, etc. the whole upper part of Kedarnath was buried and torn apart and leading to the biggest ever devastation ever witnessed in the region. The WIHG meteorological stations near Chorabari glacier recorded 325 mm rainfall at the base of the glaciers in two days on 15 and 16 June 2013. Due to heavy downpour, the town of Rambara was completely washed away on 16 June evening.

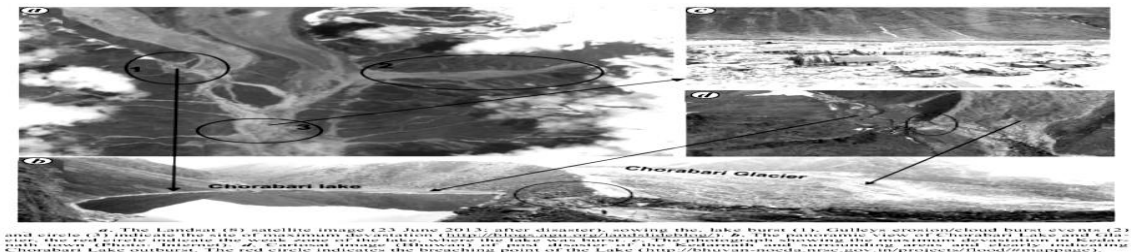
After the heavy rainfall the right lateral basin of the glacier, which is thickly covered by snow more than 2 meters thick near the upper part of lake during June 2013, rapidly melted due to rainwater allowing large amount of water accumulation in the Gandhi Sarovar lake. There were no outlets in the lake, the water was simply released through narrow passages at the bottom of the lake which were already partly blocked by silt. The sudden water accumulation blocked these passages too. Suddenly millions of gallons of water accumulated in the moraine dammed lake within 3 days, which increased their potential energy and reduced the shear strength of the dam. Ultimately the loose-moraine dam breached causing an enormous devastation in the Kedarnath valley (Figures 5 a,b,c,d & 6)

Figure 5: Shows the Devastation at Kedarnath

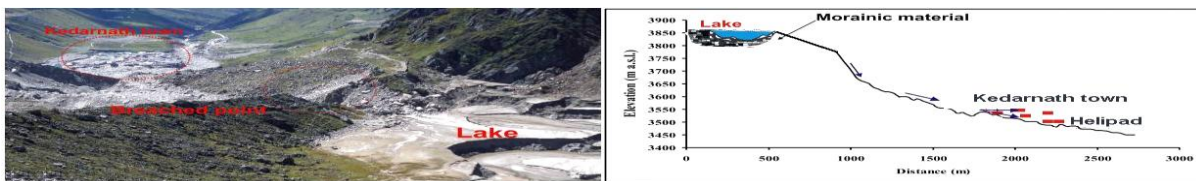
Figure 6: Showing devastation due to silt (Gupta ,2013)

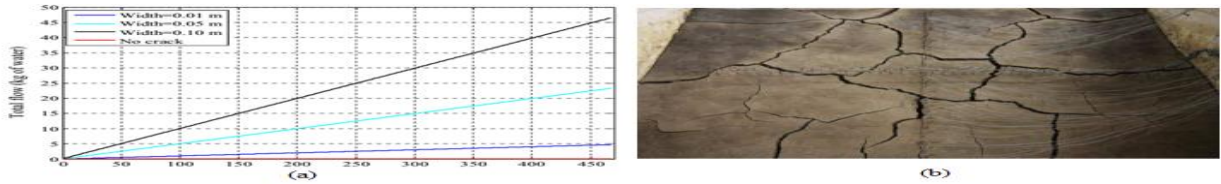
Figure 9: (a) flow v/s cracks (b) Dessication cracks (Khandelwal 2011)

The presence of cracks (fig 9b) makes the soil slopes susceptible to water seepage, erosion, loss of shear strength and consequent failures (Khandelwal 2011)

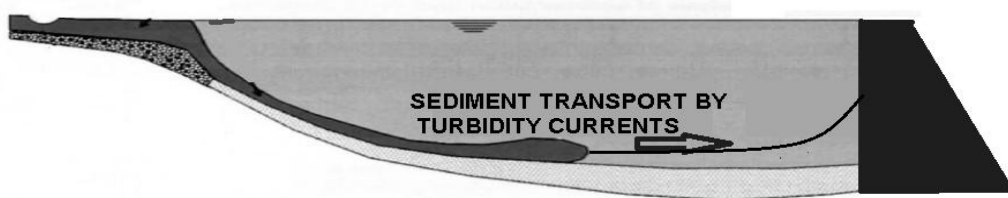
Figure 10: shows transport of sediments in dams

There is an up-wash of bottom sediments against the wall due to back pressure build up and continuity of motion (Figure 10). This causes a bowl shaped bottom that can be seen in various photographs of dried up dams elsewhere in India and internationally too.
