SERVICE LETTER

DHC3-SL-27-001

SUBJECT: DHC-3 Stabilizer Actuator Lock Ring – Special Inspection

MODEL: DHC-3 Otter

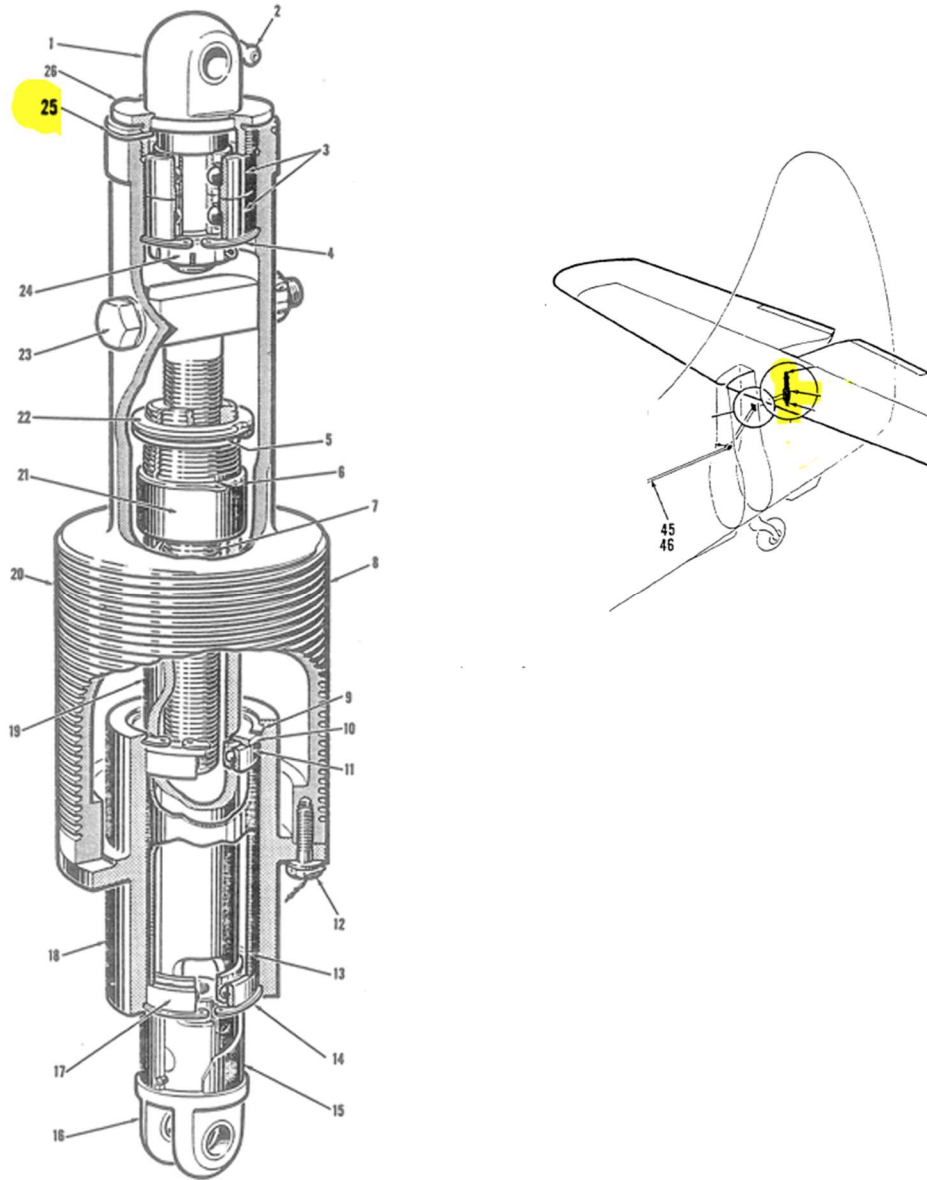
Figure 1 – Stabilizer Actuator

A missing lock ring (Item 25 in Figure 1 of this SL and PSM 1-3-2 Figure 2-18) would be identifiable from an external visual inspection (see Figure 2) by removing the stabilizer fairings. To check for full engagement of the lock ring tang (Figure 3) in the upper housing barrel and clamp nut, it may be necessary to rotate the stabilizer actuator to a suitable position using the handwheel in the cockpit.

If the lock ring is missing or not correctly installed, it is recommended that a full inspection and servicing of the stabilizer actuator be completed before further flight in accordance with PSM 1-3-5 task card C27-40-02 and PSM 1-3-2 Section 2.27, including full disassembly, cleaning, inspection, lubrication, reassembly, and installation/rigging. The lock ring part number is AN996-28 (Item 52 in PSM 1-3-4

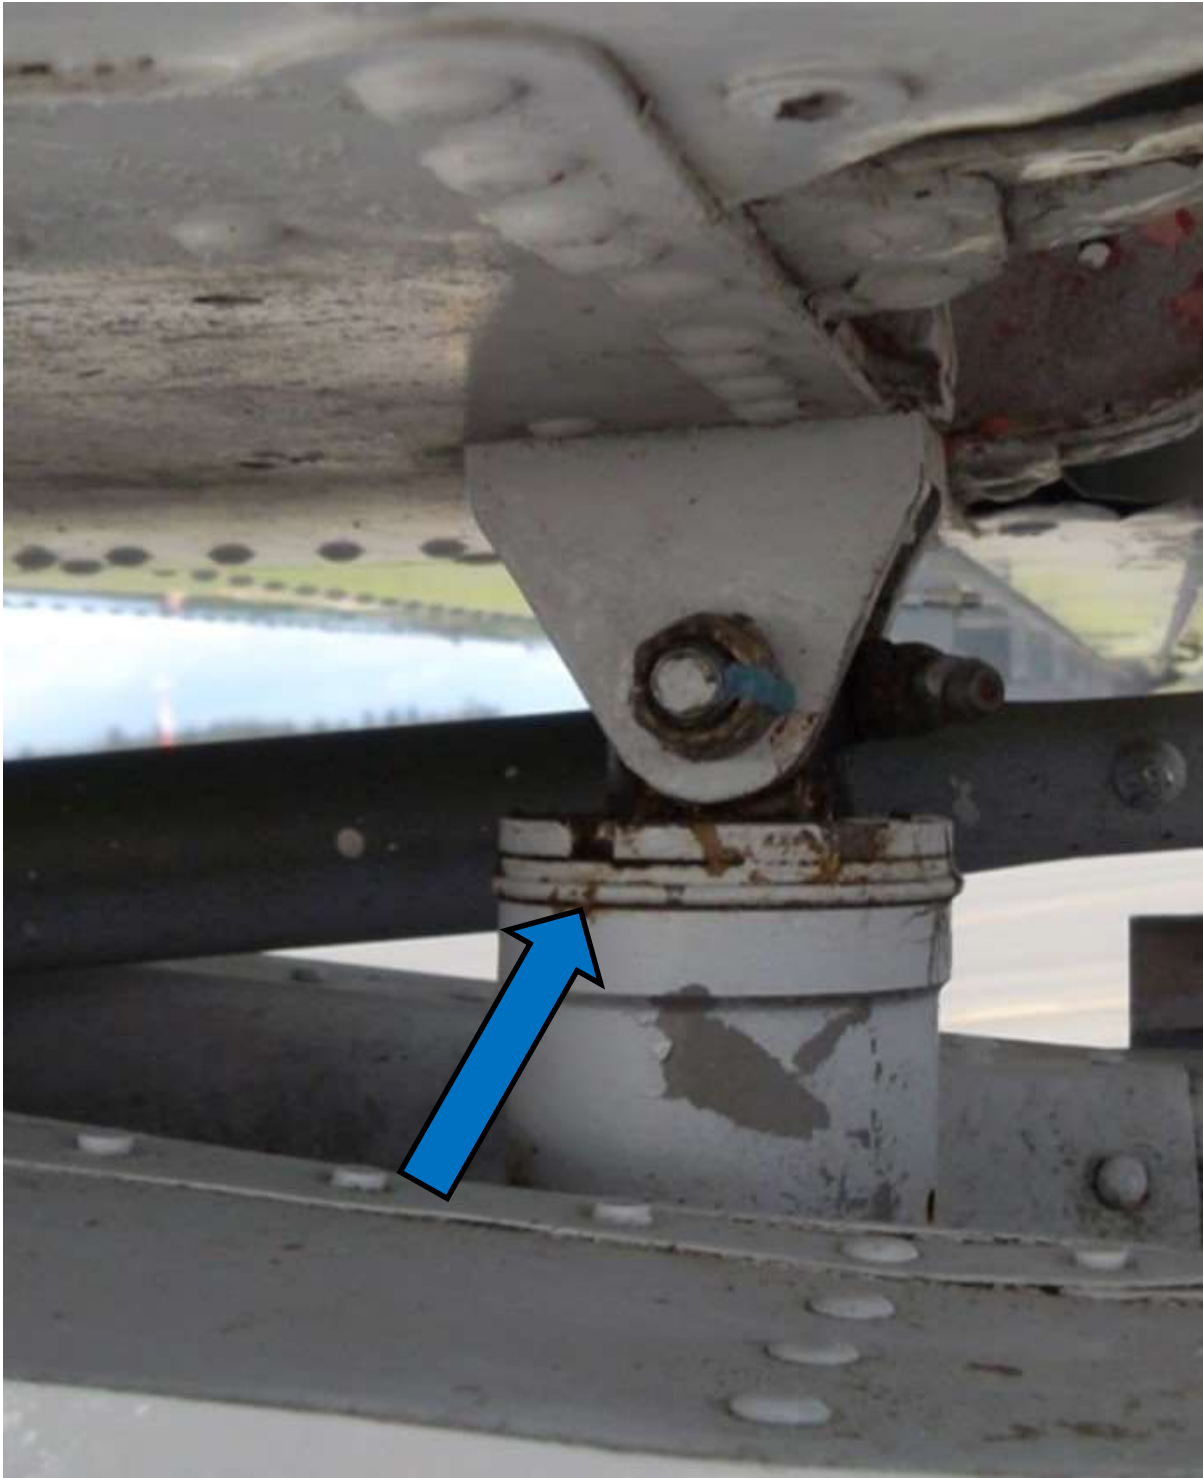
Figure 2 – Stabilizer Actuator – Upper Attachment to Stabilizer (External)

Viking recommends that all DHC-3 operators visually confirm that the stabilizer actuator lock ring is present, correctly seated in the groove in the upper housing (Figure 2) and the lock ring tang is engaged in the clamp nut (item 25 of Figure 1 and Figure 4) on all DHC-3 aircraft in their fleet upon receiving this SL, regardless of when the most recent maintenance was completed.
