MINISTRY OF INFRASTRUCTURES AND TRANSPORTS

Marine Casualties Investigative Body

COSTA CONCORDIA

Report on the safety technical investigation

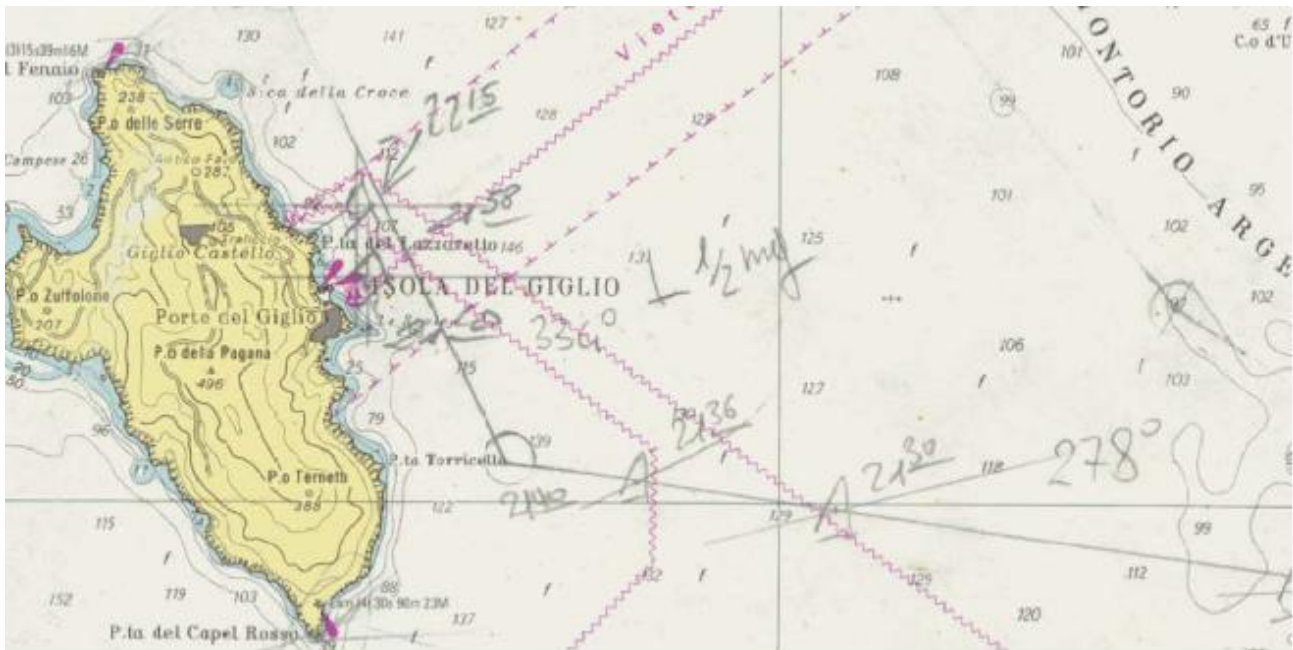
Excerpt from the chart IIM 6 recovered on board the Costa Concordia

- keeping a high speed (16 kts) in night conditions is too close to the shore line (breakers/reef);
- using an inappropriate cartography, i.e. use of Italian Hydrographical Institute. chart nr. 6 (1/100.000 size scale), instead of at least nr. 122 (1/50.000 size scale) and failing to use nautical publications;

The extract of the original chart used aboard the ship, and then recovered, shows the planned route and the boat's GPS (indicated by a triangle and time).

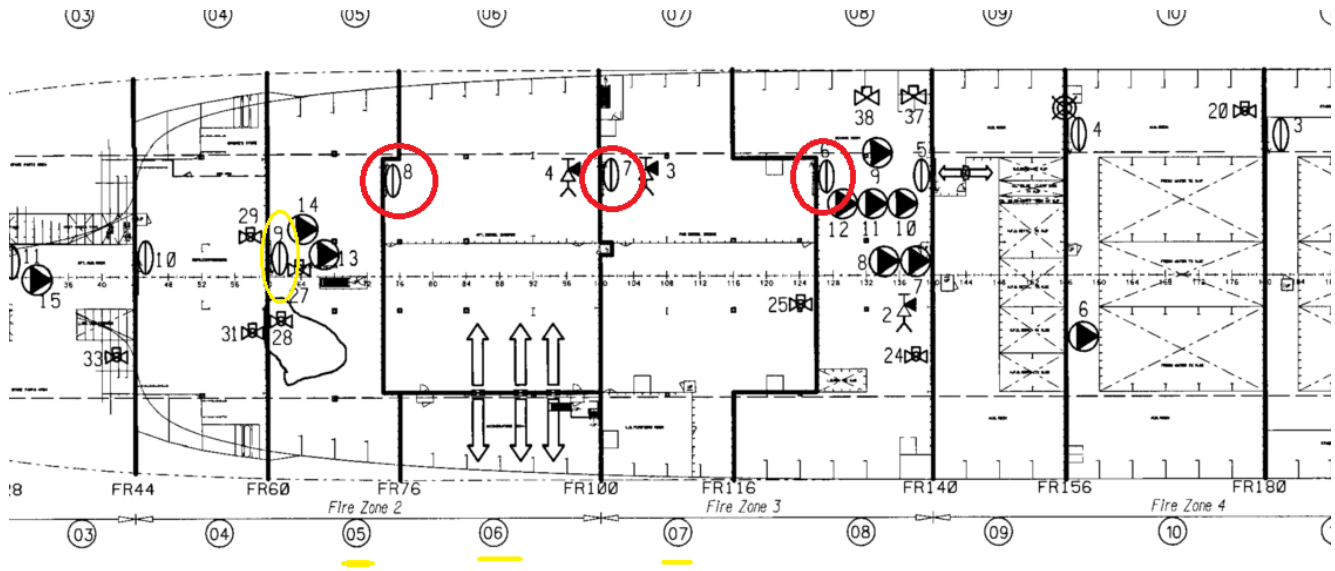
"Damage control plan" - bridge "C"

The compartments immediately affected by the flooding were, among others, 4, 5, 6 and 7 (the number 8 was flooded immediately only into the related double bottom).

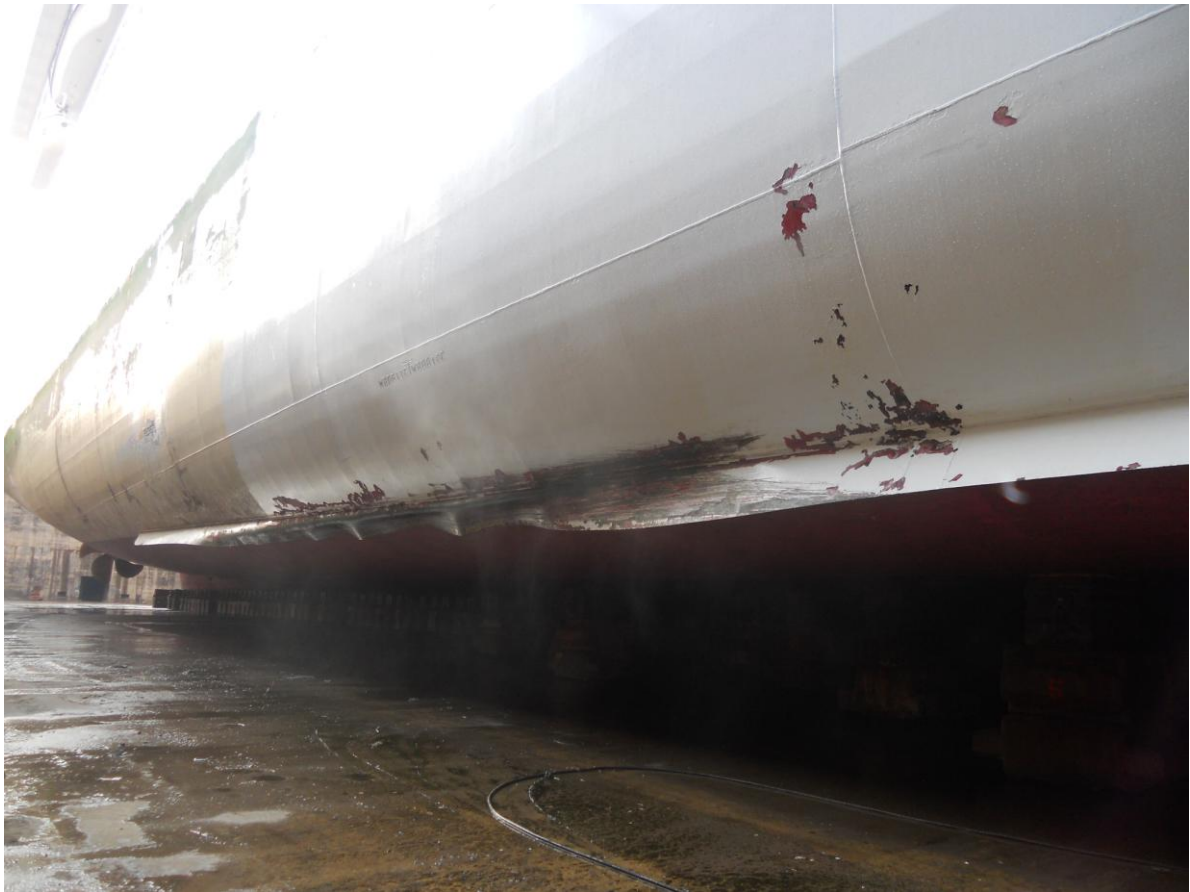
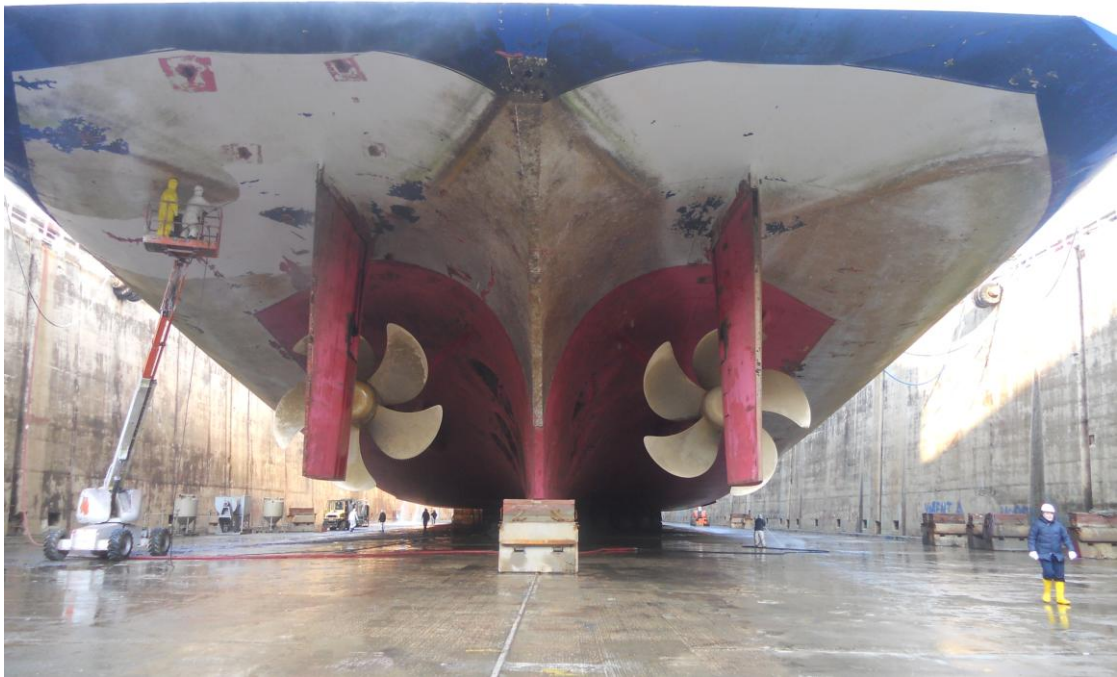
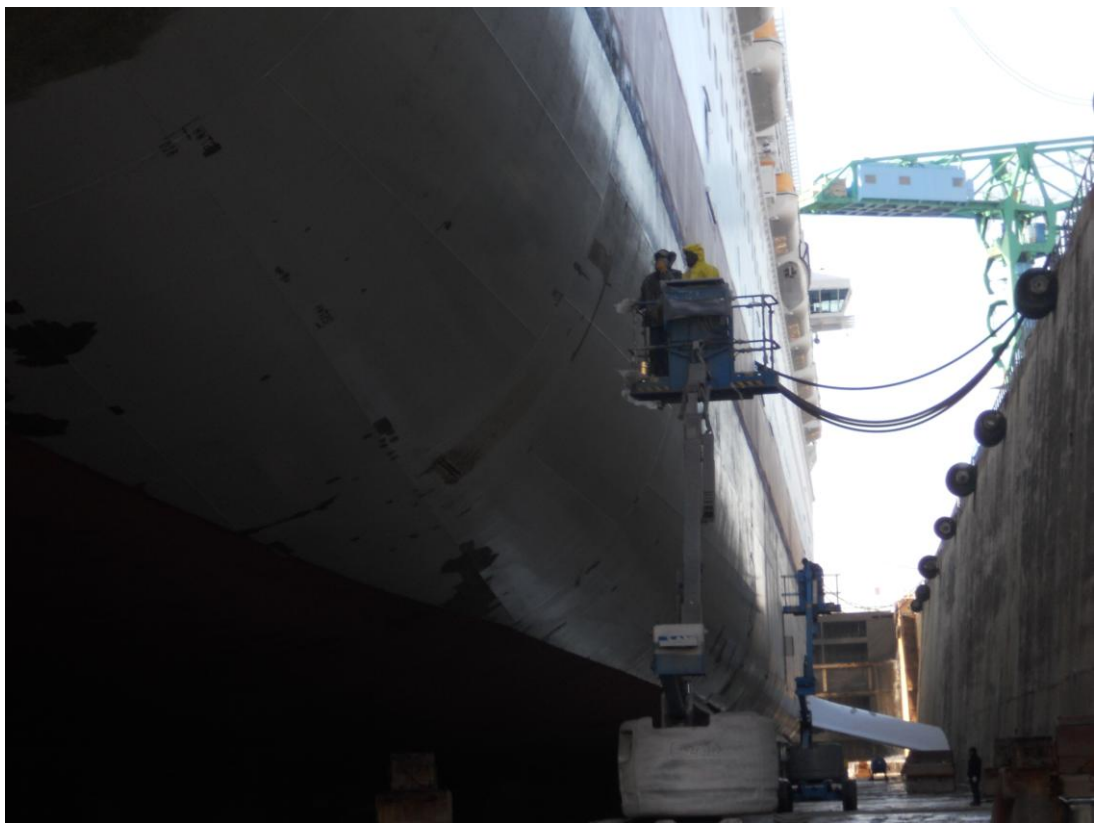
Following pictures show the hull area interested by the contact (taken from sister ship Costa Serena):

The hole on the left side upon impact, it is continuous for about 60 meters (about frames 52 to 124) located too far above the deck of the Double Bottom (so well over two meters from keel line). This was crucial in terms of severity of the accident, because rather than be hit the bottom of the ship, if the more defence due to the double hull, was vice versa affected area clear that, over the plate rail, relies directly its operating compartments (the heart). In particular, the testimonies of the 3rd Engineer Officer and 2nd Engineer Officer, as well as the 2nd Chief Engineer) - combined with audio recordings of communications between the VDR machine and Bridge - have established that in a few minutes (about 3 mins for the EMP and 7 for Diesel Generators Room. aft) the ship has lost Watertight Compartments (WC) nr. 5 and 6 (PEM and then Local DD.GG. aft), while the adjacent WC nr. 4 and 7 (respectively Compressors Galley Room and DG Room), were initially partially flooded, becoming initially dangerous free liquid water surfaces, and then completely filled after about 40 minutes from the contact.

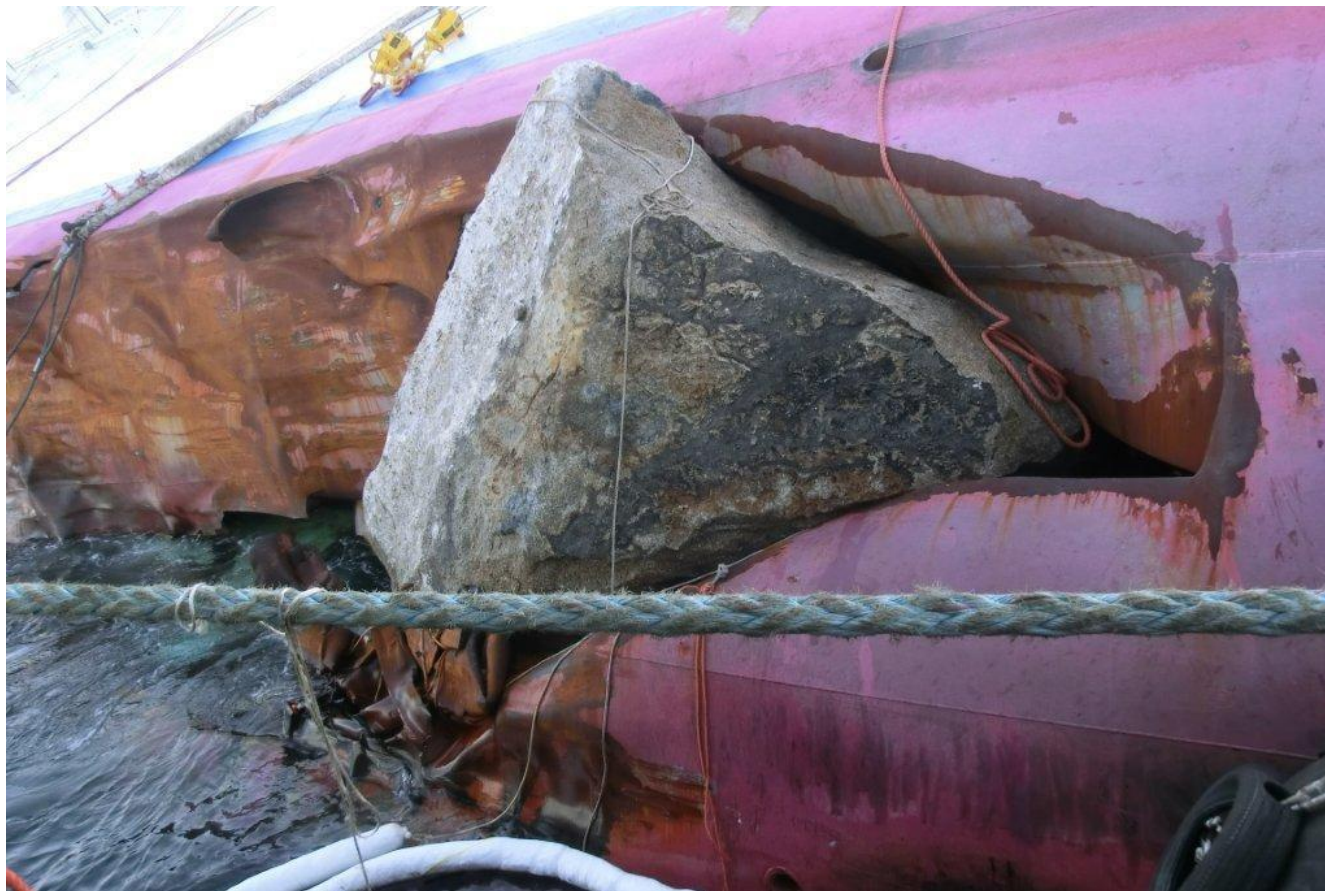
Detached rock in damaged area

An assumed density of 2.7 tonnes/m³ has been used to estimate the buoyancy of the rock to allow the submerged weight of the rock to be applied in the moment calculation. It has been estimated that the transverse centre of gravity of the rock is at 10.7m from the centre line of the vessel. The calculated moment is applied in the simulation at time 213 seconds which is at the end of the first grounding event.

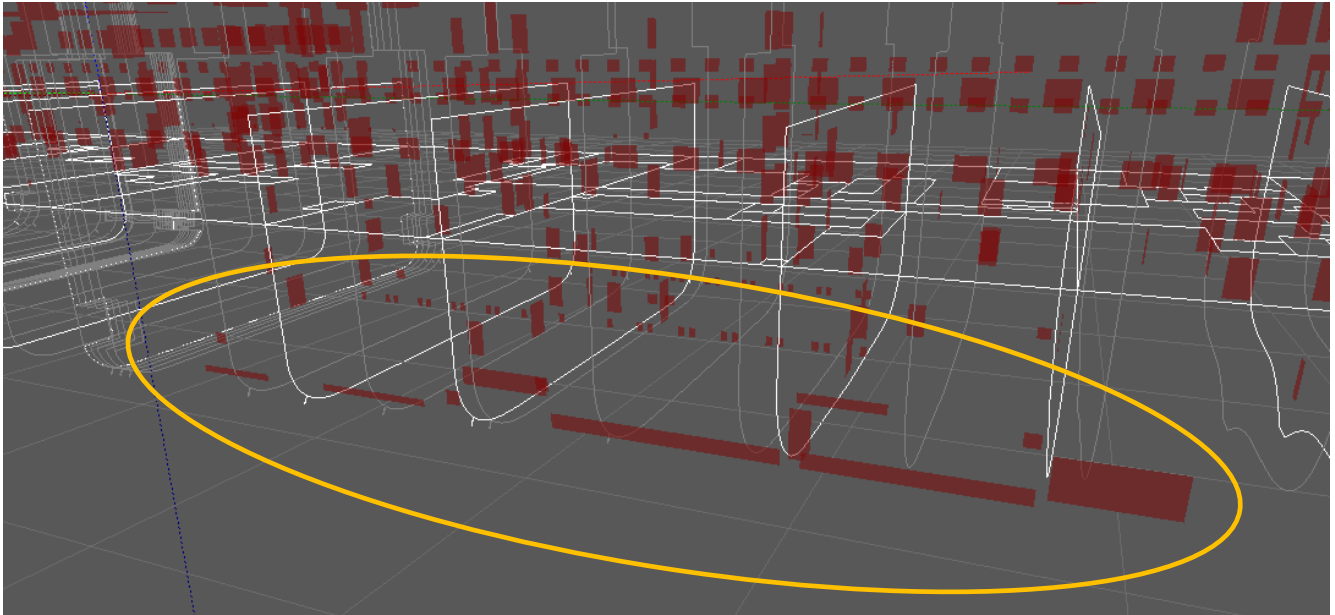
Main damage breach openings

Assumed damaged extent (according with flooding simulation)

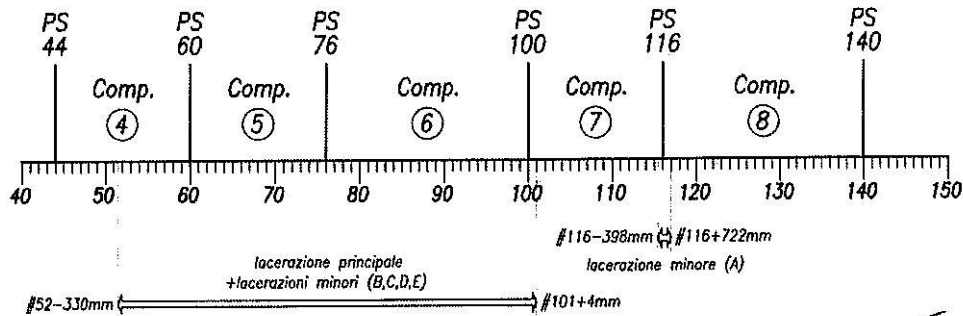
Figura 33

What above, with respect to the openings occurred, is schematically outlined in the drawing here below:

This damage is the cause of the flooding occurred to four contiguous compartments whose damage extension is considerably exceeding the one provided by the relevant regulations regarding the subdivision and stability checks in flooding (two flooded contiguous compartments) that is 10.710 m (ref. FINCANTIERI Booklet APN no. 320024 "INTACT AND DAMAGE STABILITY" approved by CDS no. 3211 dd. 10th March, 2005).

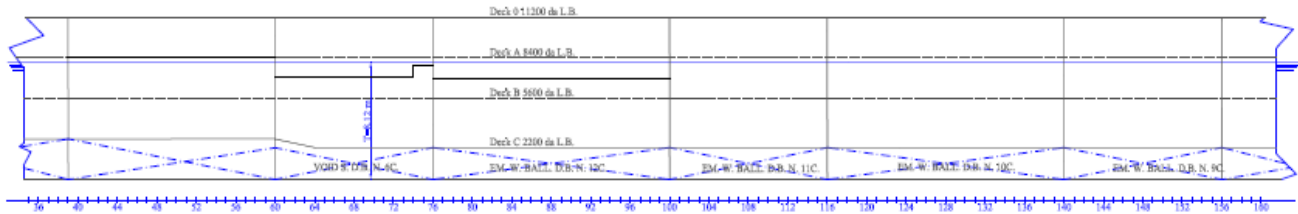
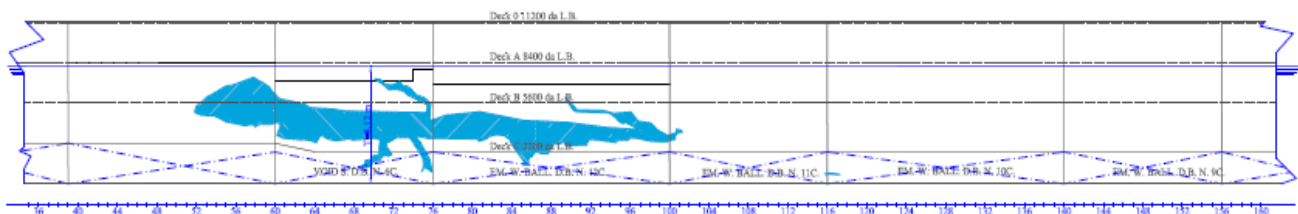
Proiezione sul piano longitudinale della falla principale e di quella minore a cavallo dell'ossatura 116

Where it is represented the longitudinal section involved by the damage upon which the shell plating breaches have been overlapped, according to their accurate assessment.

In the same table there is also the subdivision of the compartments and double bottoms in way of the shell plating, in order to immediately visualize and understand the ones flooded directly from outside,

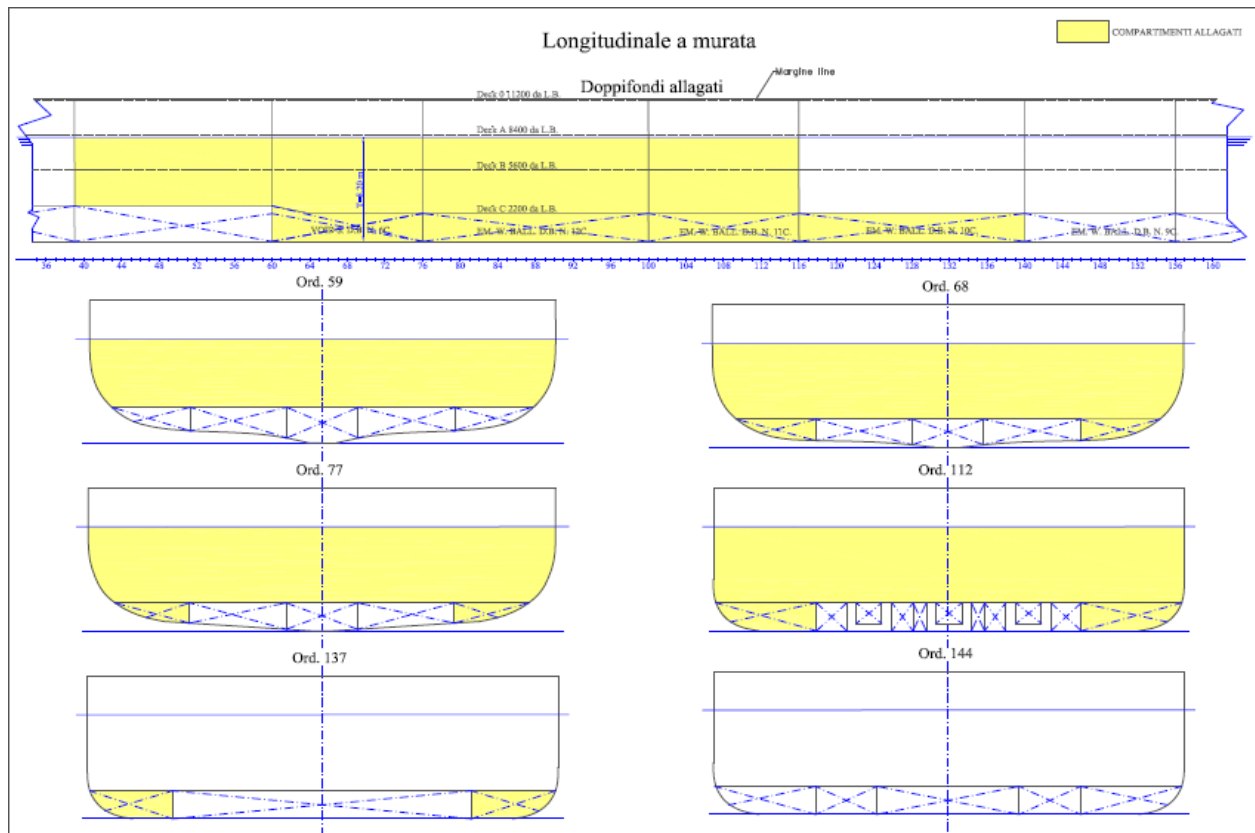
Here in this pictures the yellow parts represent the compartments and side double bottoms immediately flooded from outside at the time of the impact both on the longitudinal plan at side shell and in significant transversal sections too.

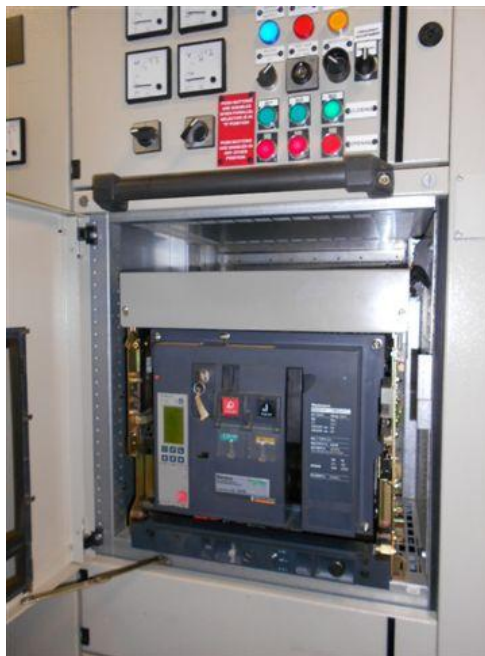
Switch nr. 901 (picture taken from Costa Favolosa)

As per above the concurrency of a short circuit in the lines powered by the ES could be the most reasonable cause of the switch 901 improper functioning.
