AIRCRAFT ACCIDENT REPORT

NORTH CENTRAL AIRLINES, INC.

MIDAIR COLLISION NEAR

AUGUST 4, 1968

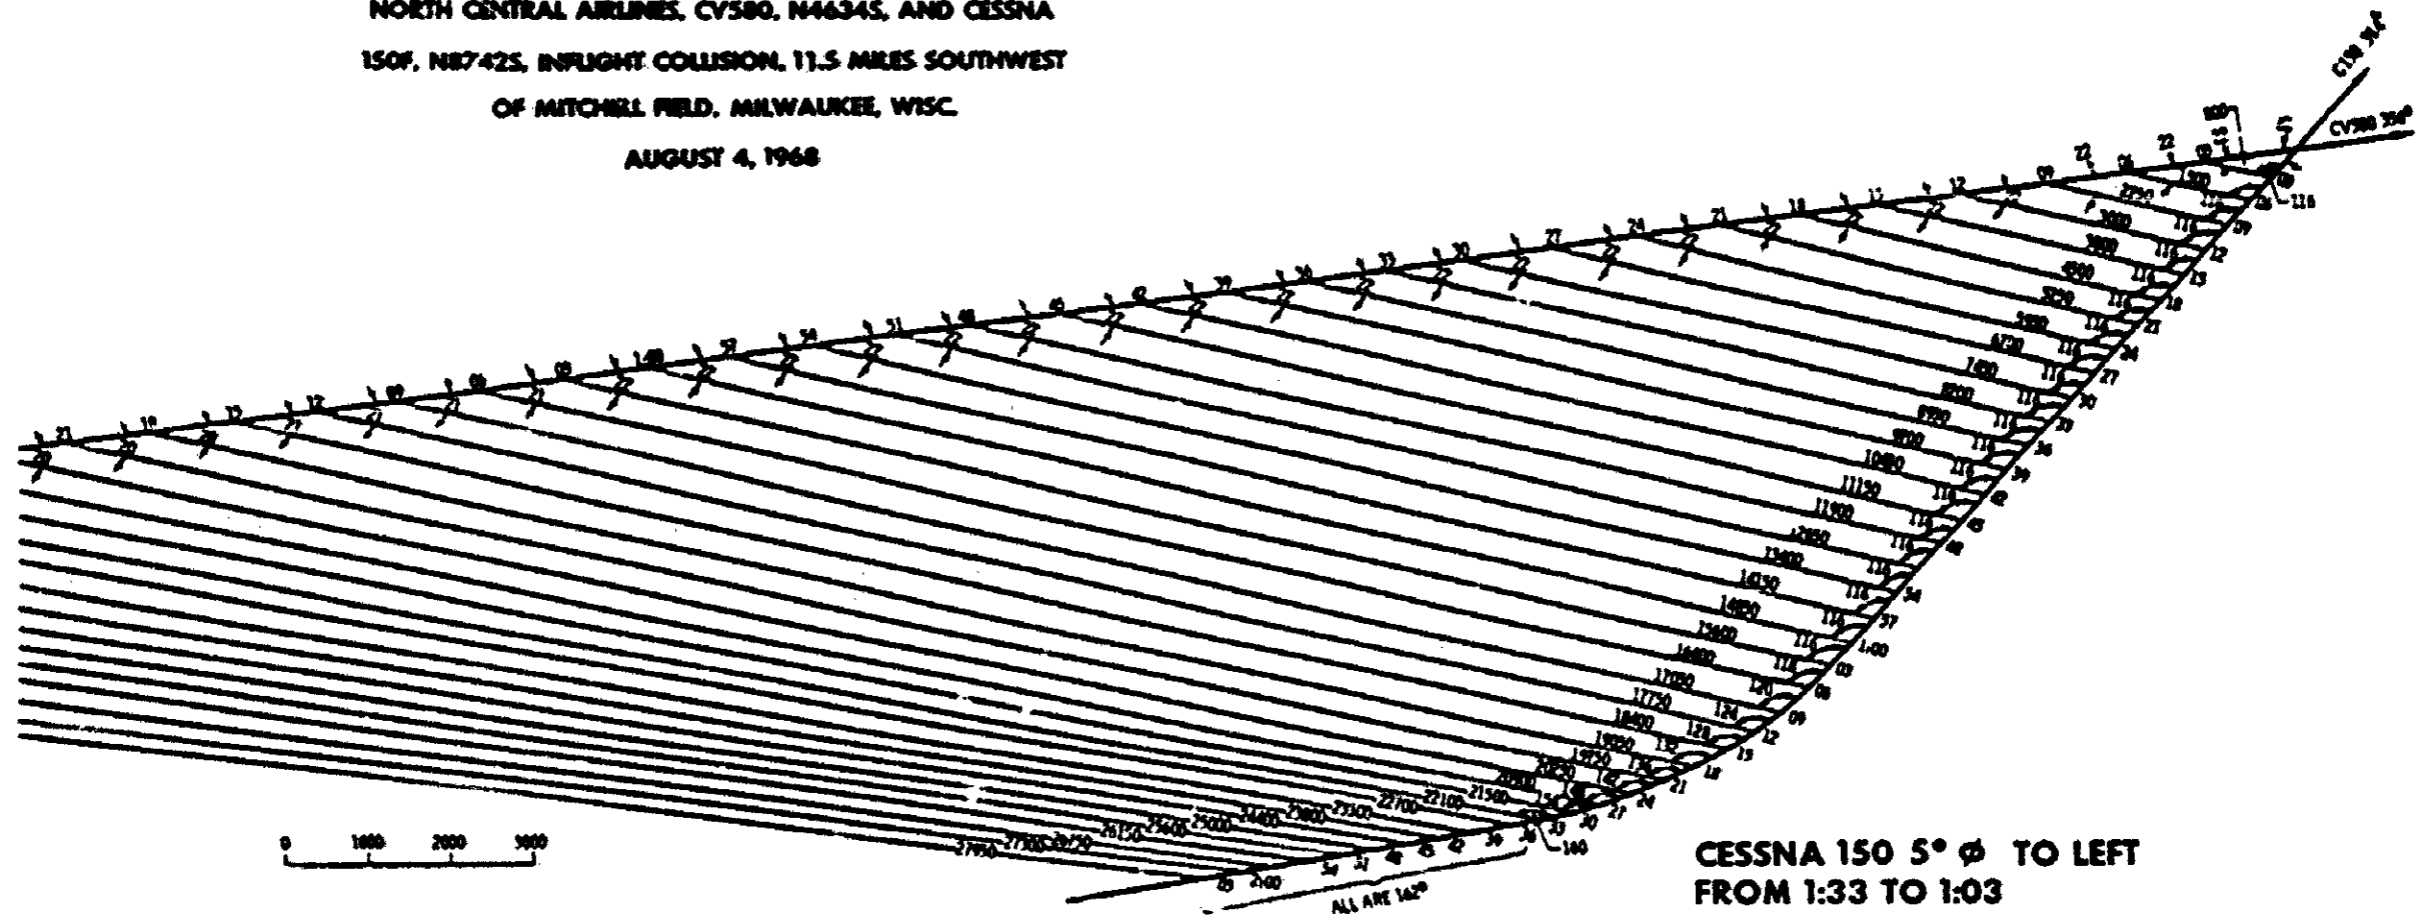
ATTACHMENT 2

NORTH CENTRAL AIRLINES, CV580, N46345, AND CESSNA
150F, N87425, INFLIGHT COLLISION, 11.5 MILES SOUTHWEST
OF MITCHELL FIELD, MILWAUKEE, WISC.
AUGUST 4, 1968
