# **AIRCRAFT ACCIDENT REPORT**

**FLYING TIGER LINE, INC.**

**Douglas DC-8-63F N785FT**

**REPORT NUMBER: NTSB-AAR-72-10**

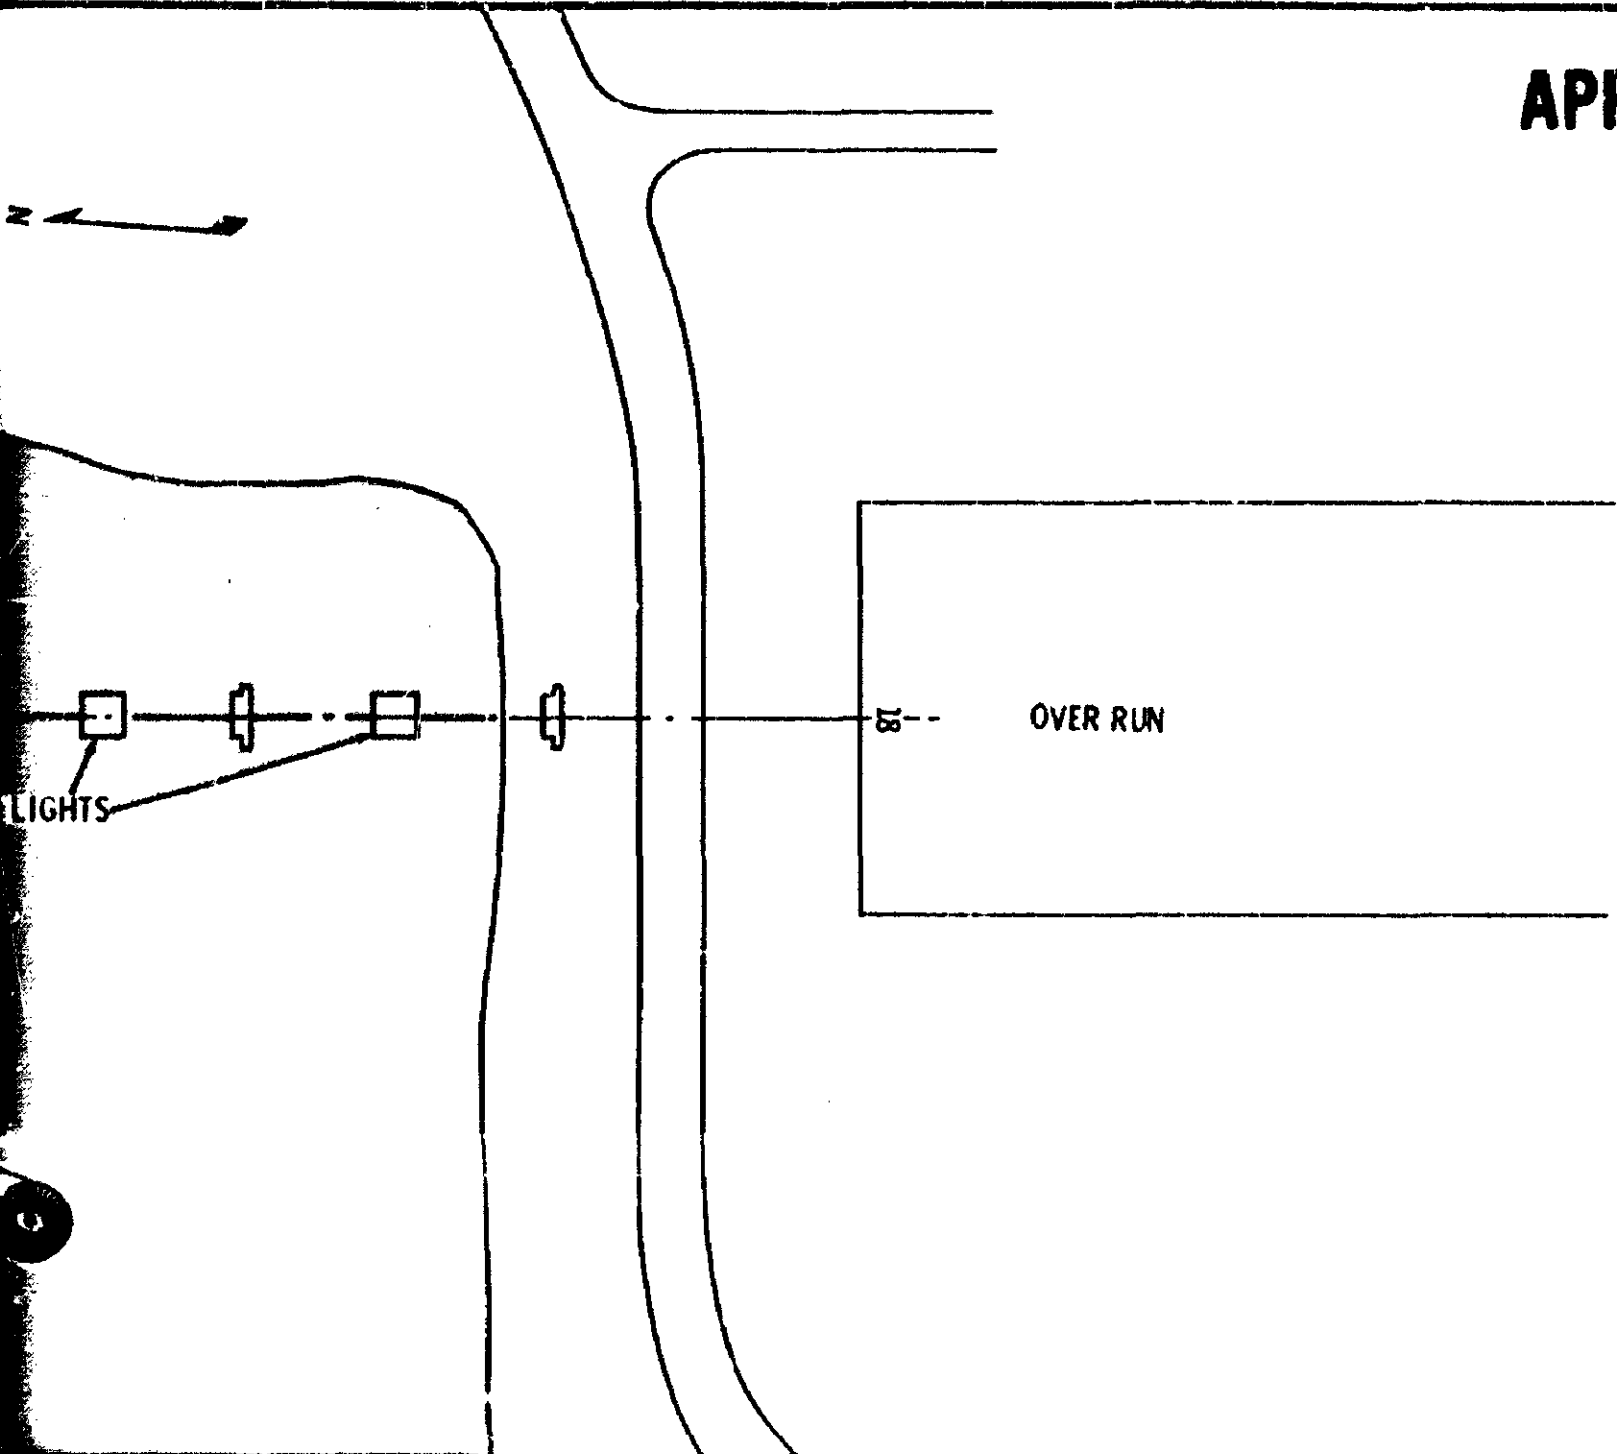
**WRECKAGE DISTRIBUTION CHART**  
**FLYING TIGER LINE, INC.**  
**DC-8-63F, N 785 FT**  
**NAHA, OKINAWA**  
July 27, 1970

The fuselage was broken into three major sections. Both wings had separated from the fuselage and the four engines were separated from the wings. The landing gears were detached from their respective attachment points. Of the recovered wreckage the nose gear and No. 2 engine were found farthest north of the approach end of Runway 18.

Approximately 90 percent of the wreckage was recovered or accounted for. All structural separations and fractures appeared typical of those caused by overloads.
