1. Report No. NTSB-AAR-74-6		2. Government Accession No.		PB 233 367	
4. Title and Subtitle Aircraft Accident Report- World Airways, Inc., DC-8-63F, N802W, King Cove, Alaska, September 8, 1973			5. Report Date May 8, 1974

WORLD AIRWAYS, INC.
DC-8-63F, N802WA
KING COVE, ALASKA
SEPTEMBER 8, 1973

NATIONAL TRANSPORTATION SAFETY BOARD
Washington, D.C. 20591
Report Number: NTSB-AAR-74-6

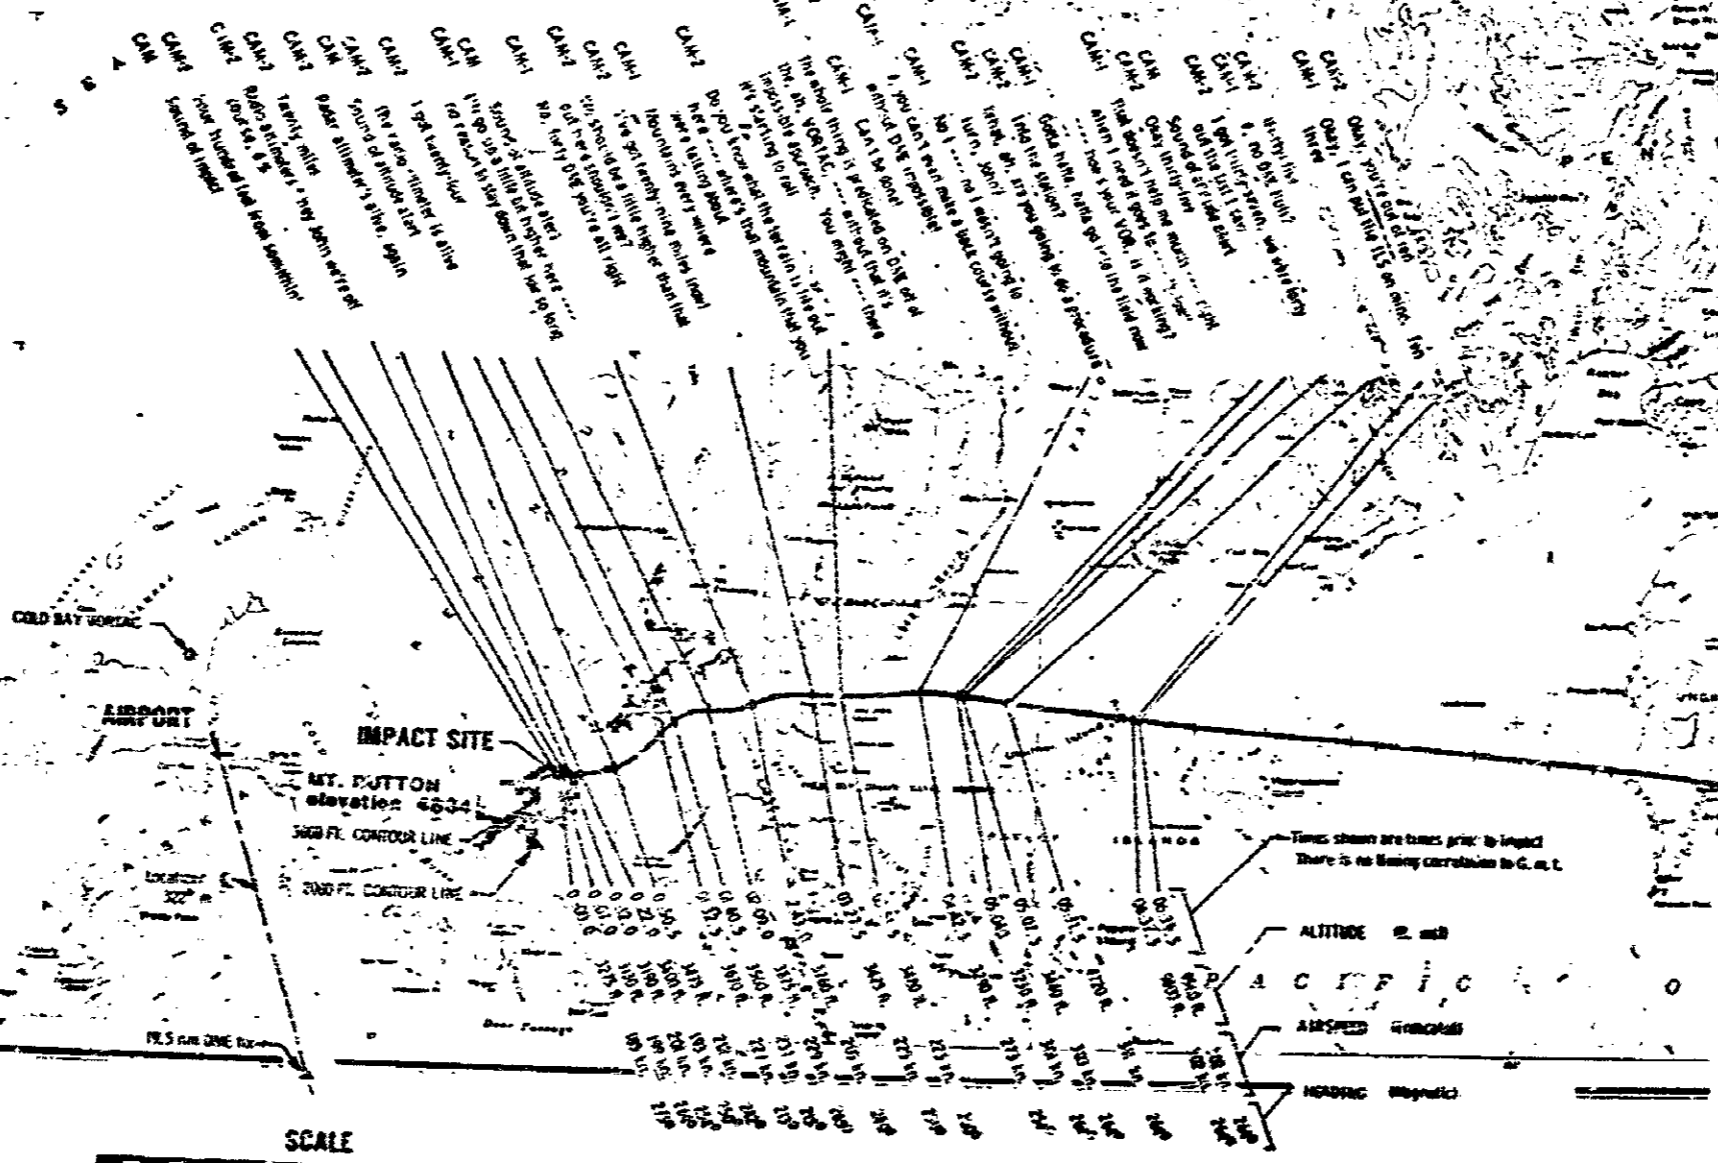
FLIGHT TRACK

After his 24 DME callout, the first officer reported twice that the radio altimeter was "alive". About 22 seconds before impact, he reported "Twenty miles," and the captain responded, "Okay, what's the inbound? One forty-one." The first officer then stated, "Radio altimeters . . . hey John, we're off course" Four seconds later, power was increased, and the first officer said, "Four hundred feet from something." Six seconds later, at 0542, the aircraft struck rising terrain, at 3,500 feet, on the 087° radial, and 18 nmi east of the Cold Bay VORTAC.

As a result of the en route descent to 3,500 feet, the flight operated for about 6 minutes before the crash in an area where high terrain would have affected the reliability of the VORTAC signals. Theoretically, descent below the line of sight to the VORTAC should reduce signal strength to a point at which warning flags should appear. However, the CVR does not indicate that the warning flags appeared. Although the aircraft had descended into the area where the VORTAC was unusable, the reflected signal strength, apparently, was sufficient to keep the VOR warning flags biased from view. According to CVR

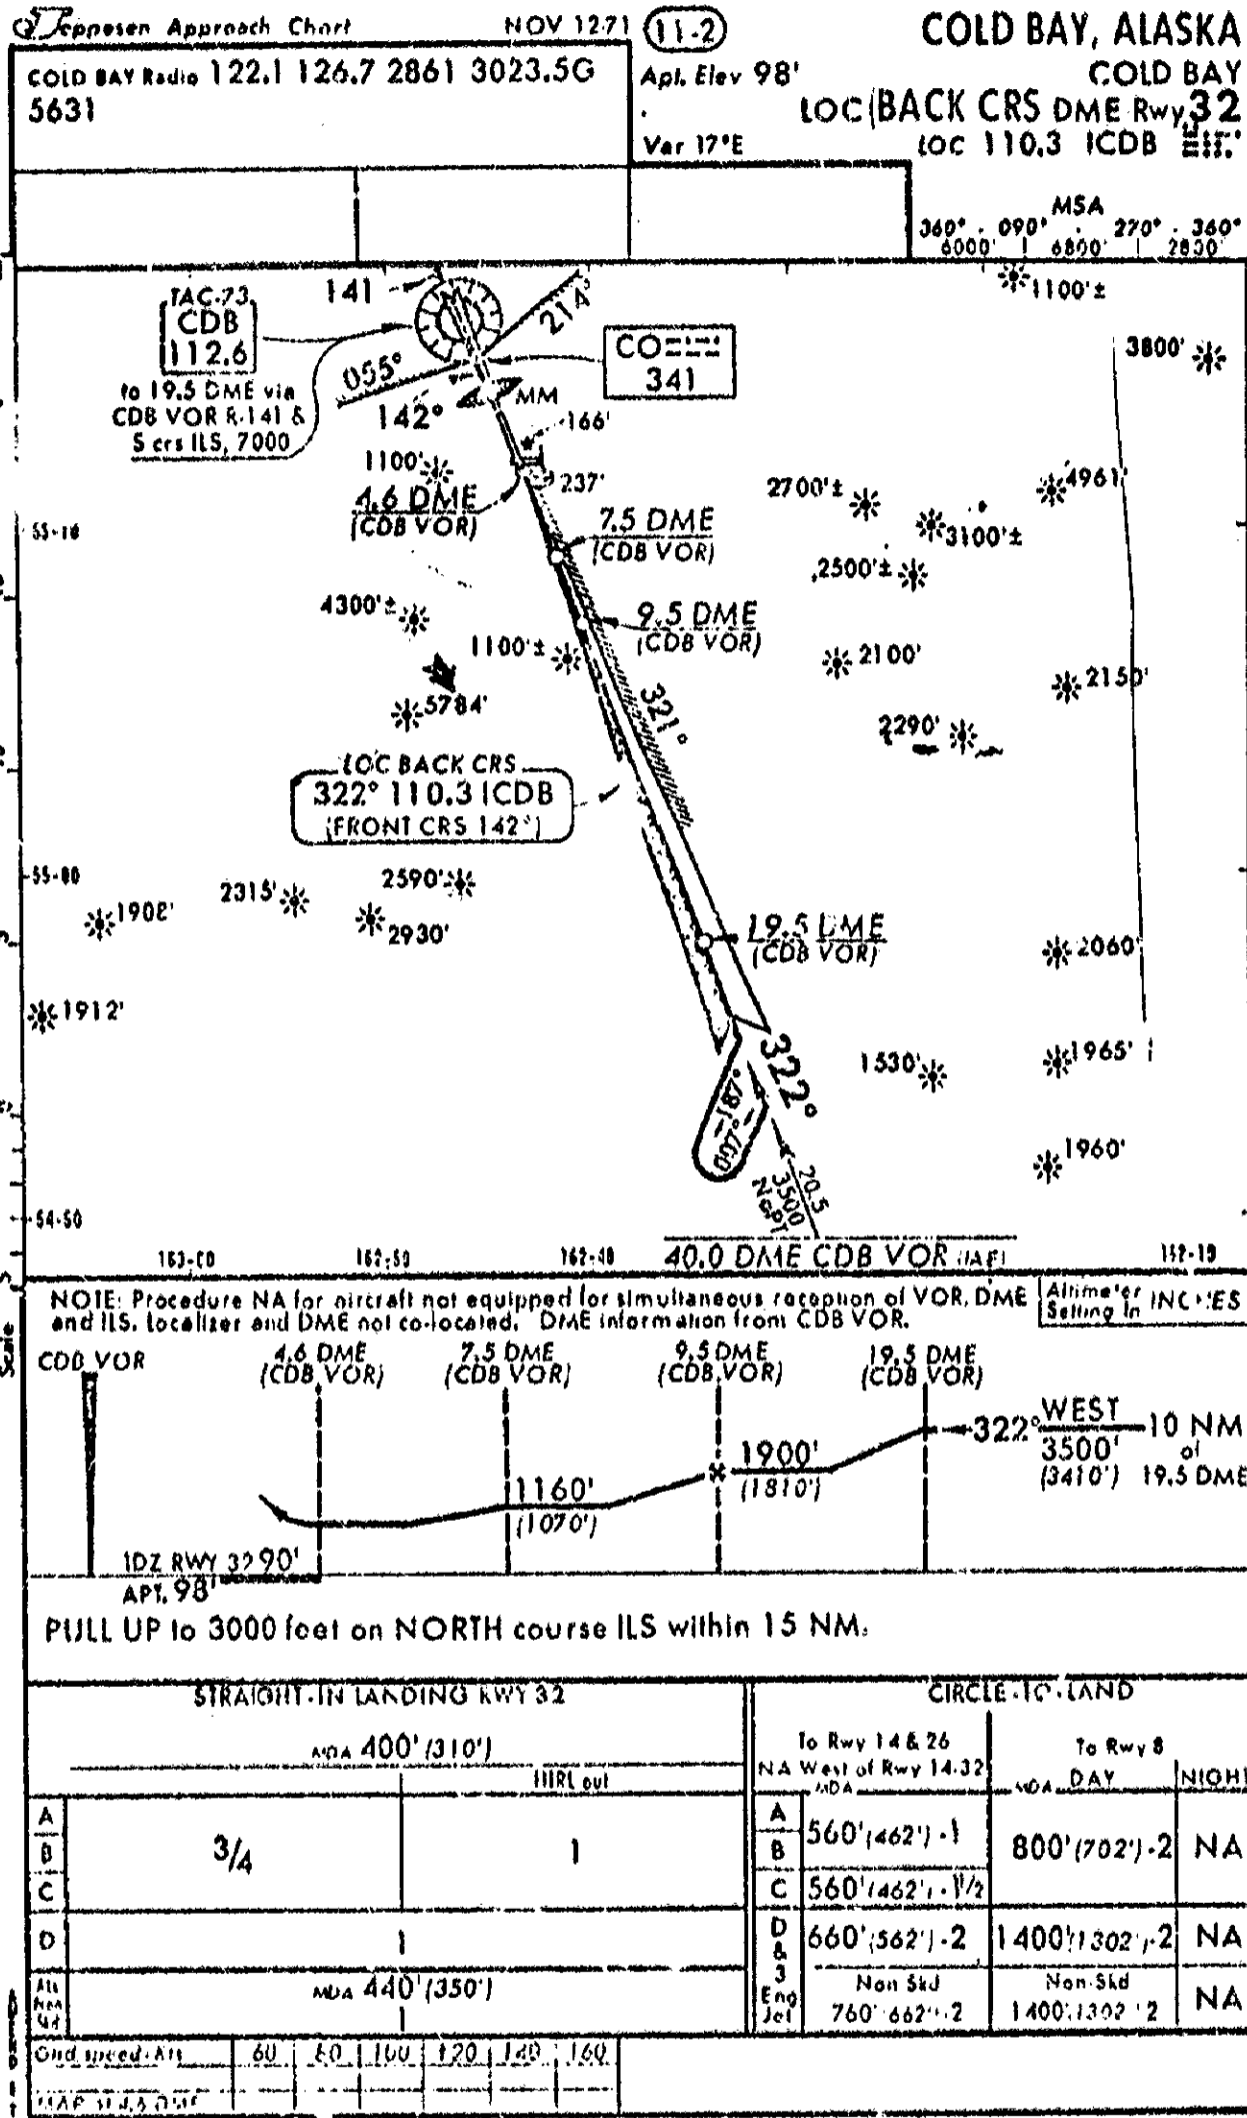
"ILLUSTRATION ONLY - NOT TO BE USED FOR NAVIGATIONAL PURPOSES"

Depicted on the pertinent IAP chart is a 40-mile DME initial approach fix (IAF) and a prescribed minimum altitude (MA) of 3,500 feet for inbound flights after they pass the IAF. The Safety Board is concerned that this information could lead to a hazardous approach situation if the flightcrew either misinterprets these data, or lacks specific knowledge of other information not found on an IAP chart. For example, knowledge of specific distances and altitudes at which NAVAID signals from the Cold Bay VOR are reported as "unusable" is essential for the pilot who elects to begin an IAP to runway 32 from over the 40-mile DME IAF. Such information is also important because the en route MA is lower than the minimum reception altitude (MRA) specific for the area beyond the 40-mile IAF. The IAP chart does not provide that information.

Modify the IAP chart for the IIS back course DME approach to runway 32 at Cold Bay, Alaska, in a manner that will highlight the altitude restrictions on the use of the VORTAC and the hazards associated with deviations from prescribed approach procedures.
