RCEM – Reclamation Consequence Estimating Methodology

Dam Failure and Flood Event Case History Compilation

**U.S. Department of the Interior
Bureau of Reclamation**

February 2014

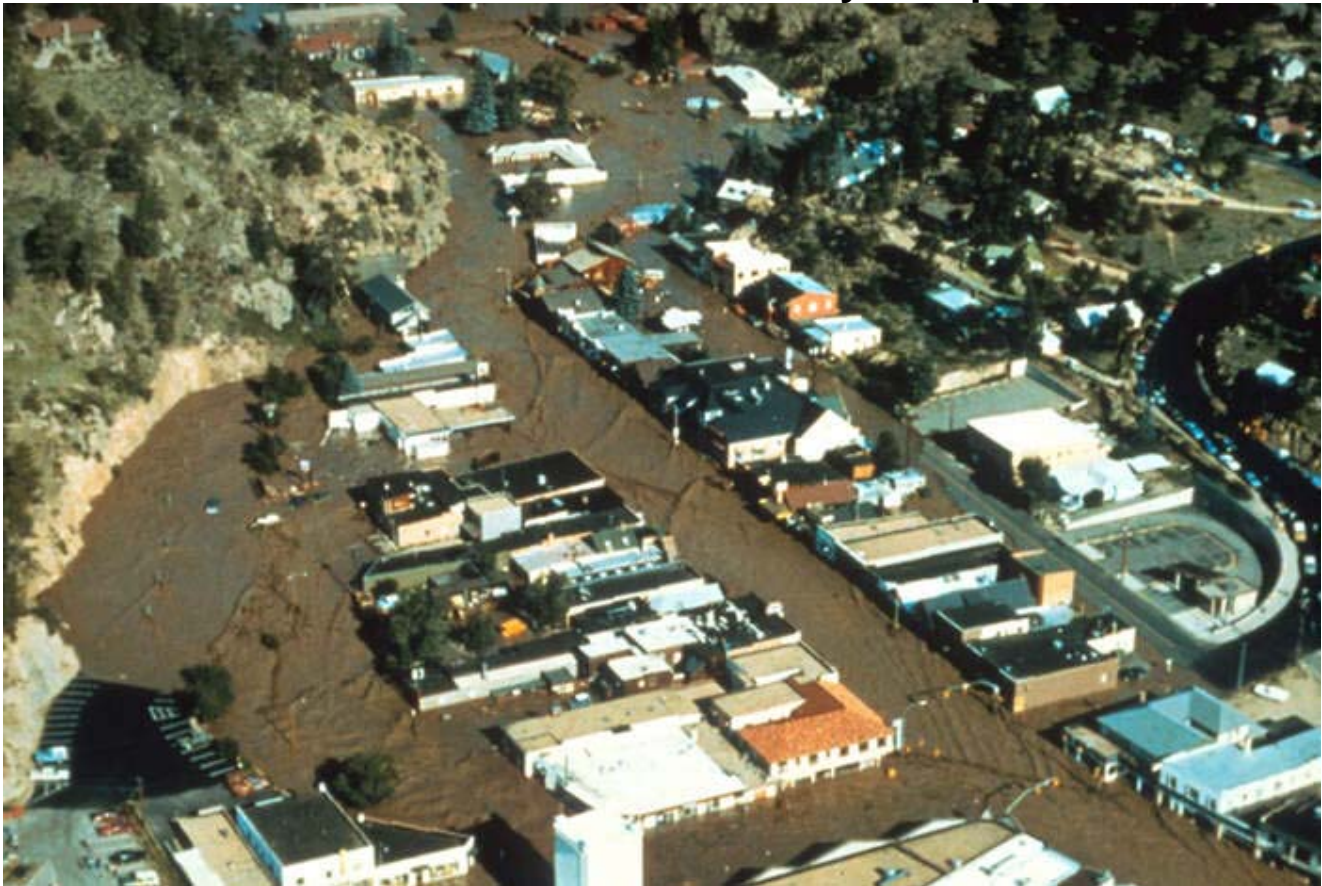
Lawn Lake Dam failure flood in 1982 at Estes Park, CO (Reclamation photograph)

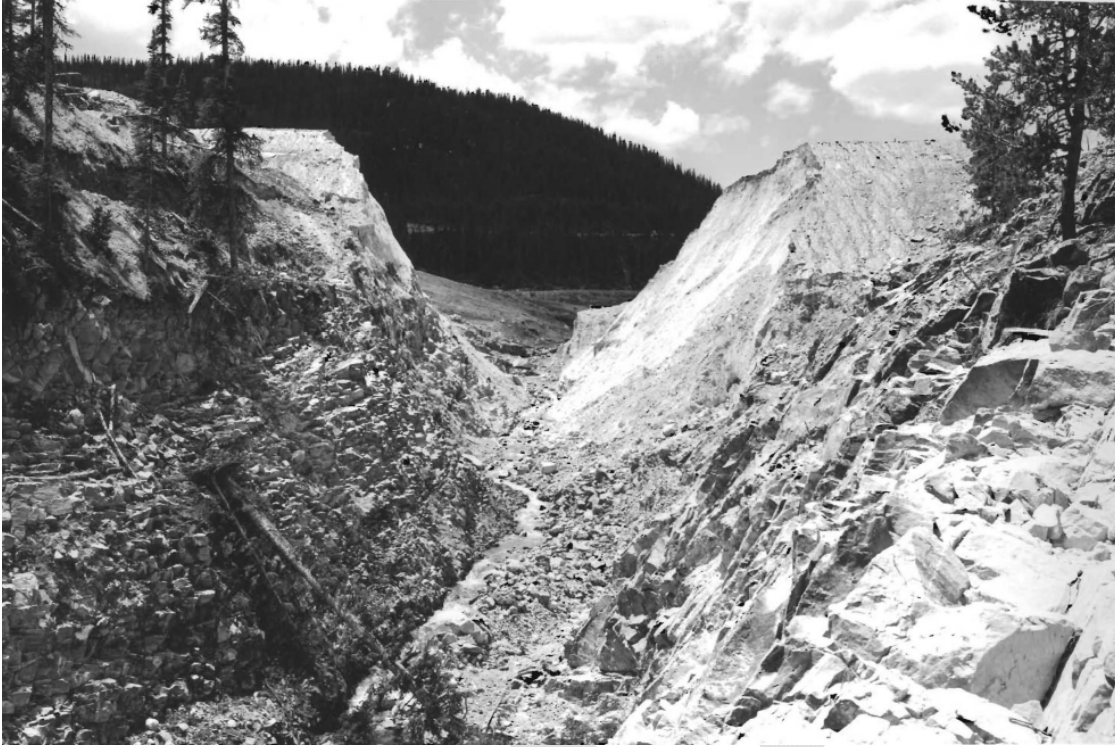
Little Deer Creek Dam, breach in maximum section
Source: Reclamation 1964

Note – an ASDSO paper (The Little Deer Creek Dam Failure, A Forensic Review of a Fatality, The Journal of Dam Safety, Winter 2004) cites an estimated breach formation time of 1 to 1.5 hours with maximum breach discharge between 14,000 and 17,000 ft³/s. This information is not consistent with other available reporting.

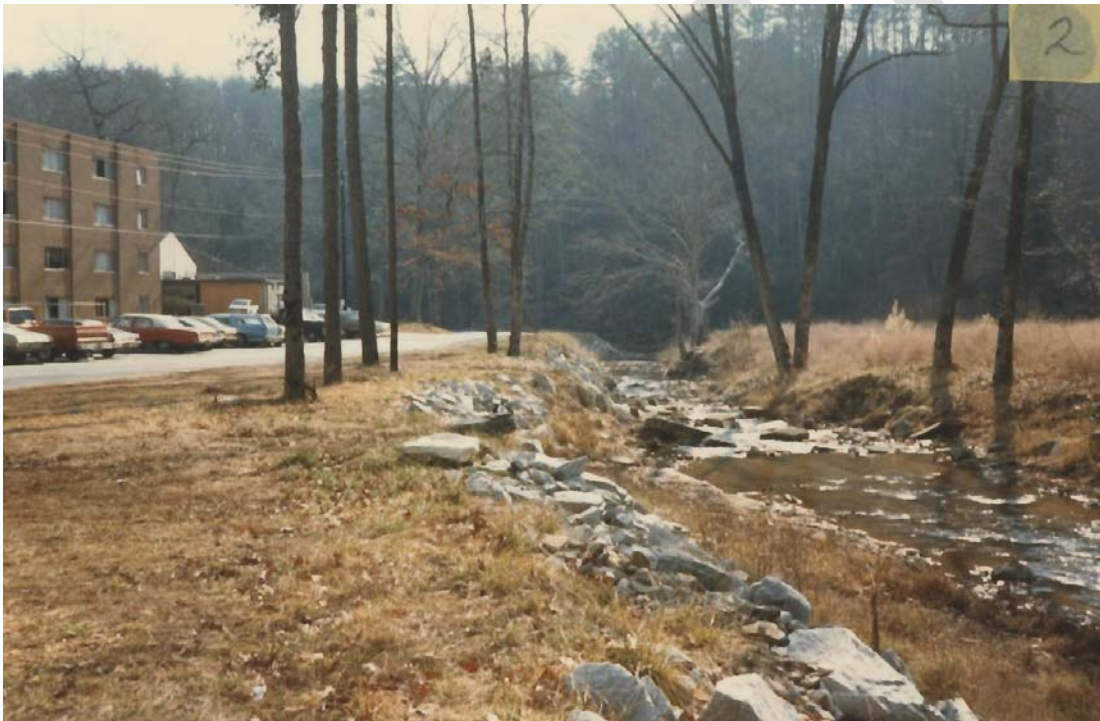
This flood is considered to have been medium severity. Downstream areas on the college campus were severely damaged, but debris and many structures remained after the flood passed. The area was not “swept clean”. Maximum DV at the Forest Hall Dormitory area is estimated to have been 120 ft²/s.

Forest Hall Dormitory on left, Toccoa Creek on right

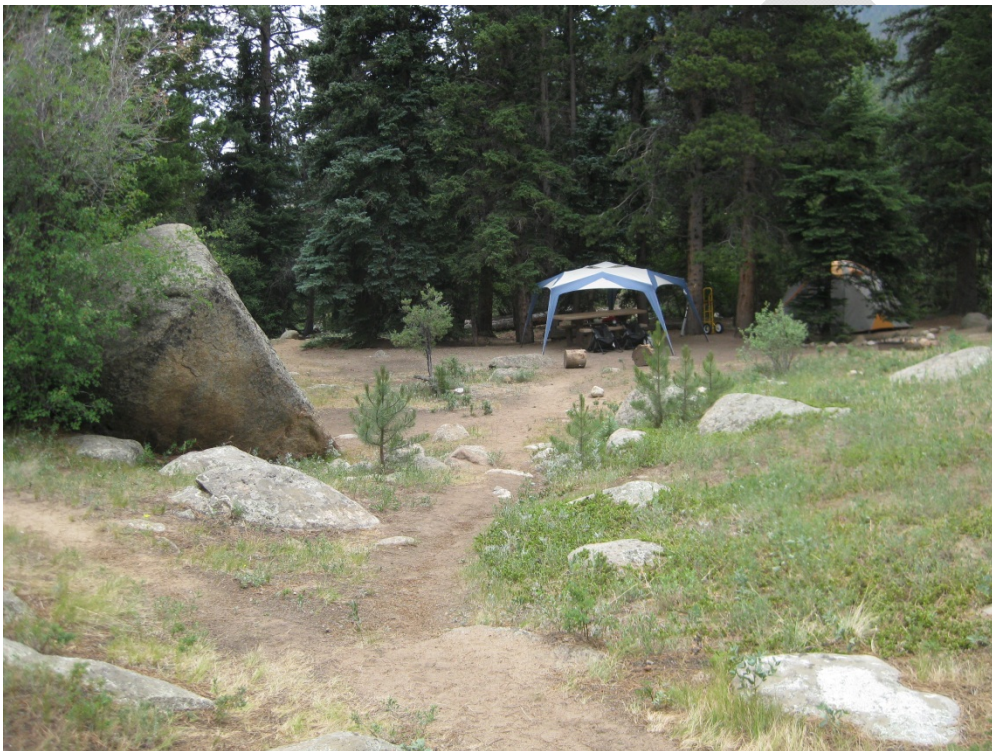
**Aspenglen Campground site near where two fatalities occurred.
Source: Bruce Feinberg, Reclamation, July 2012**

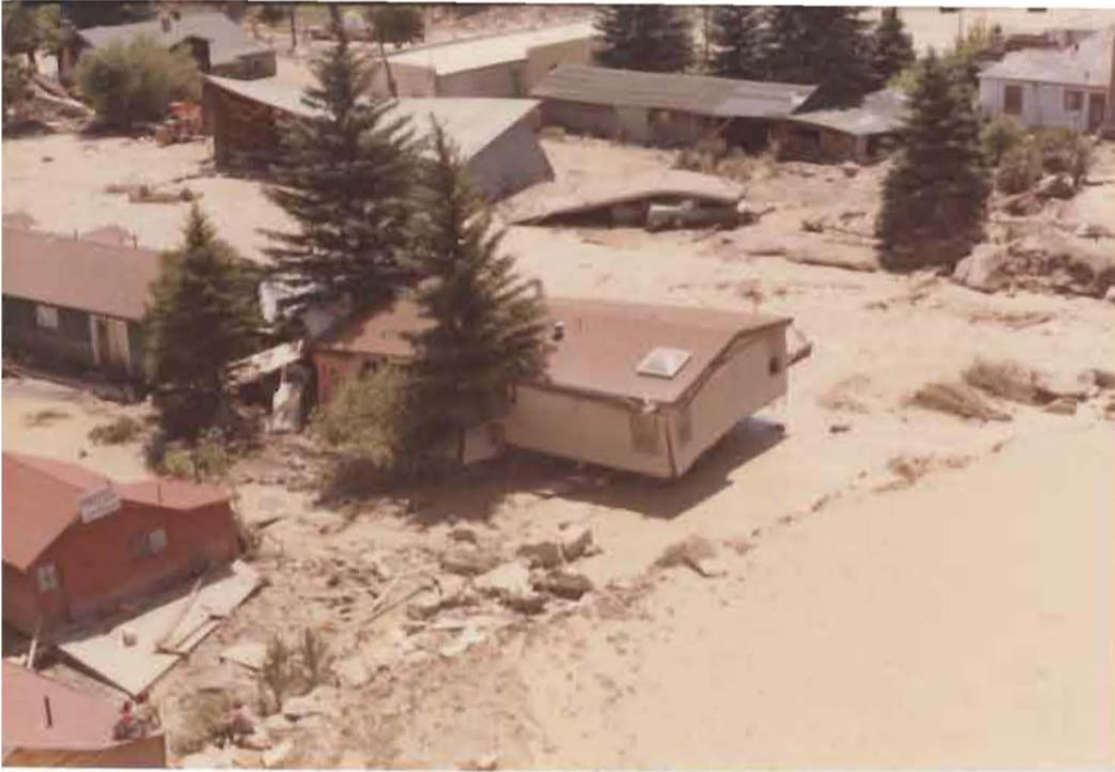
Further downstream along the Fall River Road and in the town of Estes Park, damage was extensive. The warnings in this area were successful though and no additional fatalities occurred. Flooding was fully contained in Lake Estes, the reservoir formed by Reclamation’s Olympus Dam.

Flood damage at Estes Park
Source: Wayne Graham, Reclamation, taken July 15, 1982

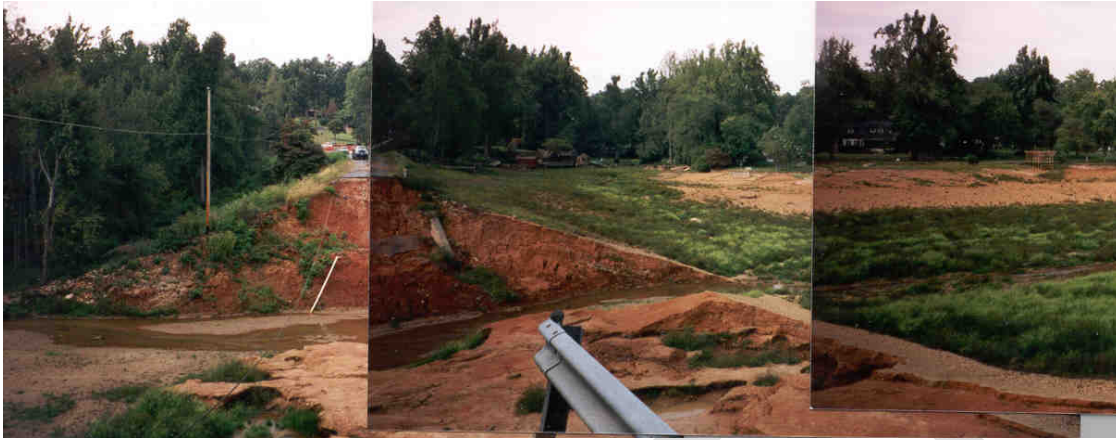
The breached Timberlake Dam
Source: Wayne Graham, Reclamation

Timberlake Dam was rebuilt about one year after its failure.

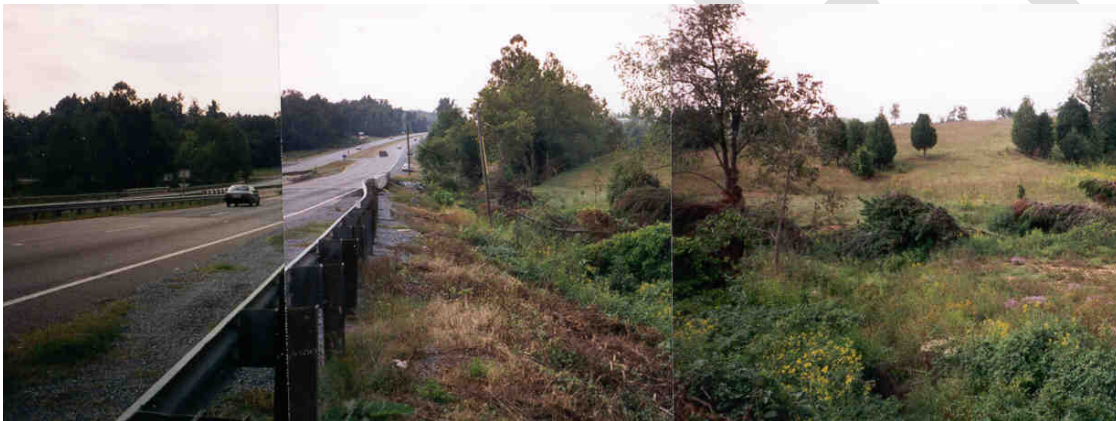
Location where rescue worker was killed
Source: Wayne Graham, Reclamation

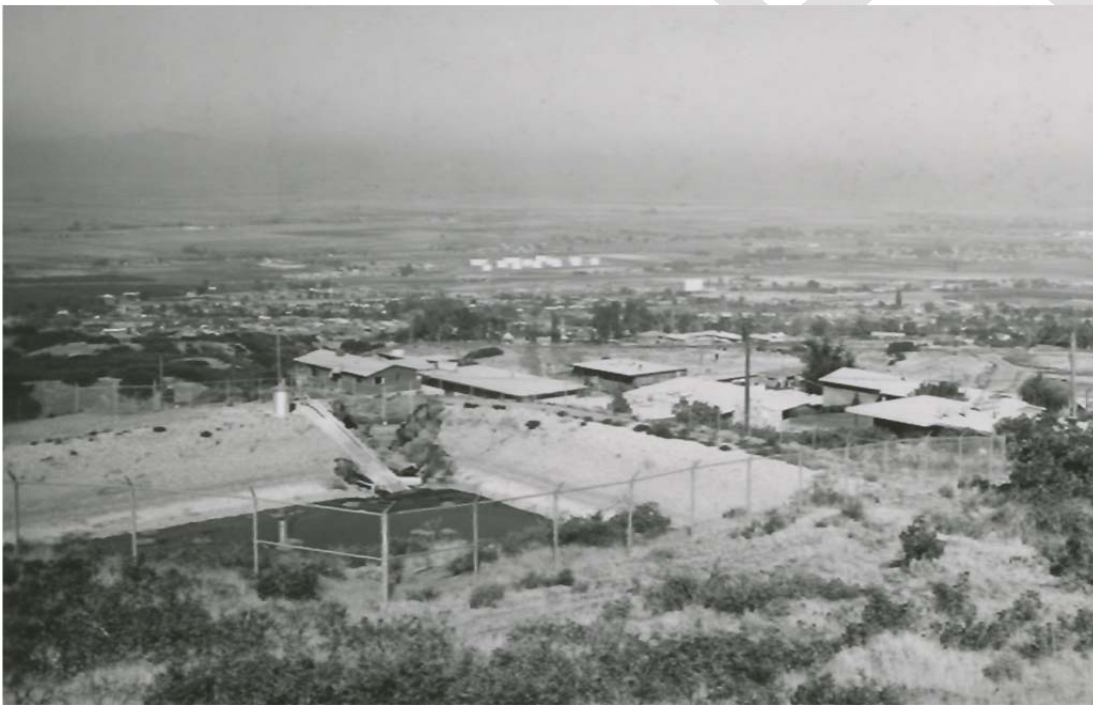
Reservoir No.1, located near Bountiful, Utah, failed on Sunday September 24, 1961 at 4:30 am. The earthen dam, which created a bathtub reservoir, was two years old when it failed from what was thought to be internal erosion. The exact height of the dam is not known, although available photographs indicate the dam height was in the range of about 15 feet. A total of 4.4 acre-feet of storage was reportedly released from the breach and the reservoir emptied in less than fifteen minutes. Failure of the dam was not detected prior to its occurrence and no warning was issued. The flood resulted in damage to about twenty properties which were damaged, but not destroyed, and there was an affected population at risk (PAR) of maybe eighty people. This event did not result in any fatalities.

Breached Reservoir No.1 Dam

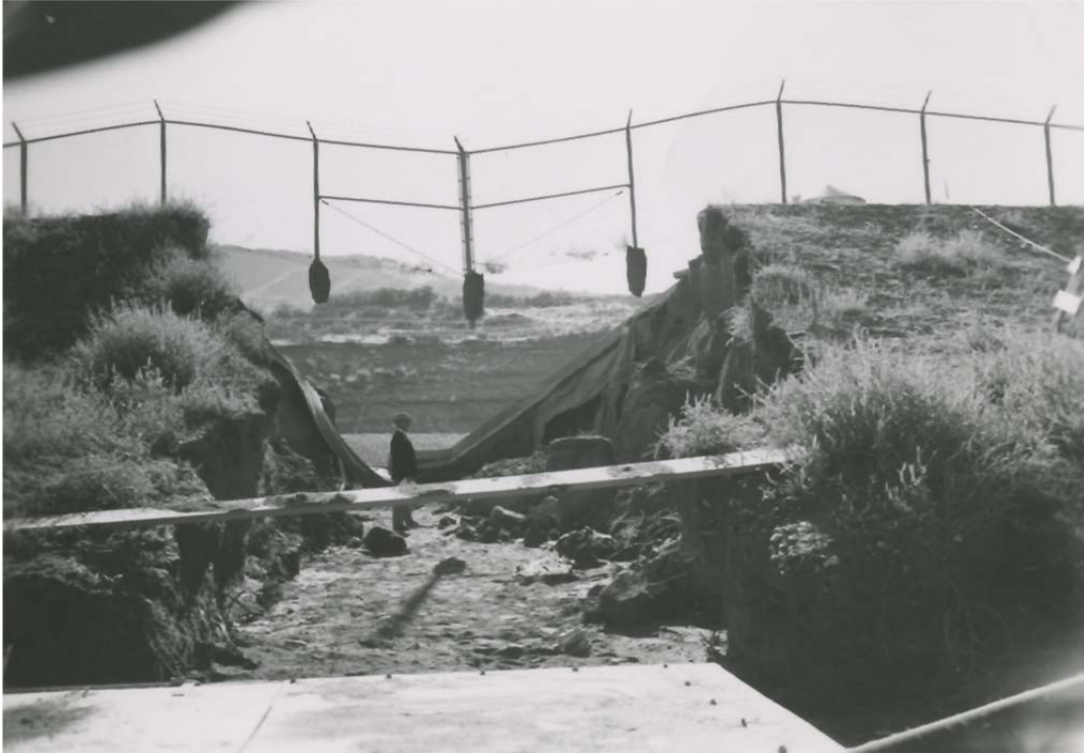
Close up of breach, Reservoir No.1 Dam
Source: Earl Bud Bay, Reclamation, September 25, 1961
