Toe Protection for H-piles on Sloping Bedrock at Rainy River

Jon E. Bischoff, Bengt H. Fellenius, Richard E. Riker

Proceedings of Deep Foundations Institute Annual Meeting, Pittsburgh October 18 - 20, 1993 pp. 215 - 222

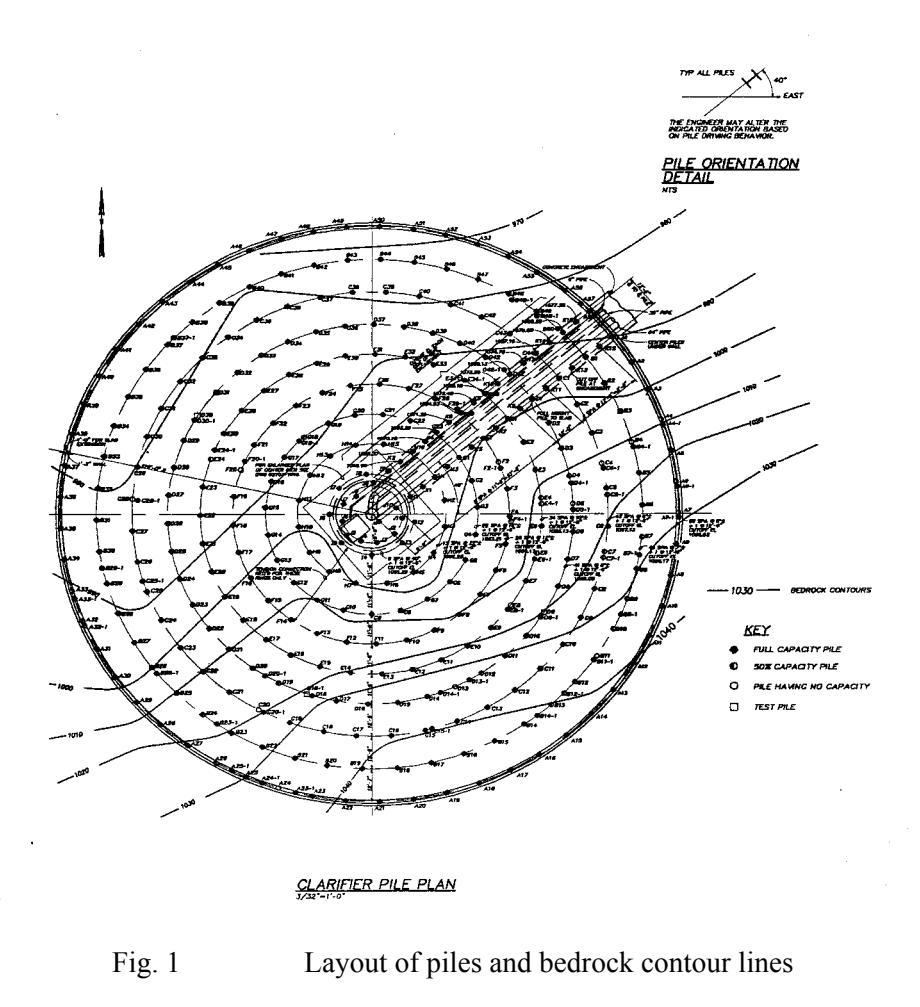
The site is located on the south bank of the Rainy River in International Falls, Minnesota on the border between USA and Canada. Construction of the 220 feet (67 m) wide, circular clarifier on compressible soil required a deep foundation system that extended to bedrock and 14HP102 H-piles were selected. Fig. 1 shows the layout of the piles and the contour lines of the bedrock surface.

When the first 50 to 75 production piles had been driven, about 25 percent of the piles had failed in a manner similar to the three failed indicator piles. In most cases, driving the replacement pile also proved unsuccessful. The failures occurred in areas where the bedrock contour lines (Fig. 1) indicated that the slope exceeded 2H:1V. The piles performed well in areas where the bedrock surface sloped less. On very steep areas, the rate of success was extremely poor.

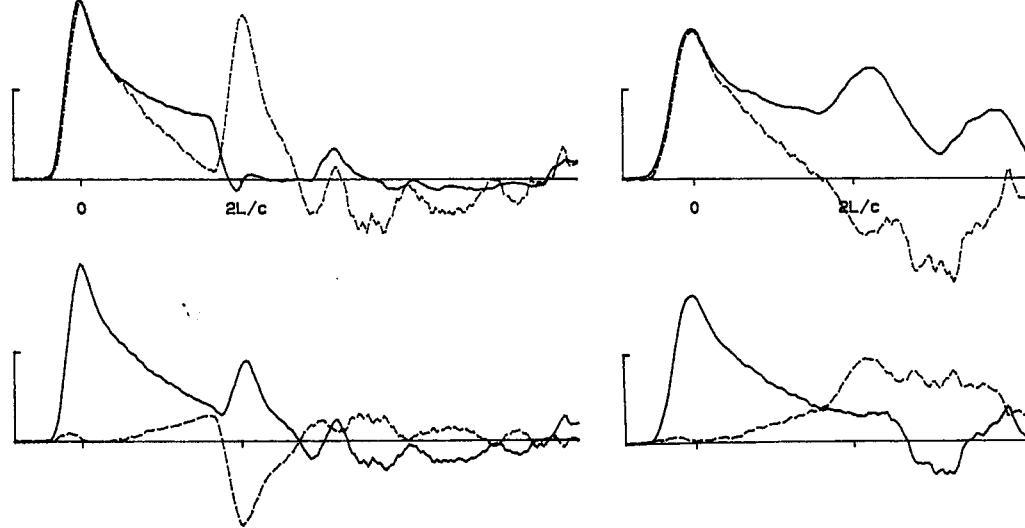
Insight to the pile behavior is contained in the PDA records as illustrated in Fig. 3. Fig. 3a presents the wave traces obtained shortly before the pile toe encountered the bedrock, as obtained from one of the three failed indicator piles. The figure includes the Force and Velocity trace pair and the Wave-Up and Wave-Down trace pair. The records obtained for this blow are practically identical to the traces obtained from preceding blows and indicate a small shaft resistance, as evidenced by the small separation of the force and velocity traces. At

Time 2L/c, the velocity increases and force goes to zero, which indicates almost total absence of toe resistance further emphasized by the Wave-Up trace. The penetration resistance is about 20 blows/foot (65 blows/m).

Fig. 3a PDA traces immediately before the pile reached bedrock

During the next blow, the pile toe made contact with the bedrock and a positive toe reflection built up for the following blows. Fig. 3b shows the traces obtained eight blows later. The trace is associated with a penetration resistance of about 7 blows/inch (7 blows/25 mm). Before the toe reflection appears in the record, the traces are very similar to those of the first blow. However, at 2L/c, there is a distinct toe reflection evident in both the force and velocity traces as well as in the Wave-Up trace.

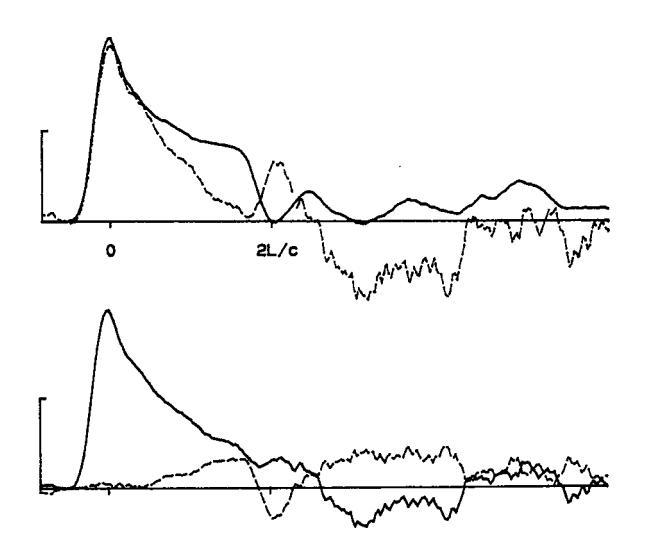
Fig. 3b PDA traces forty blows after the pile reached bedrock

Fig 3b is representative for approximately the next twenty blows. However, thereafter, the appearance of the traces alternated between that shown in Fig. 3b and that of Fig. 3c, obtained 50 blows after the blow record shown in Fig. 3a. The latter traces lack the distinct toe reflection and the records contain more "noise". The pile had "penetrated" approximately 6 inches (150 mm) for the blows and the penetration resistance had reduced to 5 blows/inch (5 blows/25 mm). In continued driving, the penetration resistance reduced further to about 2 blows/inch.

The wave traces were interpreted as follows: in places where the pile toe met with steeply sloping bedrock, the Hardbite pile shoe could not secure a hold on the bedrock. Therefore, the pile toe started to slide. On continued driving, the lower end of the pile started to bend and a dog leg developed causing the pile to deform and the sliding to get worse. Indeed, once sliding starts, although there is resistance and some blows indicate capacity, the capacity is uncertain and can not be relied on. Continued driving only results in further bending and damage to the pile.

The measurements showed that, consistently, adequate capacity was obtained more or less immediately on encountering the bedrock surface at an equivalent penetration resistance of 10 blows/inch (10 blows/25 mm). However, driving "the full 10 blows" once bedrock was encountered proved to increase the occurrence of pile damage. The termination criterion was established that on encountering bedrock, which was obvious from the change of driving behavior, five more blows were to be given to the pile and if the penetration for the sum of the five blows was smaller than 0.5 inch, the pile driving was terminated. If the penetration resistance exceeded 0.5 inch for five blows, an additional five blows were to be given, taking care no to drive any more blows than necessary.

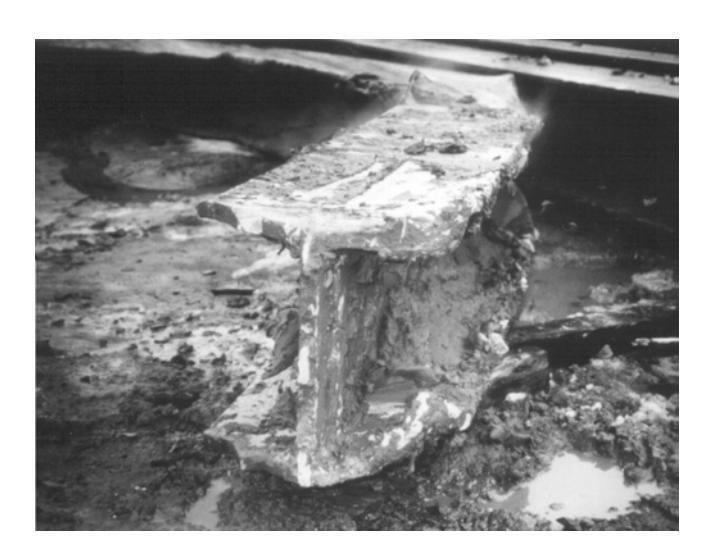
Three of the production piles suspected of damage were extracted for visual inspection. All three piles were found to be bent and have deformed pile toes. Fig. 4a shows a photo of the toe of one of these piles after extraction. The photo shows that the flanges have folded over at the side of the pile shoe. This had the effect that the shoe became a "sleigh" with "runners" causing the pile toe to slide on the bedrock. The continued driving caused the pile to bend (the pile can be seen curving behind the pile toe in the photo). The photo shown in Fig. 4b (from a different pile) further illustrates the doglegged shape of the pile caused by the sliding of the pile toe on the bedrock. The primary cause of failure appeared to be the inability of the shoe to sustain the high eccentric point loading and associated high stress near the corner of the flanges.

The inability of the pile to grip and penetrate the bedrock surface is not considered due to any defect in the Hardbite shoe, but a consequence of the steep and strong bedrock surface. Where conditions were less extreme, piles with the Hardbite shoe met the required termination criterion and showed no sign of sliding or toe damage.

Fig. 4a Damaged pile and Hardbite pile shoe after extraction

The problem was remedied by using an alternative pile shoe (the Herkules rock shoe manufactured by Scanpile, Sweden). The design of the Herkules rock shoe is well suited for piles driven onto steeply sloping bedrock. The hardened dowel allows for high compressive stress and is well supported to distribute the load uniformly at the base of the pile. The concave shape of the dowel and the overall pointed shape of the shoe allow the dowel to encounter the rock surface before the sides of the shoe or the pile, thereby ensuring that the force at the base is concentric with the long axis of the pile. The wave traces provided by the dynamic measurements demonstrated the toe response and proved a valuable asset in understanding the pile performance and conditions a the pile toe. The correlation between the penetration resistance in the bedrock and the condition of the pile toe, as made clear by the PDA wave traces, was indispensable in determining when to accept or to replace piles.

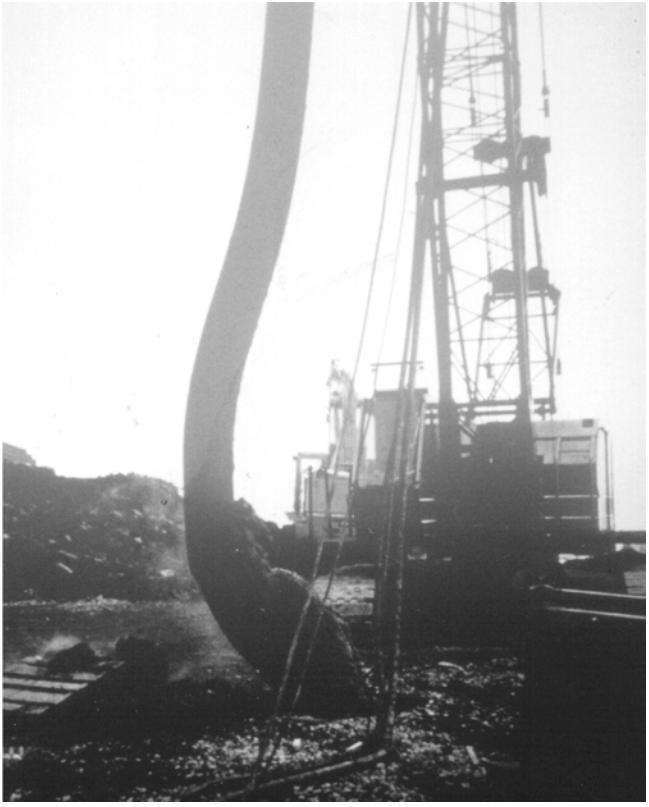
Fig. 4b Doglegged pile during extraction
