DOULTING

Conservation Area Appraisal

August 2006

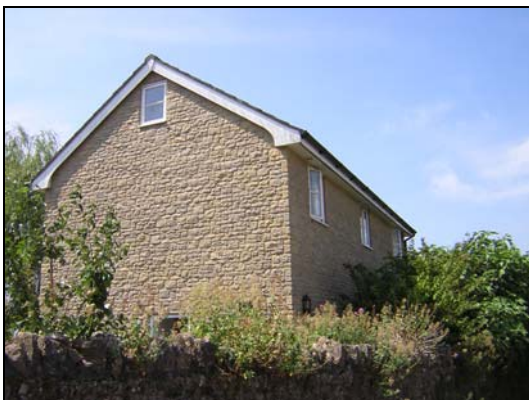
Fig Tree Cottage

Despite the availability of Doultong stone, a number of buildings in the conservation area have been built using reconstituted stone. Fig Tree Cottage, for instance, lacks the natural variation in texture, shape and colour that can be obtained from using natural stone. Furthermore, its roof pitch, window proportions, use of deep fascia and bargeboards, its ratio of solid to void and lack of chimneystacks all fail to relate to the character of the surrounding buildings.

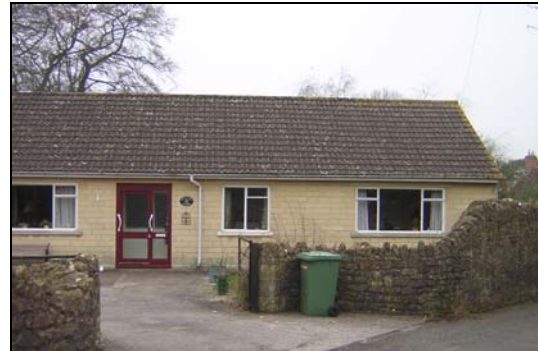
Doultong Lodge

7.23 Doultong Lodge, a 20th Century bungalow, similarly fails to respond to

the general form and character of the surrounding buildings and appears inappropriate in its context and fails to contribute to the character of the conservation area.

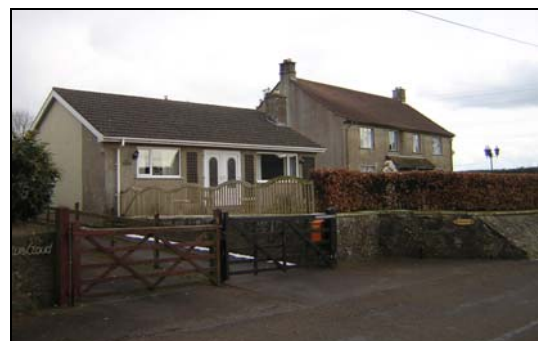
7.24 The group of four 20th Century dwellings opposite Manor Farm also do not relate well to the historic pattern of building or architectural styles. The dwellings, 2 bungalows and a pair of semi detached houses are plain in their design and set well back from the road edge. Similarly, Hylands is another bungalow situated at the eastern edge of the conservation area adjacent to a small grouping of trees that form a green edge to the village. These modern buildings fail to preserve or enhance the character or appearance of the conservation area, yet the sites on which they have been built are important in terms of its setting, and views into and out of it.

20th Century buildings on Farm Road

7.25 Due to the sensitivity of these sites and their visual relationship with the conservation area, the decision has been made to keep them in the boundary of the conservation area. This is to ensure that any future redevelopment of these sites responds to and enhances the character of the conservation area.

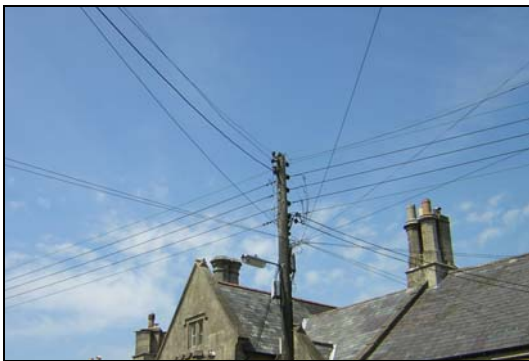
7.27 The wirescape in the centre of the village is having a significantly harmful effect on the character and appearance of the conservation area. This modern intrusion is unsightly and an inappropriate feature in an historic setting. Clutter from wires focussed on timber poles, which are also adorned with street lighting and junction boxes, is a particular problem at the top of Church Lane and detracts from the setting of the listed terrace.

Unattractive wirescape has a detrimental impact on the conservation area

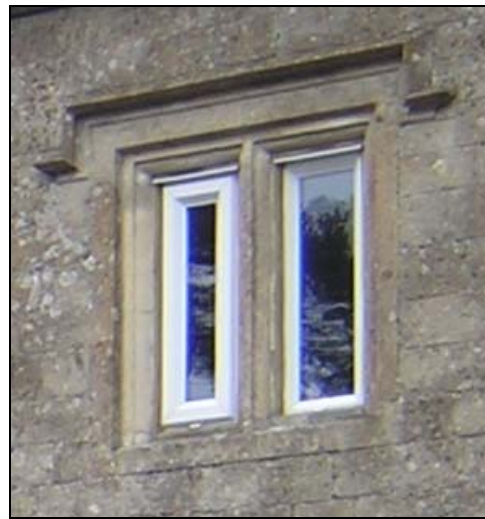
7.28 The gradual replacement of traditional windows with uPVC alternatives in unlisted historic buildings is resulting in the incremental erosion of the historic character of the conservation area. The uPVC frames appear overly large and clumsy, especially in traditional stone surrounds and the use of floating glazing bars gives the windows a bland and lifeless appearance.

uPVC casement window in traditional stone surround

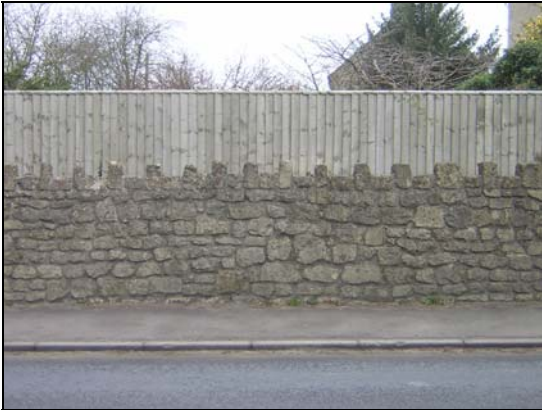
7.29 The use of timber fencing, or its erection on top of, or behind natural stone walls does not respect traditional forms of boundary treatment and detracts from the historic character and appearance of the conservation area.

Timber fencing behind traditional stone boundary wall

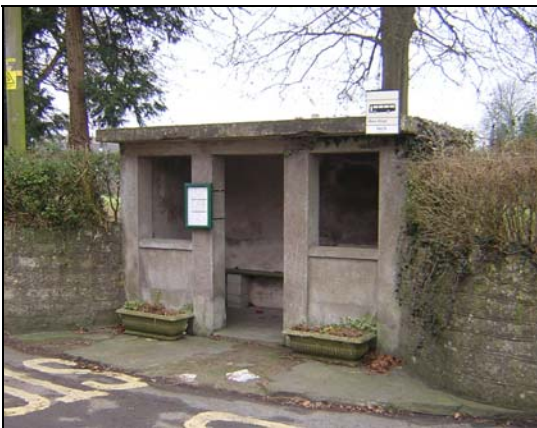
7.30 The concrete bus shelter in the centre of the village is an unattractive feature and detracts from the character and appearance of the conservation area.

The concrete bus shelter is an unattractive feature in the heart of the conservation area

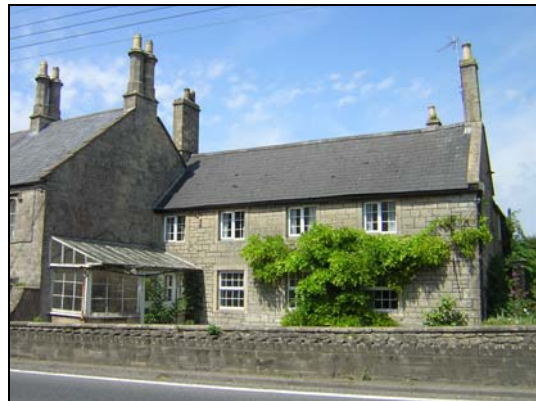
Shamba House is a well proportioned 18th/19th Century building with dressed stone elevation and window surrounds and a stone porch supported on Doric columns on the return elevation. The property has unfortunately had uPVC mock Georgian sash windows inserted and a dilapidated timber greenhouse is positioned against the gable of the adjacent terrace. Whilst it is an attractive building, the uPVC windows and poor condition of the greenhouse means the building neither enhances nor detracts from the character of the conservation area.

Shamba House; uPVC windows and a dilapidated lean-to conservatory detract from this otherwise attractive historic building

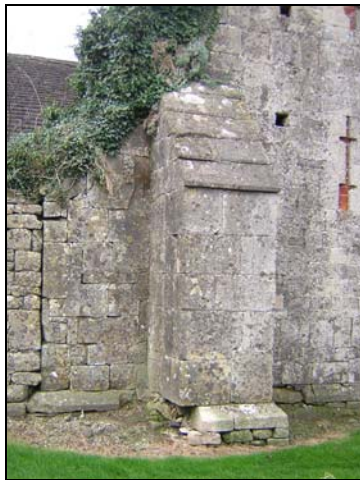
7.34 Condition of Built Fabric. The majority of buildings in the conservation area are in good condition. The Abbey Barn, a grade I listed building and scheduled ancient monument is, however, starting to show signs of disrepair and erosion at the base of the walls.

Base of pier of Abbey Barn showing signs of stone decay and erosion

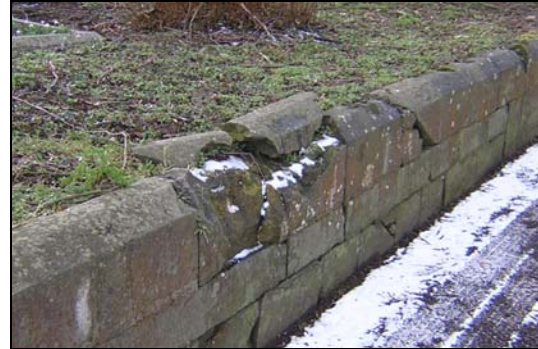
7.35 The Church boundary wall facing Church Lane is in a poor condition. Its iron railings have been removed and the wall, constructed from ashlar blocks, is starting to move and decay. Water damage, iron corrosion and

inappropriate cement repairs are causing further damage.

Damage to boundary wall of St Aldhelm's Church

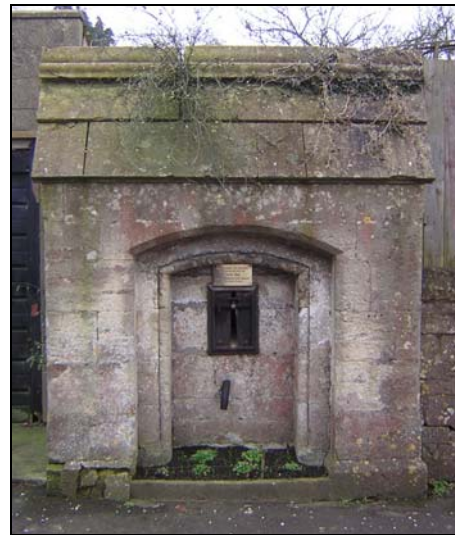
7.36 The listed water pump in Church Lane is suffering damage from water collecting in the soil filled trough and the effects of vegetation growth.

Vegetation and water damage to listed water pump
