◆ The gatehouse of Pevensey Castle

by Anthony Chapman

Excavations in 1993–95, undertaken by the Department of Archaeology of the University of Reading, discovered a sequence of rebuilding the east wall of the keep during the later Middle Ages. Alongside the excavations, the department also carried out fabric surveys of the Roman walls, the keep and the medieval walls of the inner bailey. Certain results of the keep survey and excavation were included in the 1999 English Heritage guidebook, notably reaffirmation of the homogeneous character of the keep inside the Roman wall (Allen & Al Shaikhley 1994). However, only a preliminary report on the gatehouse was produced from the survey of the medieval walls and this paper provides a revised summary of that work, with some observations on the subsequent structural development of the castle through the thirteenth century. There are documentary and architectural contexts for the construction of the lower storeys of the gatehouse during the reign of Richard I.

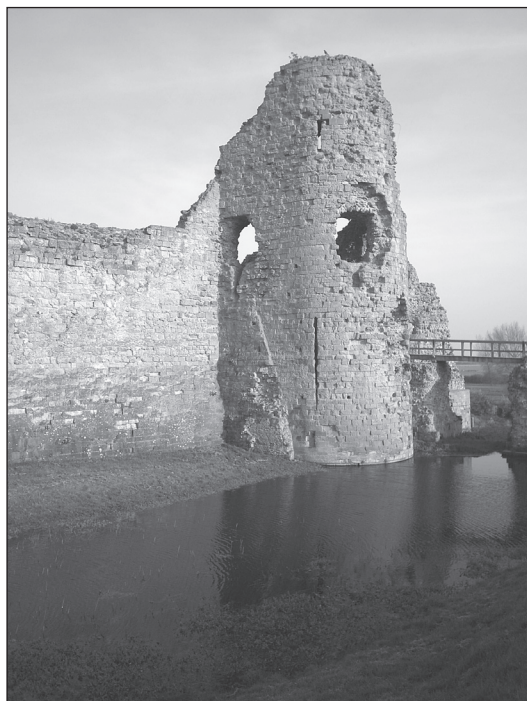
Fig. 2. The northern tower of the gatehouse.

At its southern end the batter butts against the lower storey of the gatehouse and there is no reason to doubt that the basement of the gatehouse is the earlier structure (Fig. 2). Indeed the lower face of its northern tower runs behind the batter while the chamfered ground-floor offset around the gatehouse does not continue along the west curtain, nor is it level with the top of the batter as may be expected. Less conclusive but important are the putlog holes seen on the gatehouse's northern tower but not visible on the curtain; these putlog holes are discussed below.

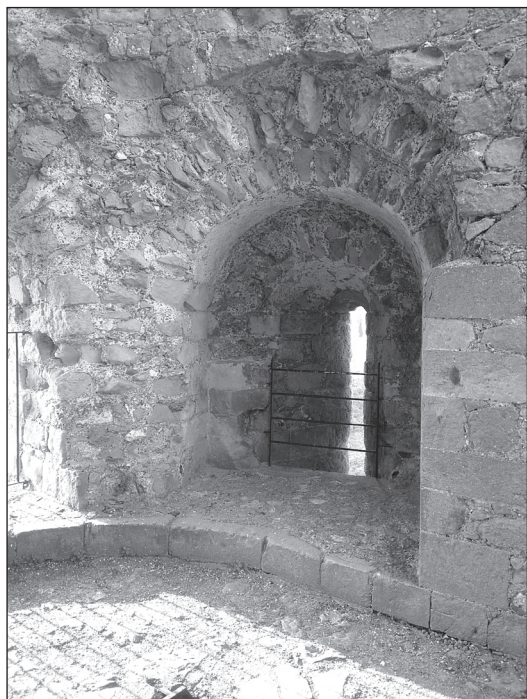
Fig. 3. The ground-floor north embrasure in the northern tower of the gatehouse.

details to enable a reconstruction (Fig. 3). They are of two orders, a large plain semicircular rear arch then the semicircular splay of the slit itself with its steep downward rake; externally the plain slit is very long, extending through the chamfered offset, and marked only by a round head cut into a coursing block.
