Guardrail End Treatments in the 1990s

DON L. IVEY, M. E. BRONSTAD, AND LINDSAY I. GRIFFIN III

An attempt is made to objectively review the most important characteristics of most commercially available and widely implemented terminals or end treatments for guardrail installations. These characteristics include collision performance in the testing and roadside environments, maintenance characteristics, and costs. Field experience with these devices is reviewed. An effort is made to compare performance, use, and costs to aid interested parties in selecting the most cost-effective terminals to meet specific needs.

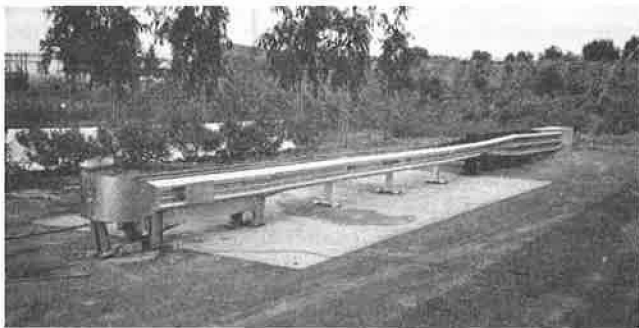
FIGURE 3 BRAKEMASTER.

BRAKEMASTER, from Energy, is shown in Figure 3 and functions in the following way. The forward structural elements of the terminal include a unique braking mechanism on a heavy longitudinal cable. When a vehicle strikes BRAKEMASTER head-on, the braking mechanism is pushed

down the cable and the side W-beam sections telescope. BRAKEMASTER has performed well in NCHRP 230 testing (31). An average installation costs about \$5,000. A fact summary sheet is shown in Figure 12.

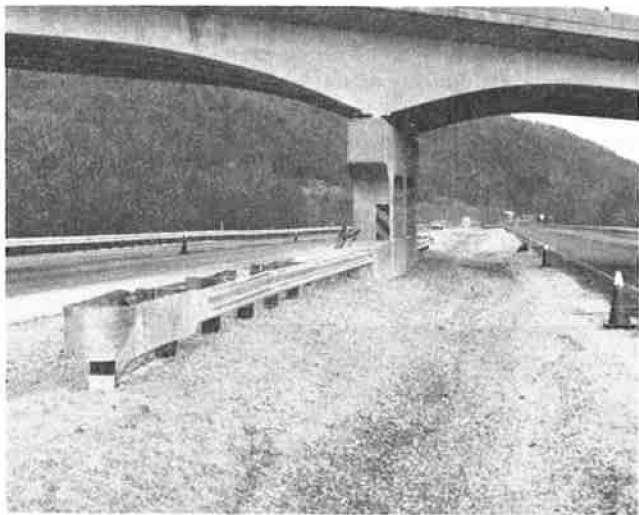
FIGURE 4 CAT installation.

The Shredder, but evolved through the designation of vehicle attenuating terminal to CAT. CAT met NCHRP Report 230 requirements and was a good step toward reasonable cost. CAT has been evaluated using 4,500- and 1,800-lb automobiles and a 5,400-lb pickup (23-26). CAT can be installed parallel to the road without flaring.

Projected cost is about \$3,700. The 42 collisions now reported indicate good field performance. An installation is shown in Figure 4, and a fact summary sheet is shown in Figure 9.

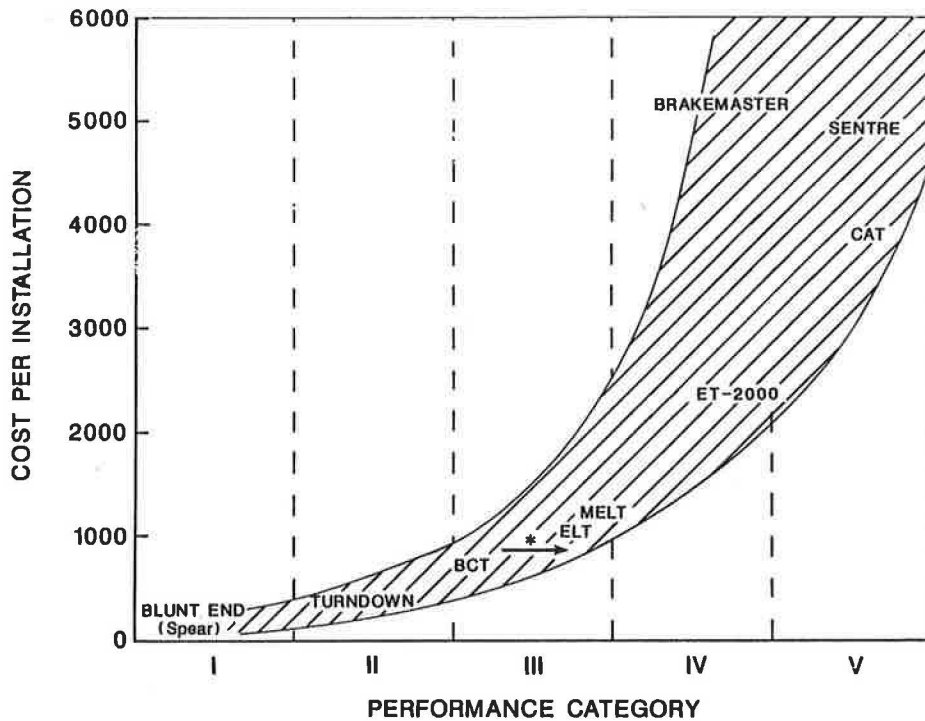
*Significant Improvement

Note: Median costs are plotted for Sentre and BRAKEMASTER. Depending on site characteristics, Sentre may vary $\pm 50\%$, while BRAKEMASTER may vary $\pm 30\%$.

The various competing systems were categorized on the basis of compliance crash testing and field experience. The costs were supplied by FHWA, Energy, and Syro. These data are shown in Figure 13. The figure shows the trade-off between cost and performance. At this time, as costs per system increase, the field-verified performance level increases. The

The following are additional observations from Figure 13:

- If field-verified performance is most important, the choice is probably between Sentre and CAT. They may be economically justified in areas in which many collisions occur.
- If MELT moves into Category V, the cost advantages would be considerable.
- Any end condition in Category I should be replaced or modified as quickly as is economically feasible.
- Any terminal in Category II (turndowns and nonflared BCTs) should be gradually phased out, with emphasis placed
