The Bristol brass industry: Furnace structures and their associated remains

Joan M Day

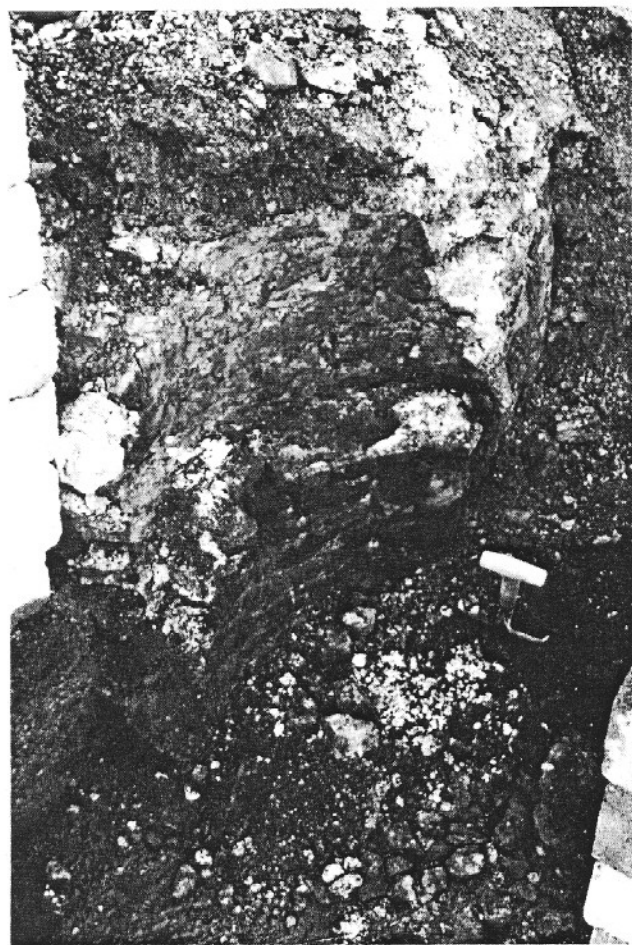
Fig. 4 The best preserved of the three furnace sections at Warmley, situated at A in Fig. 7 inset.

have met with little or no response. By chance, two members²⁶ of the Bristol Industrial Archaeological Society visited the site over the Easter Holiday, and immediately realised that the foundations had been driven through a set of three furnaces which they thought were probably calamine-brass cementation furnaces. Only about one third of a vertical section of each furnace had survived the foundation trenches, and the remainder of the weekend was spent in cleaning up these structures, measuring and photographing, and investigating to see if there were further remains of importance. (Fig. 4).

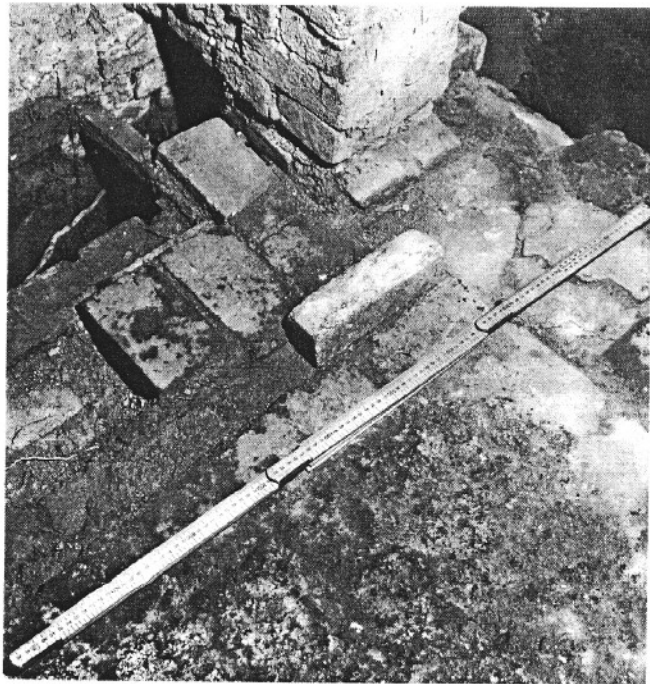
Fig. 8 The bed of the annealing furnace showing the groove from which sprang the muffle arch, and part of the firebox, top left. Scale, metre.

From these descriptions it had been apparent that the furnace had been a muffle with an interior wall which Tom Shellard remembered having to keep sealed by smearing with refractory clay. This inner arched wall, forming the furnace chamber is now missing, having disintegrated, but clearance of the furnace bed revealed grooves in the brickwork from which the arch would have sprung. A few refractory bricks of half normal width which fitted these grooves were still lying in and about the furnace. The reconstruction drawing shows how this inner arch may once have appeared (Fig. 9), although no precise details of it are known.

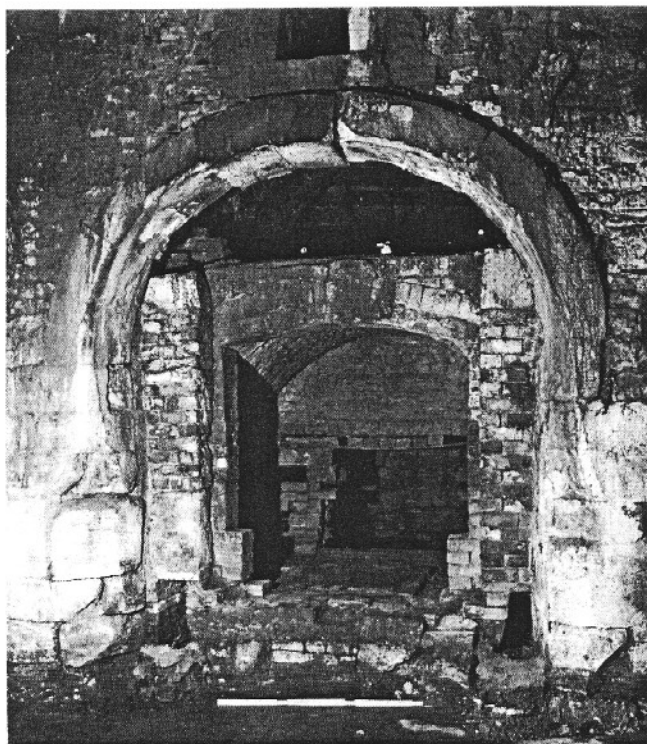
Fig. 10 Saltford annealing furnace from the front, before repair of the gaping hole in the rear face.

gaping dangerously at the time of excavation the rear face of the furnace was originally blind apart from the firing apertures. This damaged section has now been repaired to match photographic evidence. (Figs. 10 and 16).

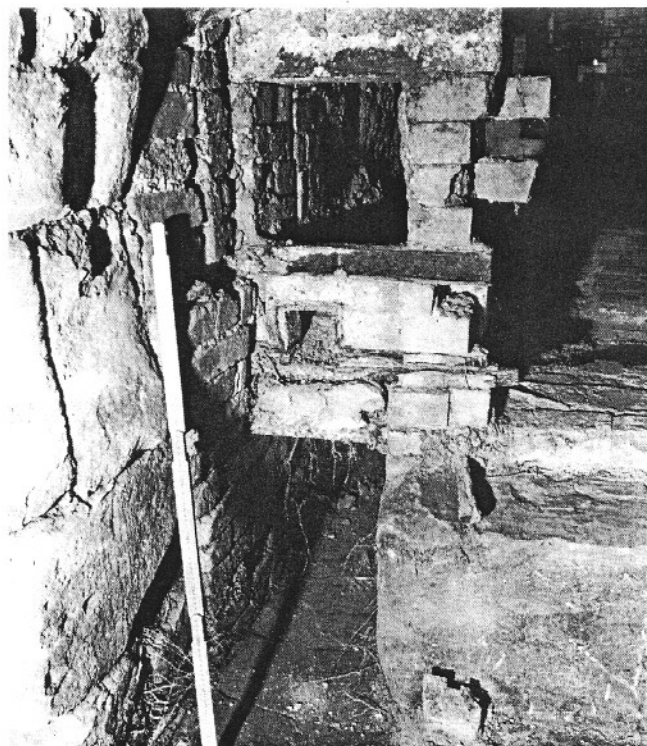
Fig. 11 Rear of annealing furnace showing door position and ashpit of left-hand firebox.

Further removal of silt revealed the two fire boxes situated at either side of the furnace bed, both extending from front to rear in, what would have been, cavities surrounding the missing protective arch. They would have been fired from the rear face through cast-iron doors, some fittings of which had still survived in place. The ashpits descended to floor level, well below the bed of the furnace, creating two troughs extending the whole length of either side. (Fig. 11). Although

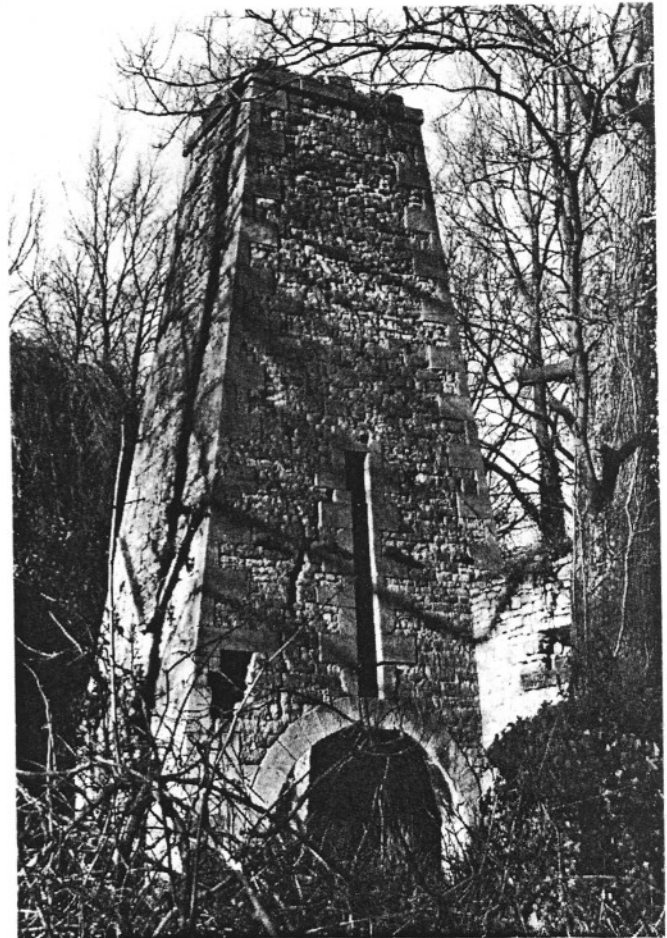
Fig. 13 One of the two shells of annealing furnaces surviving at Kelston. Of slightly different design to those at Saltford.

differs slightly in the batter of the chimney and other small details. (Fig. 13).

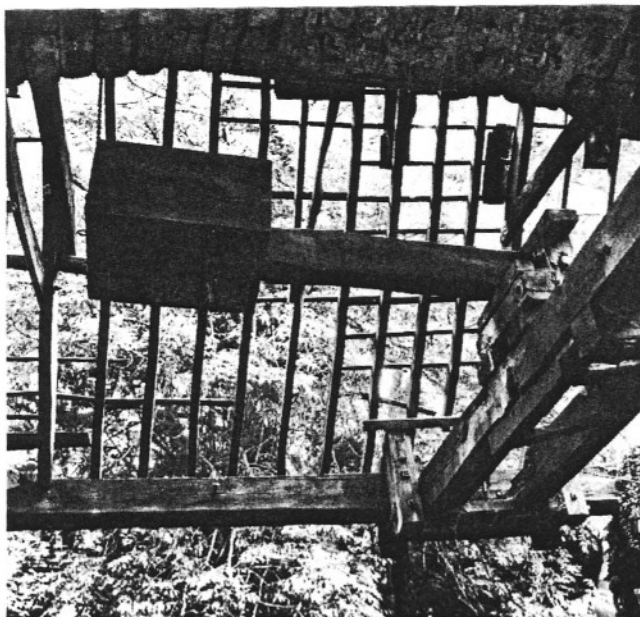
Fig. 14 The balance beam of the second partly ruined Saltford annealing furnace. This has now collapsed.

The furnace would have been loaded from the front by trolley from a revolving turntable according to Tom Shellard's memory. The turntable is no longer there, neither is the heavy firebrick door bound with iron bands but it is possible to see where it slid into place, suspended from a long timber balance beam. This horizontal beam held the door from an arch-head type hoist by protruding through a vertical slot pierced through the wall of the chimney, which accommodated its balancing movement. (see Figs. 12-14). A wooden box at the opposite end of the beam counterbalanced the weight of the door, enabling it to be opened quite easily by pulling the box down with a length of chain. The vertical chimney slot is still a distinctive feature of the structure, and the balance beam, which had crashed to the ground just prior to the excavation, has now been repaired and placed in position. (Fig. 12). An original beam is also still in place at the time of writing in front of the ruined furnace, although threatened by possible collapse. (Fig. 14).
