**Archaeological Research and Rescue Project at Naranjo: Emerging  
Documentation in Naranjo's, *Palacio de la Realeza*, Petén, Guatemala**

**Research Year:** 2005

**Site:** Naranjo

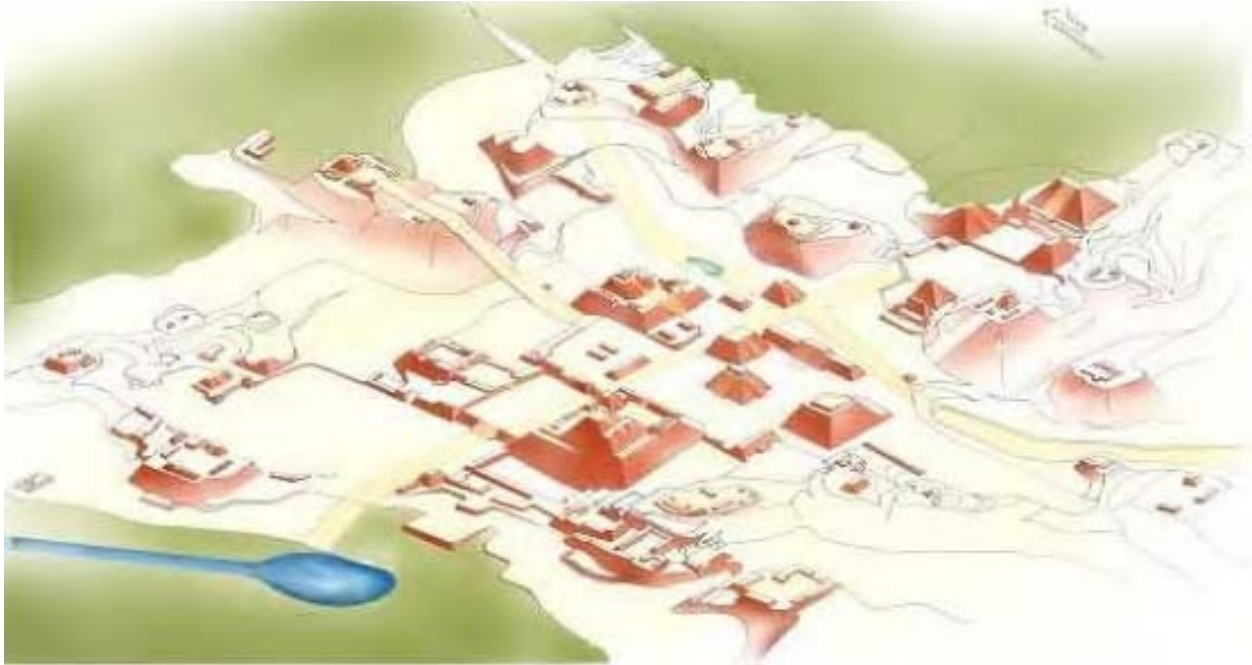
The core of Naranjo's monumental urban zone occupies an area of 2.25 km<sup>2</sup> ([Figure 2](#)). Around this area there is a residential zone of minor elites and commoner groups, which extends for at least 8 km<sup>2</sup> around the Bajo La Pita and several of the Holmul River's tributaries.

**Figure 2. Naranjo's monumental epicenter.**

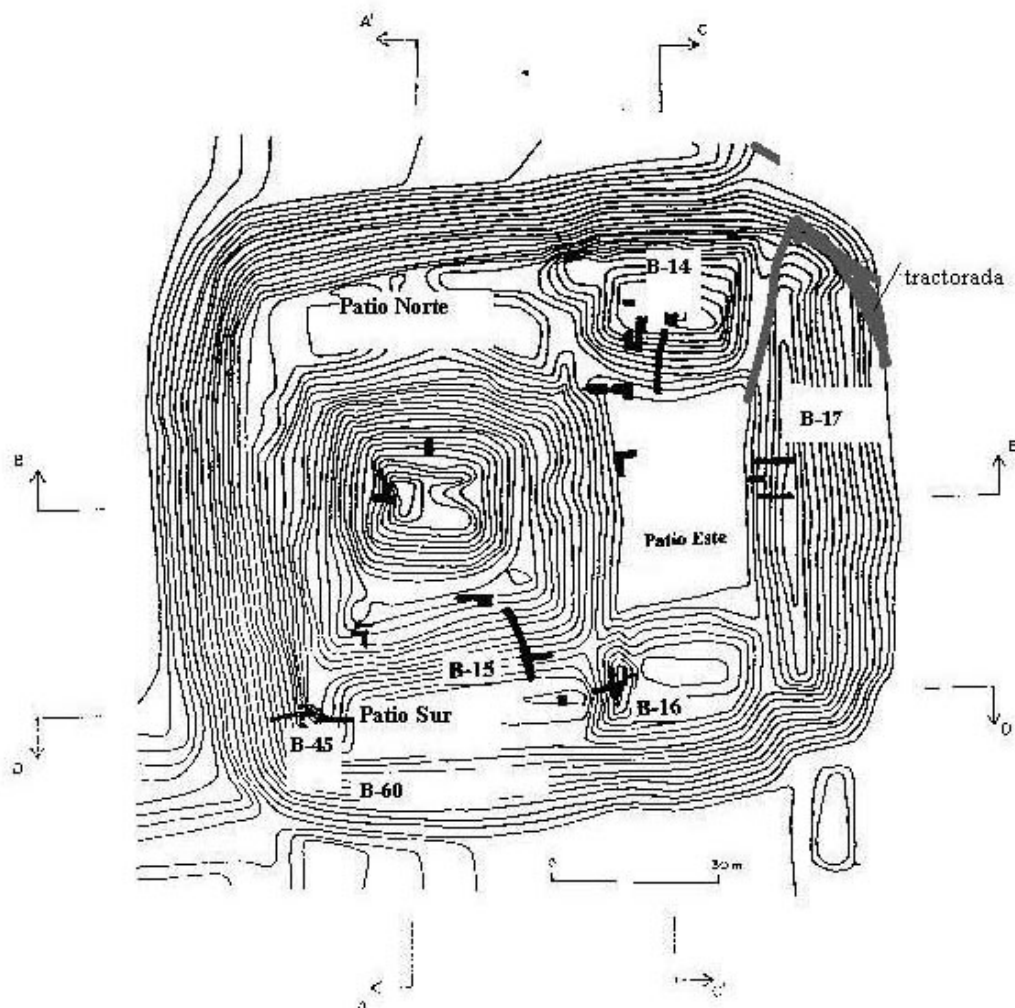
In this compound there is a total of 16 lootings, of which only seven have been recorded in the following locations: two in building B-14, two in B-15, two in B-17, and one in B-45 ([Figure 5](#)). Rescue works carried out in a tunnel within building B-16 were not finished.

**Figure 5. Location of Lootings in the Central Acropolis.**

The central palace B-15 consists of a pyramid foundation with four terraces, reaching a height of 30 m above the surrounding patios. On each terrace are several vaulted buildings, arranged lengthwise or crosswise following a format that recalls the one shown by the Caana palace of Caracol (Belize), the structure II of Calakmul (Campeche) and the palace of five floors in Edzna (Campeche). The tunnels excavated by the looters exposed precincts in the South façade (first, second and third level), the West façade (third level) and the North façade ([Figure 5](#)).

Research activities were focused on looting number 3, which is located in the southeast section of the first body of the south façade ([Figure 5](#), and [Figure 41a](#), above). It was necessary to re-open the tunnel that had been closed down in 2001. The looting had a total length of 16 m, starting as a trench (measuring 5 m in length, 1.25 m in width and 1.85 m in height) that destroyed the wall of the façade of precinct number 3, part of the door jambs (.55 m in width) and the back wall, to which a bench had been affixed (height: 57 cm; width: 99 cm). The bench still has stucco covering in good condition (see [Figure 23](#), [Figure 24](#), below, [Figure 42a](#) and [Figure 42b](#)).

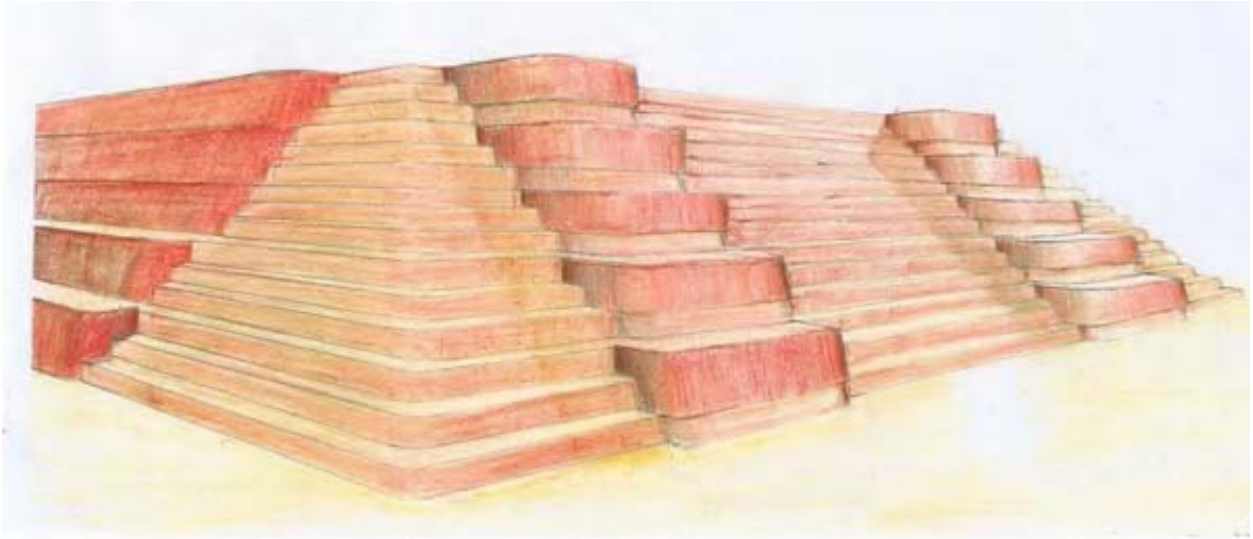
Another goal involved finishing recording the shape and dimensions of the Preclassic building which was found below the East Patio of the Acropolis, known as building B-sub 1 (see [Figure 9](#), below). It was also considered important to determine, by means of test pits, the existence of other associated early buildings, which might allow us to know

**Figure 9. Substructure B-sub 1 (ideal reconstruction).**

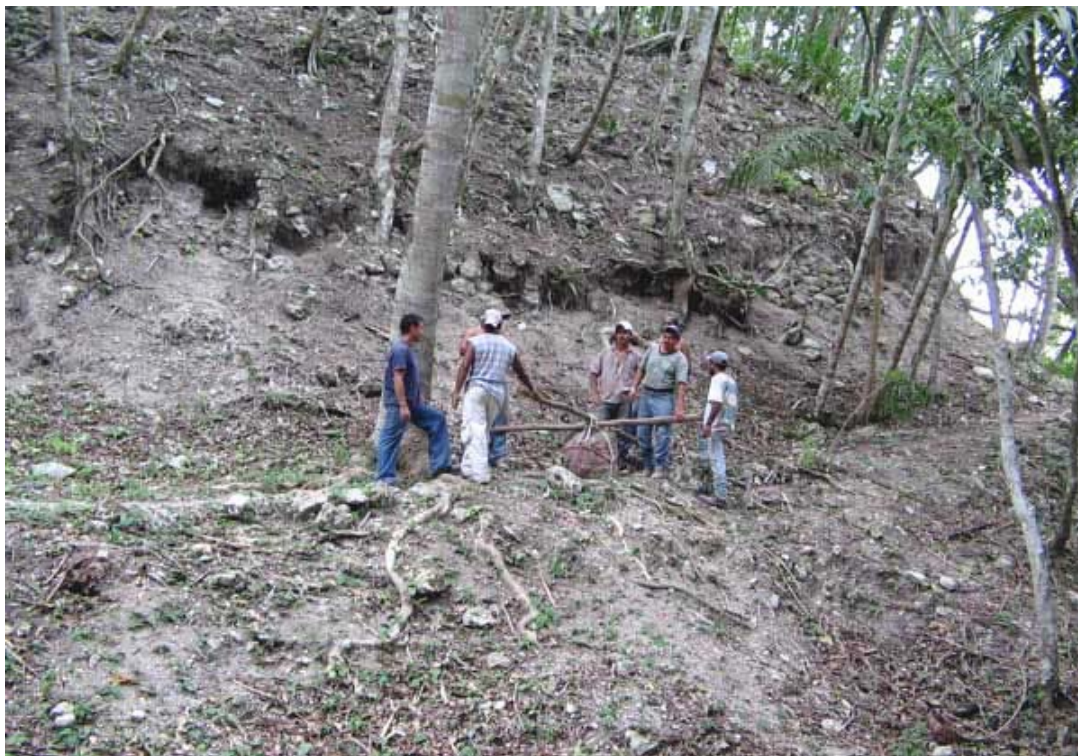
The Central Acropolis covers an area of 490 square meters, and rises 40 m above the level of the plaza that supports the foundation. During the sixties some loggers made a wide cut with a tractor in the NE foundation of the acropolis complex, apparently with the aim of stealing some major sculpture ([Figure 31](#), below).

**Figure 31. Cut made by a tractor in the Central Acropolis.**

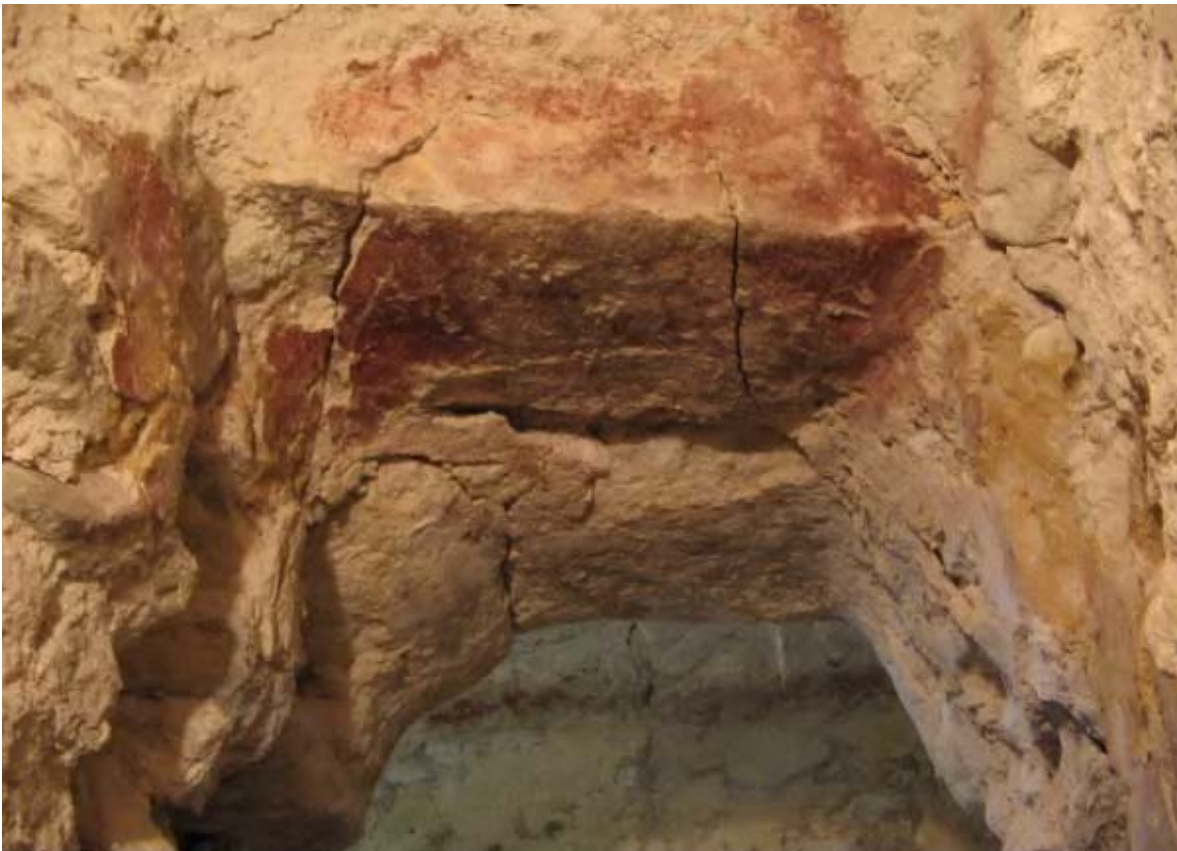
**Figure 32a. Palace B-15, painted precincts in the second level.**

In the rescue season pertaining to the year 2004 we partially recorded one of five lootings carried out in palace B-15, specifically looting number 2, located in the second level of the SE sector. Likewise we made preliminary drawings of looting number 1, whose recording was quite complex because it is located on the second level, and particularly because the precincts are totally covered with painted stucco, including the vault. These precincts have to be consolidated before being closed down ([Figure 32a](#), [Figure 32b](#), and [Figure 32c](#), below).

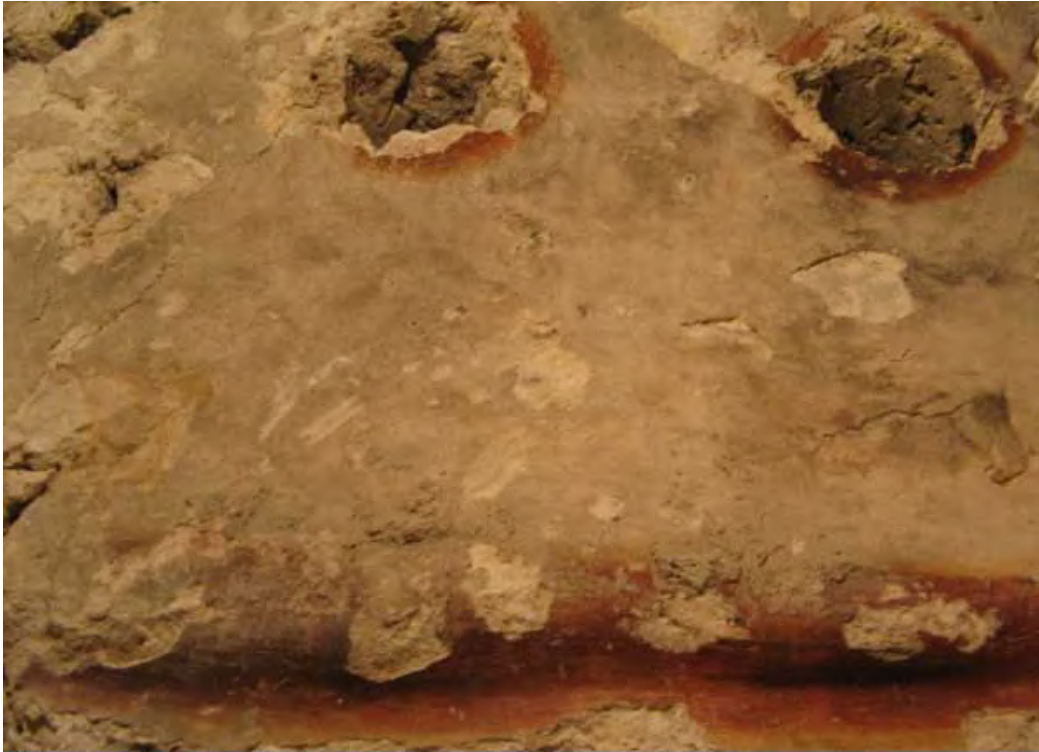
**Figure 32b. Palace B-15: vault, soffit and holes for rafters.**

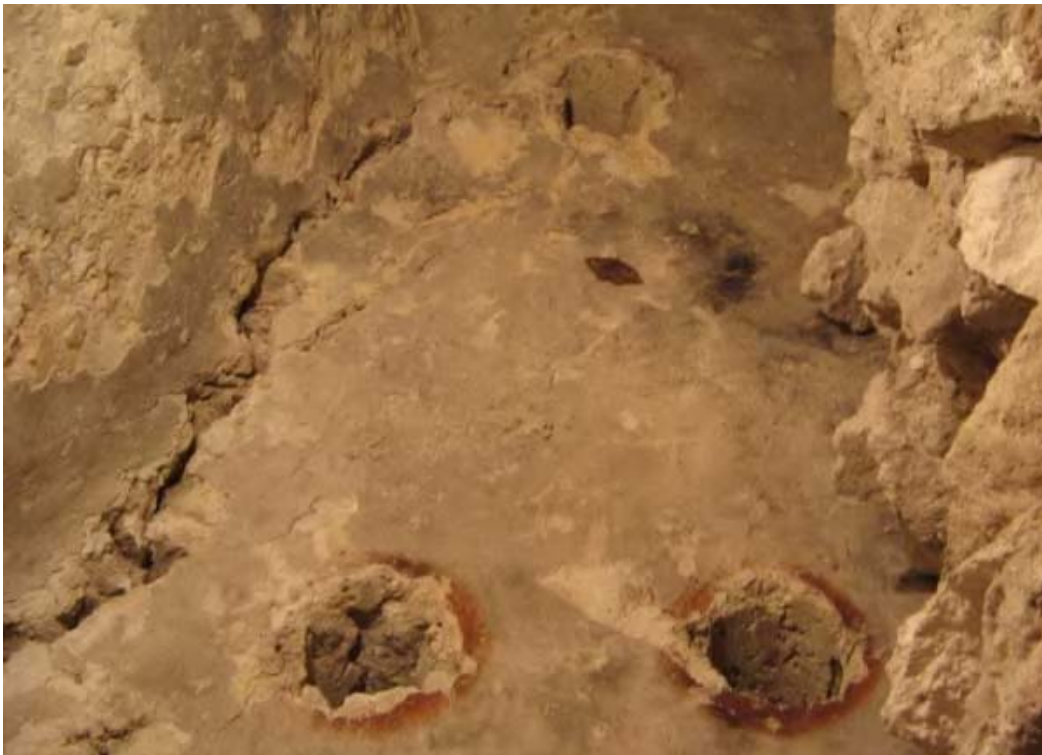
**Figure 32c. Palace B-15: vault of north precinct, second level.**

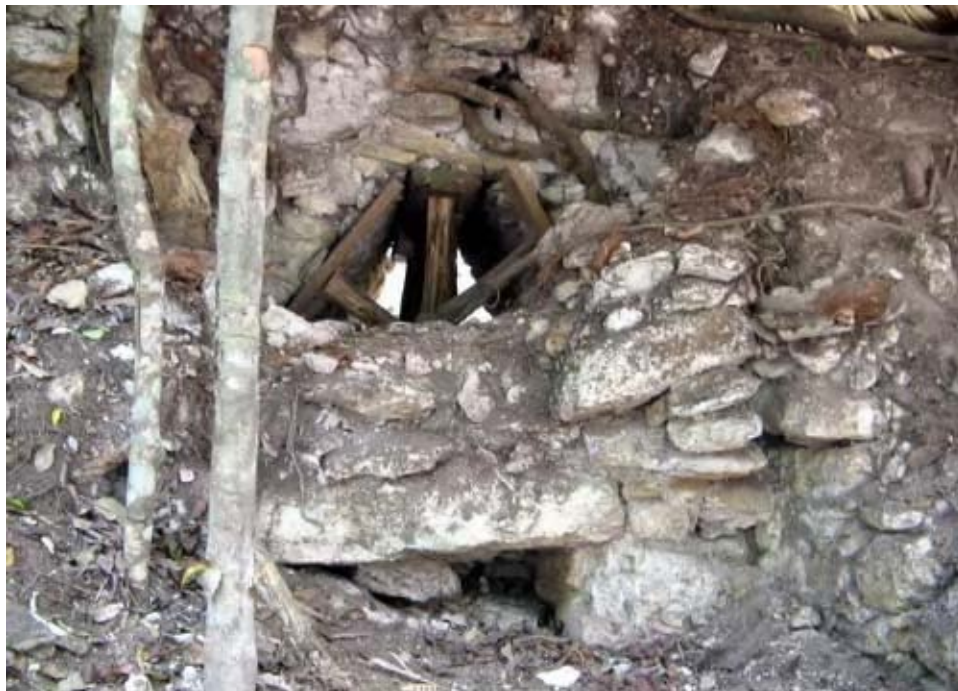
Access to this patio was by means of a vaulted corridor (B-14A) which linked it with the East Patio ([Figure 21b](#), below). The function of the North Patio may have been connected with ritual activities or ceremonies linked to public functions, because it borders with the city's Main Causeway. The North Patio is organized in two sectors, one of which is integrated with the North façade of palace B-15, which had a very wide access. The other sector of the North Patio is connected with a low L-shaped platform, located in the NW corner of the palace complex. From this spot the ruler and his family may have seen the processions which came down the Main Causeway.

**Figure 21b. Vaulted passage B-14A.**

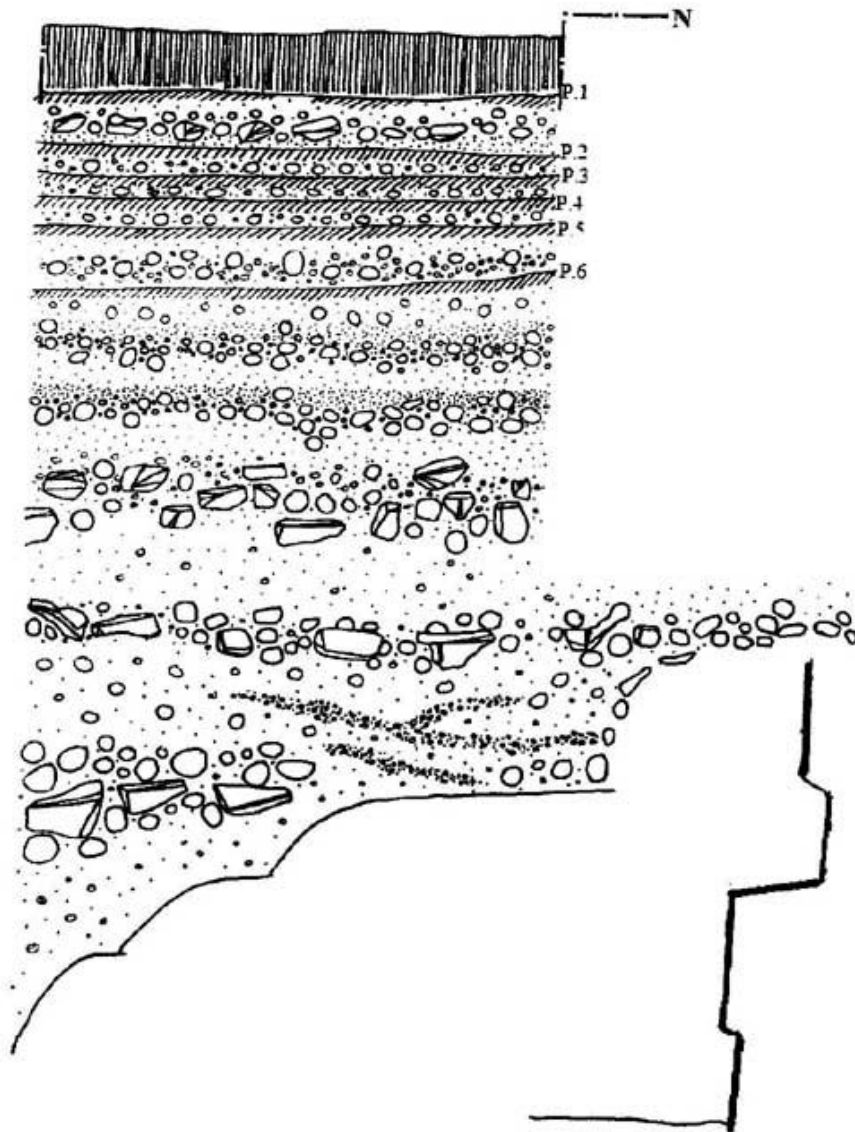
The E-10 test pit ([Figure 10](#), [Figure 35a](#), and [Figure 35b](#), below) permitted us to define three upper bodies of substructure B-sub 1 in the Southeast sector, as well as the details of the south stairway extending to the SE corner of the foundation. This is regarded as a characteristic feature of Preclassic Maya architecture.

Figure 10. Sub-operation E-10 (west side).

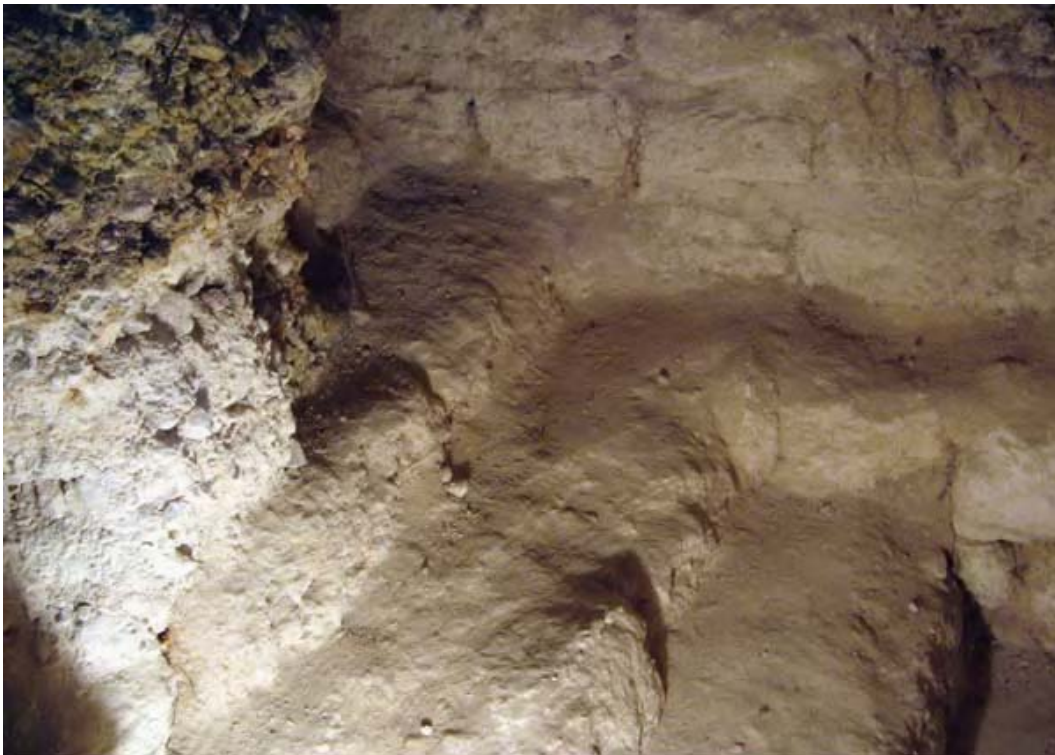
**Figure 35b. Structure B-sub 1, steps of the penultimate body.**

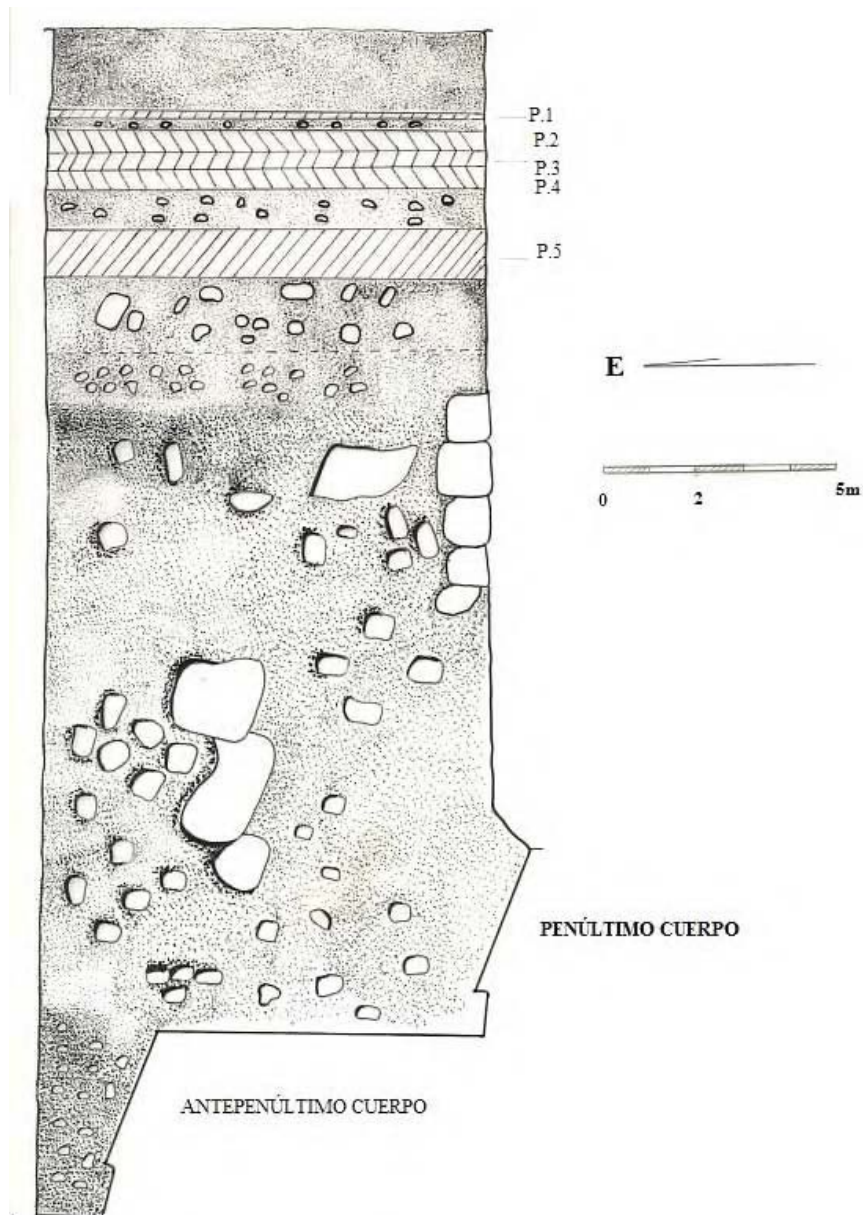
The FG-8/9 test pit ([Figure 8](#) and [Figure 13](#)), was aimed at knowing the details of the façade on the east side of B-sub 1, and to define the possible presence of great masks that could have confronted the Preclassic pyramid underlying the Temple of the Hieroglyphic Stairway (B-18) which defines the West sector of the Astronomical Complex. It was possible to know the penultimate and antepenultimate bodies of B-sub 1 with their respective landings.

Figure 13. Stratigraphy of building B-sub 1.

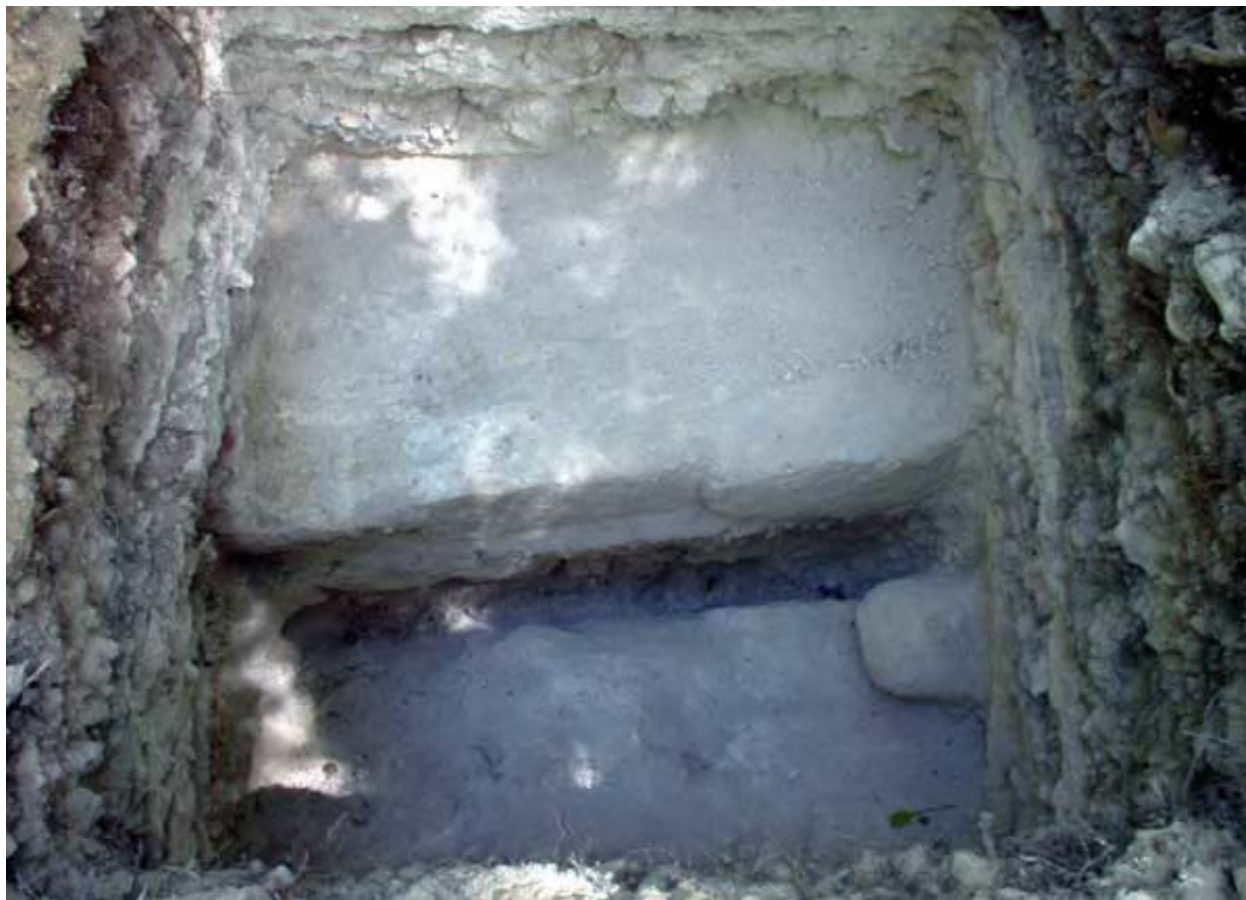
D-8 and D-9 test pits were excavated with the aim of exploring the interior of the upper platform of substructure B-sub 1 and to recover cultural materials which might allow us to know in which period the building was constructed. D-8 pit ([Figure 8](#) and [Figure 12](#)), discovered the section of the upper platform where it blends with the stairway, forming an inset. It was also possible to verify that part of the South façade of the substructure B-sub 1 sinks under building B-15 ([Figure 38](#), below).

**Figure 38. Substructure B-sub 1, upper platform and banquette.**

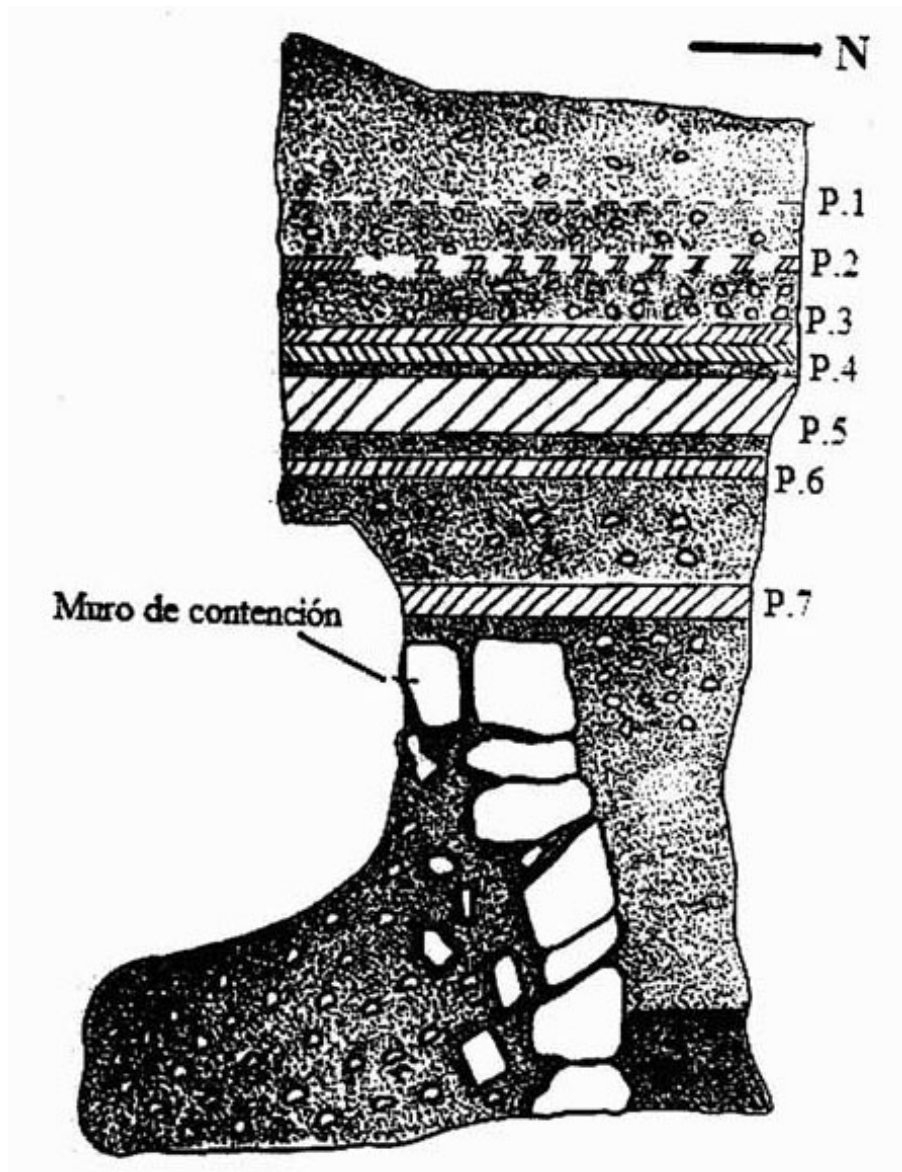
Pit D-9 ([Figure 8](#) and [Figure 14](#)), was excavated parallel to pit D-8 with the goal of finding a sector of the upper platform of B-sub 1 which could be perforated in order to obtain cultural samples of the interior fill. A retaining wall was found under floor 7, made of irregular, mid-sized limestones, of which a height of just 1.35 m was seen. In the excavation process, which involved a volume of 3 m<sup>3</sup> of material, only two eroded

Figure 14. Sub-operation D-9, west side.

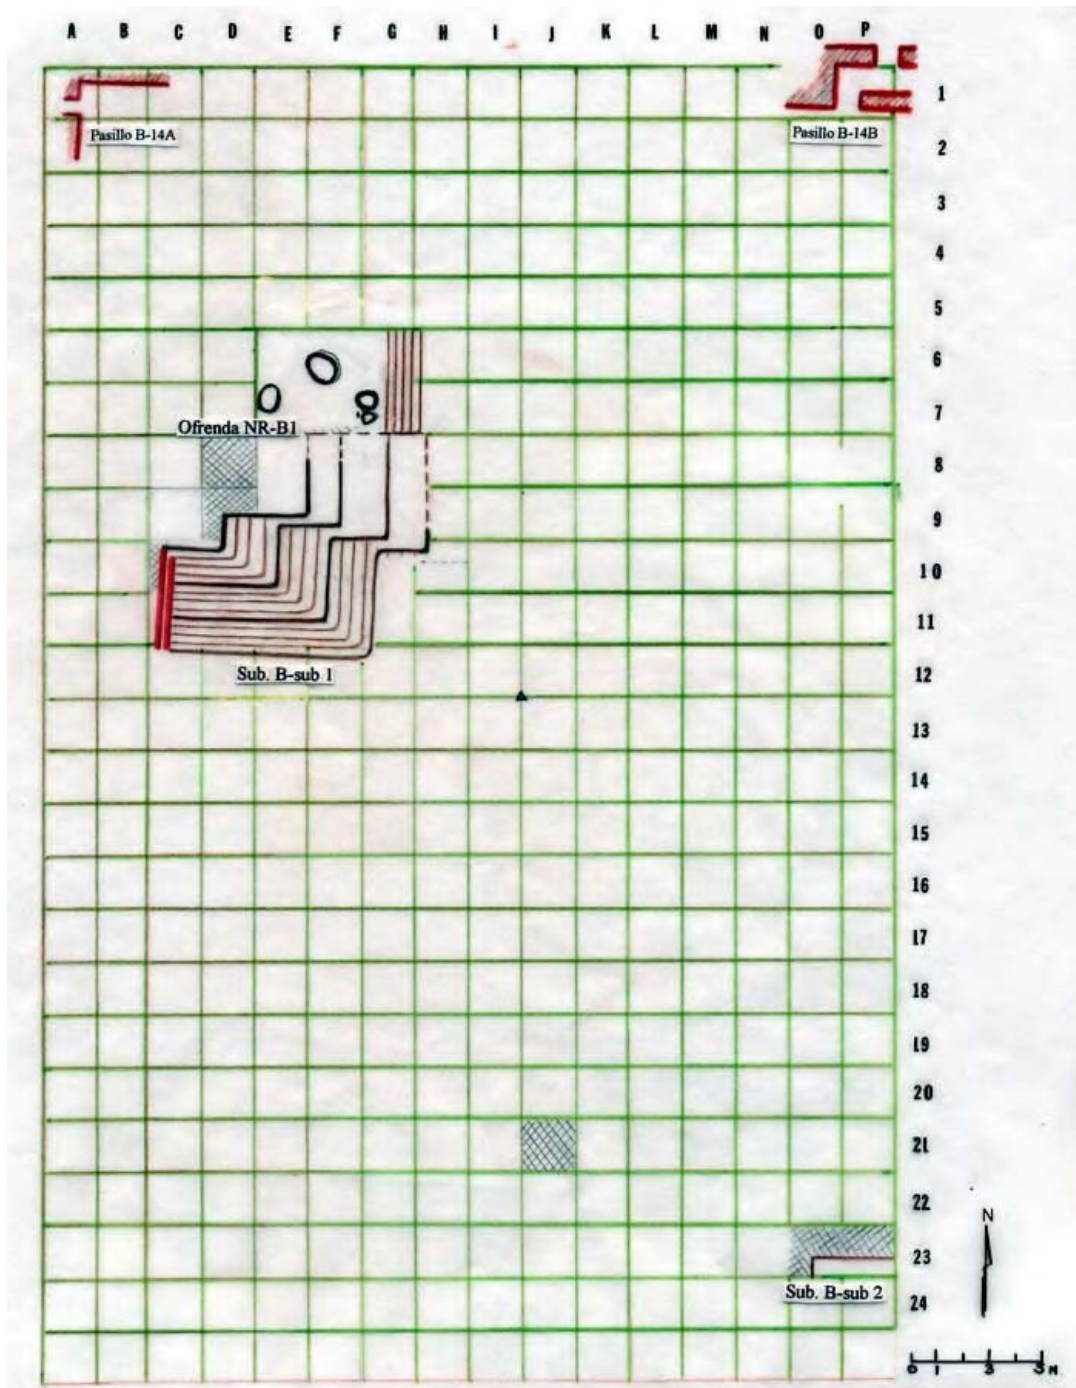
Figure 8. Map showing excavations in the East Patio.

Sub-operation O-23 ([Figure 8](#) and [Figure 19](#)), was placed on the NE corner, with the objective of knowing in detail aspects of the plaza's drainage, as well as the existence of a substructure that might be related with B-sub 1. At a depth of 2.80 m, under nine successive floors, we found the west façade of B-sub 2, a substructure that consisted of a platform built of small, densely compacted limestones with a fill of reddish-orange color ([Figure 19b](#), [Figure 19c](#), [Figure 40a](#), below, and [Figure 40b](#), below). Substructure B-sub 2 was mutilated on the NW corner, before being buried by fills that are associated with the middle of the Chicanel phase. In a section of the building with a relatively good state of preservation it was possible to measure a height of 2.10 m with an inclination angle between 5° and 15°. The floor of the upper platform was remodeled with an additional layer which gave it a total thickness of 0.07 cm. In the inner fill we found abundant diagnostic ceramic material pertaining to the Middle Preclassic period, apparently more closely associated with the early Belizean wares than to the wares characteristic of the Pre-Mamom sphere of the central and northeast section of Petén. Still pending is the comparative ceramic analysis that will enable us to confirm this supposition.

Sub-operation J-21 ([Figure 8](#) and [Figure 20](#)), which was performed 7 m to the west of O-23, shows a stratigraphic deposition associated with fills from the Late Chicanel phase, lacking cultural materials as early as those observed in O-23. It is likely that, although substructures B-sub 2 and B-sub 1 were not contemporaneous, both coexisted during a brief period of time.

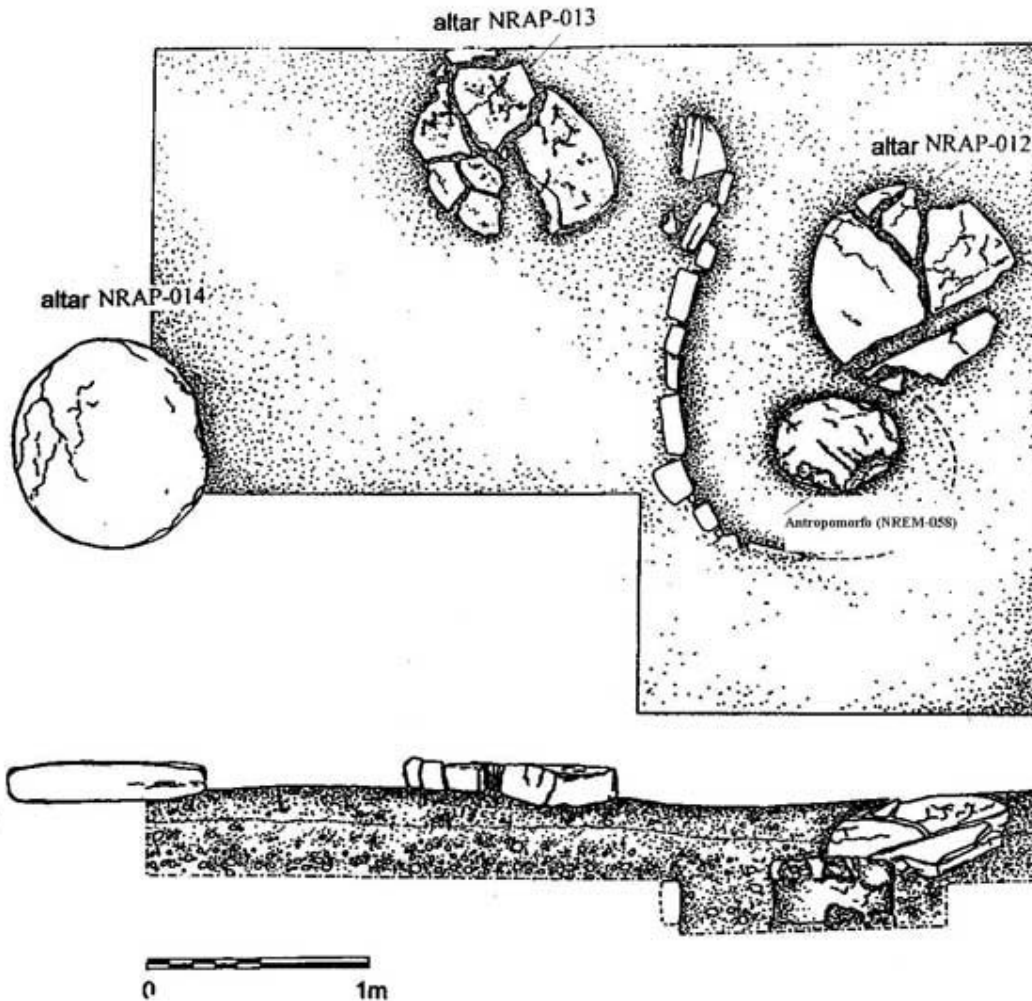
This excavation was aimed at increasing the information related to the find (NR-B1) during the 2004 season of three plain altars and an anthropomorphic figure of the *barrigón* (pot-belly) type (NRAP 012, 013, 014 and NREM-058) located in the northwest sector of the East Patio of the palace complex (see [Figure 8](#), [Figure 8a](#) and [Figure 11](#)).

Figure 11. Sub-operations EFG 6/7 and GH-7 (Offering NR-B1).

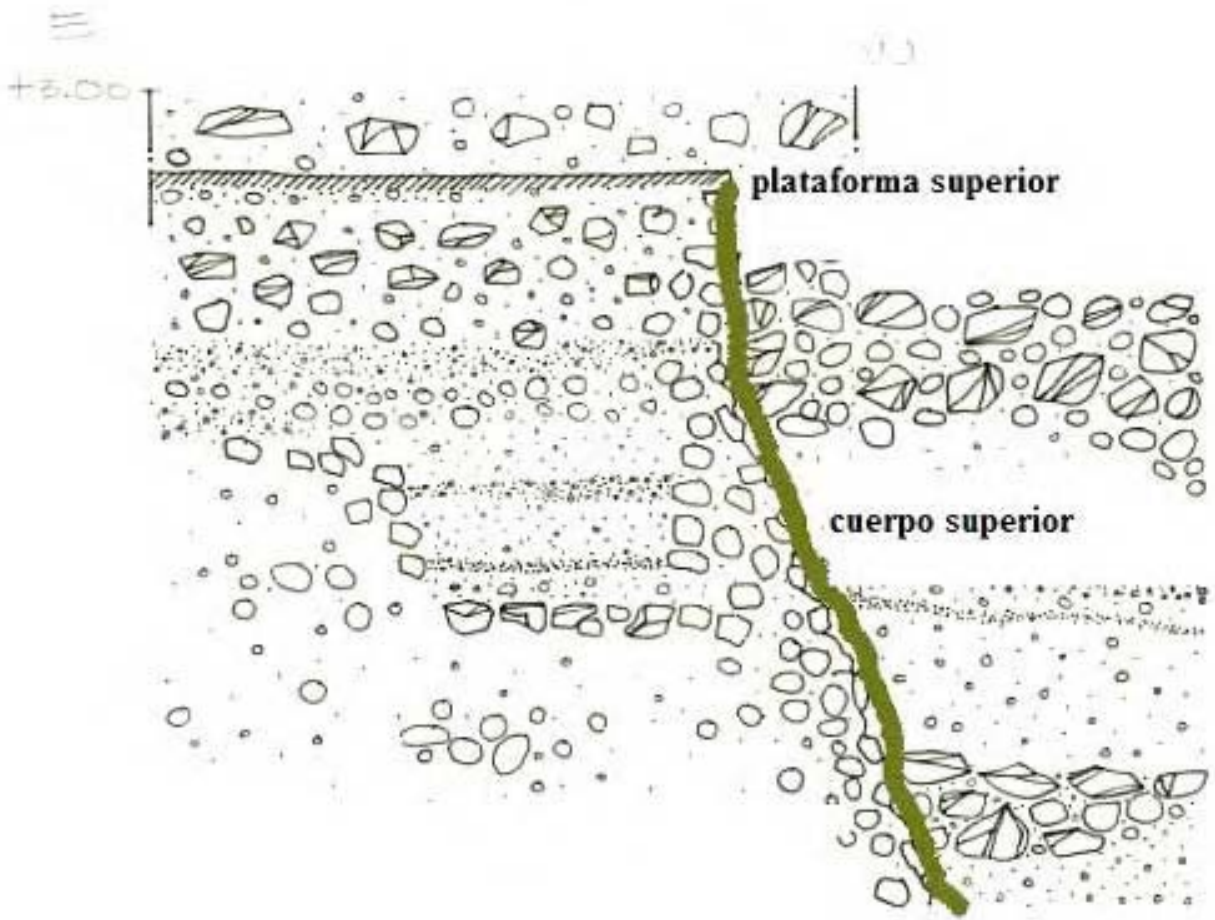
Figure 19. Stratigraphy of Structure B-sub 2.

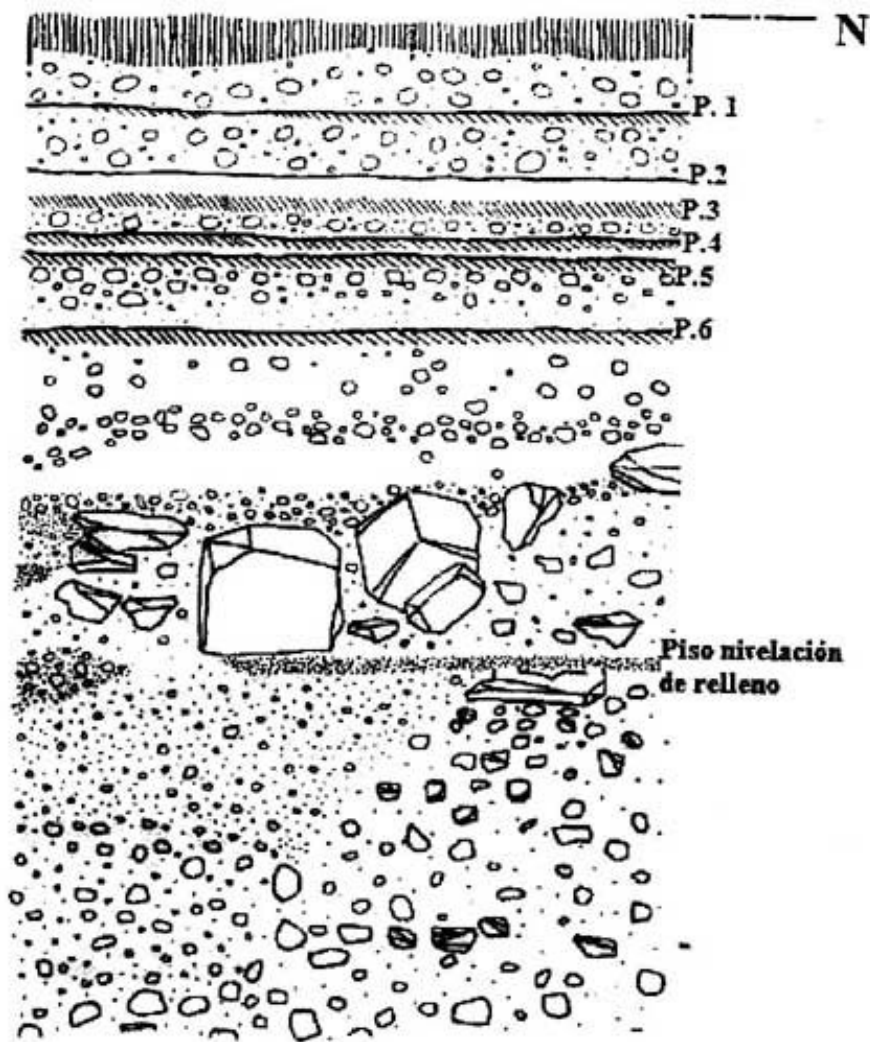
Figure 20. Sub-operation J-21, east side.

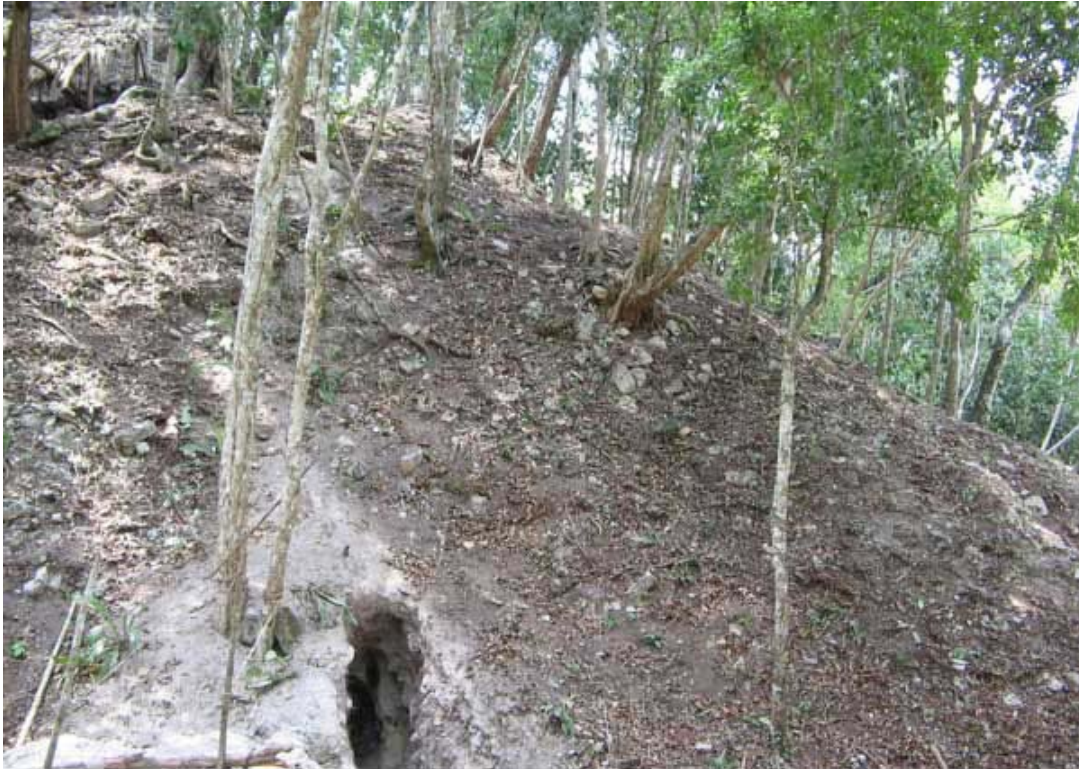
**Figure 41a. Palace B-15, tunnels in the first and second level.**

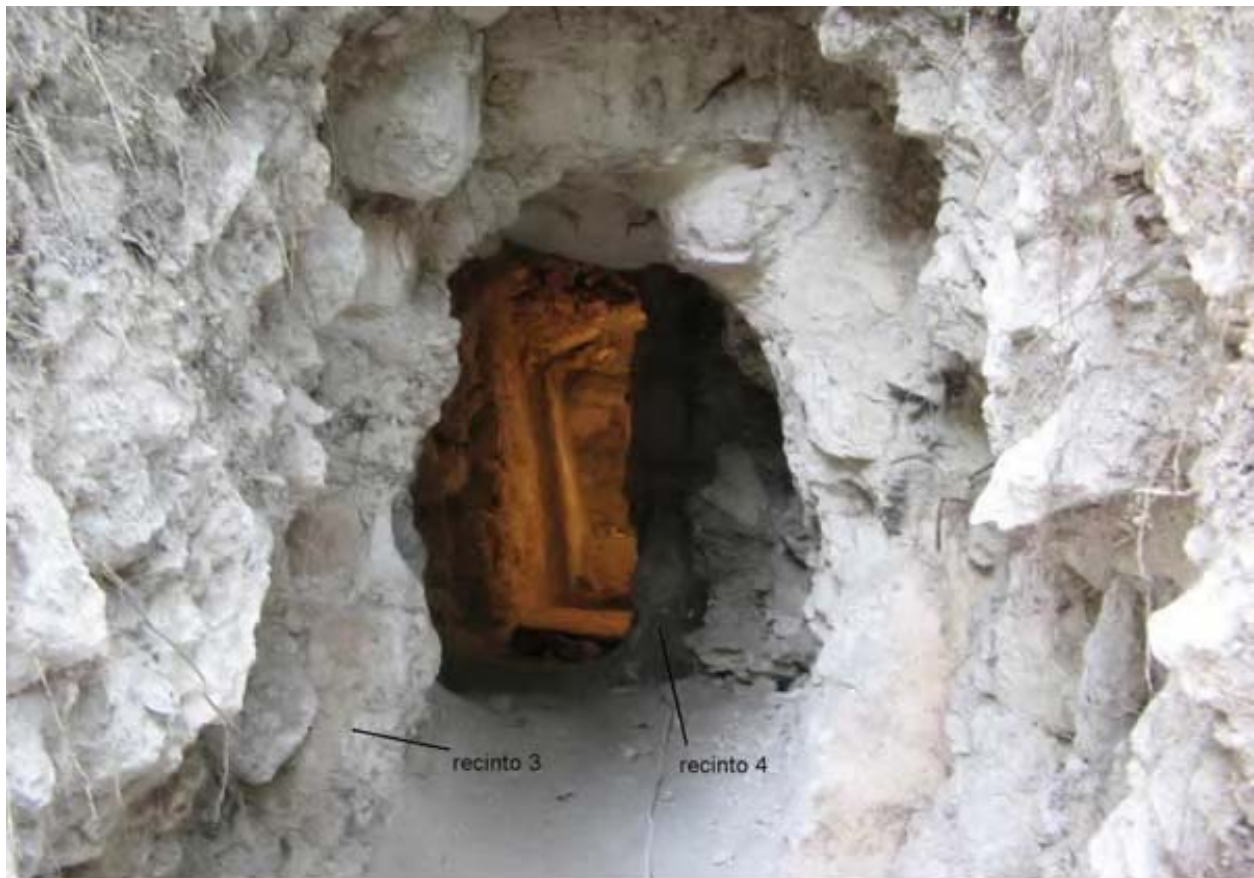
**Figure 24. Looter's tunnel B-15.**

Upon going through the back wall of precinct number 3, the excavation turned into an 11 m- long tunnel, with an average height of 1.48 m and a width of 1.25 m. The tunnel destroyed two earlier construction phases (Substructure B-15-2 [precinct number 4] and Substructure B-15-1) (see [Figure 24](#), above, and [Figure 25](#), below). In one of the limestone blocks that were part of the vault's soffit in precinct number 4, the looters wrote the word "Pichoy" which may be the surname of one of the looters.

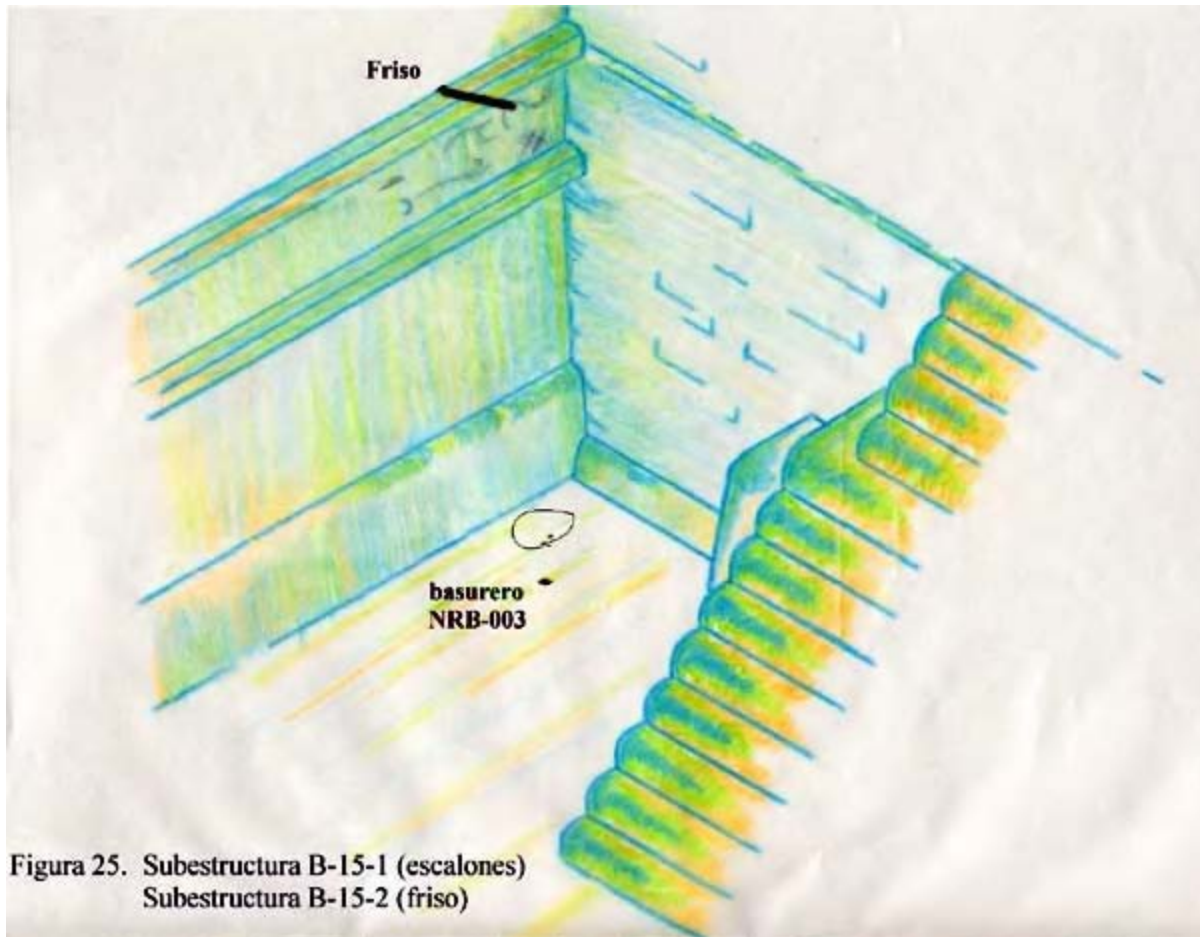
Figure 25. Substructure B-15-1 (steps) and Substructure B-15-2 (frieze).

This substructure consists of the foundation of a probable palace of at least two stories ([Figure 23](#) and [Figure 25](#)). Looting exposed two bodies linked to the south façade, and part of the stairway of the east façade which pertains to the second body, integrated by five steps with a 34 cm tread and a 37 cm riser. The first step of the second body blends into the side wall forming a socle. The height of the first body is thought to have been 1.60 m, while the second one may have reached 2.70 m. It is likely that on top of the landing of the second body there were one or several vaulted precincts.
