**Archaeological Research and Rescue Project at Naranjo: Emerging  
Documentation in Naranjo's, *Palacio de la Realeza*, Petén, Guatemala**

**Research Year:** 2005

**Site:** Naranjo

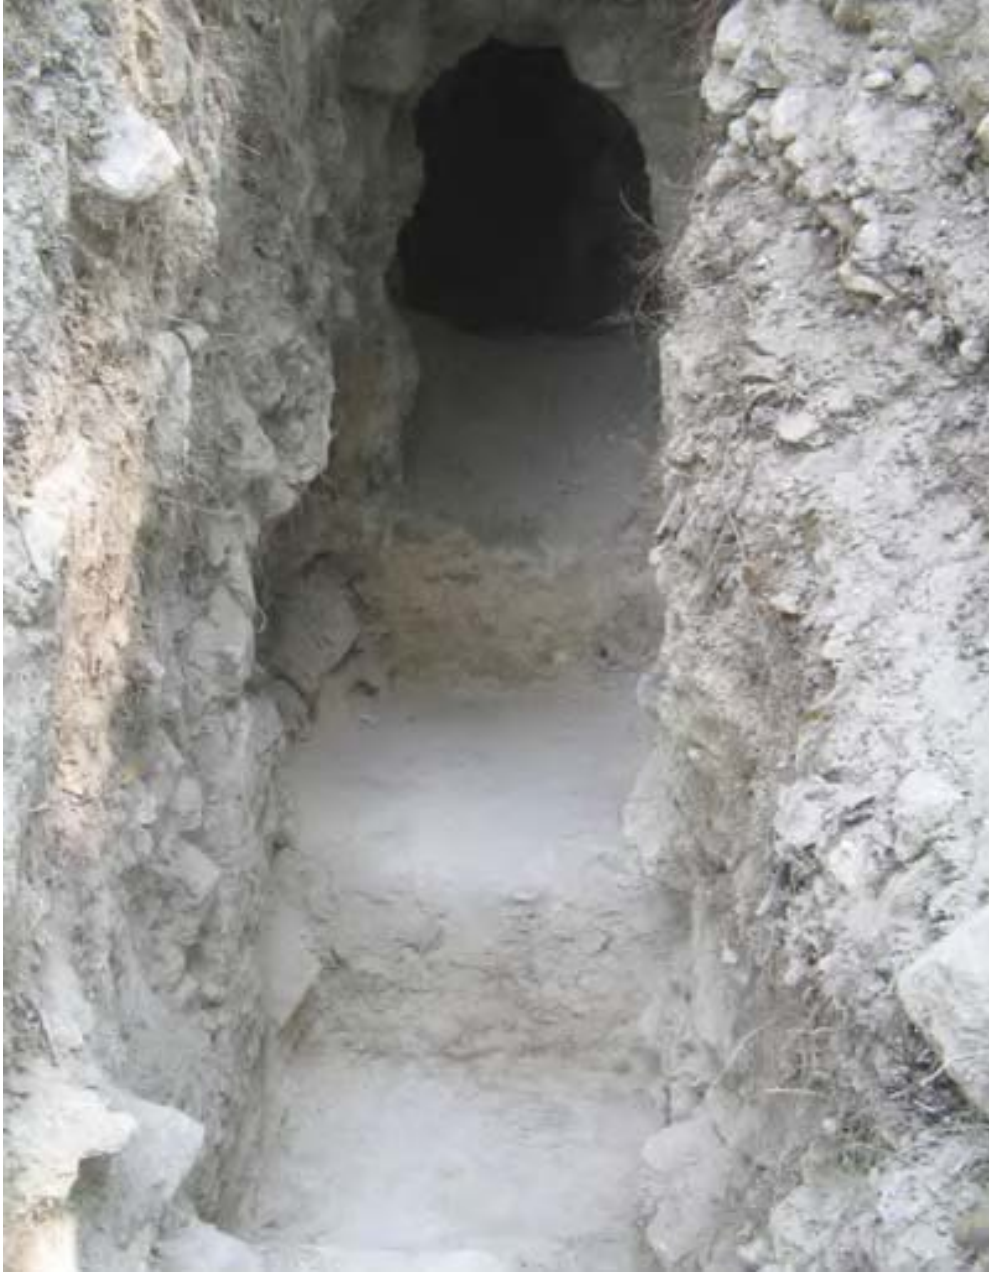
Precinct 3 consisted of a rectangular space (2.70 m long by 1.39 m wide); its access bay had an approximate width of 1.22 m, the jamb on the west side was observed (.55 m in width, 1.30 m in visible height). The precinct's interior was painted in red, as can be seen in the section of the vault's soffit belonging to the back wall. A bench (57 cm high, 99 cm wide, 2.70 m long) occupied most of the precinct, except for a space of barely 38 cm at the front ([Figure 23](#), [Figure 24](#), [Figure 41b](#), [Figure 42a](#), below, and [Figure 42b](#)).

**Figure 41b. Bench and wall destroyed by looting.**

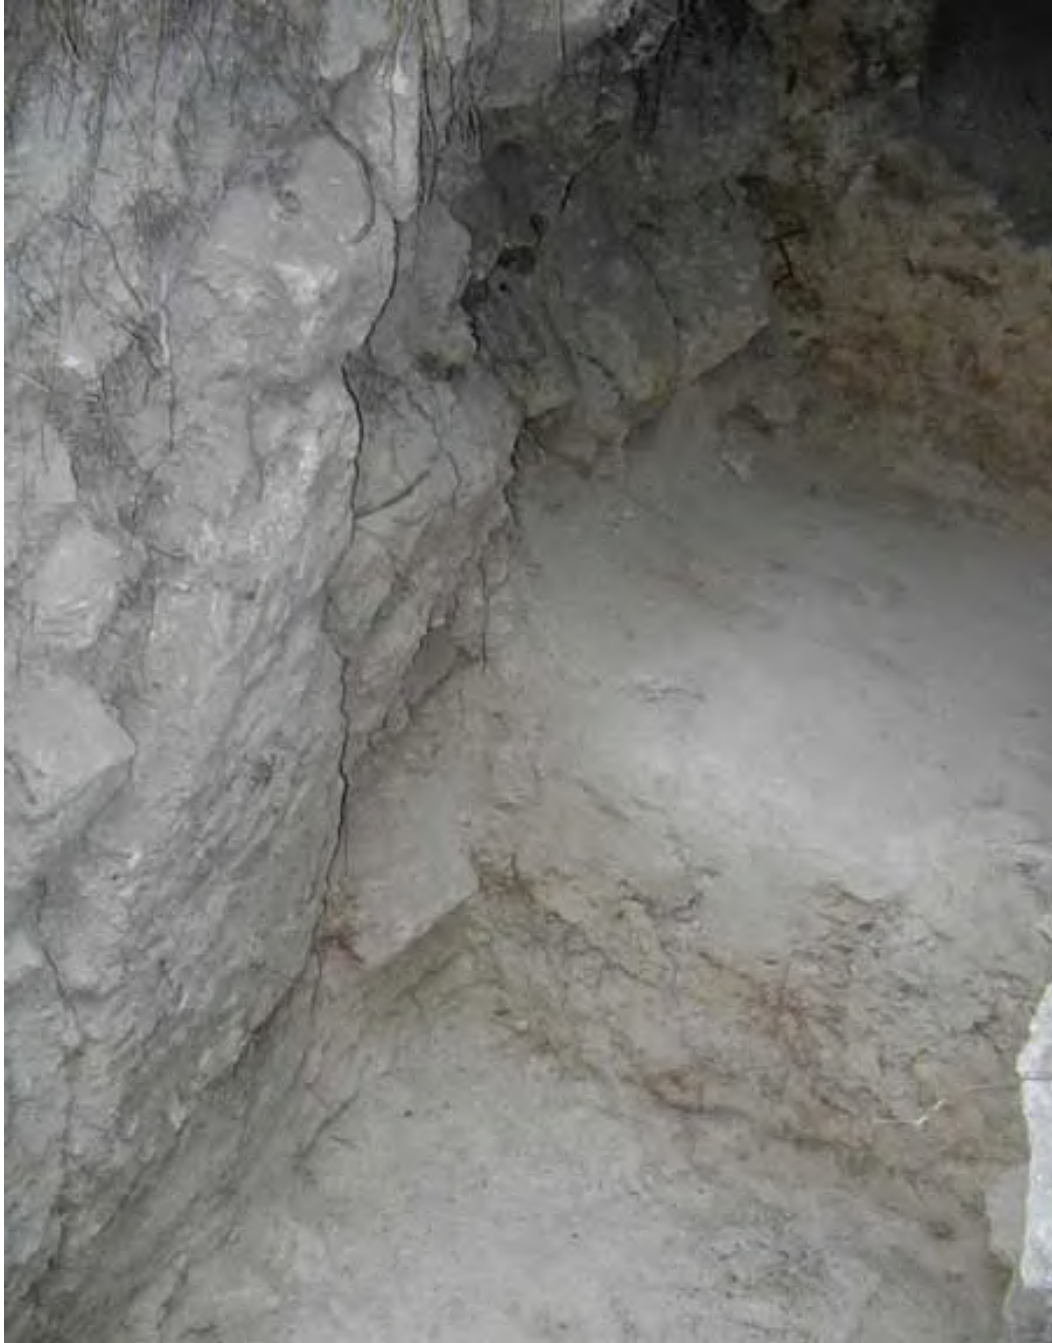
**Figure 42a. Palace B-15, precinct 3.**

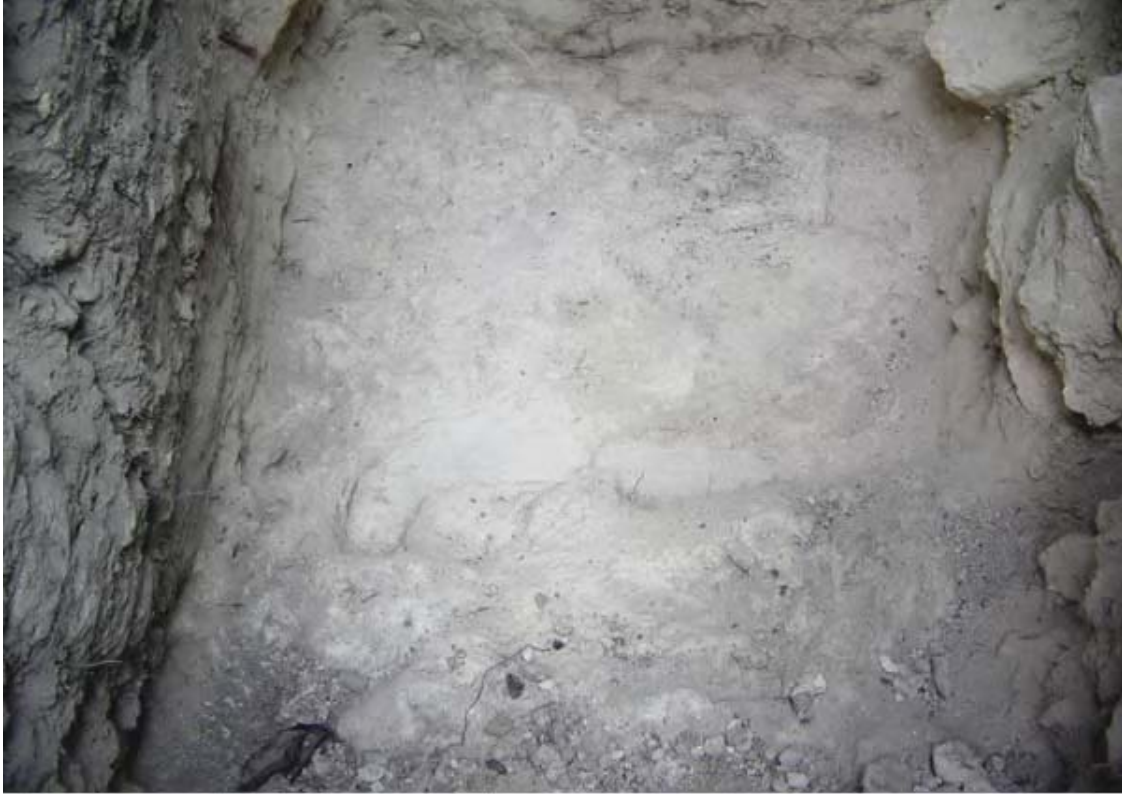
The bay apparently included a lintel covered by a layer of stucco with designs in relief, since between the rubble from the collapsed vault and the façade covering the floor of the bay's sector we found a .05 cm- thick layer of mortar and stucco with wavy designs ([Figure 42b](#), below). Precinct number 3 is considered to belong to a remodeling period associated with the latter part of the eighth century AD or the beginning of the ninth century (Tepeu 2-3 phase).

**Figure 42b. Precinct 3, stucco design on floor.**

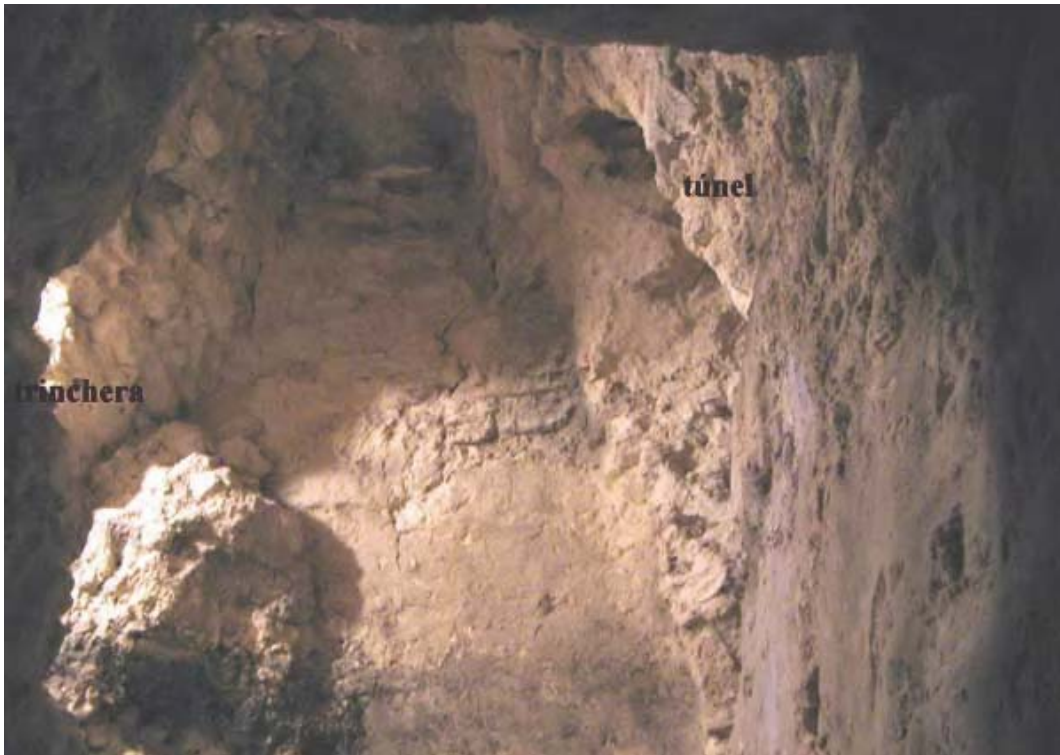
The looter's tunnel brought to light an earlier version of the palace, located behind the back wall of precinct number 3. This is a vaulted precinct with a rectangular plan and an average width of 1.65 m, measuring 3.40 m in height from the floor to the vault's keystone. We could only observe 7 m in length. The vault had a height of 1.45 m, and the soffit 0.10 m of projection ([Figure 23](#), [Figure 24](#), [Figure 43a](#), below, and [Figure 43b](#)).

Figure 43a. Precinct 4.

The looter's trench destroyed the north wall of precinct 4, which shows on its outer side (see [Figure 43a](#)), a façade decorated with a frieze oriented toward an inner courtyard which was circumscribed on its north and west ends by substructure B-15-2A ([Figure 25](#)). The frieze is in a relatively good state of conservation, one can still see designs in relief showing a reed mat and hieroglyphic cartouches painted in red ([Figure 26](#), [Figure 26b](#), [Figure 26c](#), below, [Figure 26d](#) and [Figure 26e](#)). The façade of the frieze of substructure B-15-2 is partially sealed by the west wall of substructure B-15-2A, which may have been built in the middle of the eighth century. Until we know the west façade of the building that covered the frieze, we won't be able to tell if its construction is linked with the cultural episode that sealed the inside of precinct 4 of substructure B-15-2.

The process of filling-up the inside of precinct 4 involved the use of mid-sized and large carved limestone blocks which were firmly cemented with mortar and masonry mixed with small bits of charcoal ([Figure 23](#)). The inside of the precinct was burned before being filled up, as we could see on the walls, floor, vault and bench. At the height of the vault's soffit we found a 25 cm thick layer of charcoal, which could be the remains of a rafter; there were remains of thatching as well. We took samples for analysis ([Figure 43a](#) and [Figure 43b](#)).

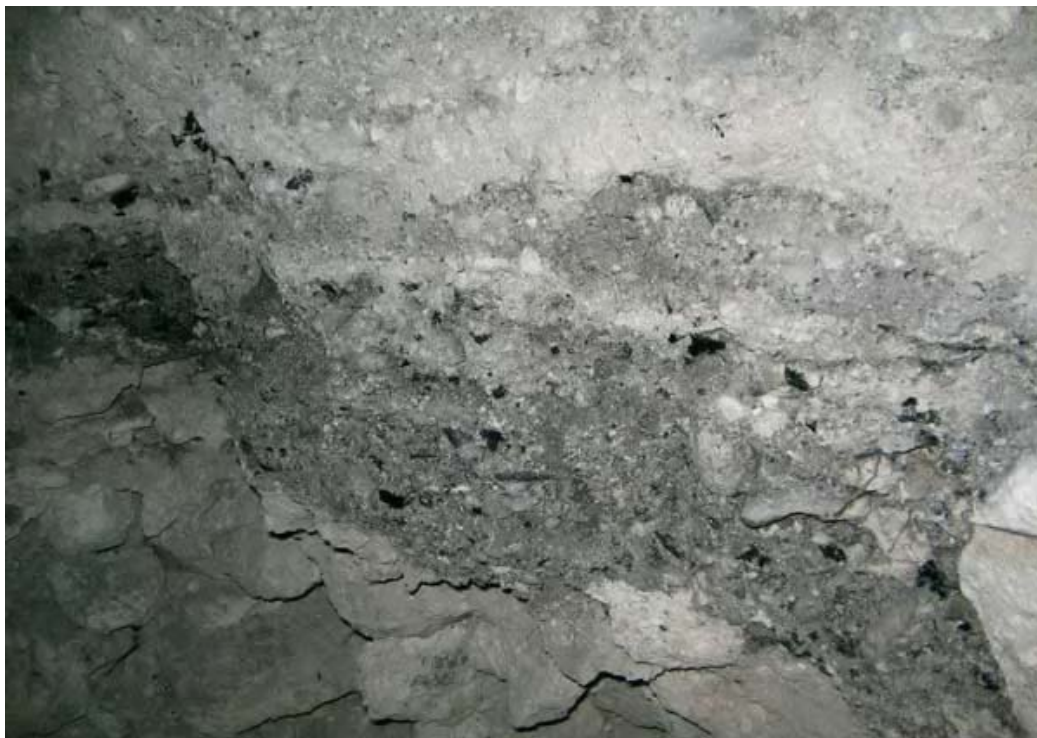
Figure 43b. Charcoal layer in vault of precinct 4.

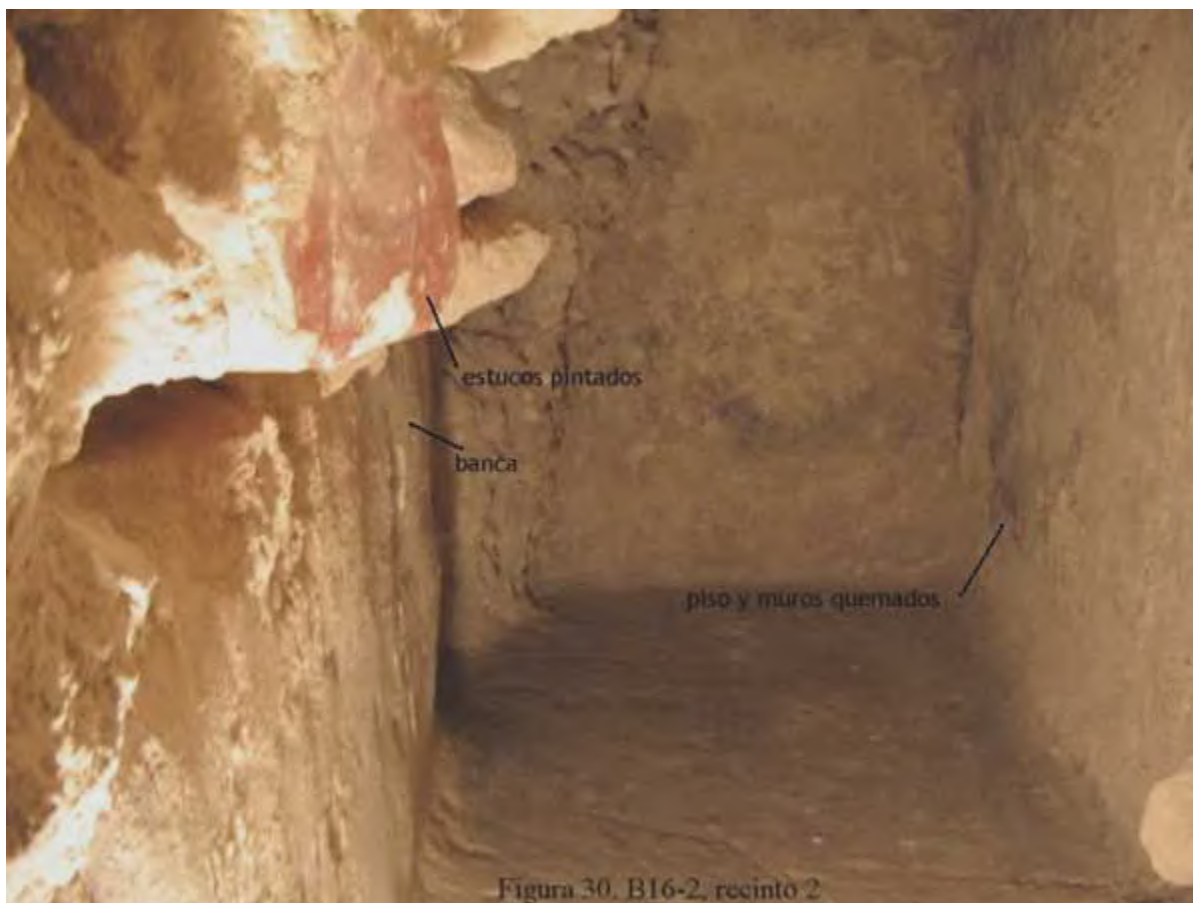
**Figure 30. B-16-2, precinct 2.**

Prior to constructing a new building, and before sealing substructure B-16-2 with big masonry blocks, the Maya performed a termination ceremony in which the building was burned down including the bench; they also cut and unassembled several sections of the walls (see [Figure 30](#)).

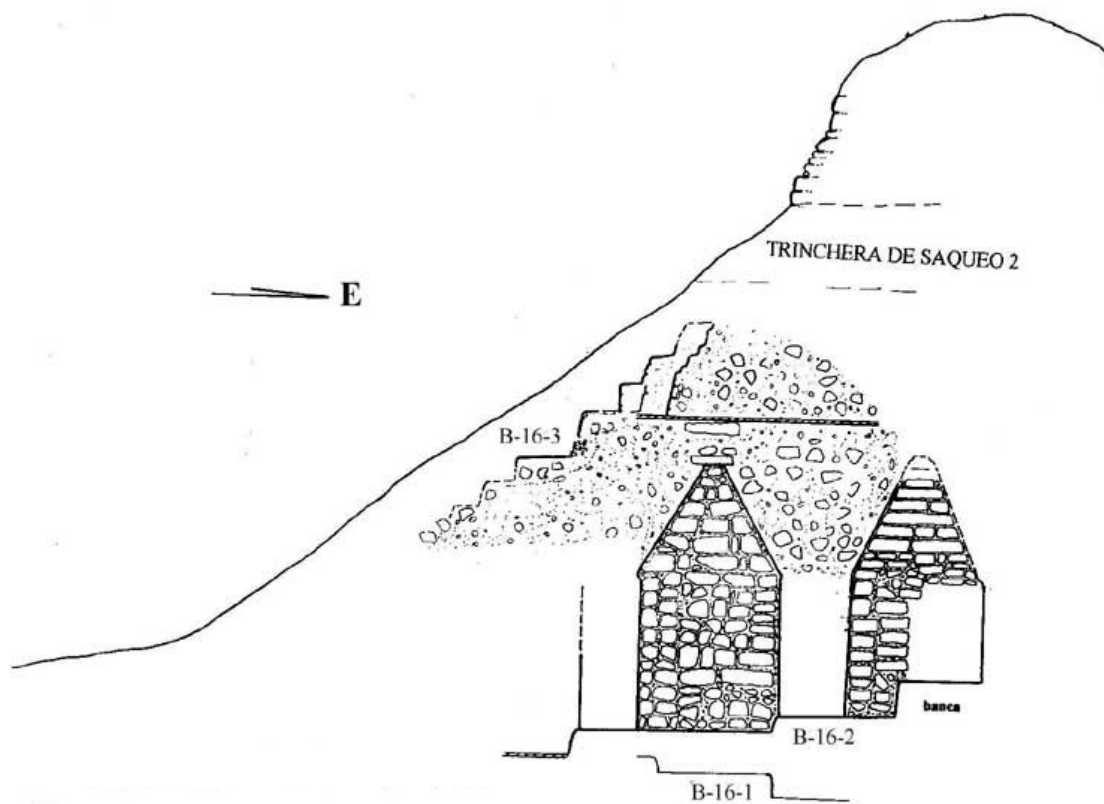
**Figure 28. Substructures of Palace B-16.**

The looter's trench exposed part of what had been a third body, of which we only found a section measuring 1.45 m in height, supported by a 65 cm banquette. The remains of three steps were found integrated to this body, with steps and risers measuring 25 cm on average. The steps were part of a stairway of free-standing type. Under the banquette of the third body we could see other three steps with similar dimensions to the ones described above ([Figure 28](#)).
