# Landslides in the Vancouver-Fraser Valley-Whistler region

S.G. Evans<sup>1</sup> and K.W. Savigny<sup>2</sup>

*Evans, S.G. and Savigny, K.W., 1994: Landslides in the Vancouver-Fraser Valley-Whistler region; in Geology and Geological Hazards of the Vancouver Region, Southwestern British Columbia, (ed.) J.W.H. Monger; Geological Survey of Canada, Bulletin 481, p. 251-286.*

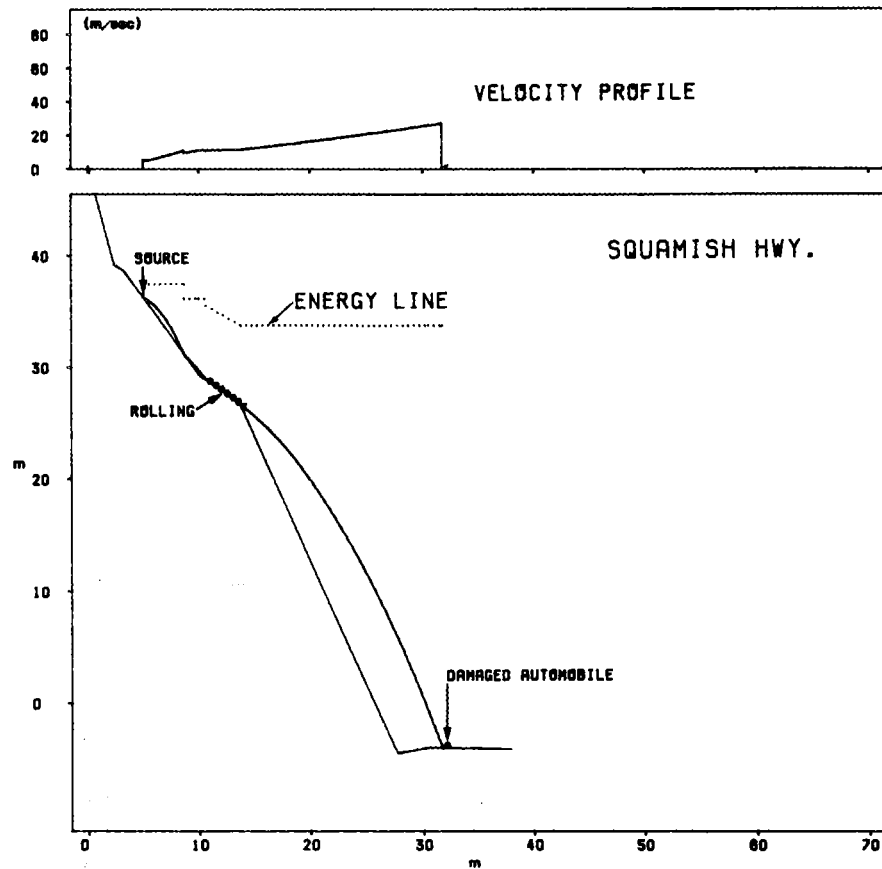
*Figure 3. Simulated trajectory of a single boulder which caused the 1982 rockfall accident on Sea-to-Sky Highway, 22 km north of Horseshoe Bay (from Hungr and Evans, 1988).*

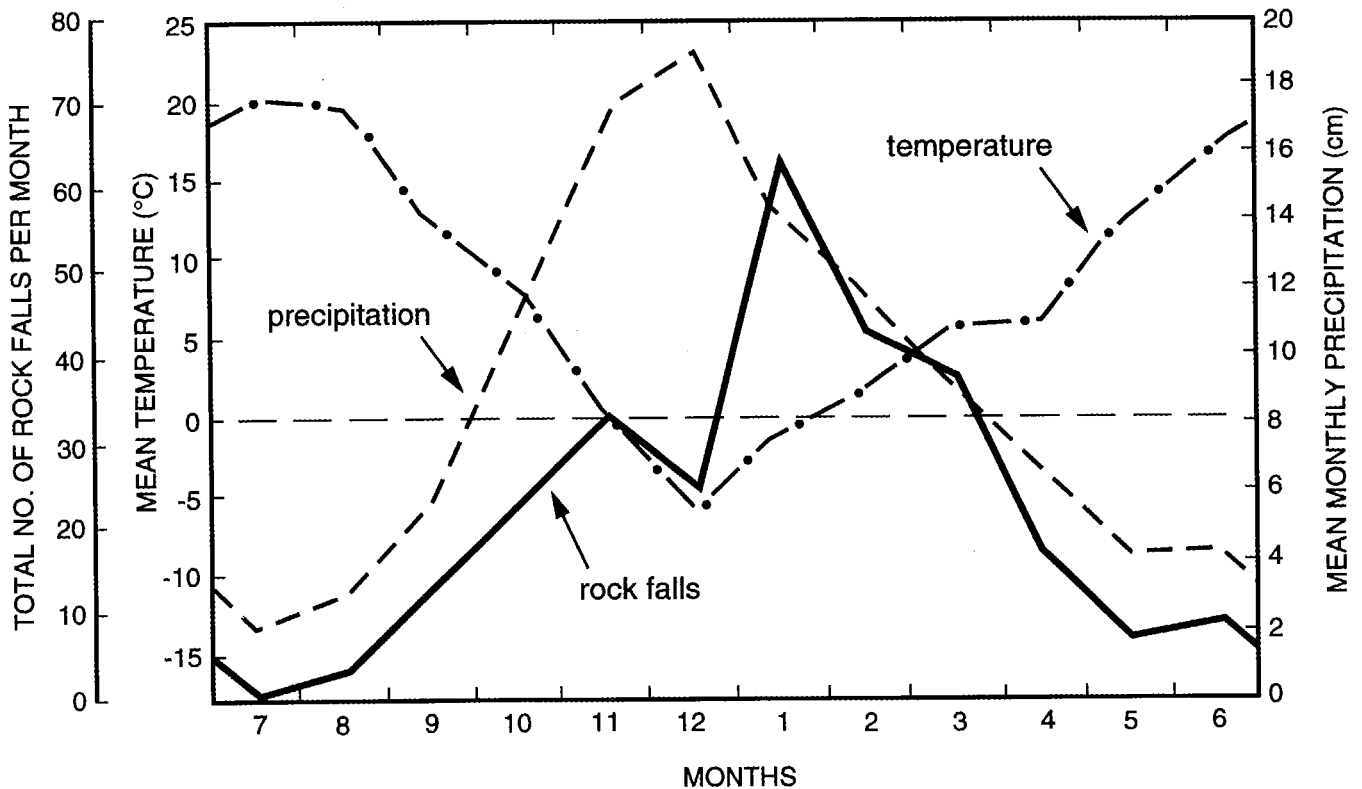
Figure 6. Rockfall frequency and weather over the period 1933-1970, Fraser Canyon, Yale subdivision, Canadian National Railway (modified from Peckover and Kerr, 1977).

Rockfall frequency shows a marked correlation with the weather (Peckover and Kerr, 1977; Fig. 6). Figure 6 shows data for rockfall frequency on Canadian National Railway tracks in the Fraser Canyon. The highest frequency is found in January, February, and March, the time when freeze-thaw cycles are most frequent, thus reflecting the role of frost wedging in rockfall release. When the mean monthly temperature is above zero (March-November), the number of rockfalls per month varies more or less directly in proportion to mean monthly precipitation (Peckover and Kerr, 1977).

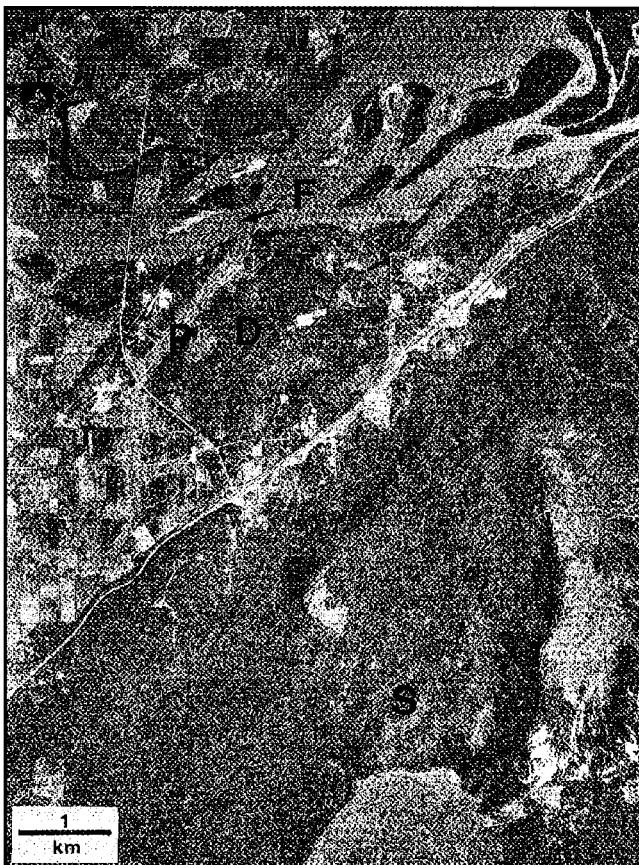
**Figure 14.** Airphoto of Cheam slide(s), Fraser Valley. Both source area (S) and extent of debris (D) have yet to be defined in detail. The debris is crossed both by the Canadian National Railway and the Trans-Canada Highway. Radiocarbon dates quoted in text were obtained from wood in debris in pit marked P. Fraser River (F) and flow direction are indicated. NAPL A27109-40

Cheam slide is a prehistoric rock avalanche complex located on the southeast side of the Fraser River valley 20 km east of Chilliwack (Fig. 1 and 14). The landslide debris forms a hummocky surface which contrasts sharply with the surrounding flat Fraser Lowlands and the adjacent steep slopes of the North Cascade Mountains. The landslide was first examined by Smith (1971); the debris was mapped by Armstrong (1980) as a slope deposit. Naumann (1990) undertook a detailed assessment of both the source and deposition areas and Naumann and Savigny (1992) reported a detailed numerical analysis.

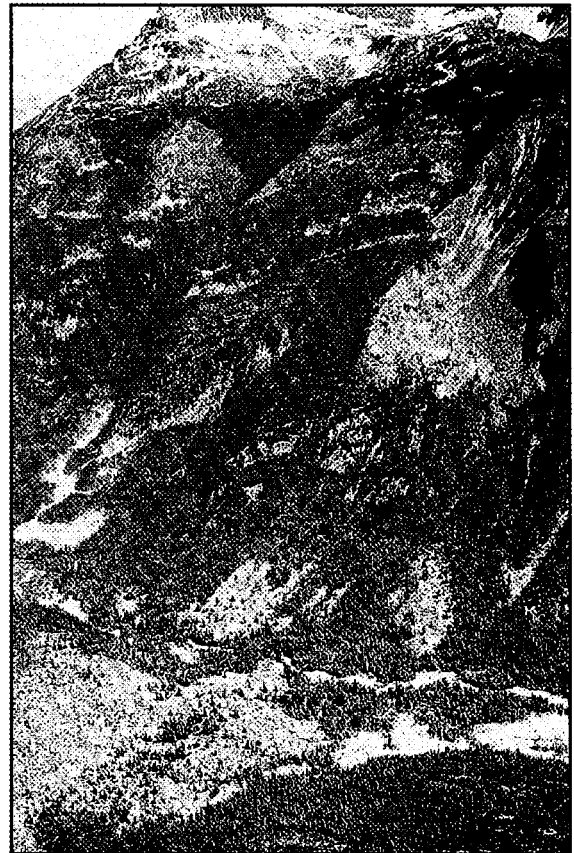
**Figure 15.** Oblique aerial view to the east of the prehistoric Mystery Creek rock avalanche, 20 km northeast of Whistler. Toppling shown in Figure 16 occurs on right hand (southern) margin of scar. GSC 204107G

The Mystery Creek rock avalanche (Fig. 1, 15; estimated volume 40 000 000 m<sup>3</sup>) is located 20 km north of Whistler and involved the failure of a portion of the east side of the Green River valley. The debris covers an area of 1.2 km<sup>2</sup> in the bottom of the Green River valley, and is traversed by a B.C. Hydro main transmission line and B.C. Highway 99. The landslide was first reported by Eisbacher (1983), and described briefly by Clague et al. (1987) and Evans (1992a). The rock avalanche involved the failure of a mountain slope consisting of foliated, hard intrusive rock of the Pemberton Dioritic Complex. Slopes adjacent to the scar of the rock avalanche show indications of mountain slope deformation (Fig. 15).

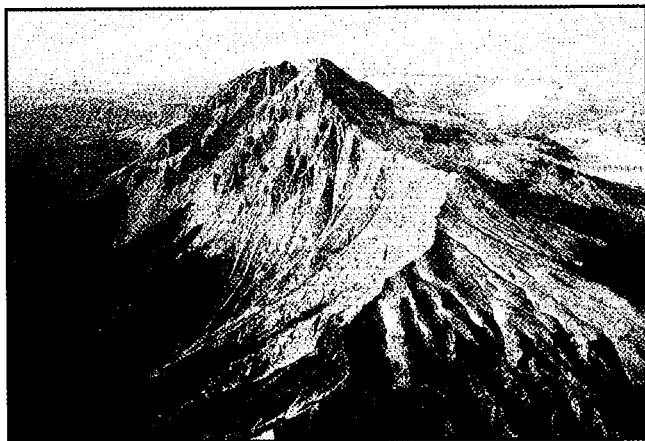
**Figure 25.** Oblique aerial view of Mount Garibaldi viewed from the south. The steep western face of the volcano is essentially a scarp formed by the Late Pleistocene flank collapse of the volcano. GSC 1994-709H

The debris avalanche deposits originated in the dacitic lavas and tuff-breccias which make up the western flank of Mount Garibaldi. The amphitheatre-shaped headwater region of the Cheekye River (Fig. 25) is in effect a massive landslide scar created by multiple failure events. Successive failure events may have built up what Mathews (1952a) termed the 'terraced fanglomerates' at the mouth of the Cheekye valley. Unpublished radiocarbon dates obtained by S.G. Evans and Thurber Engineering/Golder Associates (1993) suggest that large landslides continued to occur on the western slopes of Mount Garibaldi and travelled down the Cheekye valley to the Cheekye Fan through prehistoric time. The occurrence of these events has had a major impact on recent land-use decisions regarding the fan (Hungry et al., 1993; Thurber Engineering/Golder Associates, 1993).

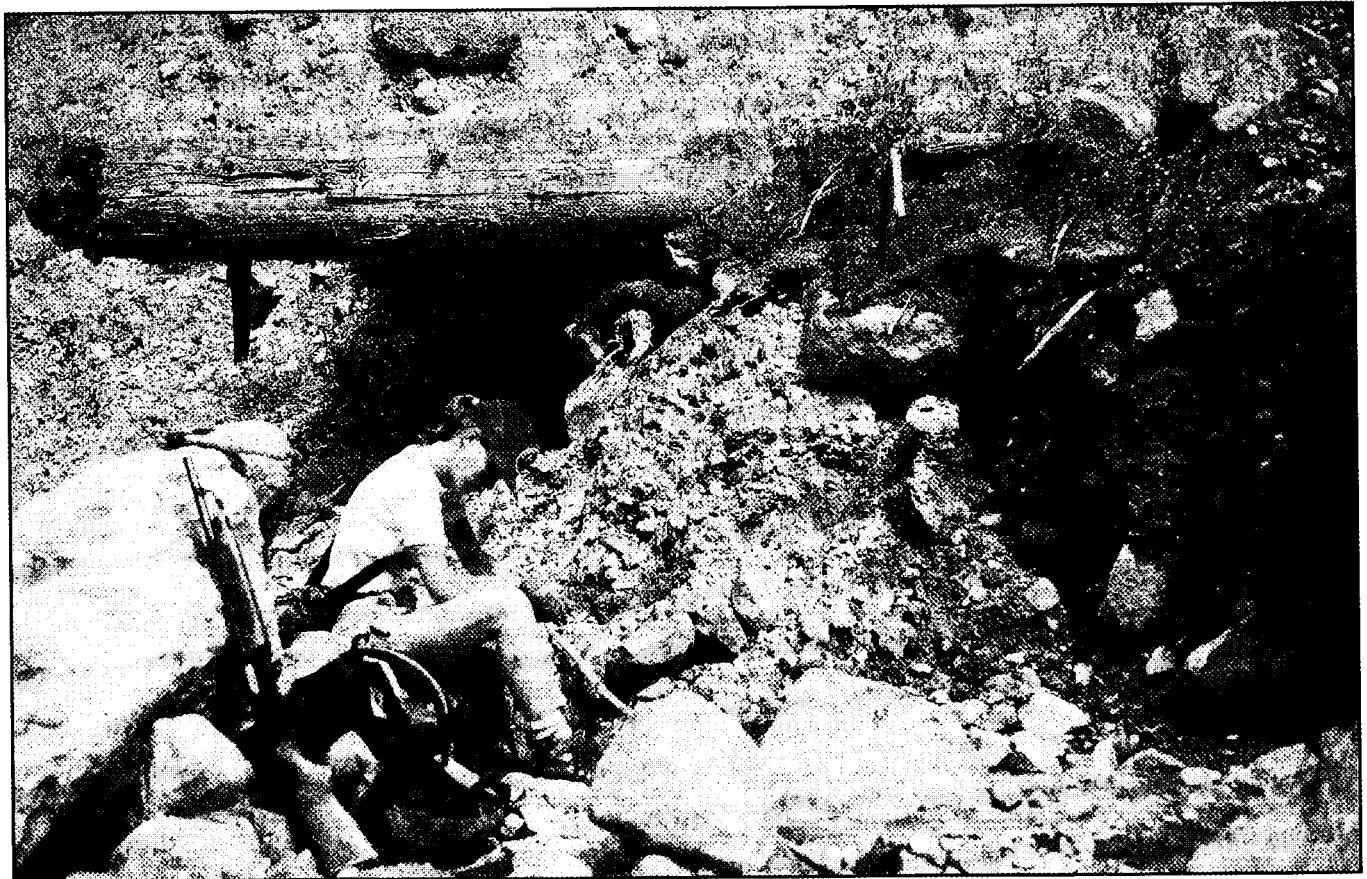
*Figure 30. Broken trees in debris avalanche deposits in Turbid Creek. Tree above person's head gave radiocarbon date of  $950 \pm 80$  (GSC-5195). GSC 1994-709J*

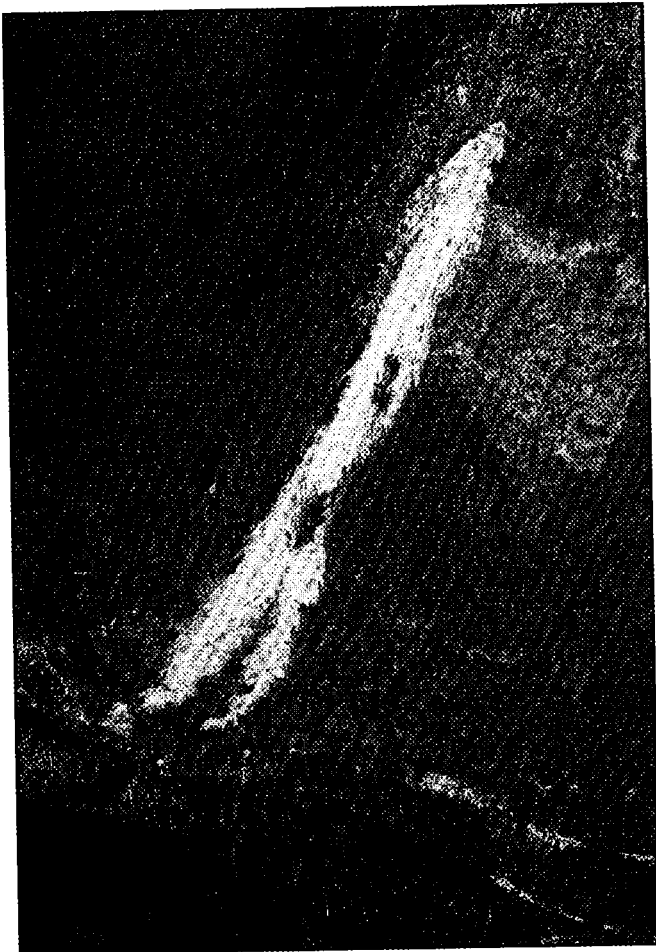
**Figure 33.** Debris avalanche (or open slope debris flow) which occurred in August 1991 as a result of heavy rains on north side of Britannia Creek, 4 km upstream of Britannia Beach. The landslide overran part of the abandoned townsite of Tunnel Camp. GSC 1994-492B

Shallow failures occurring on steep, open slopes do not necessarily become channellized, but may still develop into what are termed debris avalanches or open slope debris flows (Evans, 1982). Figure 33 shows an example from the northern side of Britannia Creek which occurred as a result of heavy rains in September 1991. The landslide overrode part of the abandoned townsite of Tunnel Camp.

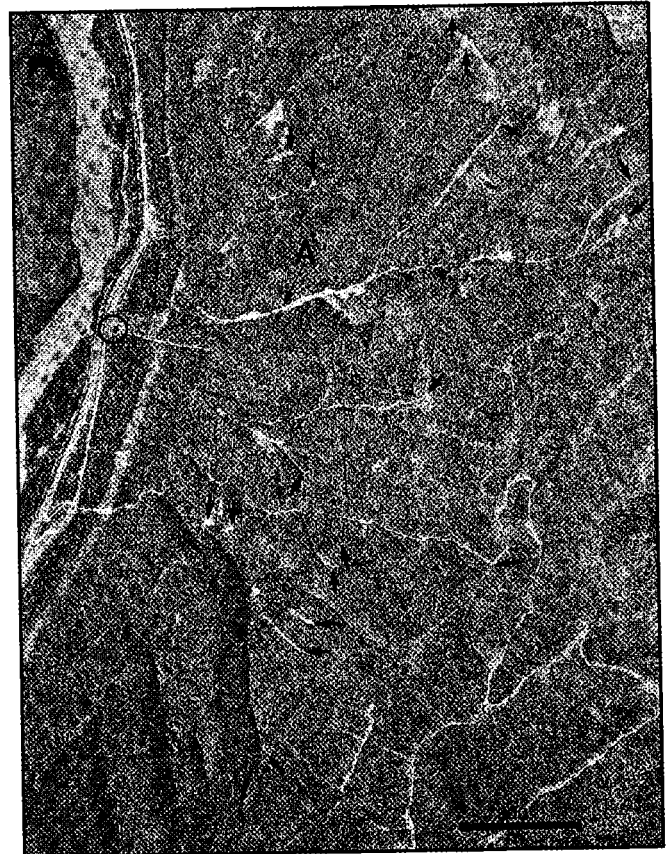
**Figure 34.** Aerial photograph showing 1983 debris flows in vicinity of Wahleach Power Station (circled) in the Fraser Valley. Multiple starting points of debris flows are arrowed. Note at least three sources for the debris flow in Ted Creek (A) discussed in text. Point "D", located just south of Ted Creek, is an area of topographic linears associated with rock slope deformation illustrated in Figure 19. (BC 83020-104)

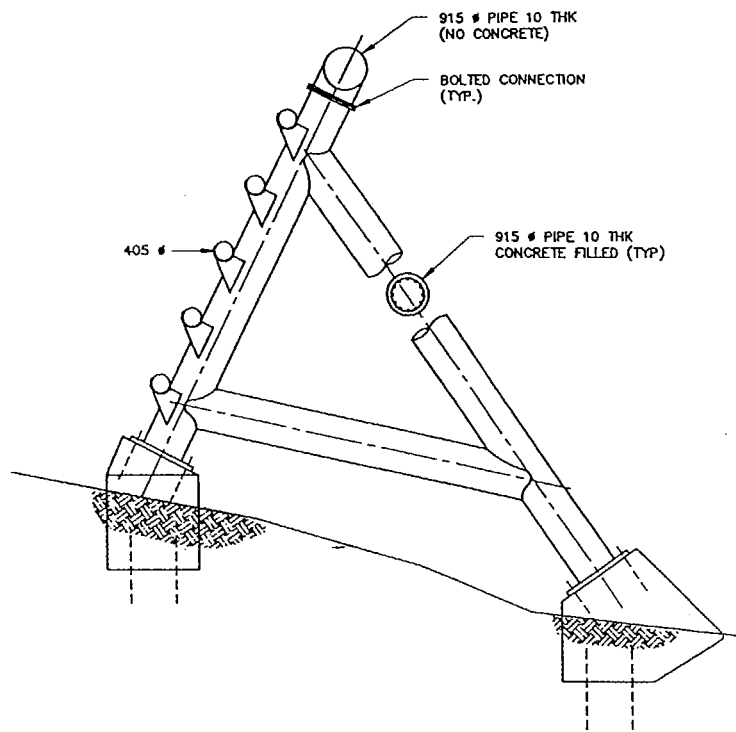
**Figure 40.** Conceptual design of debris retention barrier for Whistler Creek (from Hungr, 1993, courtesy Ker Priestman Associates).

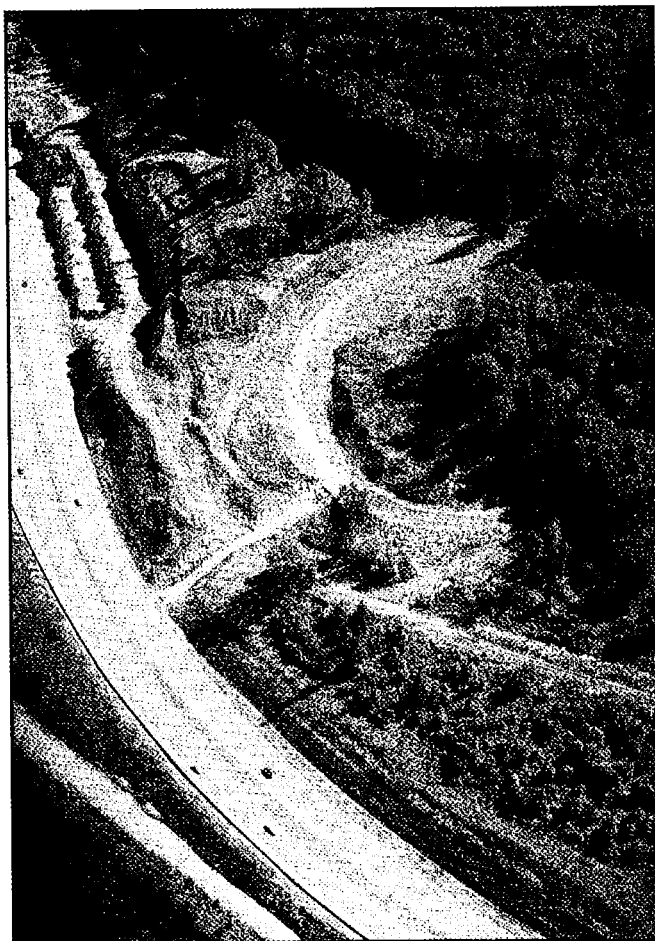
**Figure 41.** Debris deflection barrier (or berm) constructed to protect Trans-Canada Highway and Canadian National Railway rail track, 5 km southwest of Laidlaw in the Fraser Valley. GSC 1994-492E

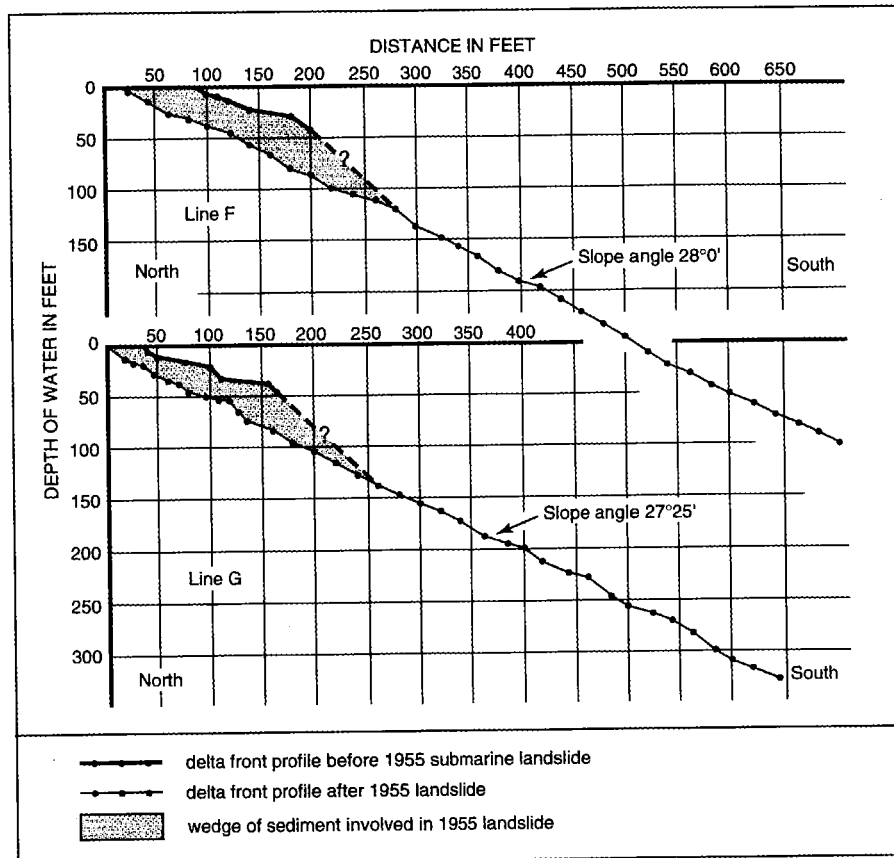
Figure 45. Vertical sections through Woodfibre delta front before and after 1955 slide (modified after Terzaghi, 1956).
