2011 Flood: Technical Review of Lake Manitoba, Lake St. Martin and Assiniboine River Water Levels

October 2013

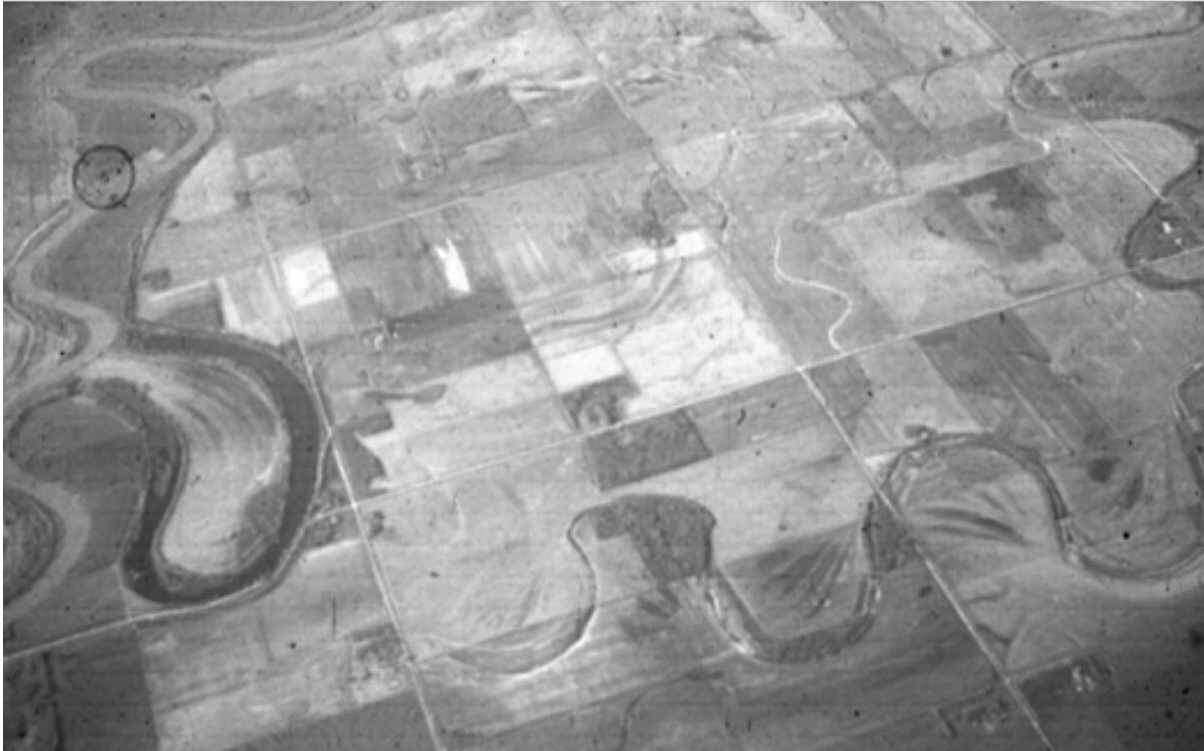
Figure 9: Air photo showing the Assiniboine River on the left edge of the photo and Mill Creek paleochannel. North is oriented towards the top of the photo (Photo courtesy of Dr. Bill Rannie).

The abandoned paleochannels on the alluvial fan are often indistinguishable on the ground having been in-filled by centuries of sedimentation during floods. However, they are strikingly clear from the air (see Figure 9). Some of the paleochannels are now used by smaller streams; for example, the present LaSalle River flows eastward through a paleochannel of the Assiniboine River to join the Red River at St. Norbert.

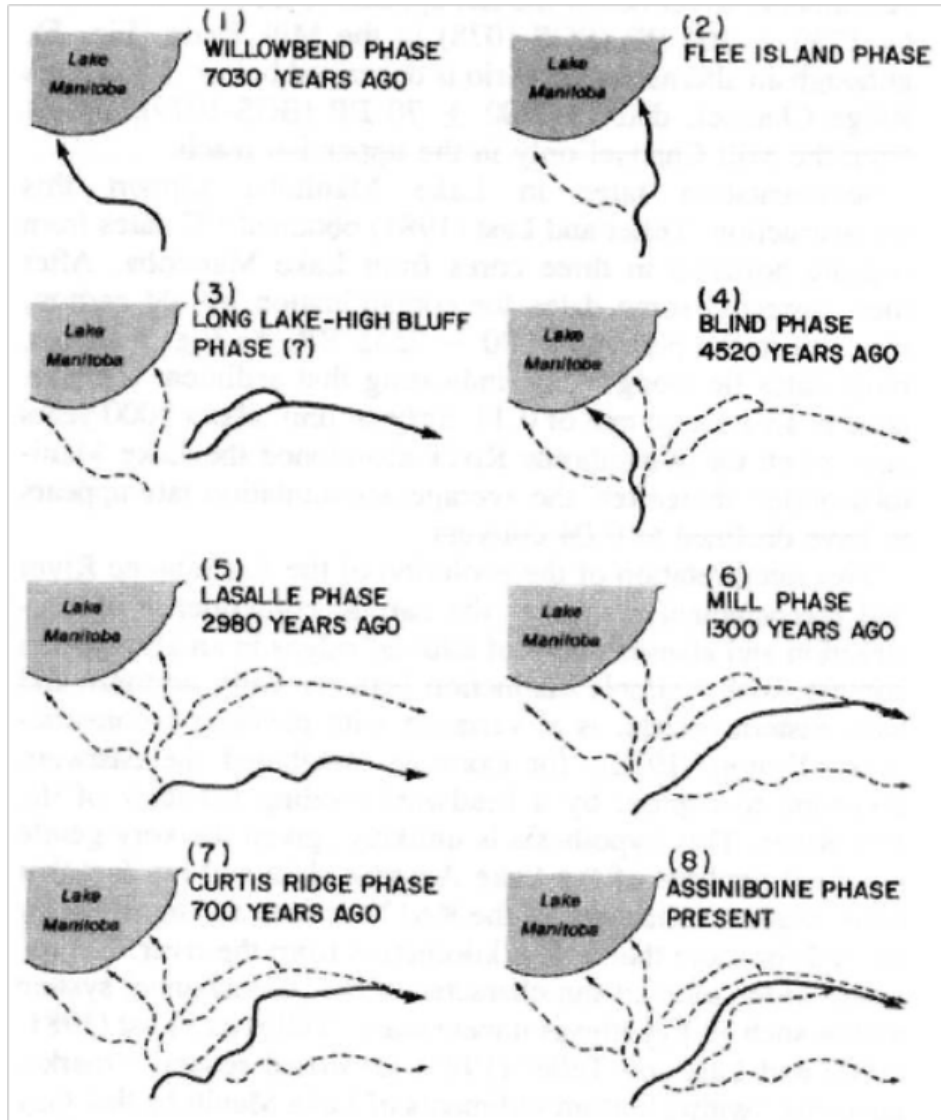
Figure 10: Sequence of paleochannel evolution of the Assiniboine River (Rannie, Thorleifson, & Teller, 1989)© 2008 Canadian Science Publishing or its licensors. Reproduced with permission.

The evolution of these paleochannels over the past 7,000 years is shown schematically in Figure 10. The paleochannels divide into two groups: those which end in Lake Manitoba (Willowbend, Blind/Fort la Reine, Flee Island) and those which ultimately end in the Red River (current Assiniboine, LaSalle, Long Lake/High Bluff).

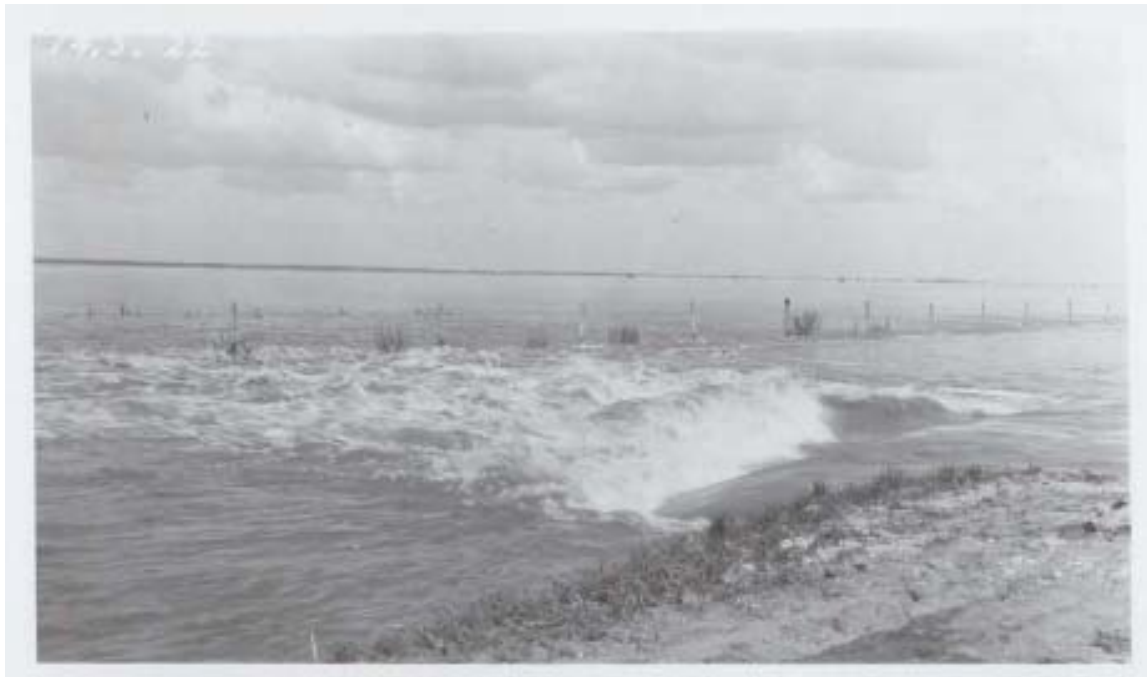
Figure 14: Photograph from 1922 showing the overflows from the Assiniboine River overtaking the Winnipeg-Portage highway – two miles east of Poplar Point (Attwood, 1923).

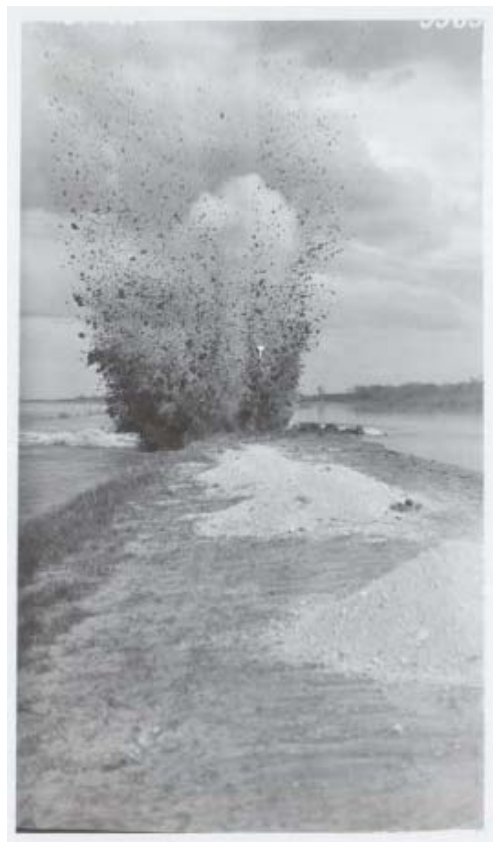
Figure 15: Photograph from 1922 showing blasting of the Winnipeg-Portage highway to allow flood waters to pass without destroying the entire length of road (Attwood, 1923).

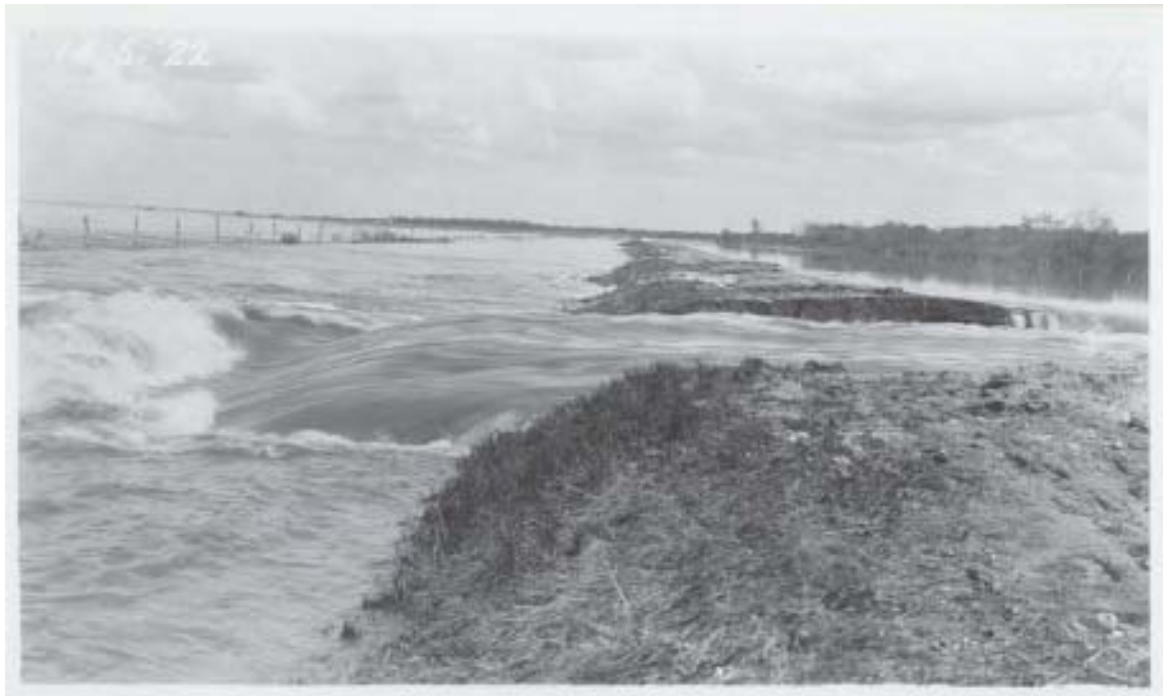
Figure 16: Photograph from 1922. A hole was blasted in the Winnipeg-Portage highway two miles east of Poplar Point to pass waters north and prevent destruction of the entire road (Attwood, 1923).

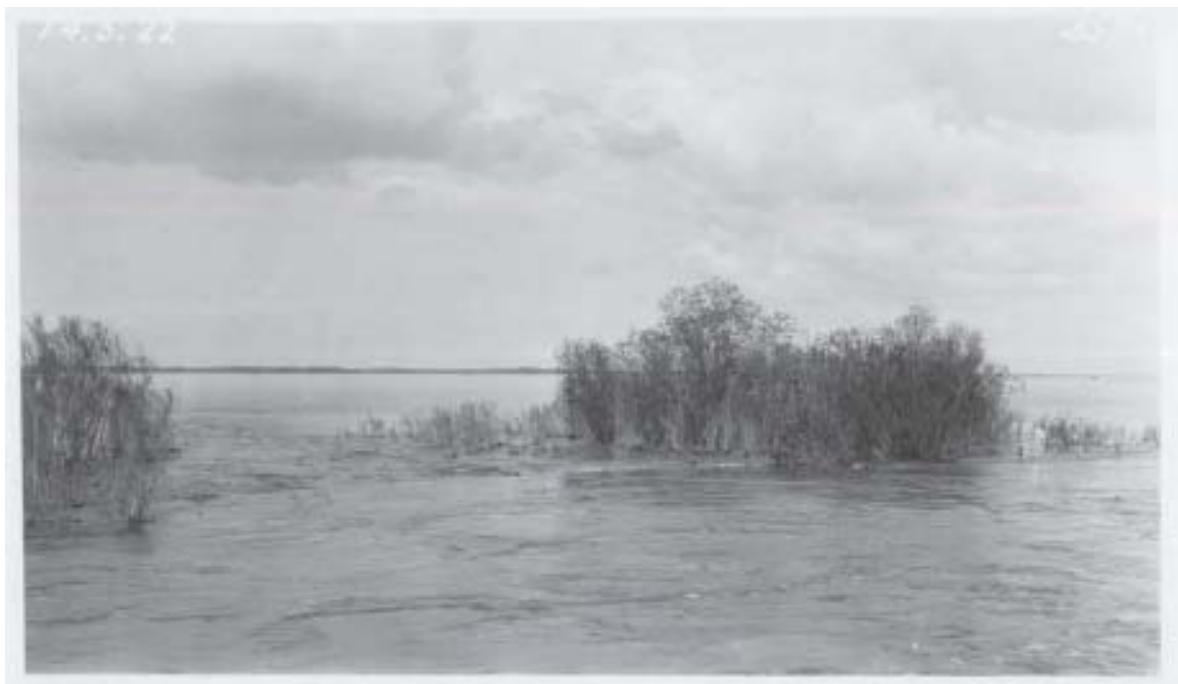
Figure 17: Photograph from 1922, looking north from Winnipeg-Portage highway to Raeburn, from point two miles east of Poplar Point (Attwood, 1923).

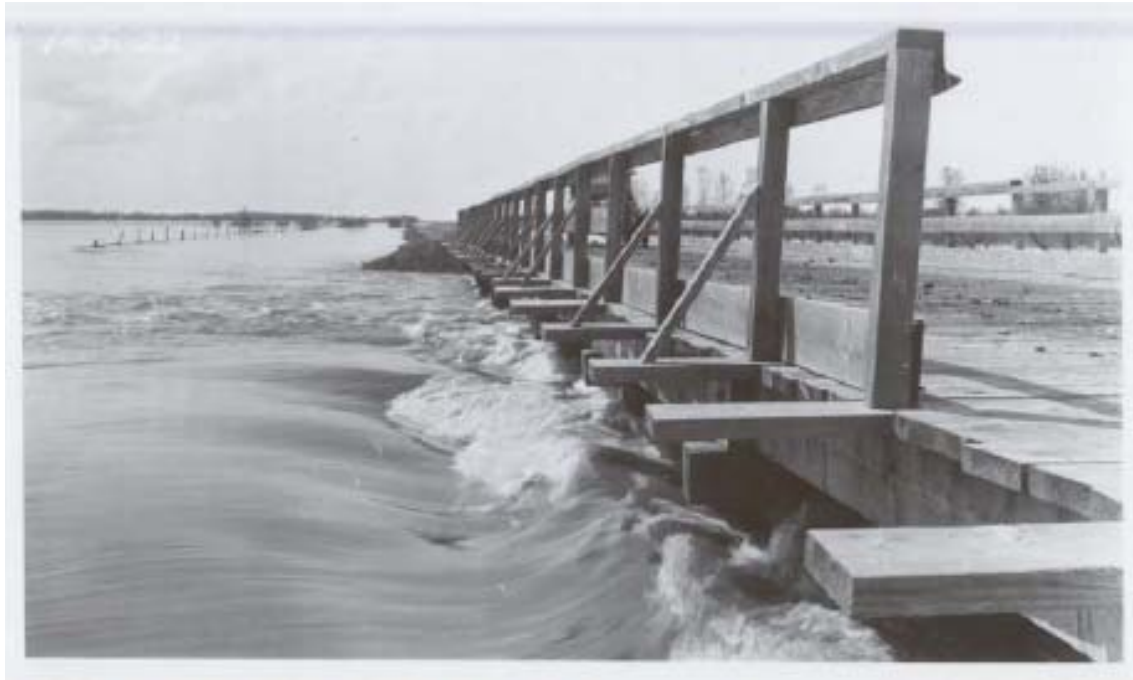
Figure 18: Photograph from 1922 showing water flowing north under a bridge on the Winnipeg-Portage highway that was reported to be normally dry (Attwood, 1923).

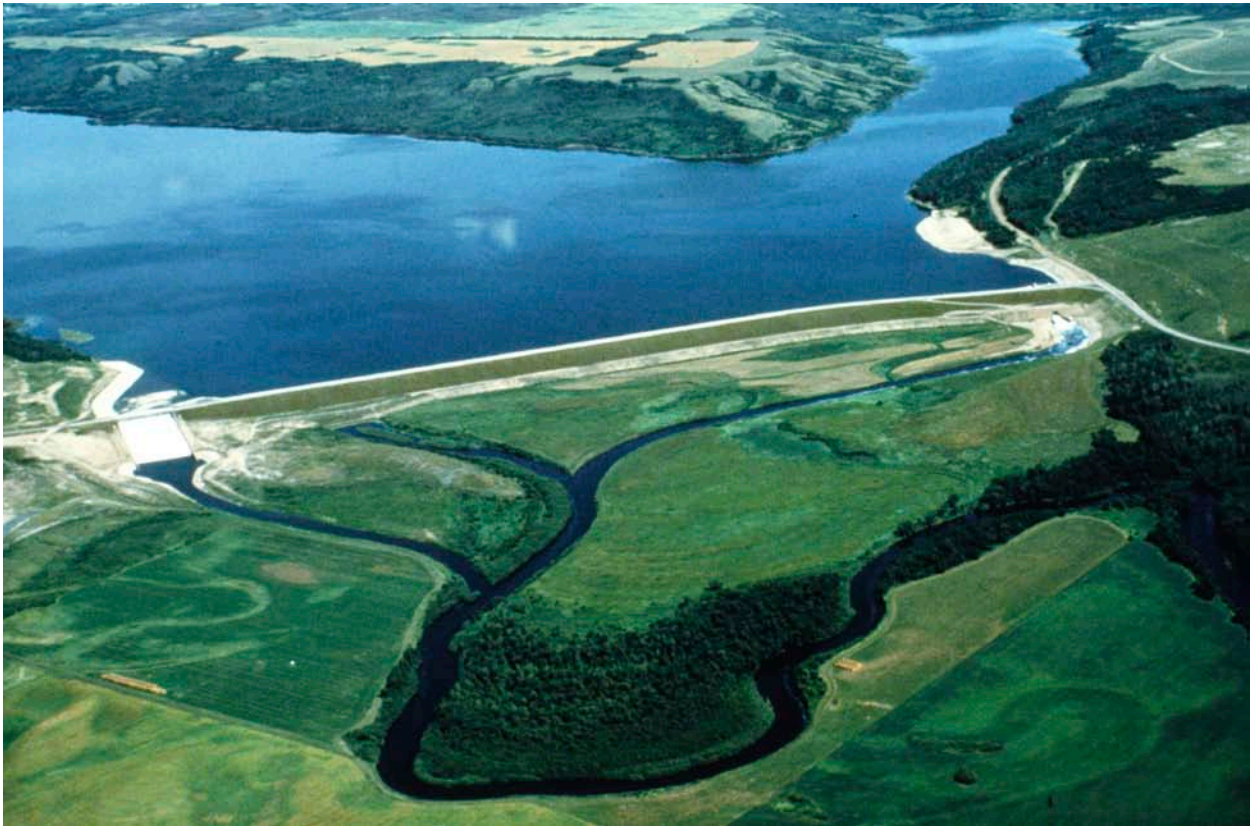
Figure 26: An aerial view of the Shellmouth Dam looking upstream. The outlet for the conduit is on the right hand side of the photo and the spillway is on the left hand side of the photo.

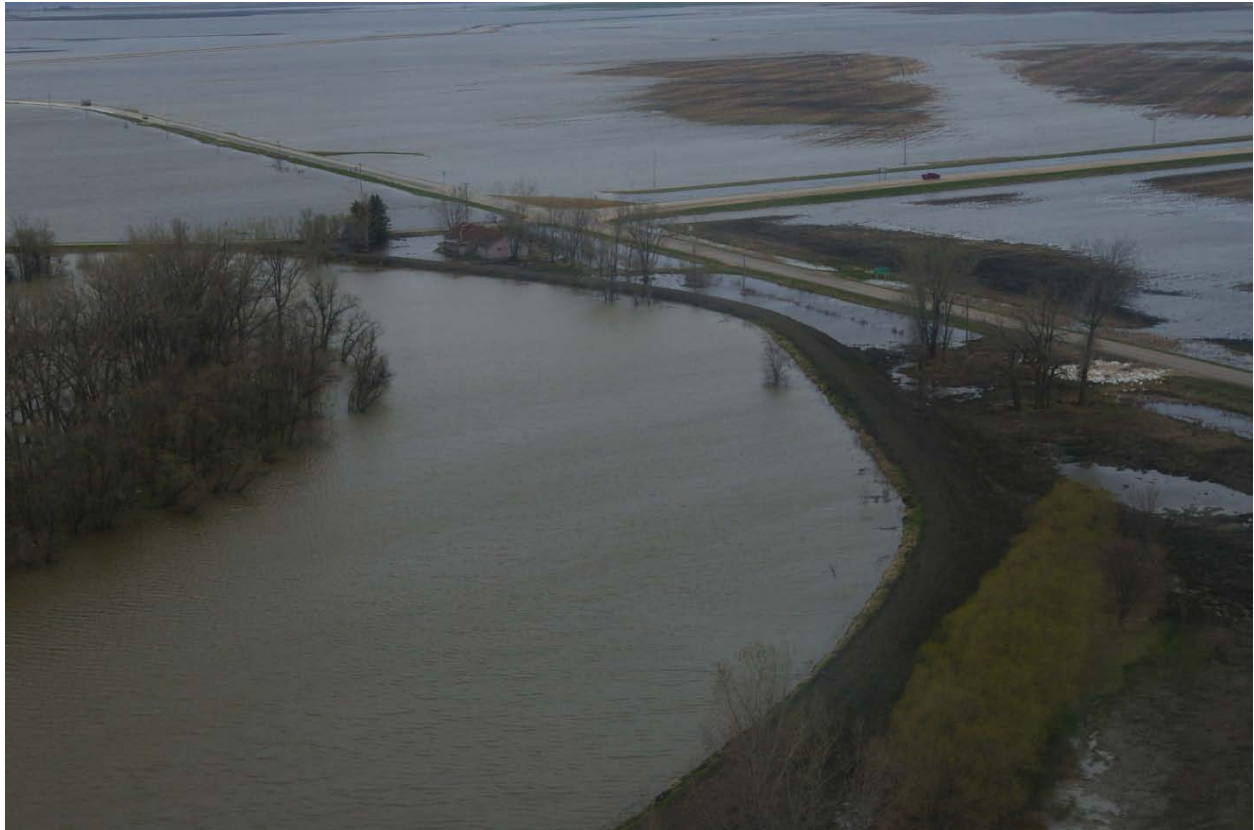
Figure 28: Photograph of the Assiniboine River and dikes in the vicinity of Baie St. Paul, taken on May 15, 2011. Note that there is freeboard remaining on the dikes (they are not in danger of being overtopped).

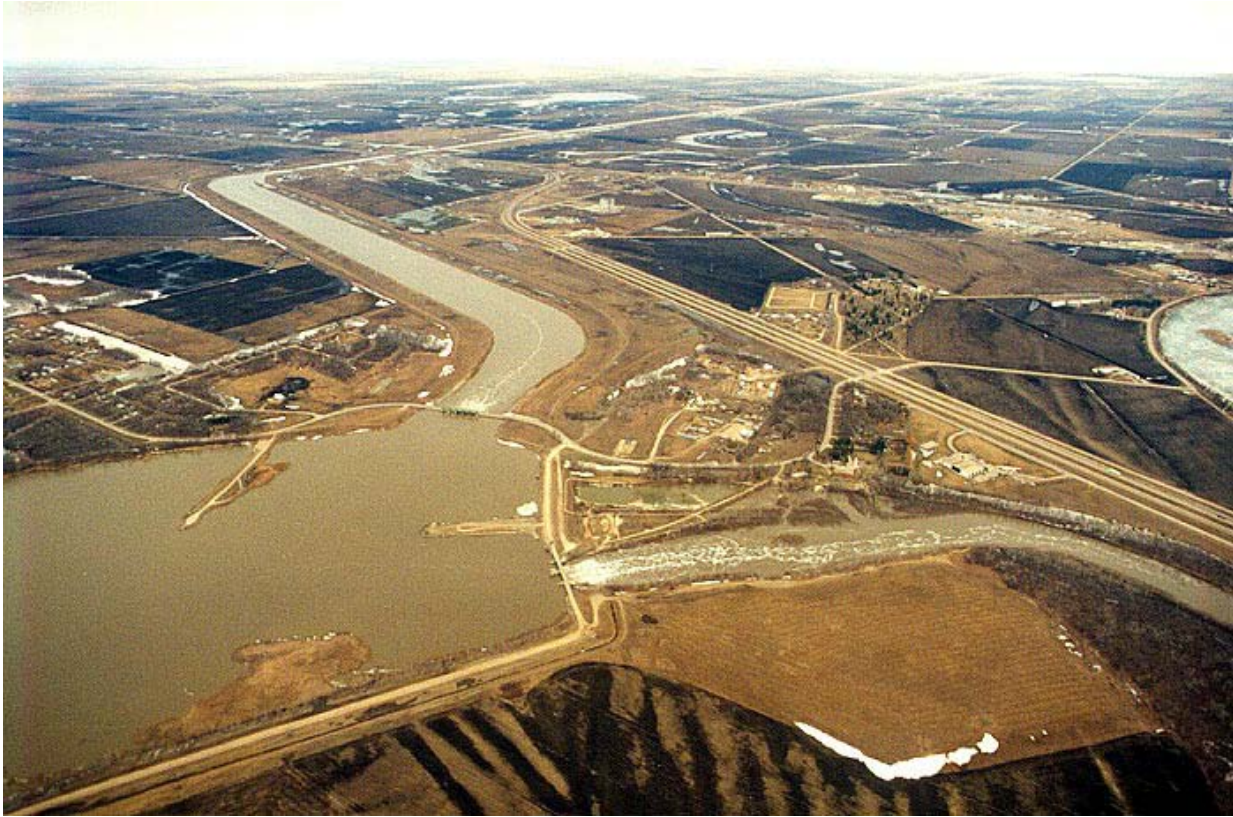
Figure 29: An aerial photograph of the Portage Diversion during a flood event; the year is unknown. The Portage Reservoir is visible on the left edge of the photo, the diversion channel continues northward into the background of the photo, and the Assiniboine River flows off the right hand edge of the photo. Of note, a portion of the Blind (or Fort la Reine) paleochannel is visible downstream of the control structure on the river, running north from the highway into the background.

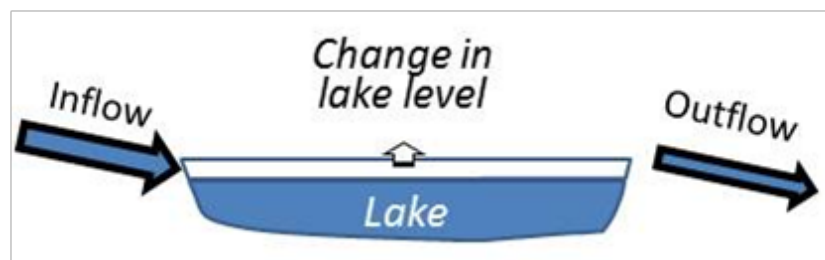
Figure 35: Lake water balance.

The unregulated water levels on Lake Manitoba were calculated using water balance methodology, which is based on the principle of Conservation of Mass. The difference in volume between the total inflows to the lake over a defined period, minus the total outflows over that same period, is equal to the change in volume in the lake. The principle is shown in Figure 35. If the total inflow exceeds the total outflow, the lake level rises by an amount equal to the volume difference. If the total inflow is less than the outflow, then the lake level drops. The challenge in using this approach is determining the unregulated inflows and outflows, many of which must be computed based on regulated inflows and outflows.

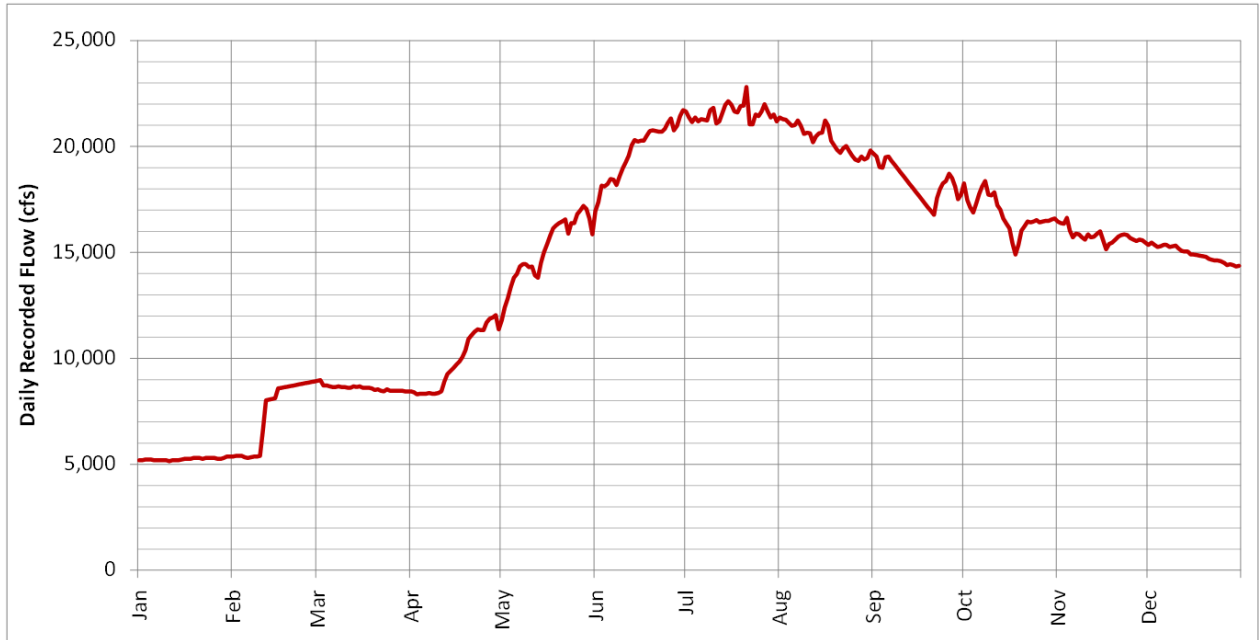
Figure 38: 2011 Recorded Fairford River flows (recorded outflows from Lake Manitoba).

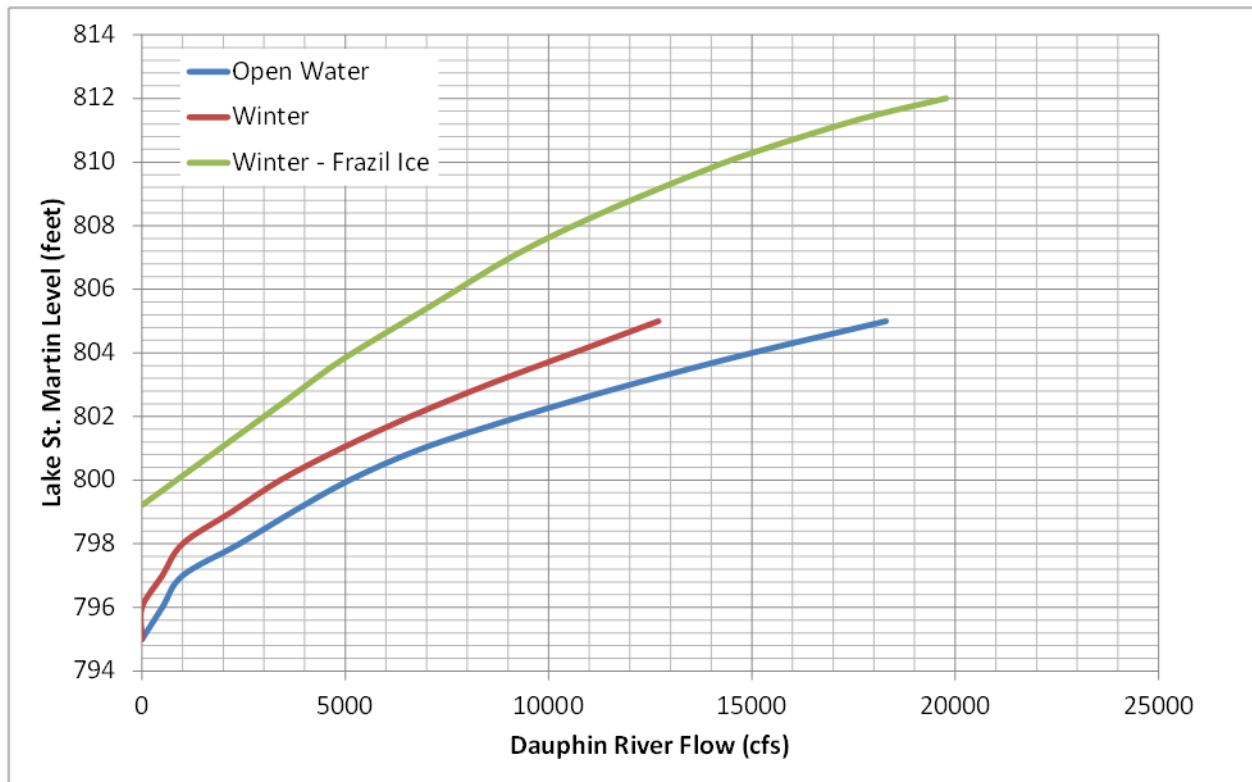
Figure 41: Lake St. Martin outflow rating curves.

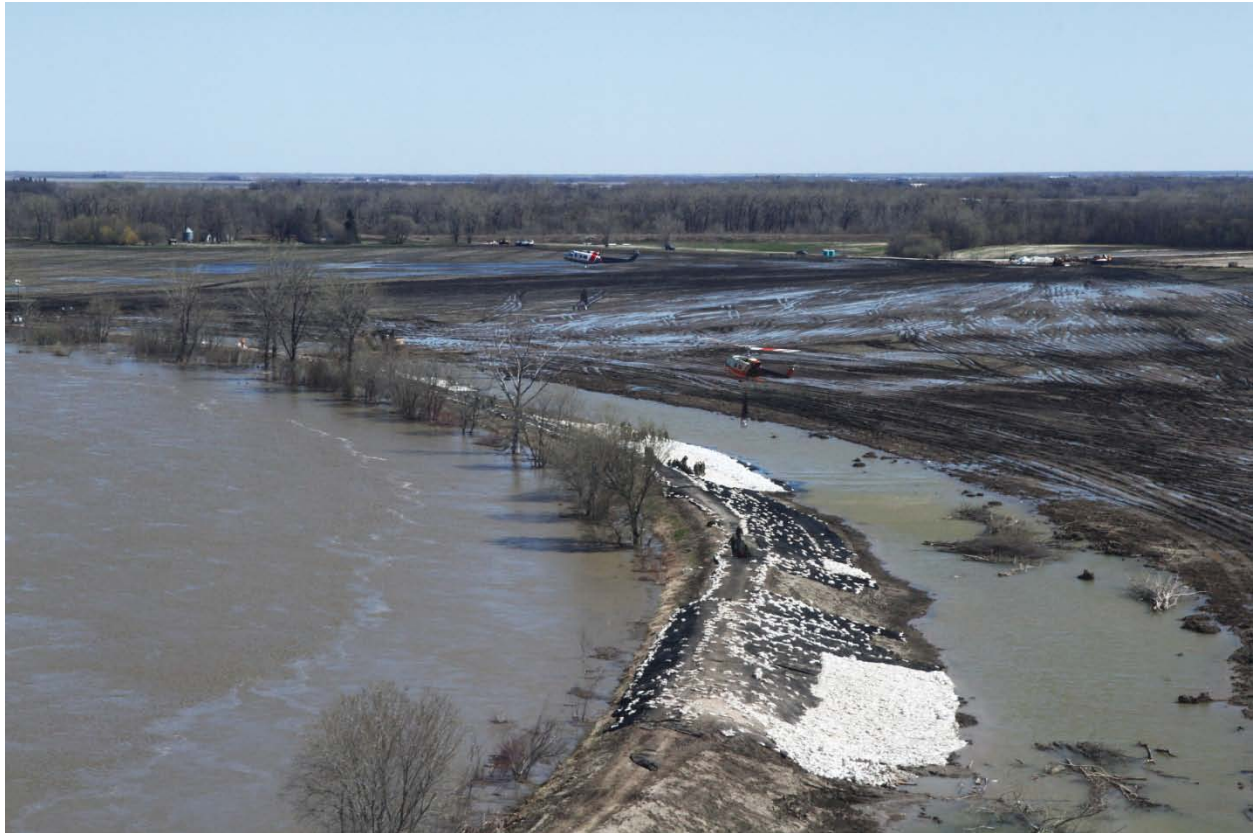
Figure 45: Photograph showing sandbags and filter cloth being used to shore up weak spots in the Assiniboine River dikes (photo from May 14, 2011).

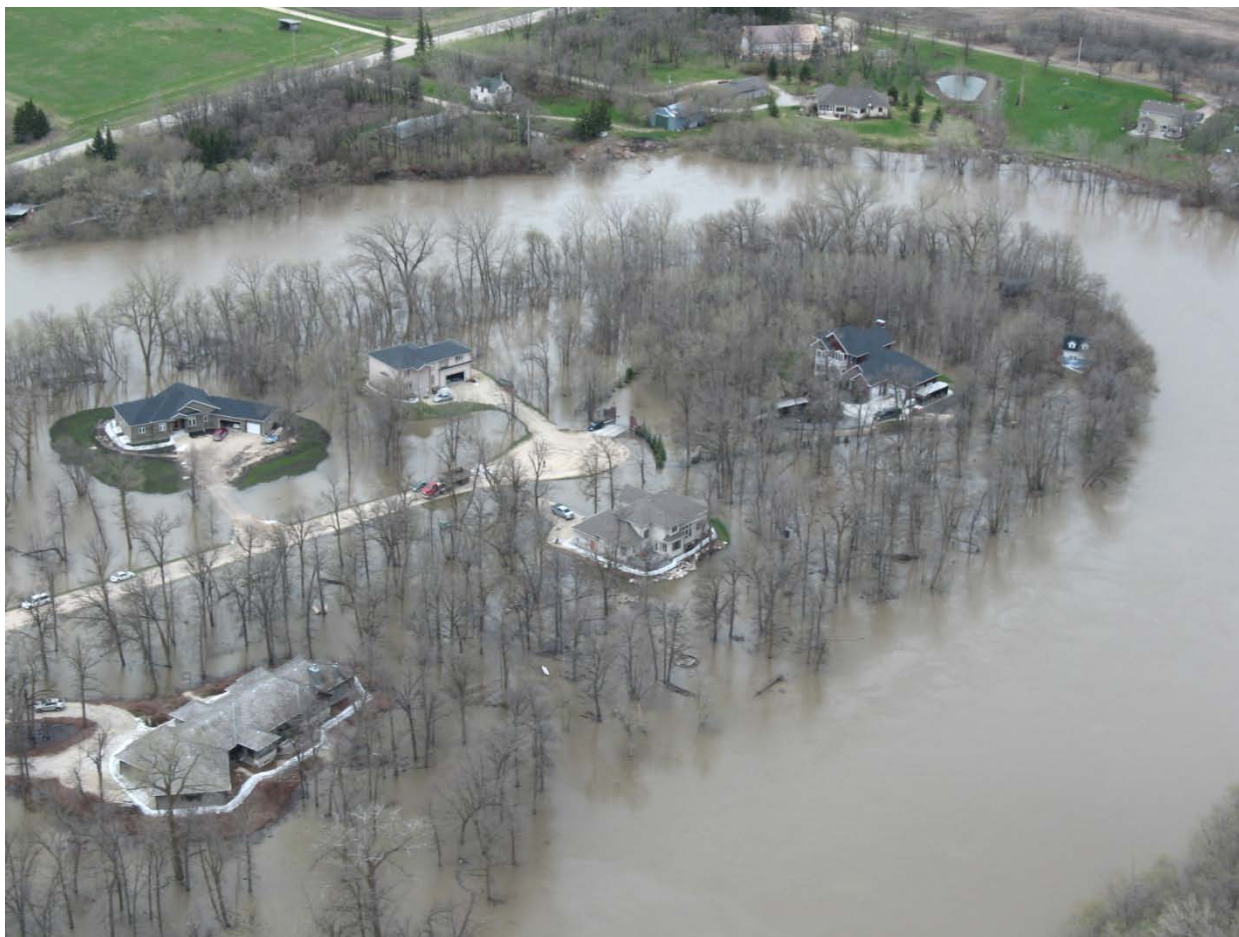
Figure 47: Example of flooding along the Assiniboine River between Baie St. Paul and Headingley. Note that some homes are protected by temporary flood protection works.

Flooding of farmland and residential yards occurred along portions of the Assiniboine River between Portage la Prairie and Winnipeg. However, many residential properties were adequately flood protected (see Figure 47).

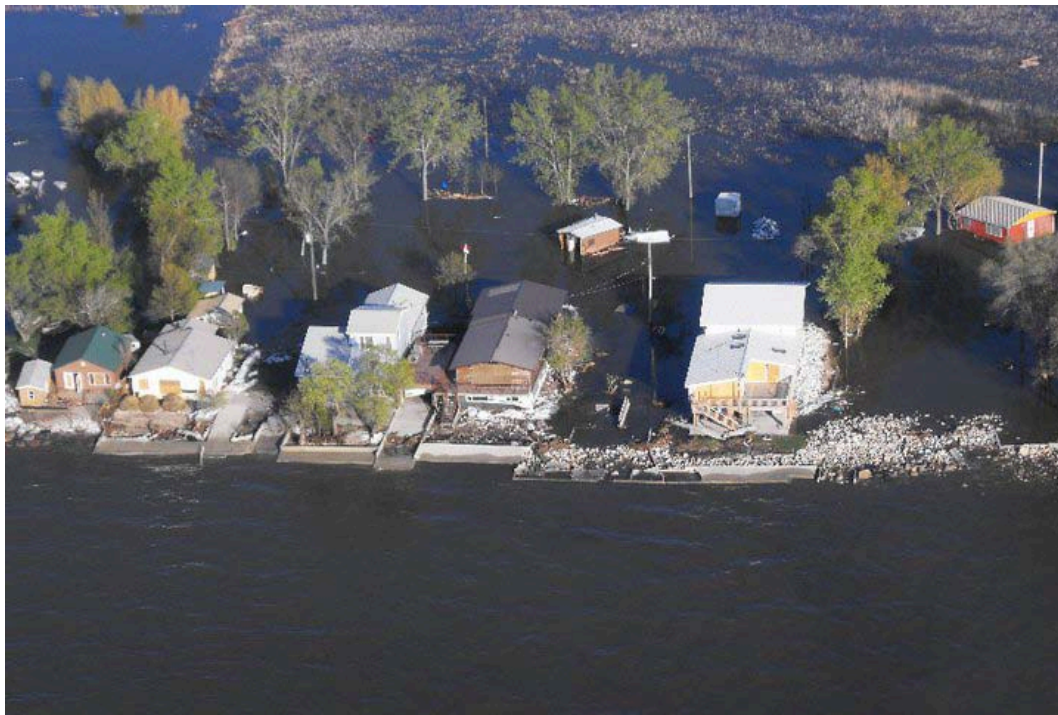
Figure 51: Photograph illustrating damage to cottages in the Twin Lakes Beach area, on the southern shores of Lake Manitoba.

Above average precipitation and storms. In the spring and early summer of 2011 there was significantly higher than normal rainfall over the lake and the surrounding watershed. The storm between May 27 and June 1 was of particular significance. Many of the homes and properties on Lake Manitoba were damaged during the windstorm event that occurred on May 31 (see Figure 51 for an example of the property damage experienced as a result of that storm event). According to recorded wind data from a weather station at St Laurent, the six-hour average north-northwest wind on that date reached over 60 kilometres/hour (35 miles/hour) and hit a peak of 89.9 kilometres/hour (55.9 miles/hour). These strong, sustained winds forced the water into the south basin of the lake, raising lake levels in the south basin by over 3 feet (1 m) if wave effects are not considered. This is a phenomenon known as wind set-up (see

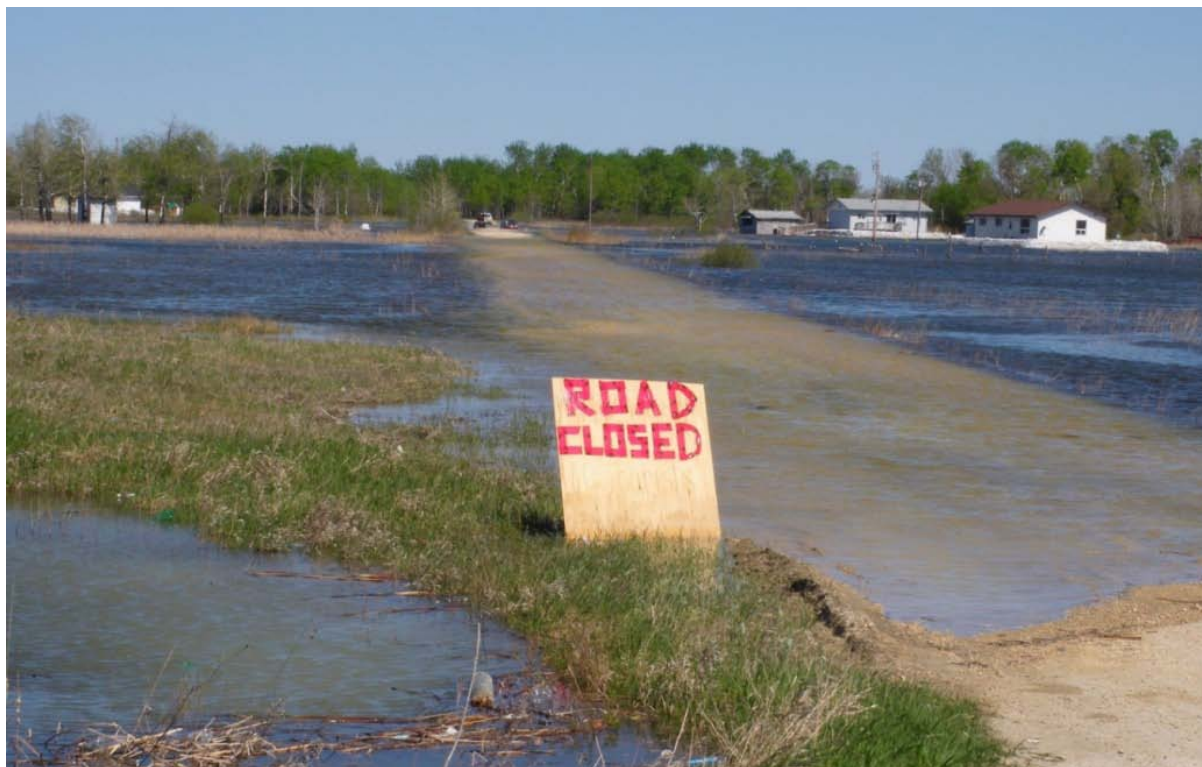
Figure 54: Lake St. Martin flooded shoreline and backshore area.

Lake St Martin is susceptible to flooding because of the low lands surrounding the lake and the limited outflow capacity of the Dauphin River. Above average precipitation in 2010, high flows to Lake Manitoba from the Waterhen River and the Portage Diversion and the subsequent operation of the Fairford River water control structure to help lower Lake Manitoba, produced high inflows and caused levels on Lake St. Martin to reach the maximum desirable level of 801 feet (244.145 m) in January 2011. Lake St. Martin levels rose even further due to record high spring and summer flows on the Fairford River, raising the water to a maximum level of 805.5 feet (245.516 m) in July, approximately 2.0 feet (0.6 m) higher than the previous recorded maximum level. Shorelines and backshore areas around the lake were flooded and forced the evacuation of residents from a number of First Nation communities (see Figure 55 and Figure 54).

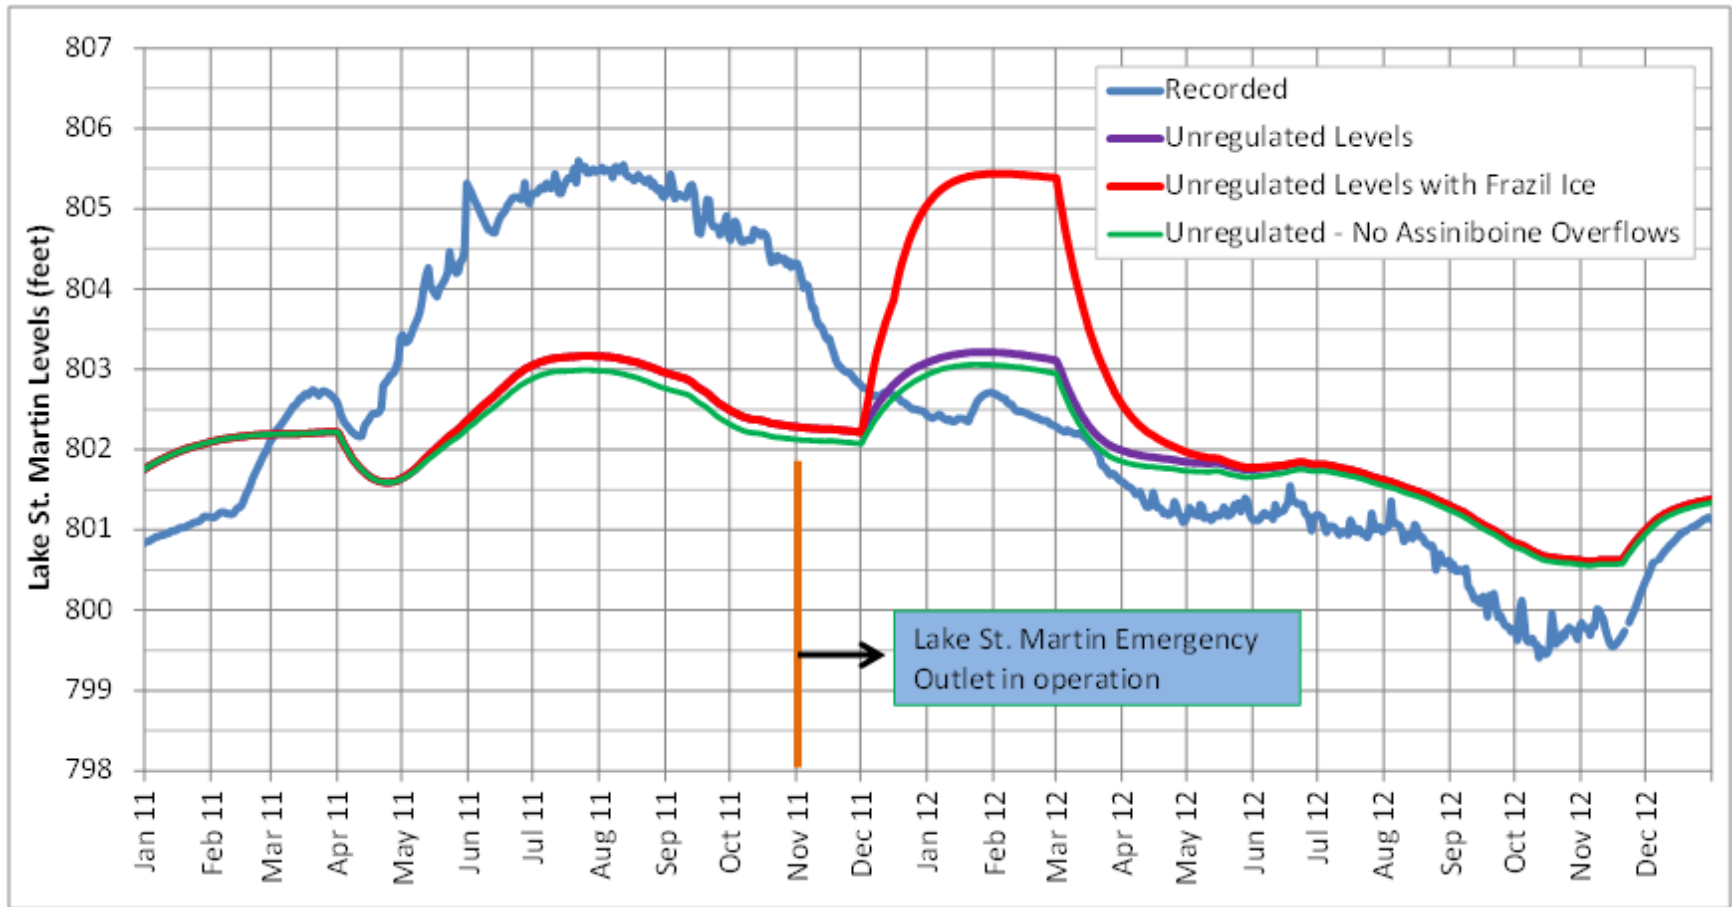
Figure 69: Recorded, and unregulated Lake St. Martin water levels, with and without overflows from the Assiniboine River.

The results of the modelling on Lake St. Martin showed that, from January until late February 2011, prior to spring runoff, the recorded Lake St. Martin water level was approximately one foot below the unregulated water level. This benefit was quickly negated when the flows through the Fairford River water control structure were increased late in the winter of 2011. The operation of the Fairford River water control structure, which lowers water levels on Lake Manitoba during high water periods, serves to artificially increase inflows and causes artificially high water levels on Lake St. Martin. The Portage Diversion, by increasing inflows to Lake Manitoba, also adds to the total volume of water that flows through Lake St. Martin. As a result of the operation of these two structures, the water levels on Lake St. Martin were artificially high from early March until early December, 2011. Lake St. Martin reached a maximum level of 805.60 feet (245.547 m) versus an unregulated peak level 803.17 feet (244.806 m), meaning that water levels on Lake St. Martin were artificially high by up to 2.4 feet (0.73 m). The Lake St. Martin emergency channel helped to significantly reduce water levels on Lake St. Martin much faster than they would have dropped under unregulated conditions. This is illustrated by the steeper decline in recorded lake levels beginning on November 1, 2011, the date that the emergency channel began operation. Operation of the Lake St. Martin emergency channel dropped the recorded water level on Lake St. Martin below the unregulated water level in December 2011.
