# *Watershed-Based Plan*

## *North Mill Creek - Dutch Gap Canal*

# **NORTH MILL CREEK-DUTCH GAP CANAL WATERSHED-BASED PLAN**

**November 2011**

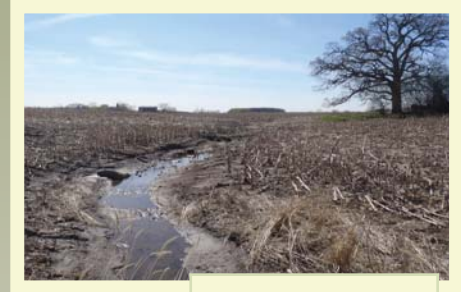
*Gully erosion washes topsoil off land and into creek*

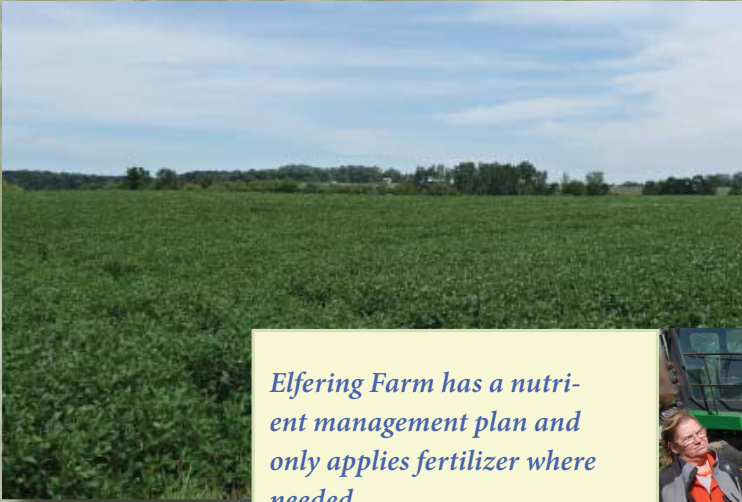
*Elfering Farm has a nutrient management plan and only applies fertilizer where needed*

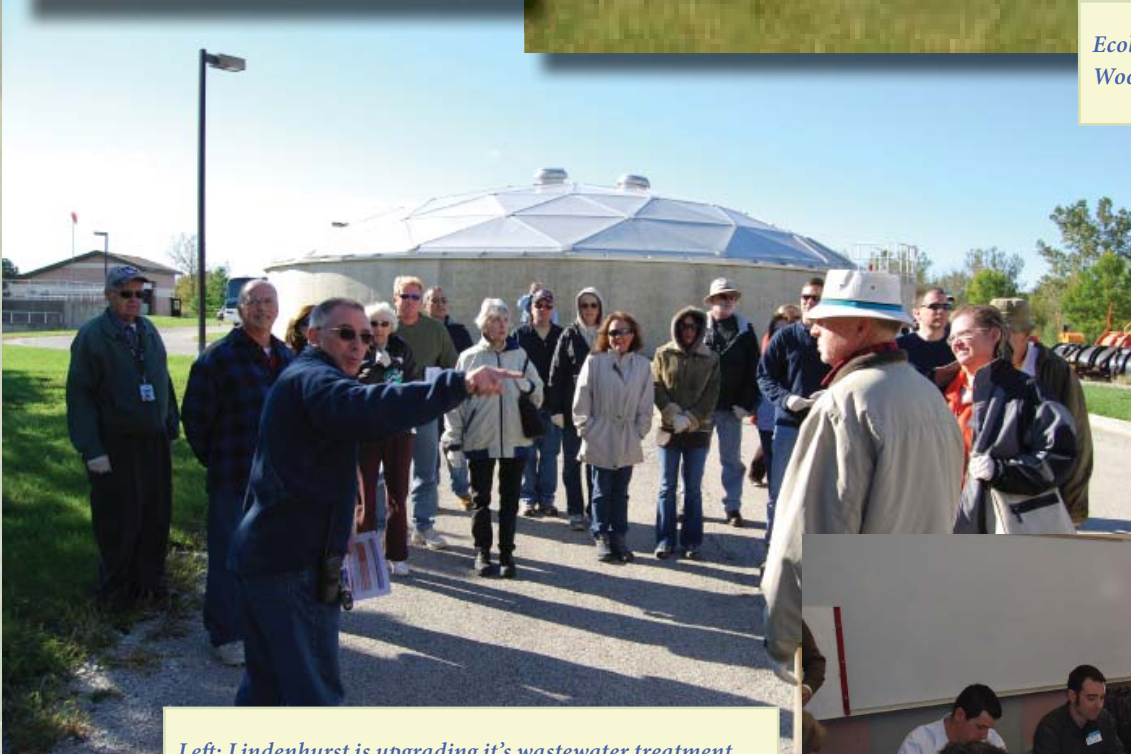
*Left: Lindenhurst is upgrading its wastewater treatment plant 2011-2012 to include nutrient removal*

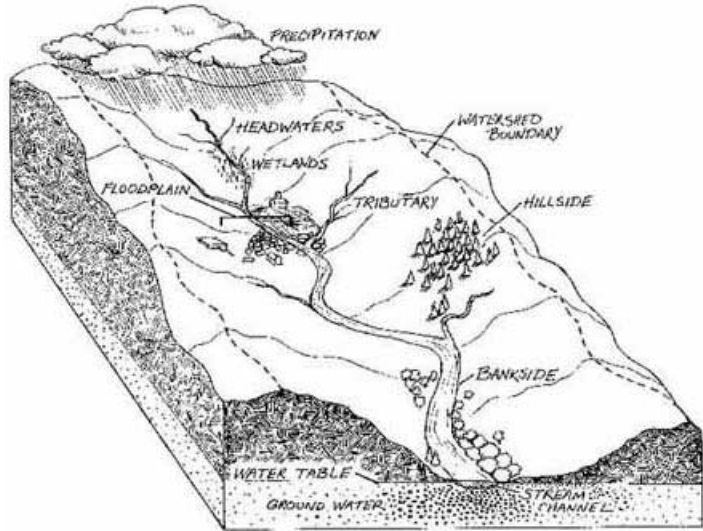
FIGURE 1-1 WATERSHED MAP  
\*Graphic courtesy of the USEPA

**Watershed:** An area confined by topographic divides that drains to a given stream or river. The land area above a given point on a waterbody (river, stream, lake, wetland) that contributes runoff to that point is considered the watershed.

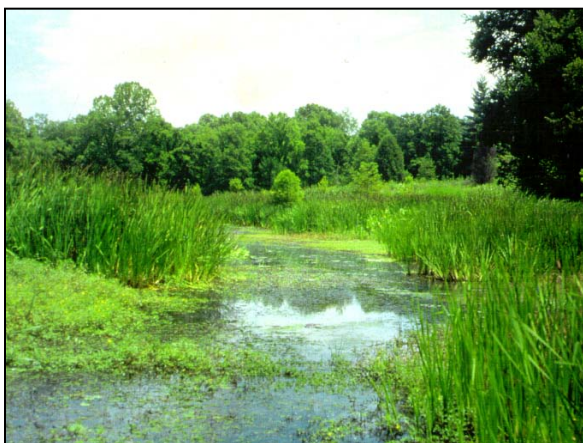
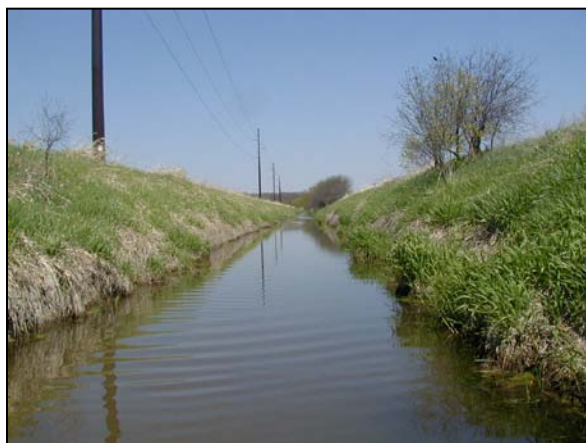
### FIGURE 1-6: HISTORIC MARSH SLOUGHS were channelized to improve drainage for farming.

Typical historic stream channel

Typical altered stream channel – Dutch Gap

These natural communities likely worked in unison to infiltrate and treat precipitation, which minimized surface stormwater runoff leaving the watershed with the large marsh/prairie complexes rather than defined stream channels in the north. Red Wing Slough is likely the landscape that most closely resembles the marsh/wetland complexes that once existed in the northeast part of the watershed. Following European settlement, most of the watershed was altered for agricultural purposes. This resulted in the clear-cutting of savanna and woodlands, clearing of prairies, and installation of drain tiles and agricultural ditches to convey water from the marshes into stream channels to create farmland. The Dutch Gap Canal is actually a channel that was excavated to drain wetland for farmland. The name Dutch Gap shows up for the first time on an 1887 plat map. It was probably formed by the individual efforts of several Wisconsin farm families before it was completed by a steam-powered dredge in 1916. (Kenosha News December 6, 2000)

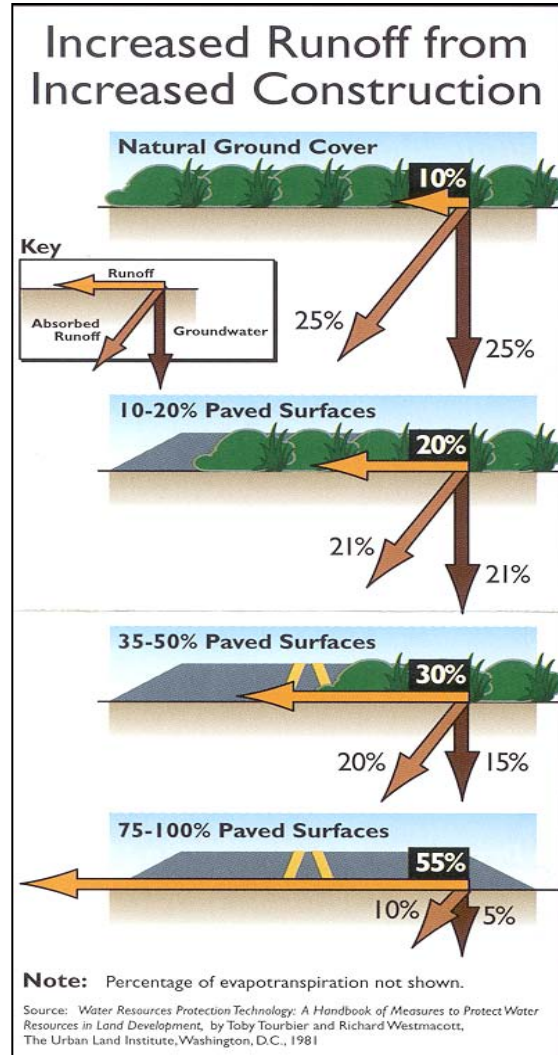
**FIGURE 1-7: INCREASED RUNOFF FROM INCREASED CONSTRUCTION DIAGRAM**

NOTEWORTHY: Urbanization Increases Runoff  
 As farms, fields and woodlands in the watershed are developed into more urban land uses, what was once pervious open space is converted to *impervious* built up surfaces. This action reduces the amount of land available for the natural infiltration of precipitation into the ground. As impervious surfaces increase so does the volume of stormwater runoff, which can result in flooding and degraded water quality and habitat. In the absence of sensitive development practices, projected development trends over the next 20-30 years are expected to worsen flooding and water quality problems and decrease open space areas.

The rapid flow of water to streams results in what is termed “flashy hydrology”. Water levels rise quickly during a storm event to a much higher than natural level and then fall quickly after a storm is over. In addition, since much the precipitation has been converted from infiltrating into the ground to runoff, there isn’t enough shallow ground water to maintain stream base flow in the dry months to support aquatic habitats and water quality, and ground water aquifers that support our water supply are not being recharged.

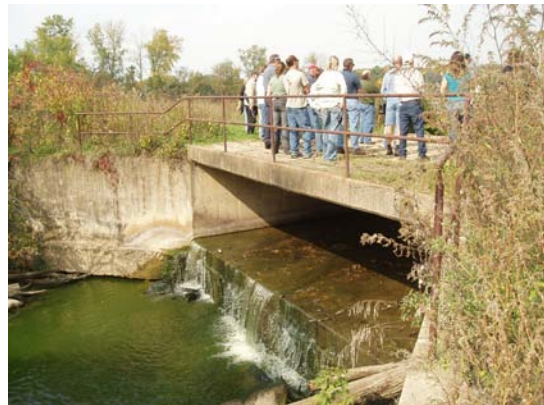
Lake County Forest Preserve will be removing the dam on Mill Creek that creates Rasmussen Lake and restoring the historic stream channel.

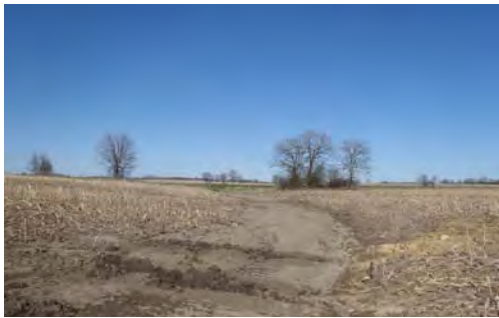
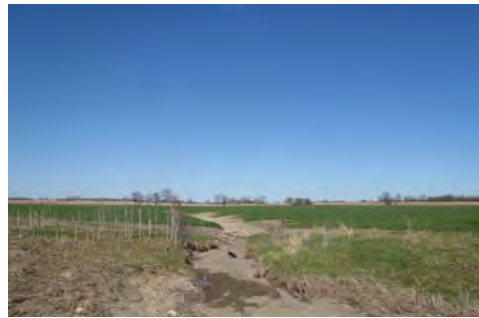
Photos of farmland erosion in the watershed

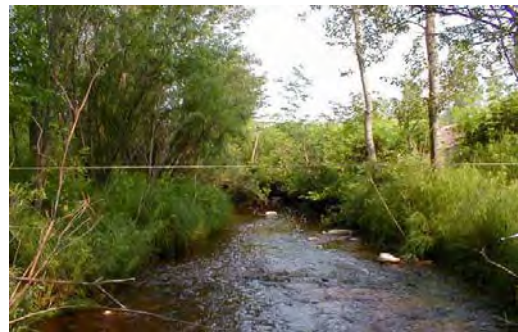
- Sensitive SMUs generally exhibit little impervious cover (<10%). Therefore, they usually have stable stream channels that are not severely eroding, downcutting, or filling with sediment. Streams in sensitive SMUs also tend to have excellent stream habitat (such as diverse substrate or bed material,

Condition typical of sensitive SMU

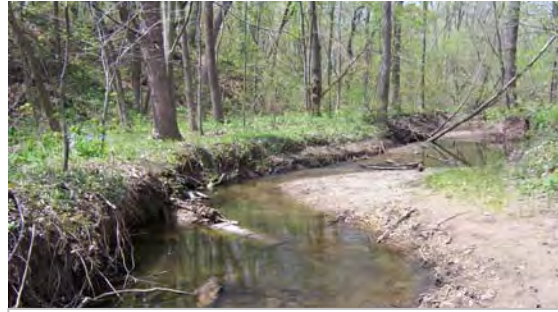
watershed urbanization. The most obvious sign of impacts from impervious cover is often stream bank erosion, channel widening and channel incision or “downcutting” as a result of larger stormwater runoff volumes. These are also signs of stream channel “instability”. These physical changes in the stream channel can also impact stream habitat, including scouring of the streambed, deposition of silt or fine sediment, and loss of riparian habitat. Water quality is often degraded as nonpoint source pollutants are carried into the stream by runoff from impervious surfaces. If the stream is incising (“downcutting”), it may become disconnected from the floodplain, only overflowing the streambanks during exceptionally high flows. This not only affects floodplain habitat but can also result in downstream flood problems. Because of the changes in stream channel conditions, water quality, and habitat, the diversity of aquatic life in impacted SMUs is diminished. The most sensitive species are absent from impacted streams.

Condition typical of impacted SMU

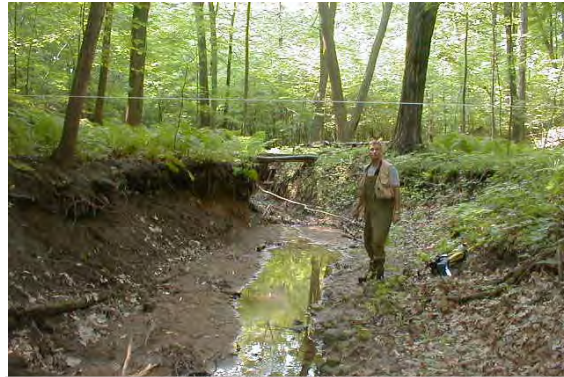
- Non-Supporting SMUs have high impervious cover (>25%). At this level of watershed impervious cover, streams lose much of their ecological functionality and function primarily as flow pathways for urban runoff. Under “non-supporting” conditions, stream channels are highly unstable and exhibit severe and prevalent erosion, widening, downcutting,

Condition typical of non-supporting SMU

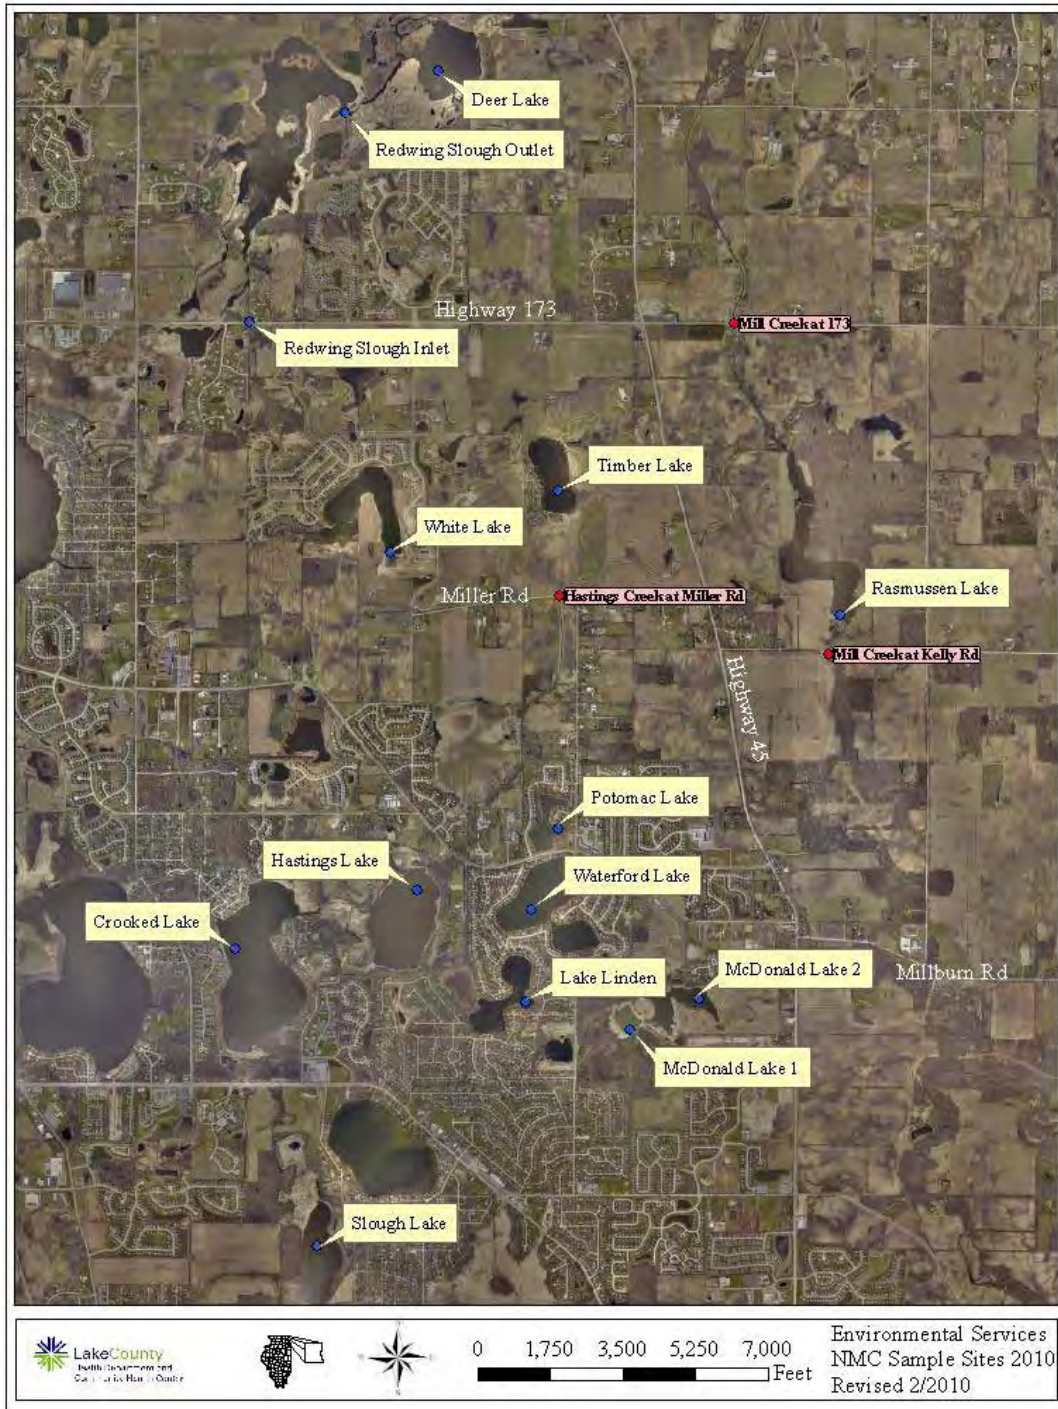
Figure 3-33: LCHD 2010 Sampling Locations.<sup>1</sup>

<sup>1</sup> Rasmussen Lake has not been assessed by LCHD since 2001.

Water quality studies have been completed by several agencies within the North Mill Creek-Dutch Gap Canal waters. The sample site locations can be found in Figure 3-32 and the Figure 3-33 aerial.

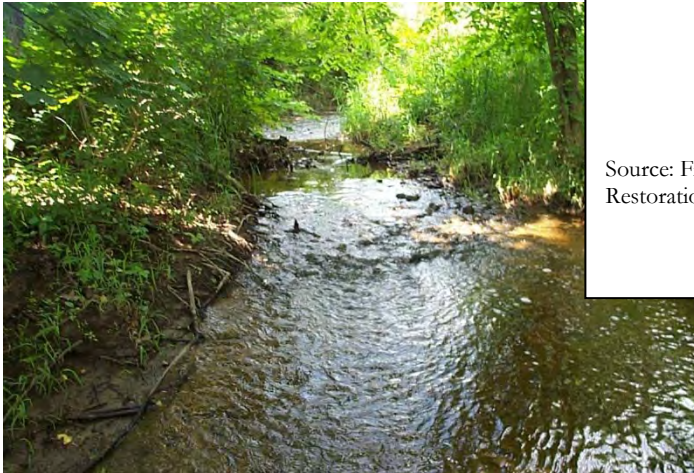
**NOTEWORTHY:** Stream Geomorphology  
Complex riffle/pool sequences are usually associated with naturally meandering stream channels formed by the energy of the flow. Deeper pools are generally located in the bend of the channel while shallow riffles occur in the runs that connect each pool in the bend. Pool/riffles benefit the stream system by providing various habitats while aerating the water during low flow conditions. Channelized streams are often void of any riffles and pools depending on the degree of channelization. Under baseflow conditions, pools are low-

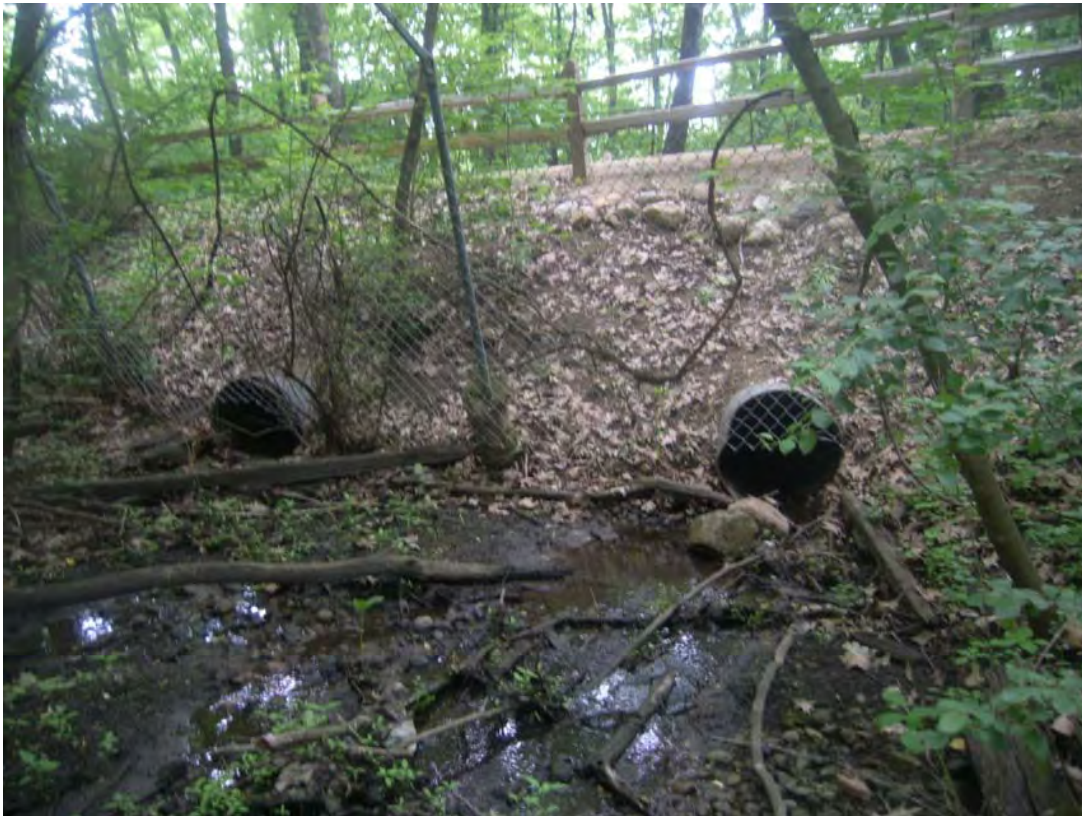
**Figure 3-67: Example of a problem hydraulic structure**

The following photograph (Figure 3-67) depicts a problem hydraulic structure. By examining the picture, it is apparent that the structure lacks appropriate levels of rip rap and needs to be cleared of some woody debris. A chain link fence can also be seen in front of the culvert. At times of high water flow this could potentially restrict the movement of water through the pipe.

Figure 3-68 provides the location of the 43 problem hydraulic structures identified in the watershed. They are identified by their photo ID number. Thirty-four of the problem hydraulic structures are located in the Lake County portion of the watershed. Appendix C contains a comprehensive list of the structures and associated problems. The Action Plan includes recommendations for addressing these problematic hydraulic structures.
