A new approach for landslide-induced damage assessment

Matteo Del Soldato, Silvia Bianchini, Domenico Calcaterra, Pantaleone De Vita, Diego Di Martire, Roberto Tomás & Nicola Casagli

ABSTRACT

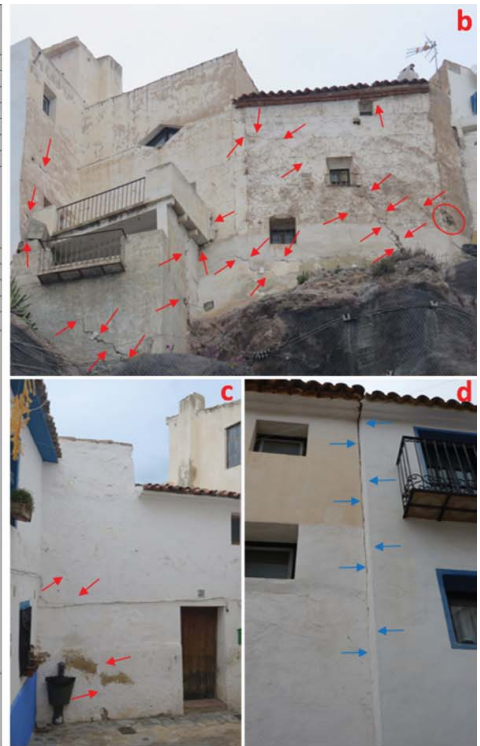
Figure 2. Recording scheme (a) of a building in Finestrat, Alicante (Spain) affected by cracks (arrows in b and c) and joints (arrows in d).

The first example is a three-floor masonry structure located in Finestrat, Alicante (SE Spain) built atop the crown of a natural 15 m steep slope. From a geological point of view, Finestrat is situated within the easternmost region of the Betic Cordillera, in the so-called Prebetic Zone (Colodrón et al. 1981). Three stratigraphic units can be observed along the cliff (Tomás et al 2013a, 2014). The first is represented by massive Keuper Triassic stiff gypsum located at the top. The next consists on alternating layers of clay, marl and sandstone located at the bottom. The slope is affected by an active rock spread which exhibited displacements of up to 4 cm on the façades of the buildings placed on the crown between February 2011 and August 2012, which were measured using 3D Point Clouds obtained using a Laser Scanner (Tomás et al 2013b). Currently, one-half of the building demonstrates ‘Very severe damage’ (G5) (i.e. cracks, the distortion and rotation of the structure and road), while the second half exhibits ‘Weak damage’ (G2) (i.e. tilted walls and fractured service pipes) ([Figure 2](#)). Therefore, utilizing [Table 3](#) with $1/3 < G5 < 2/3$ and $1/3 < G2 < 2/3$, we obtain a score of 4.900, which corresponds to a ‘Very Severe’ damage level.

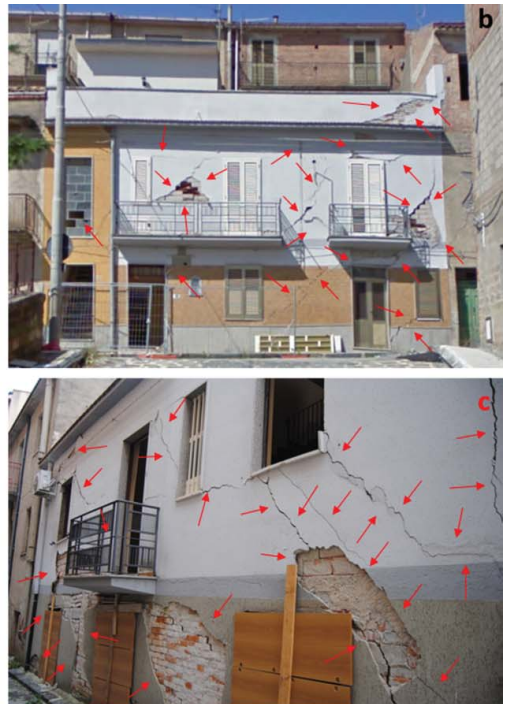
Figure 3. Recording scheme (a) of a building in the village of San Fratello (Sicily, southern Italy) affected by cracks and a loss of material (arrows in b and c).

The second example is a private building in the village of San Fratello (in the Sicily region, southern Italy), located atop the crown of a severe landslide that occurred on 14 February 2010 involving structurally complex Cretaceous-Oligocene formations (Ciampalini et al. 2014; Bianchini et al. 2015a). The landslide, which extended up to approximately 1 km², was triggered by intense rainfall, thereby inducing immense damage and casualties. The damaged building is a masonry structure with visible open diagonal cracks and ruined plaster on the external façades. The building also displays a tilting and bending of constructive elements (i.e. doorways and windows), resulting in distortion and unserviceability ([Figure 3](#)). According to the proposed approach, one-third of the building is affected by G3 level damage, and the remaining segments are afflicted by G5 degree damage. Due to

the severity of the damage and their extent, the entire structure is categorized as ‘*Potential collapse*’ using Table 3, reaching a score of 6.067 (i.e. $>2/3$ G5 and $<1/3$ G3). Despite the severity of tilting and level of cracking that affected the building, the collapse had not occurred due to the lateral structural constraints of other close edifices; however, in January 2013, the structure was demolished (Bianchini et al. 2015a).
