**SURVEY, DESIGN AND TRAINING FOR THE
STABILIZATION OF WWII HISTORIC
FEATURES, OBJECTS AND MONUMENTS
ON WAKE ATOLL**

September 2010

Robert G. Lodge, Artifacts Conservator
Ricky Workman, Archaeology Intern

For: RFQ# WI 10-084
“Wake Island Cultural Resource Restoration Consulting”
Chugach Support Services, Inc.

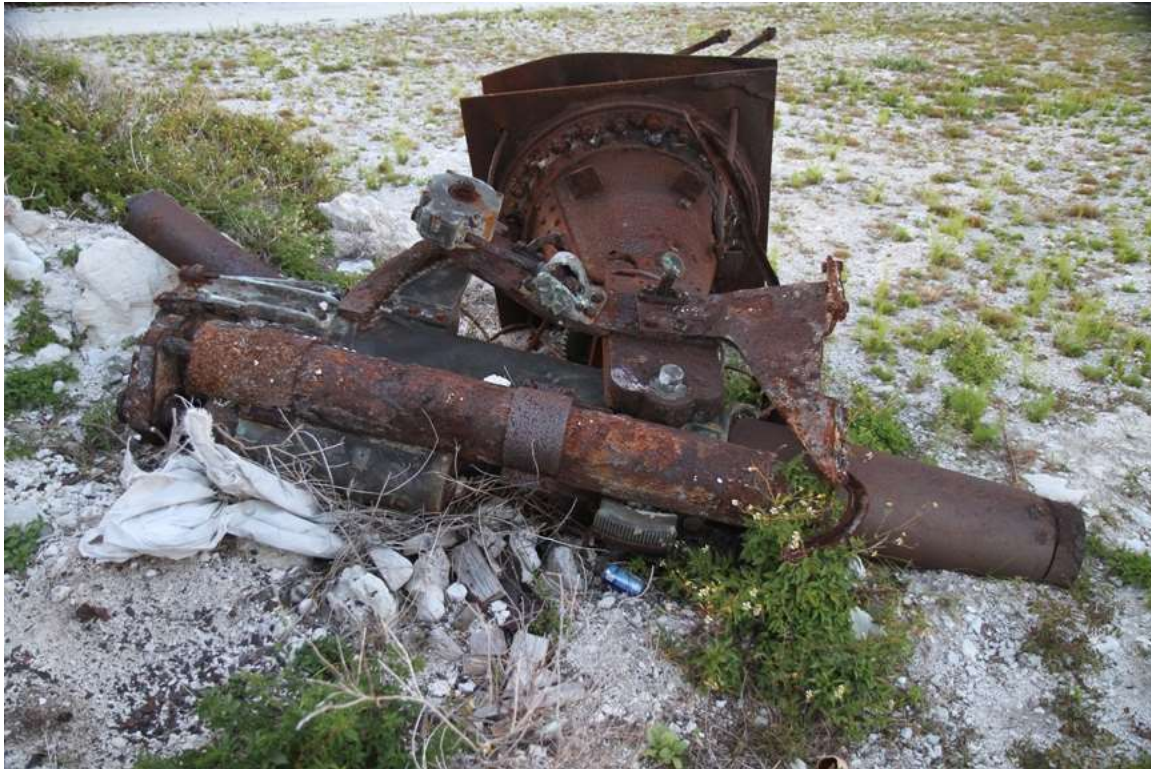
WL01 *Coral Rubble Mound and 3 Inch Anti-Aircraft Gun:*

Located in the south-central end of Wilkes Island, southwest of the jet fuel tank farm, this cluster includes a 4 meter high coral rubble mound that was used as a defensive measure against anti-aircraft, as well as a 3-inch anti-aircraft (AA) gun. Several pieces of wood protruding vertically at the northeast edge on the depression may indicate a collapsed entrance. The 3-inch AA gun lies on the base of the mound on the northeast side (see video files). It has been mentioned that the gun was actually dragged in from a previous location closer to Kuku Point, and does not belong to the gun emplacement associated with the coral mound. The 3-inch AA gun would have high interpretive value if transported to another, more accessible location. We recommend that this gun be mounted on the emplacement located in cluster WK61-690-14. If the emplacement at this location were removed and cleaned, the coral mound rebuilt with the addition of a concrete pad on its top, and the emplacement mounted to the pad with the 3-inch AA gun in place, this historic structure would hold very high interpretive potential for visitors to

the Wake Island Terminal. The barrel of this gun has been cut off and is missing. It is recommended that a steel replica barrel be made, even though lacking in historical accuracy, and welded in place, to convey at a distance an approximation of the gun's original profile.

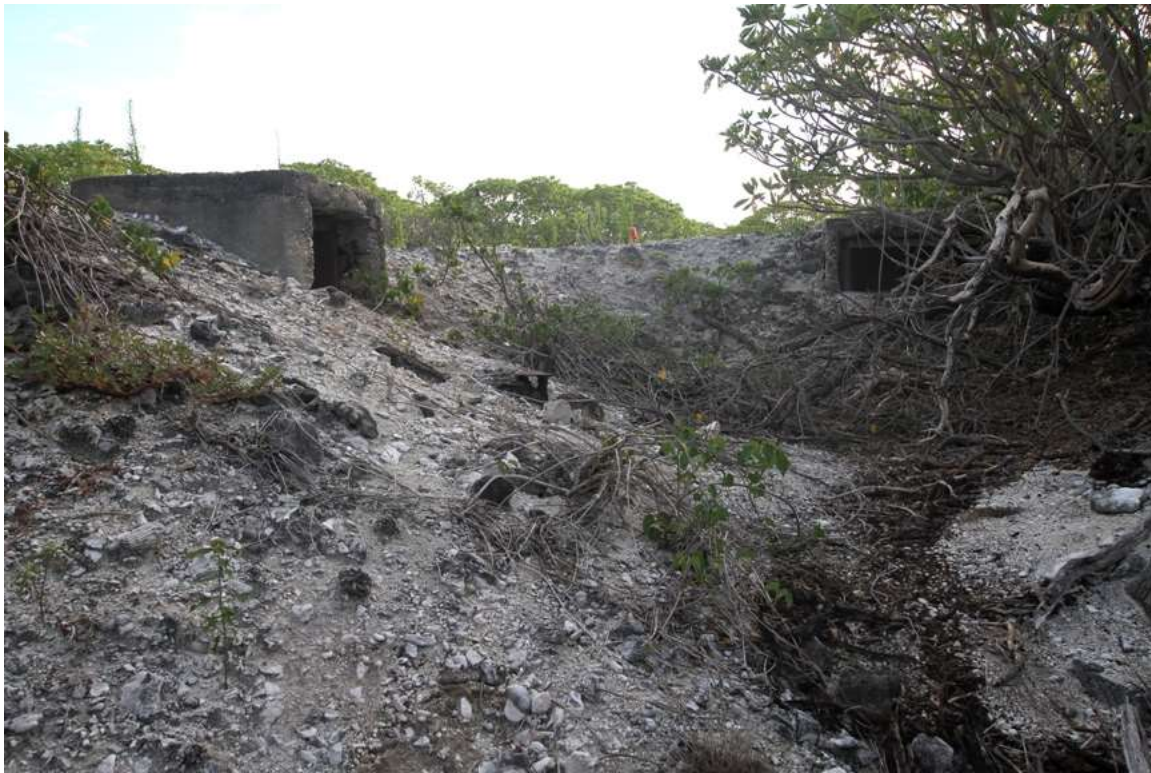
WL02 *Concrete Foundation, Gun Emplacement, Concrete Bunker, Artillery Shell Boxes, and Trenches:*

Located on Wilkes Island to the northwest of the submarine channel and gravel pit, this cluster includes the remains of a Japanese concrete foundation, 3-inch AA gun emplacement, a concrete bunker and a series of well-crafted trenches. The concrete foundation has bolts that extend upward from the lip at regular intervals but no superstructure exists. The gun emplacement contains two concrete artillery shell boxes on the top edge which are unique to the atoll. They were lined with wood. The emplacement also displays a large crater that seems to be the remnants of a 50-100 lb bomb which would have destroyed the original structure. It has been determined that any remains of the 3-inch gun or revetments were taken as scrap metal during salvage operations in the 1960's. The series of Japanese trenches throughout the cluster, some up to 1.5 meters in height, are in excellent condition and hold great potential to interpret Japanese defensive fortifications as well as a very high potential for archaeological remains. Vegetation should be removed from the entirety of the structures, detailed mapping conducted, and annual upkeep should be undertaken to keep the site void of modern trash and free of vandalism. Archaeological investigations should ensue.

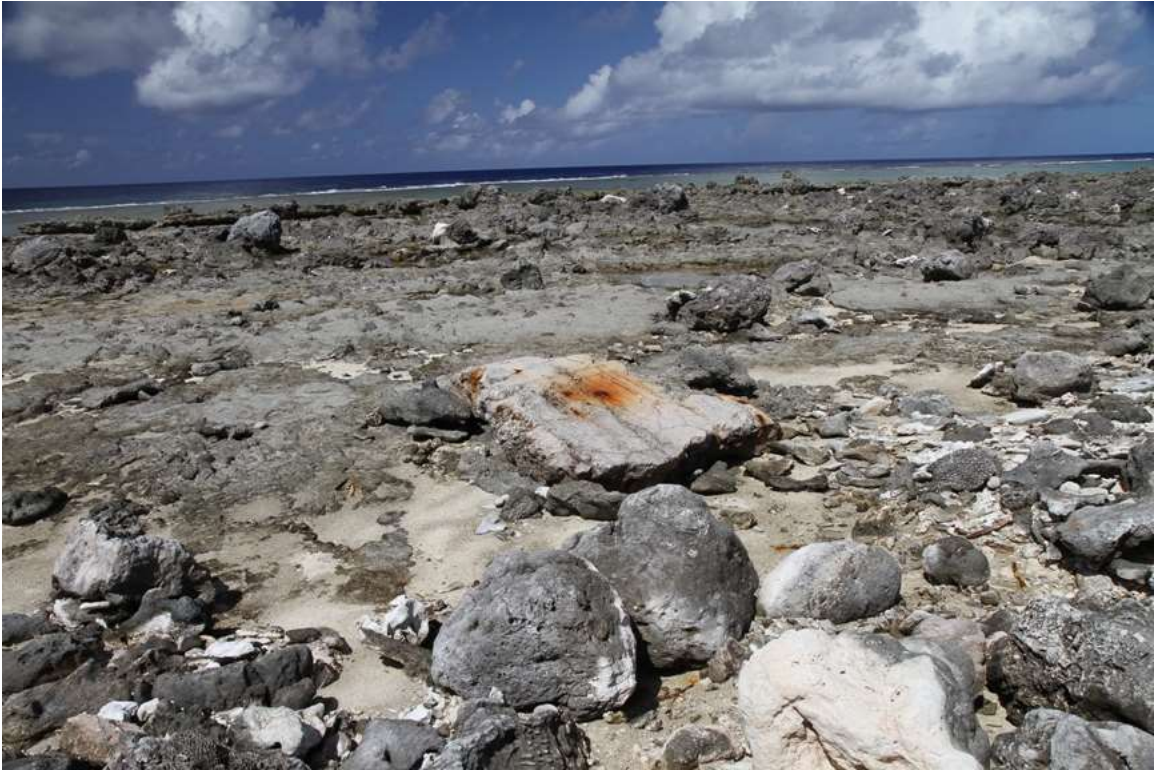
WL04***Destroyed Ferro-Concrete Pillbox:***

Located on the northwestern shore of Wilkes Island, this Japanese pillbox has deteriorated to the point of total loss. The structure now consists of two fragments lying directly on the waterline at high tide. While there is nothing left to preserve, this feature should stand as an example to what will eventually happen to all such features remaining on the atoll without the help of preservation methods. The interpretive value has been lost and the archaeological potential is low due to wave action.

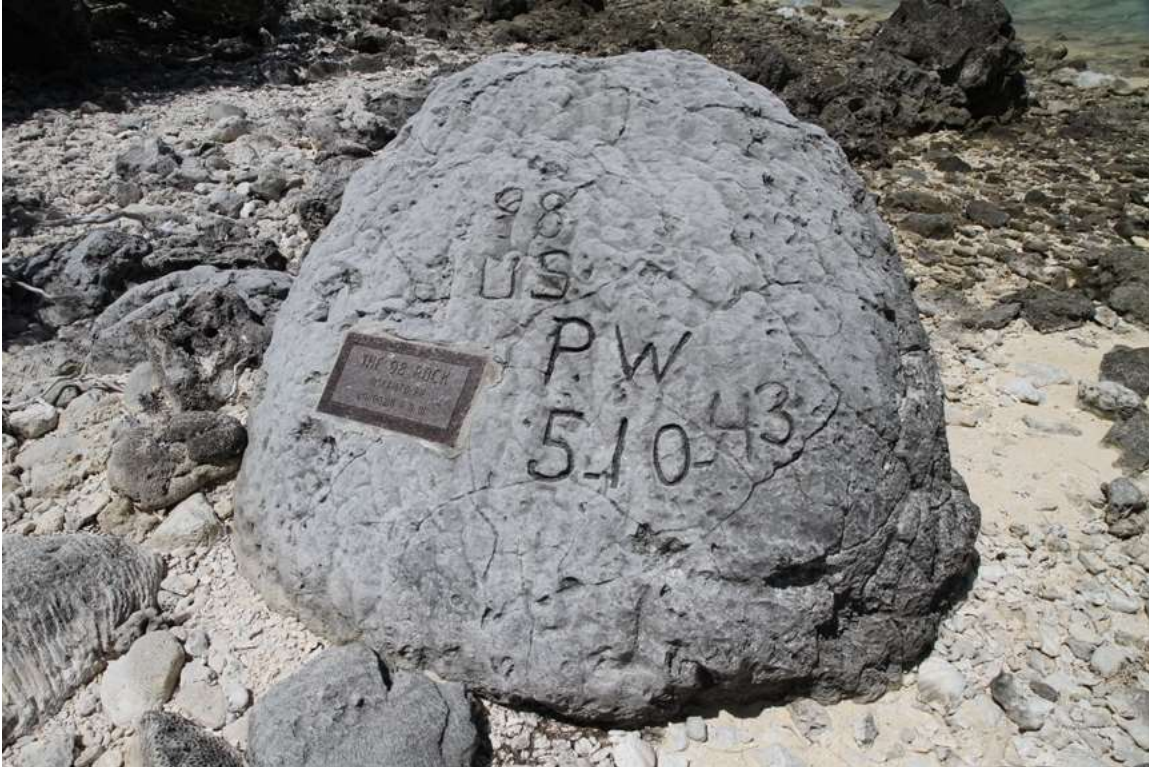
Located on the lagoon shore on the southeastern portion of Wilkes Island, POW Rock is a large coral boulder just at the waterline which bears the inscription "98 US P.W. 5-10-43".

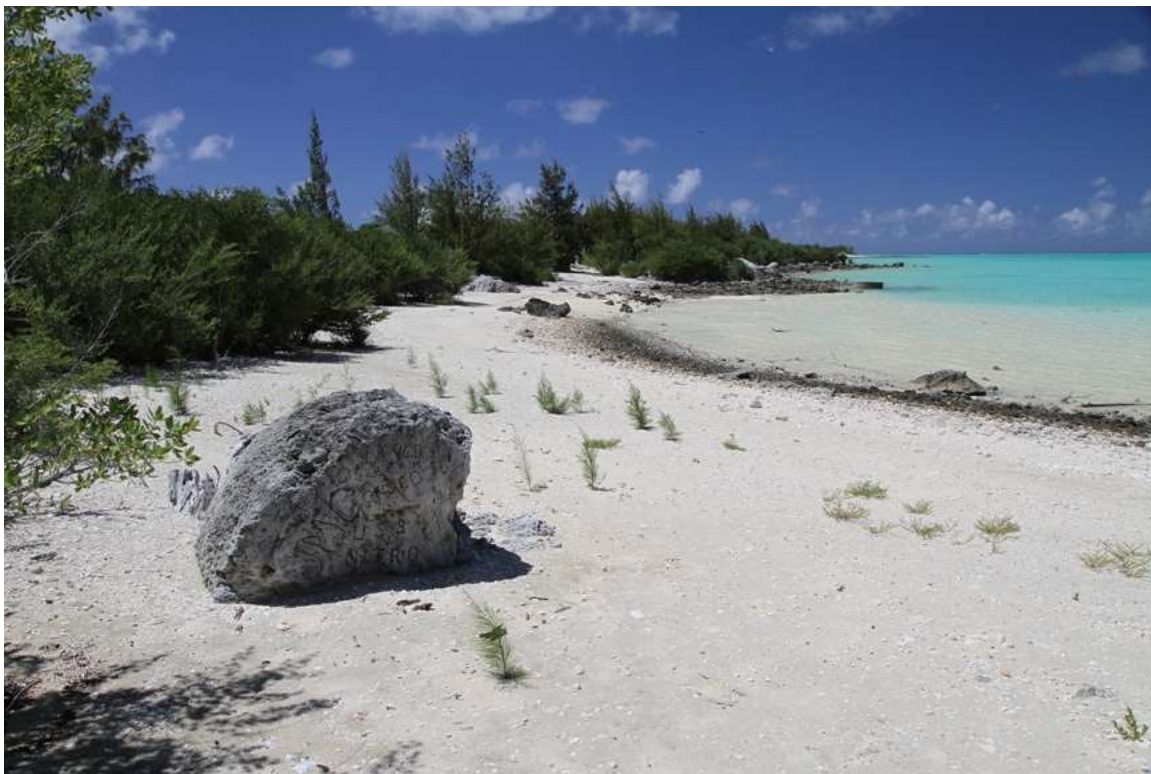
WL06 *U.S.S. Nitro Rock:*

Located on the lagoon shore on the southeastern portion of Wilkes Island, 50 meters to the southeast of WL5, this feature is a large coral boulder with graffiti inscribed into the rock. The oldest graffiti on the rock commemorates the 1935 visit of the U.S.S. Nitro and is dated "3-9-35". This is likely the oldest historic feature still extant on the island. There have been numerous additions to the graffiti on this feature in the forthcoming years,

including a similar inscription to the one on WL5 but reading "5.8.43 98 US PW". This inscription, we believe, lends credence to the above hypothesis as to the scribes of WL5.

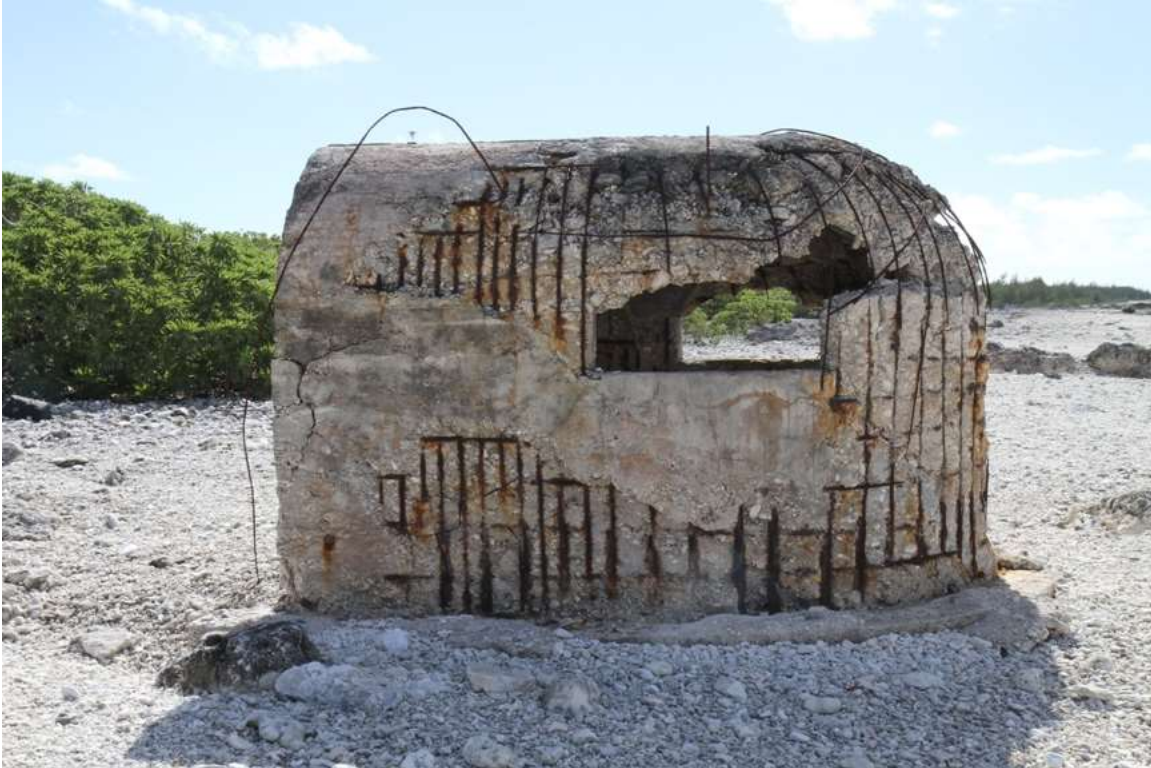
WL07 (WL-690.27) *Heavily Deteriorated Japanese Ferro-Concrete Pillbox:*

Formerly designated by PHRI as 690-27, this ferro-concrete pillbox located northwest of the submarine channel on Wilkes Island is in perhaps the worst state of degradation of any of the existing structures on Wake Atoll. With this being said, the structure holds high interpretive potential and is still worth conserving. As with all of the defensive structures constructed between the years 1941-1945 by the Japanese on Wake Atoll, this concrete structure was built with a coral aggregate mixed with sea water. The use of ocean water heavily amplified the inclusion of chlorides, which has led to the vast corrosion of rebar in these structures. The feature should be maintained with the appropriate designated conservation materials and methods discussed in this report.

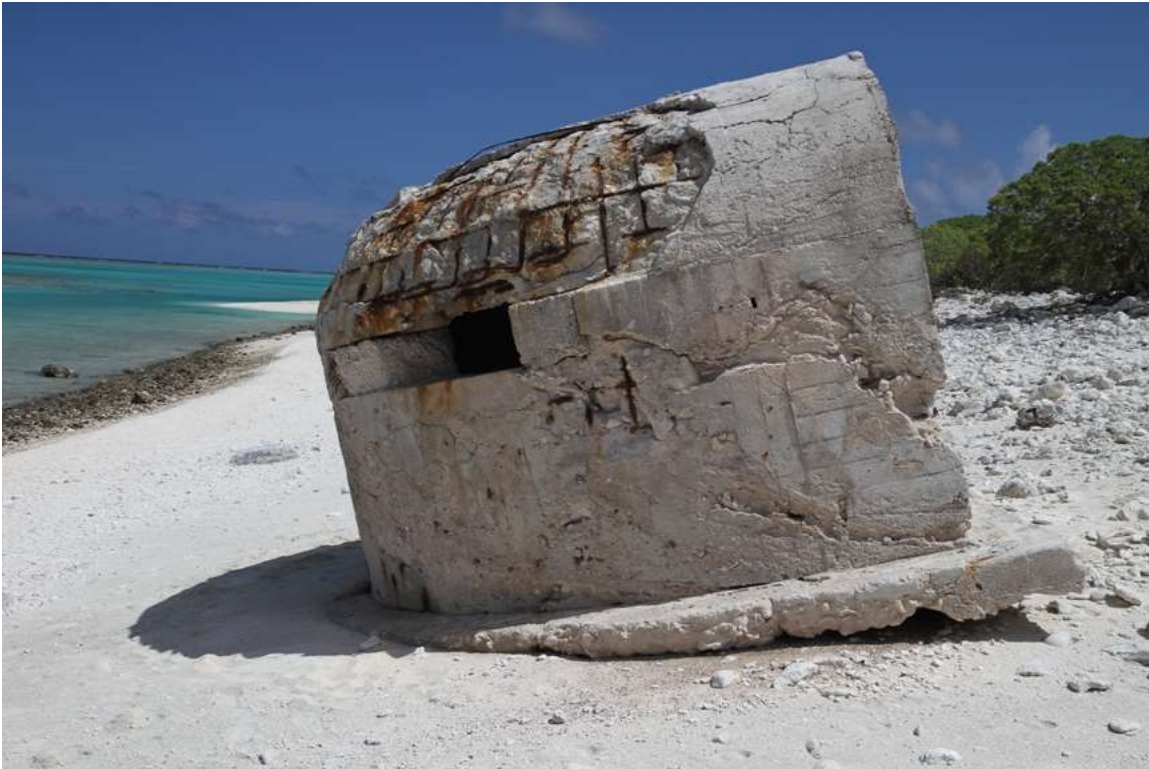
WL08 (WL-690.26) *Japanese Ferro-Concrete Pillbox:*

Formerly designated by PHRI as 690-26, this ferro-concrete pillbox located northwest of the submarine channel on Wilkes Island near Kuku Point holds high interpretive potential and should be conserved. As with all of the defensive structures constructed between the years 1941-1945 by the Japanese on Wake Atoll, this concrete structure was built with a coral aggregate mixed with sea water. The use of ocean water heavily amplified the inclusion of chlorides, which has led to the vast corrosion of rebar in these structures. The feature should be maintained with the appropriate designated conservation materials and methods discussed in this report.

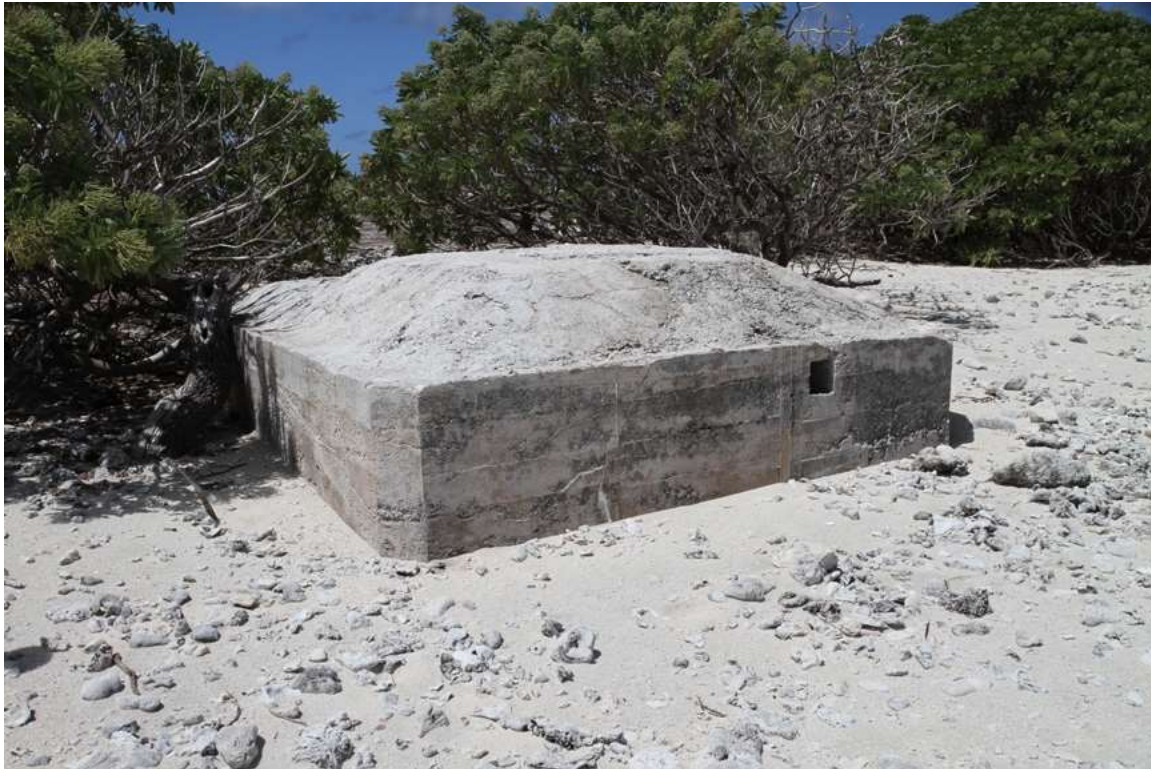
WL09 (WL-690.25) *Japanese Ferro-Concrete Bunker:*

Formerly designated by PHRI as 690-25, this ferro-concrete bunker is situated above the beach on the south side of Wilkes Island. This low lying feature is almost entirely encompassed by coral wash, burying most of the structure. There is evidence of a square entryway on the southwest face of the bunker. The feature should be completely excavated to reveal the interior and should be maintained with the appropriate designated conservation materials and methods discussed in this report.

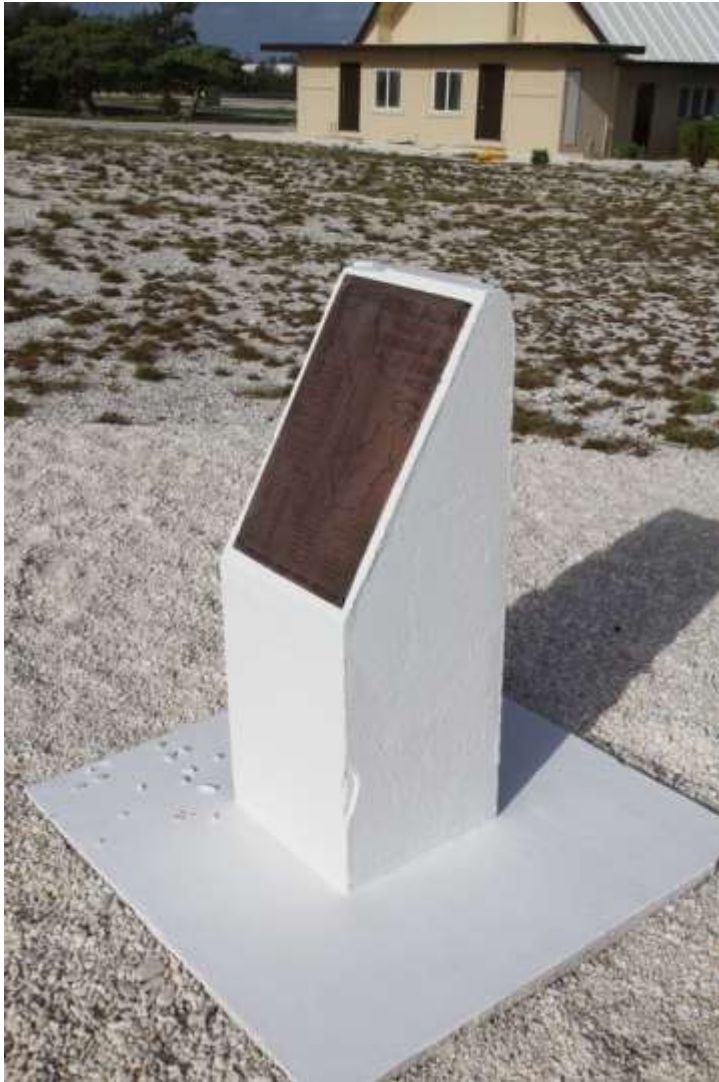
WK07 ***Guam Memorial:***

This memorial, located east of Elrod Drive behind the modern terminal, was constructed in 1990 to commemorate the citizens from Guam who were on Wake Island at the time of the Japanese attack in December 1941. The upkeep of this memorial is extremely important as it is one of the features most seen by visitors to Wake Atoll. This feature should be maintained with the appropriate designated conservation materials and methods discussed in this report to prevent future deterioration.

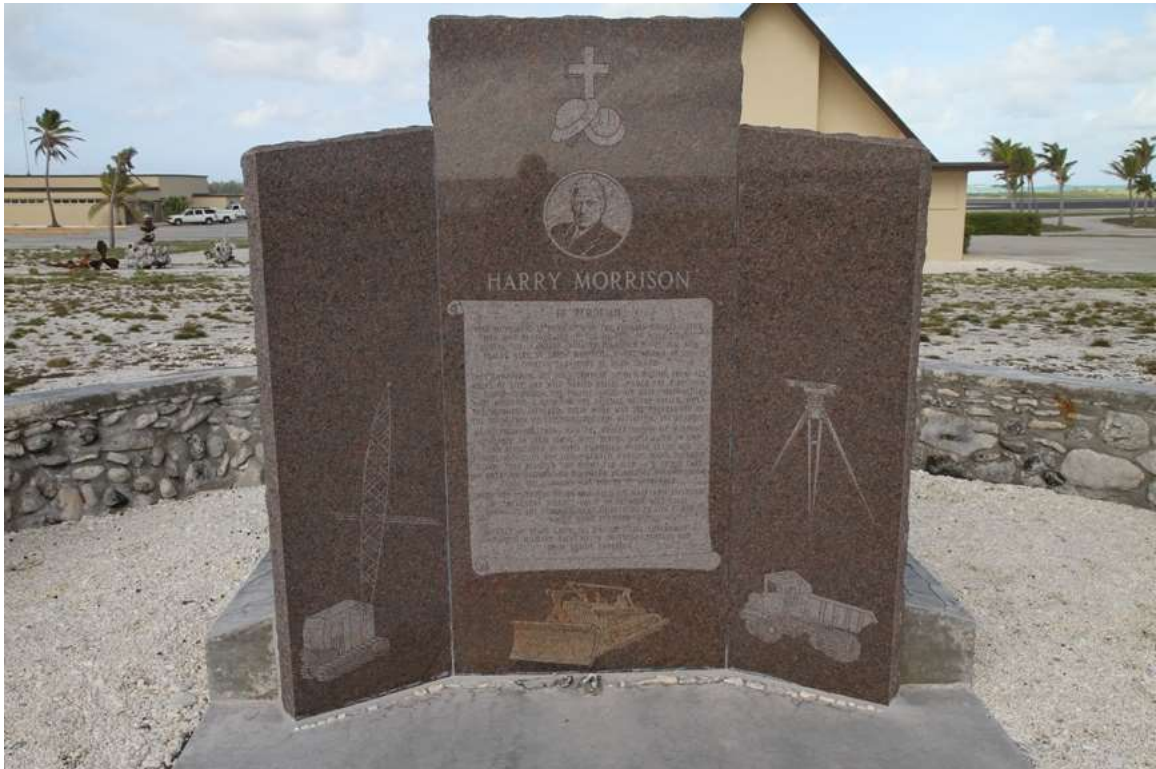
WK08 *Morrison Knudson Memorial:*

This memorial, located east of Elrod Drive behind the modern terminal, was constructed in 1988 to commemorate the civilian employees of the Morrison Knudson Company who were constructing the naval base at the time of the attack and helped in the defense of the island. The upkeep of this memorial is extremely important as it is one of the features most seen by visitors to Wake Atoll. This feature should be maintained with the appropriate designated conservation materials and methods discussed in this report to prevent future deterioration.

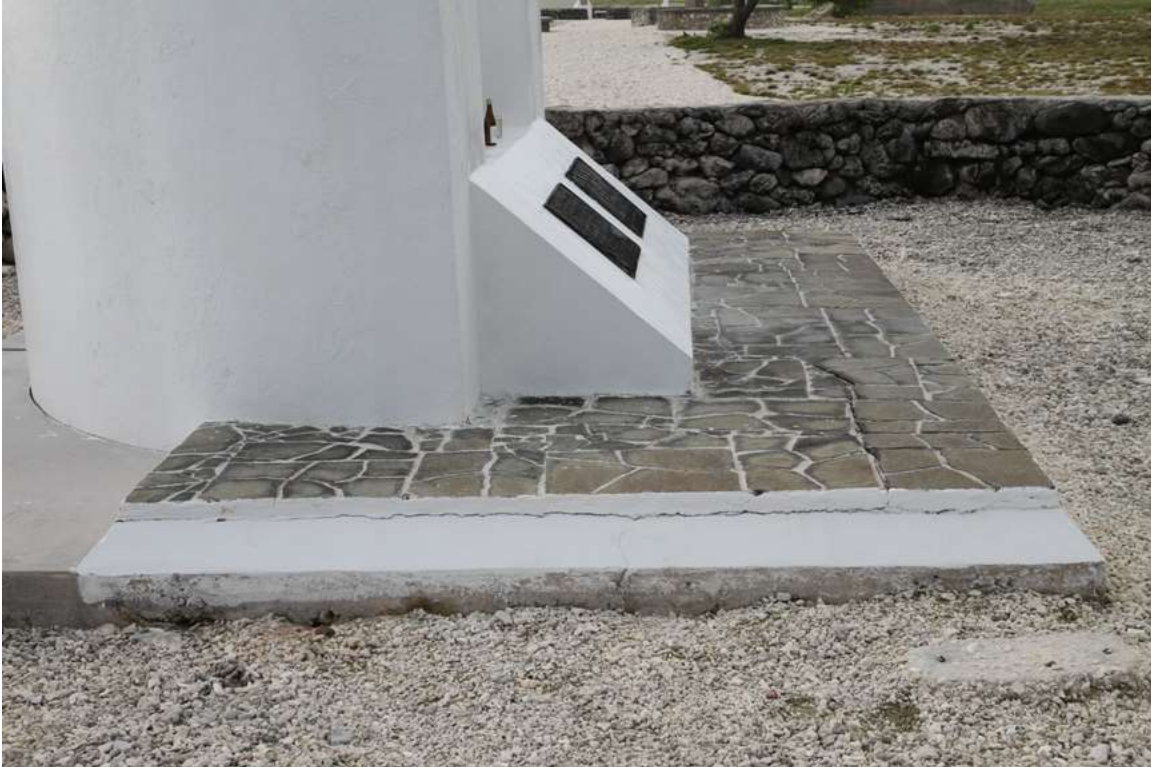
WK09***Japanese Memorial:***

This memorial, located east of Elrod Drive behind the modern terminal, was constructed in 1957 (with an engraved stone added in 1966; Hitchcock 1996) to commemorate the Japanese Soldiers who perished on Wake Island in the years between 1941-1945. The upkeep of this memorial is extremely important as it is one of the features most seen by visitors to Wake Atoll. This feature should be maintained with the appropriate designated conservation materials and methods discussed in this report to prevent future deterioration.

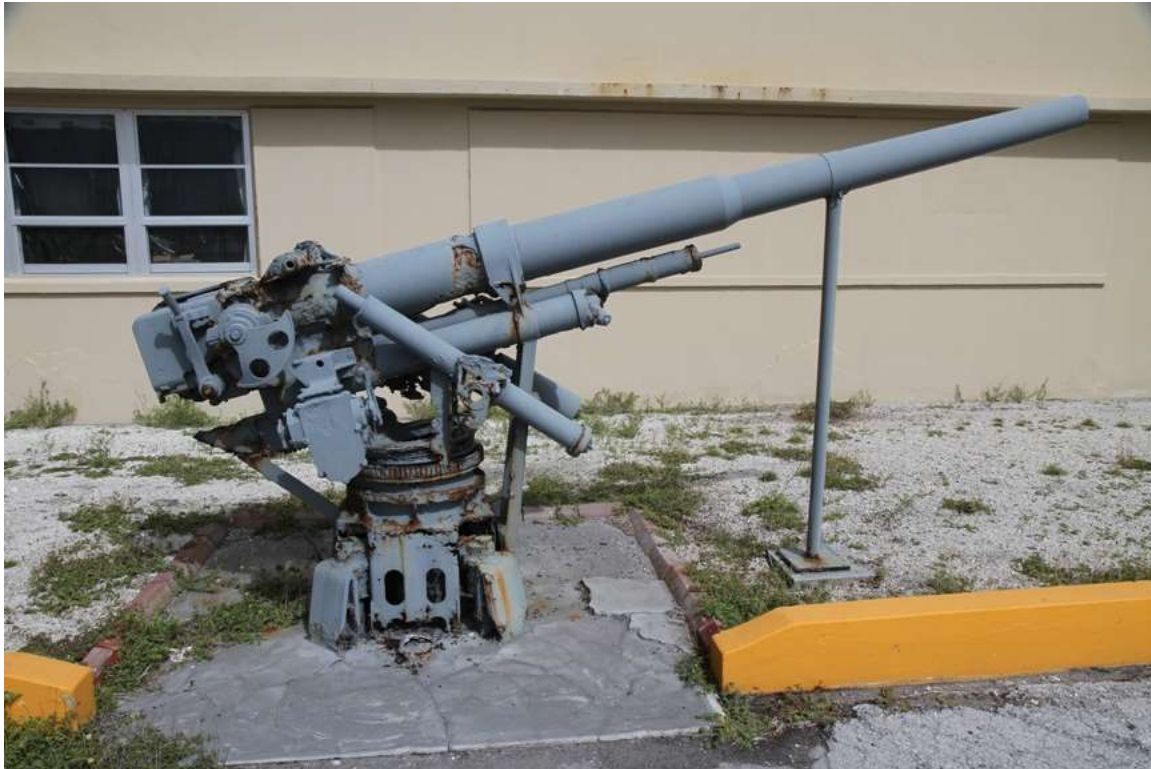
WK14 *Painted U.S. 3-inch Anti-Aircraft Gun:*

This static display, located in front of the modern terminal, is one of two U.S. 3-inch anti-aircraft guns located on Wake Atoll (the other, WK15, is located at the entrance to the downtown area) which has been painted gray to slow corrosion. The paint coating system did not adequately protect the metal and corrosion continues. The upkeep of this memorial is extremely important as it is one of the features most seen by visitors to Wake Atoll. This feature should be maintained with the appropriate designated conservation materials and methods discussed in this report to prevent future deterioration.

An example of its use prior to painting would be complex surfaces of the anti-aircraft guns (WK14) located at the air terminal and at the entrance to the housing area. After application and penetration, and after the Ship-2-Shore has hardened, it can then be painted over along with the rest of these guns. Simply painting over the corrosion on these corroded parts of the gun will leave access to oxygen and the steel will continue to corrode under the paint. Paint adheres well enough to dry Ship-2-Shore films in places where handling and foot wear is not present.

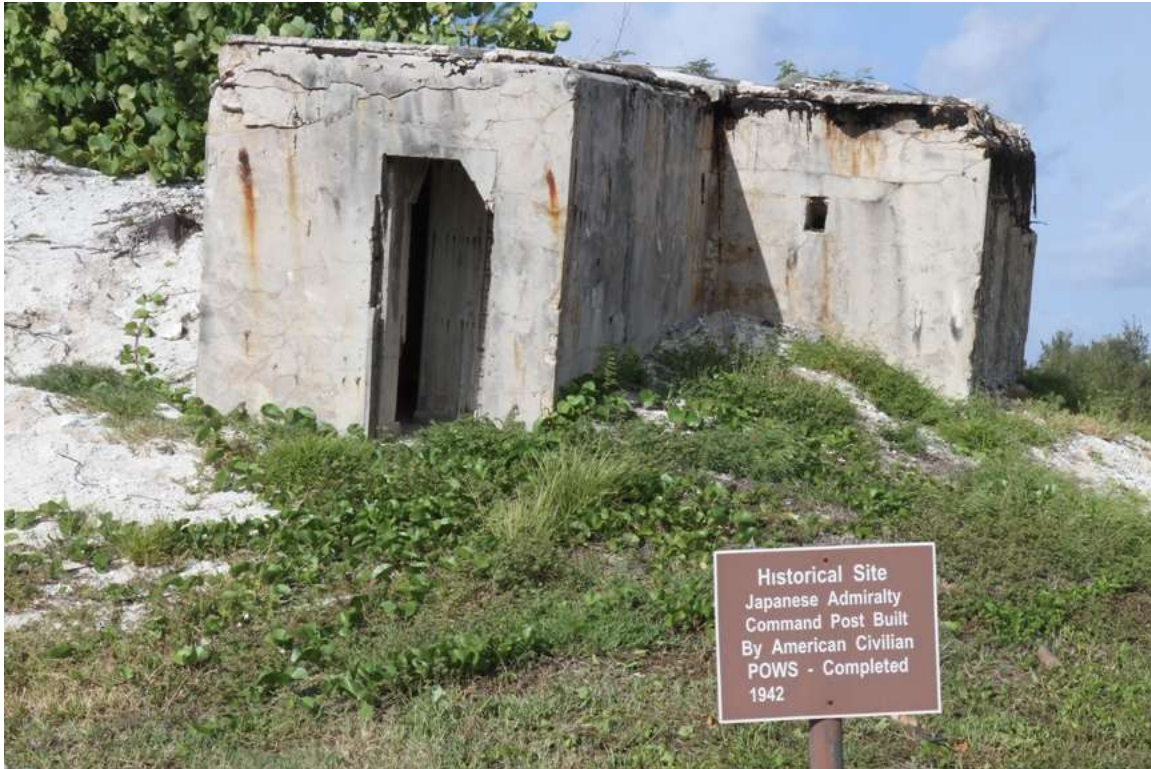
This feature, located on the northeast point of Wake Island near the downtown area and the burned bridge, is composed of a Japanese ferro-concrete bunker used by Rear Admiral Sakaibara as his command post. Drawings from a 1946 report, conducted by the United States Strategic Bombing Survey, indicate that the structure was once two stories high. Today only the second story is visible and accessible. Parts of halls or tunnel entrances on the east and west ends of the second story have been removed leaving only the central portion of the second story intact but buried, and the entire structure is tilted around 15 degrees to the northeast. Gun emplacements and observation posts that are visible in the 1946 drawings are now gone.

The interior of the structure has features of interest. The two side entrances to the extant second story have barriers that create a zig-zag maze that would slow an enemy entrant and also only permits single-file entry. The ferro-concrete walls are covered with distinctive, 1 x 6-inch, cedar lap paneling, painted light green with a lead carbonate-based paint and laid horizontally over planks (1.75 in. or 4.5 cm thick) of compressed cork. Around a half of this planking remains. Cork was a common insulation used for Japanese submarines during WWII. The use of cork in this structure has been suggested to be a defense against either humidity or sound. The interior planking is heavily garnished with graffiti dating back decades. The interior structure shows signs of increased spalling over the past 10 years. The treatment of this structure requires several important procedures. To treat the interior for corrosion, all cedar lap paneling must be labeled and removed to

CAUTION: The paint on the cedar planks within the structure is powdering and is easily transferred to hands and clothing. The paint contains lead (probably lead carbonate) and is toxic. Access to this structure should be barred and warning signage placed.

treat the hidden concrete with the migrating corrosion inhibitor and then replaced. The entire structure also needs to be leveled on the northeast side, built up with coral debitage, and a barrier wall built between the structure and the lagoon to protect from erosion. This feature should be maintained with the appropriate designated conservation materials and methods discussed in this report to prevent future deterioration.

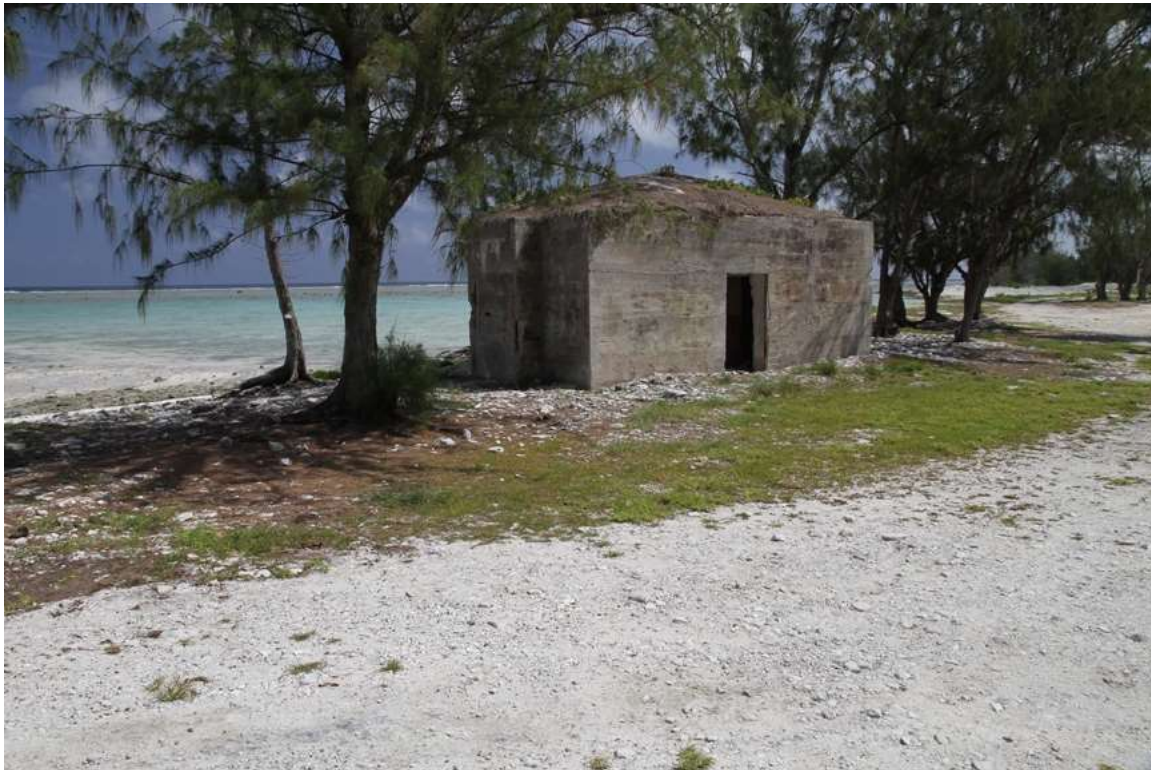
WK36 *Japanese Blockhouse:*

This structure, located on the northeast end of Wake Island adjacent to the billets and behind the Drifter's Reef Bar, is a good example of an American built, Japanese ferro-concrete blockhouse. Measuring 7.6 m in length and 6.9 m in width, this structure is half-octagonal in shape and has three gun ports. The south wall is straight, with the entrance in the center of the wall. Directly inside the entrance is a concrete wall; one must step to the left or to the right to go around this wall to access the area with the gun ports. This structure shows moderate amounts of spalling which can be fixed using methods described in this report. All vegetation and debris should be removed from the structure and it should be maintained with the appropriate designated conservation materials and methods discussed in this report to prevent future deterioration.

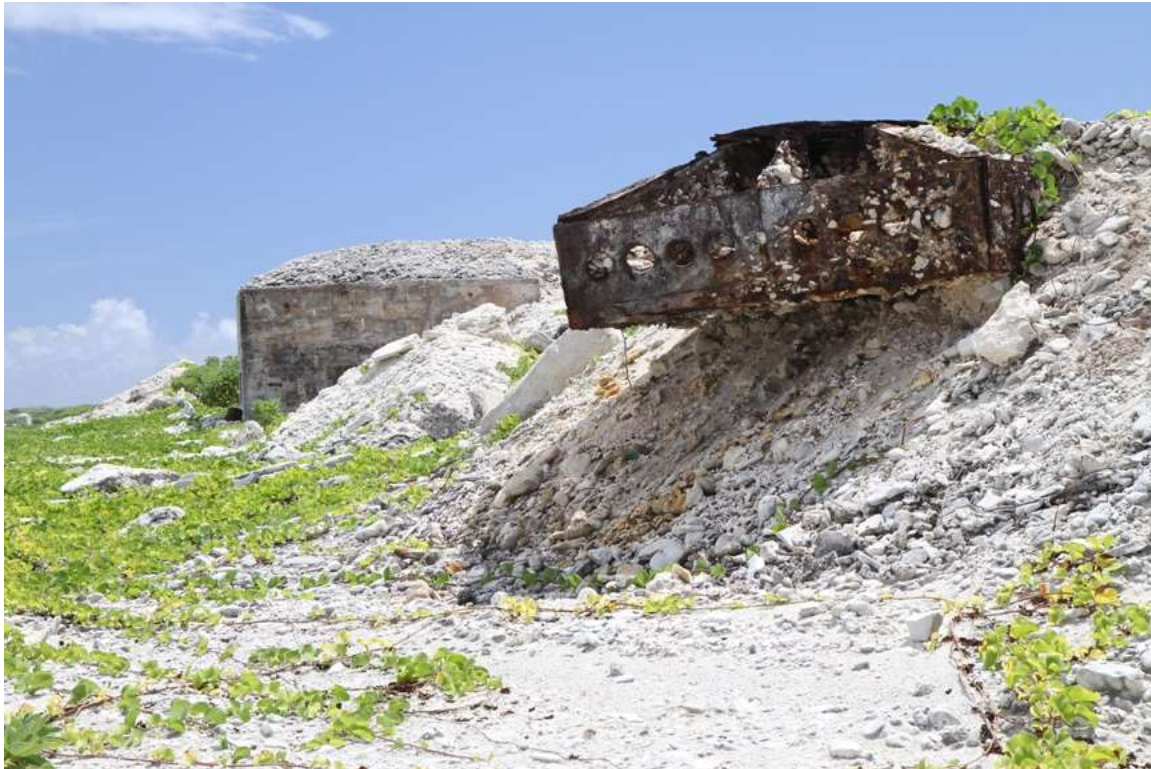
This complex of features contains a blockhouse with observation post, a 5-inch gun mount, coral rubble mounds with rifle pits, and an array of other defensive features. Previously designated as Feature J, the blockhouse and adjacent connected observation post is of the same general design as WK36 with three gun ports. Coral rubble that has been graded flat lies atop the blockhouse. There is an entryway into the lower level of the observation post on the west side of the structure. Also, there is an entryway from above into the connecting tunnel from a point in between the observation post and the blockhouse. The interior of the feature reveals heavily spalled walls and ceilings that create an obvious hazard to visitors. The entire inside should be cleaned of debris, treated with the migrating corrosion inhibitor, certain areas patched with mortar, and vegetation removed. This structure holds very high interpretive potential as a Japanese defensive position. The nearby 5-inch gun mount has been discussed earlier when describing plans for the 3-inch AA gun located on Wilkes Island. The corresponding rifle pits and defensive features should all be cleared of vegetation and trash debitage.

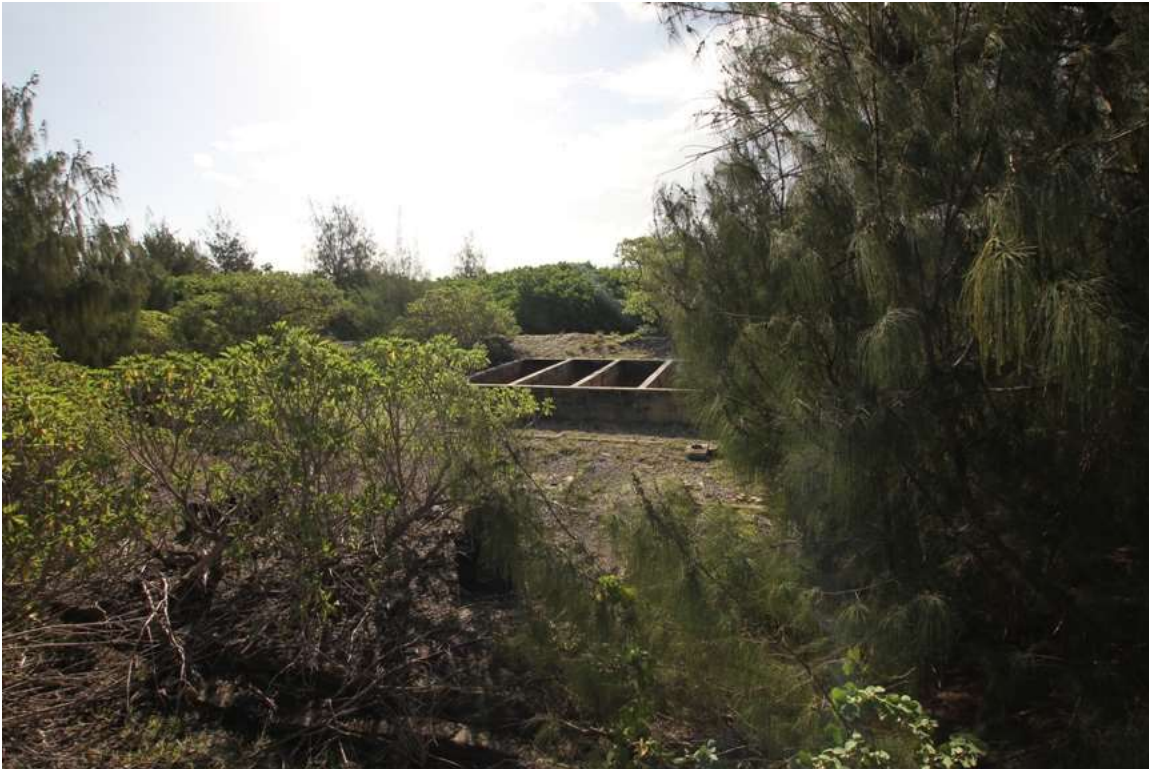
PI01***Japanese Barracks Complex:***

This cluster of features, located in the southeastern portion of Peale Island, is comprised of a concrete foundation belonging to barracks, a water cistern, fire-brick cooking ovens, and an underground chamber or bin located northwest of the ovens. The site has high archaeological potential as well as high interpretive value. The features should be investigated with archaeological excavation and thoroughly mapped. Any discovered artifacts should be kept for the new museum. All vegetation should be removed from the site and thorough analysis of the coral berm revetments surrounding the features is necessary to determine if interior structures exist.

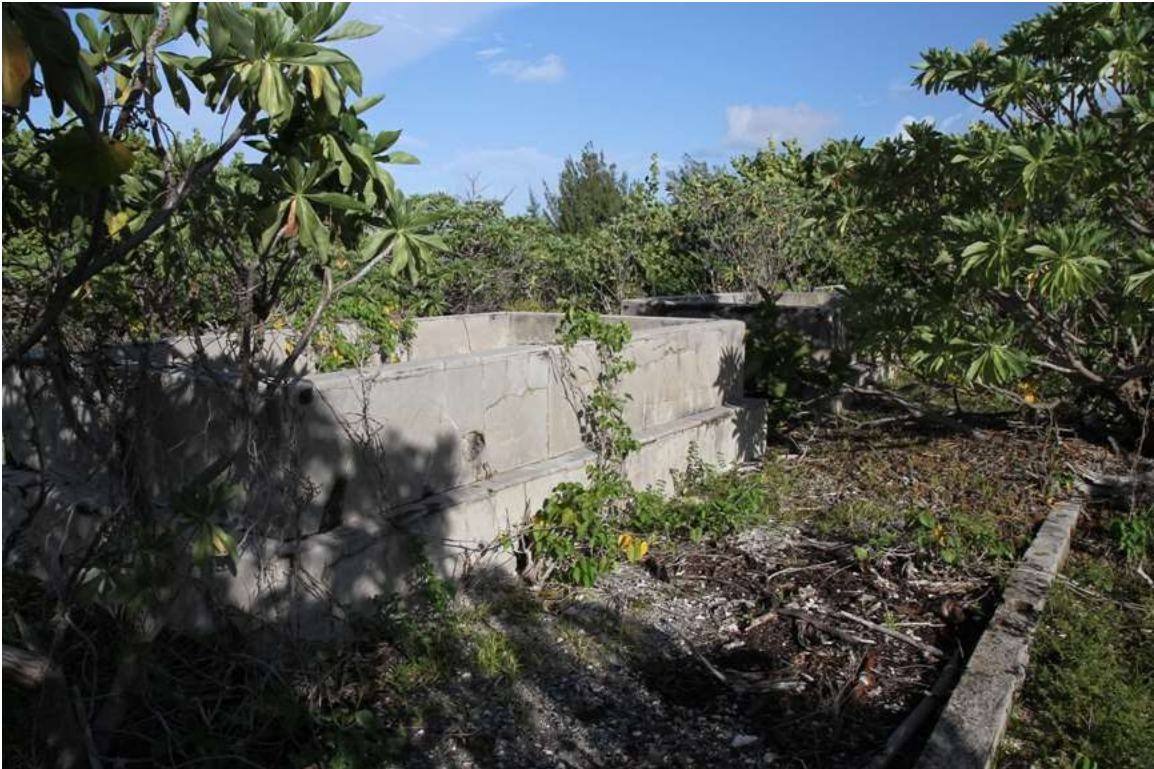
Japanese Baths, Cisterns, and Kitchen Area:

This cluster of features, located in the center of the southern tip of Peale Island, consists of the remains of cisterns, a kitchen area, and baths used by the Japanese officers during their occupation of Wake Atoll. Only the well-made concrete foundations of most of these structures exists. There is a moderate scatter of artifacts including Japanese beer bottles and colored glass fragments. The site should be investigated through archaeological excavation and any discovered artifacts should be kept for the new museum. All vegetation should be removed from the site.

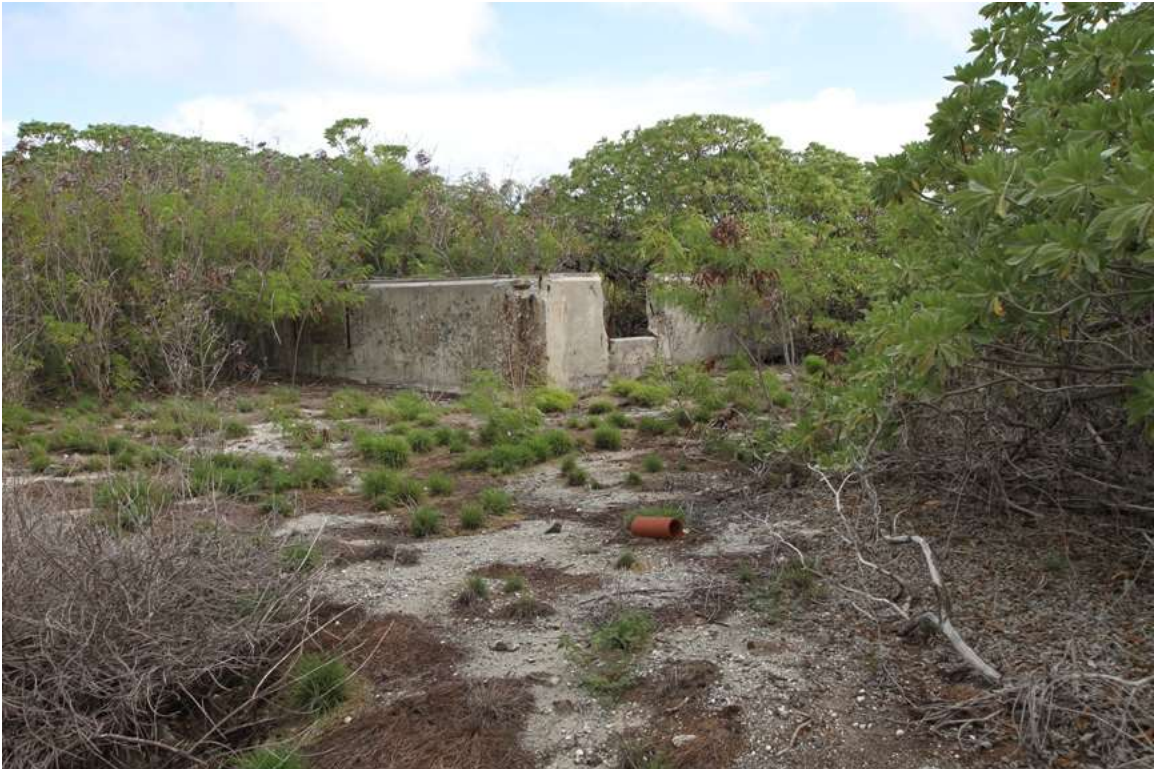
This concrete foundation, located on the south side of Peale Road, southeast of the Coast Guard station, is part of the remains of the U.S. Naval Air Station and the location of a 1978 Japanese cremation. This foundation consists of a large concrete slab with concrete walls extending 1.65 m above the floor. The concrete used in construction of this foundation was finely made using coral sand and gravel aggregate. There are at least four doorways or entries to this structure. Several floor drains are visible where vegetation is cleared. According to Hitchcock (1996, 2010), the remains of 954 Japanese soldiers were cremated here before being returned to Japan in 1978. Bullet holes are present in the walls and the walls are collapsing in several areas. No roof or superstructure is present. Vegetation should be cleared from this area and the migrating corrosion inhibitor should be used on all surfaces to prevent further corrosion.

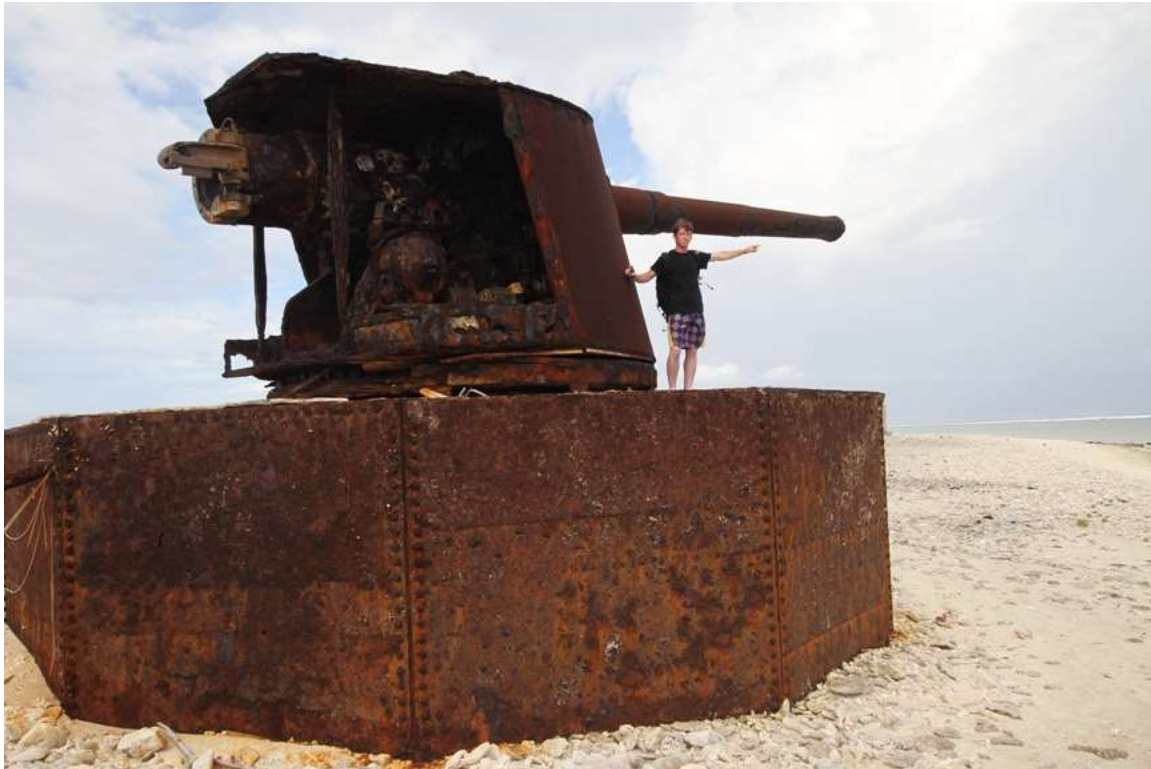
PI19***8-inch Gun:***

This feature, located in the northwest portion of Peale Island, consists of an 8-inch gun and several coral mounds, depressions, and coral cobble features. The 8-inch (200 mm) coastal defense gun is the commanding artifact on this island. The gun is in its original mounted position overlooking the ocean side of the island, and could be pivoted for aiming at targets at sea. A ladder provides access to a cavity under the gun, presumably for maintenance or operation, and may also access a possible tunnel connecting it to an adjacent coral rubble mound. The gun is in a rapidly deteriorating state due to long exposure to humid climate and ocean weather. The logistics of conserving this important piece are detailed within this report.

This gun may represent one of the 12 8-inch, quick-firing guns produced by Vickers company which were purchased legally from England in 1905 by the Japanese for use against the Russians (Alexander 1993). Alternately, the gun may be a Japanese copy of the Vickers type gun, as the Japanese are known to have copied designs from foreign gun manufacturers during World War II (Denfeld 1981).

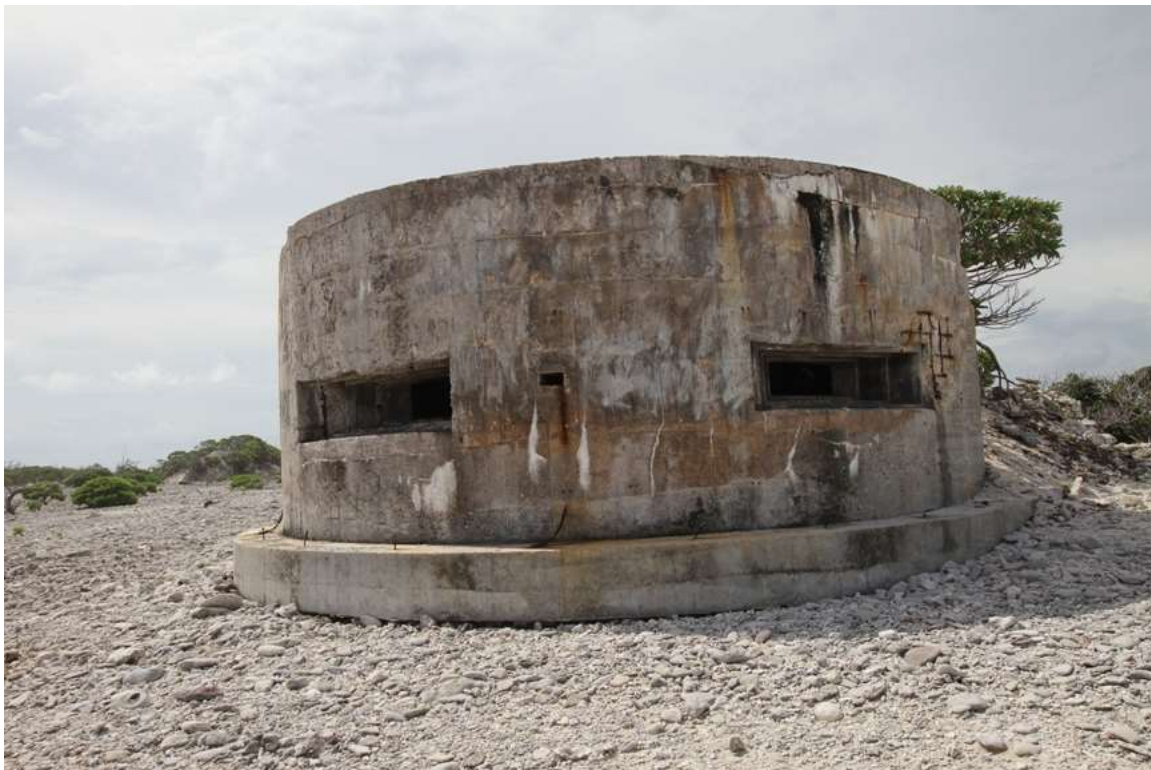
PI28 *10-4-42 Blockhouse:*

Located in the northwestern portion of Peale Island, this cluster is a large defensive bunker complex containing ten features including a ferro-concrete blockhouse. This blockhouse is partitioned into three rooms by concrete walls on the inside. Each has a gun port overlooking to the ocean. The gun ports are 60 cm tall and 2 m wide on the outside, but narrow to only 1 m wide on the inside. The structure is cracked and starting to spall off in several places. There is an inscription, the date "10-4-42", carved in the cement at the northwest corner of the structure. As of 1999 this corner was still intact, but has since spalled off. Additional inscriptions are inscribed in the concrete on the southwest corner. These inscriptions are faint, but appear to be Japanese characters. This feature should be cleared of debris, mortared where necessary, and sprayed with the migrating corrosion

inhibitor. The "10-4-42" inscription is a vital part of this structure and should be reattached immediately.
