**SURVEY, DESIGN AND TRAINING FOR THE
STABILIZATION OF WWII HISTORIC
FEATURES, OBJECTS AND MONUMENTS
ON WAKE ATOLL**

September 2010

Robert G. Lodge, Artifacts Conservator
Ricky Workman, Archaeology Intern

For: RFQ# WI 10-084
“Wake Island Cultural Resource Restoration Consulting”
Chugach Support Services, Inc.

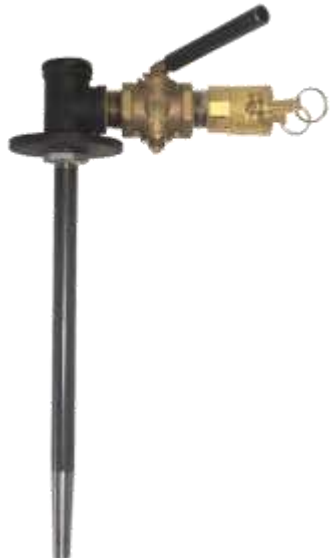
ChemGrout Inc. DrivePacker

Injection nozzles are needed to place into drilled ports to deliver the grout slurry to voids behind spalled concrete. Nozzles have to fit tightly to overcome back pressure of the slurry and keep the slurry under pressure within voids to cause it to disperse as far into the voids as possible. Pressure fit tapered nozzles are the most simple. A nozzle such as the ChemGrout, Inc. “DrivePacker” illustrated below may be the most appropriate for the tasks on the Wake structures.

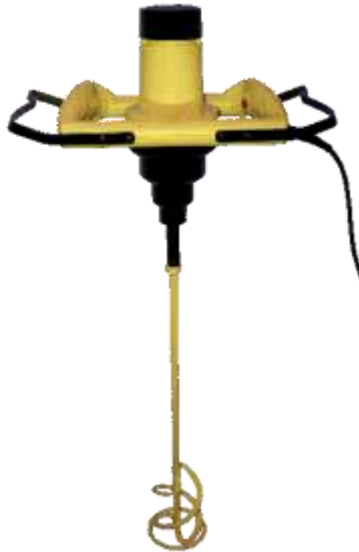
ChemGrout Hand Held 1 HP Electric Grout Mixer

Cementitious grout could be mixed in small quantities manually in mortar tubs with a hoe but an electric mixer is highly recommended even for small quantities to develop uniform and free-flowing properties, as well as to speed production and reduce labor. Though fluid, grout is tough to mix and a powerful mortar mixer is needed for even small quantities of 5 gallons. A specialty grout mixer is recommended, such as the 1 HP electric mixer offered by ChemGrout or similar mixers by others.

If grout is mixed too thinly, two things will go wrong: (1) the grout will shrink in the void on curing, and (2) the solids will fall out of suspension either in the mixing container or in the void.

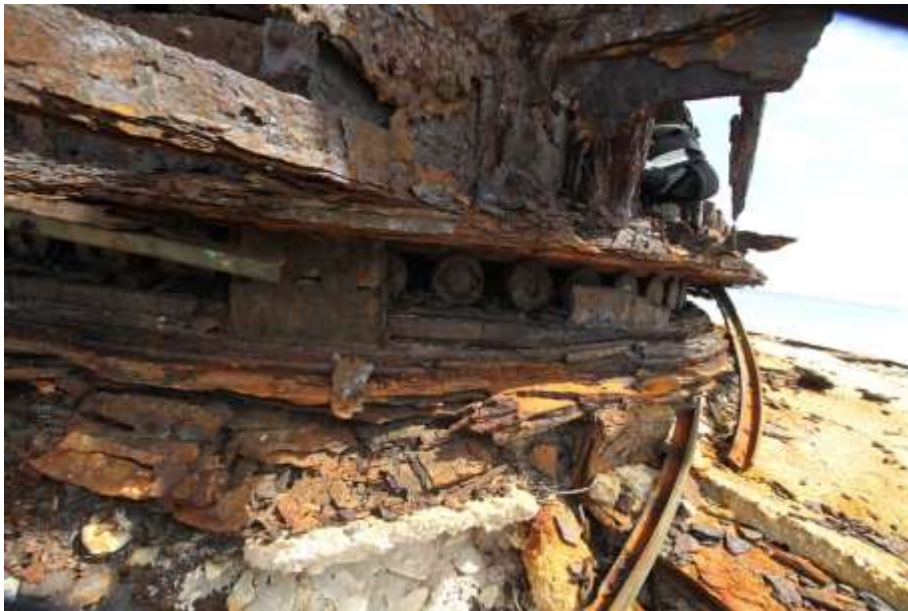
1. Peale Island 8 in. Gun (PI19).

Two examples of this complete loss to corrosion are:

The recommended penetrant and consolidant would be one of two low viscosity 2-part 100% solids industrial epoxies:

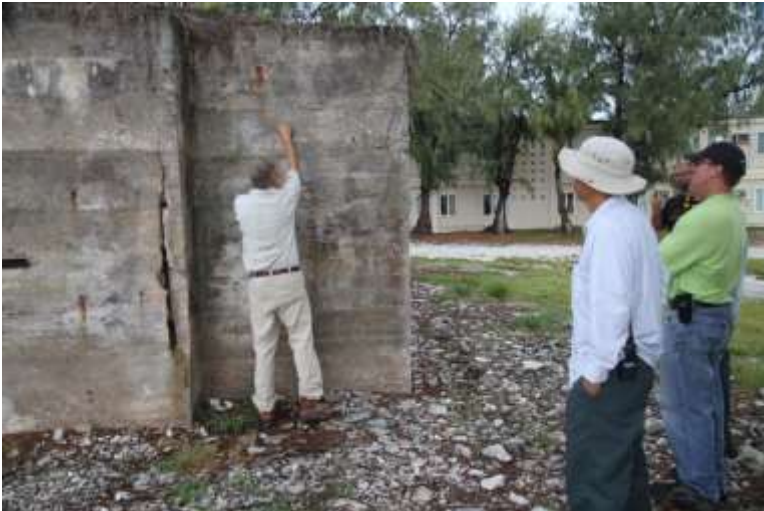
Robert Lodge demonstrating to BOS personnel how to locate voids that need grout injection and/or pinning.

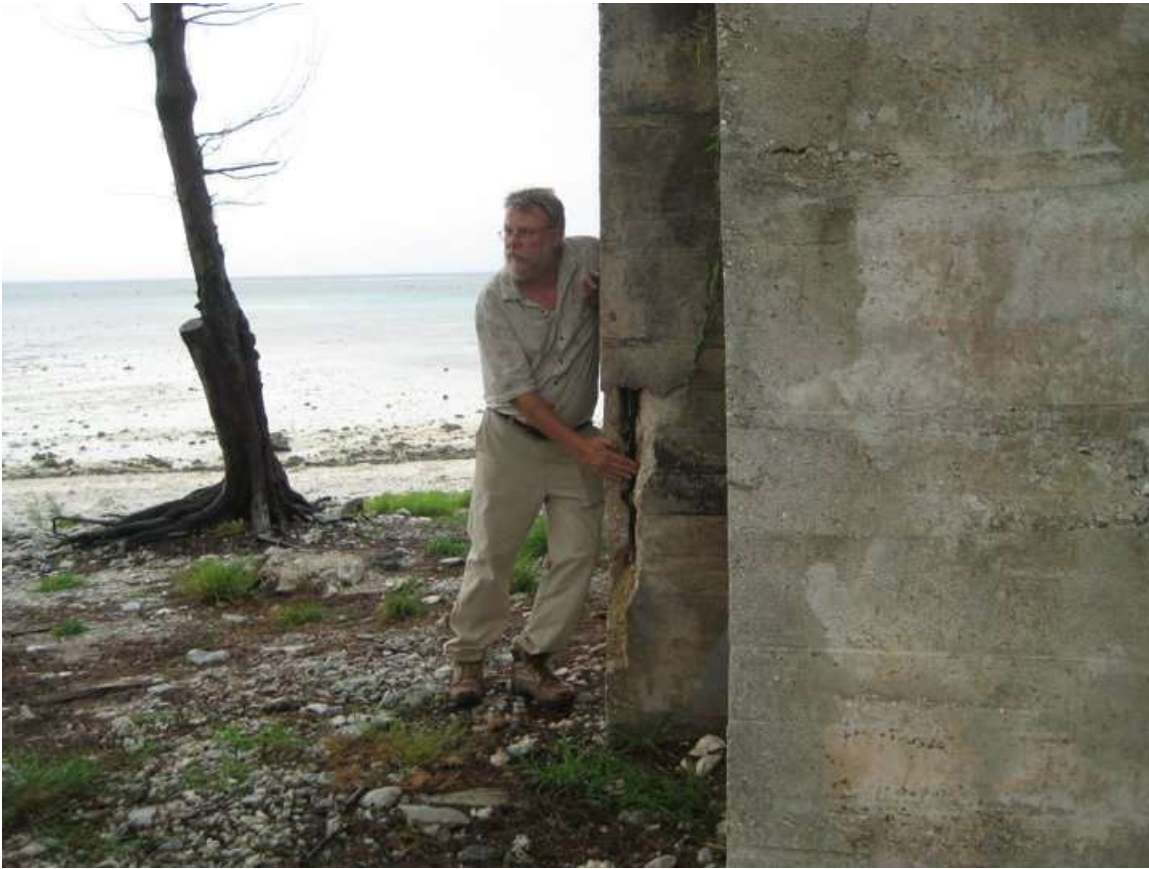
Robert Lodge at the Japanese blockhouse (WK36) explaining the preliminary procedures necessary prior to grout injection and pinning. Here, he explains how available openings to voids such as this side crack can be used for pressure-washing out debris. Then, such openings need to be sealed with mortar to prevent grout loss under the pressure of injection. Finally, the strategies for drilling injection ports for grout and drilling for pins were explained, including the use of mechanical anchor pins and grouted pins.
